ANNUAL REPORT FOR 2013

**Unnamed Tributary to Smith Mill Run
Wayne County
TIP No. R-2554BA – Permitted Site 4
COE Action ID: SAW-200-00252
DWQ #: 20080570**

Prepared By:
Roadside Environmental Unit & Natural Environment Section
North Carolina Department of Transportation
July 2013

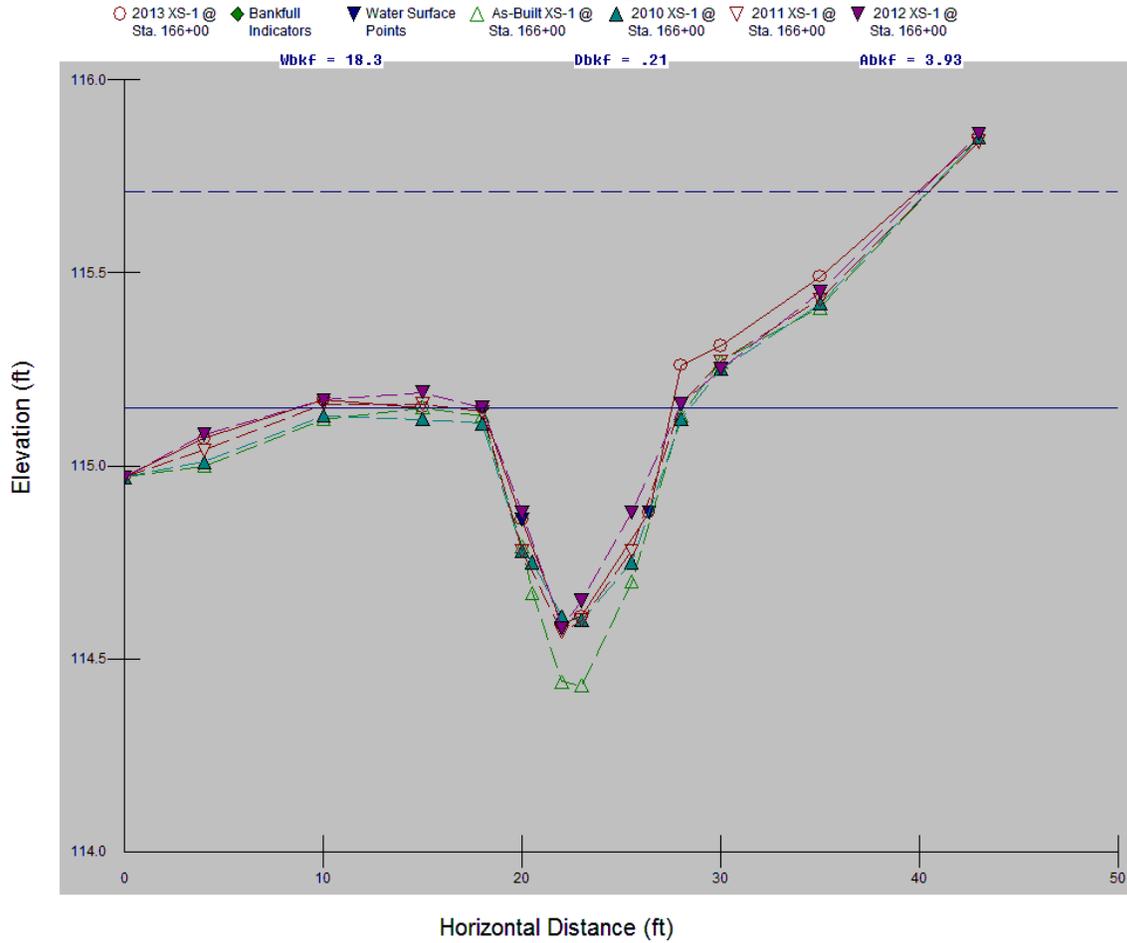
R-2554BA Site 4 XS-1 @ Sta. 166+00

Cross-Section #1 (Riffle) Abbreviated Morphological Summary					
	2010	2011	2012	2013	2014
Bankfull Width (ft)	9.93	9.87	9.91	9.54	
Bankfull Mean Depth (ft)	0.32	0.34	0.30	0.34	
Width/Depth Ratio	31.03	29.03	33.03	28.06	
Bankfull Cross Sectional Area (ft ²)	3.18	3.4	2.93	3.22	
Maximum Bankfull Depth (ft)	0.51	0.57	0.57	0.56	
Width of the Floodprone Area (ft)	43	40.46	40.27	39.89	
Entrenchment Ratio	3.9	4.1	4.06	4.18

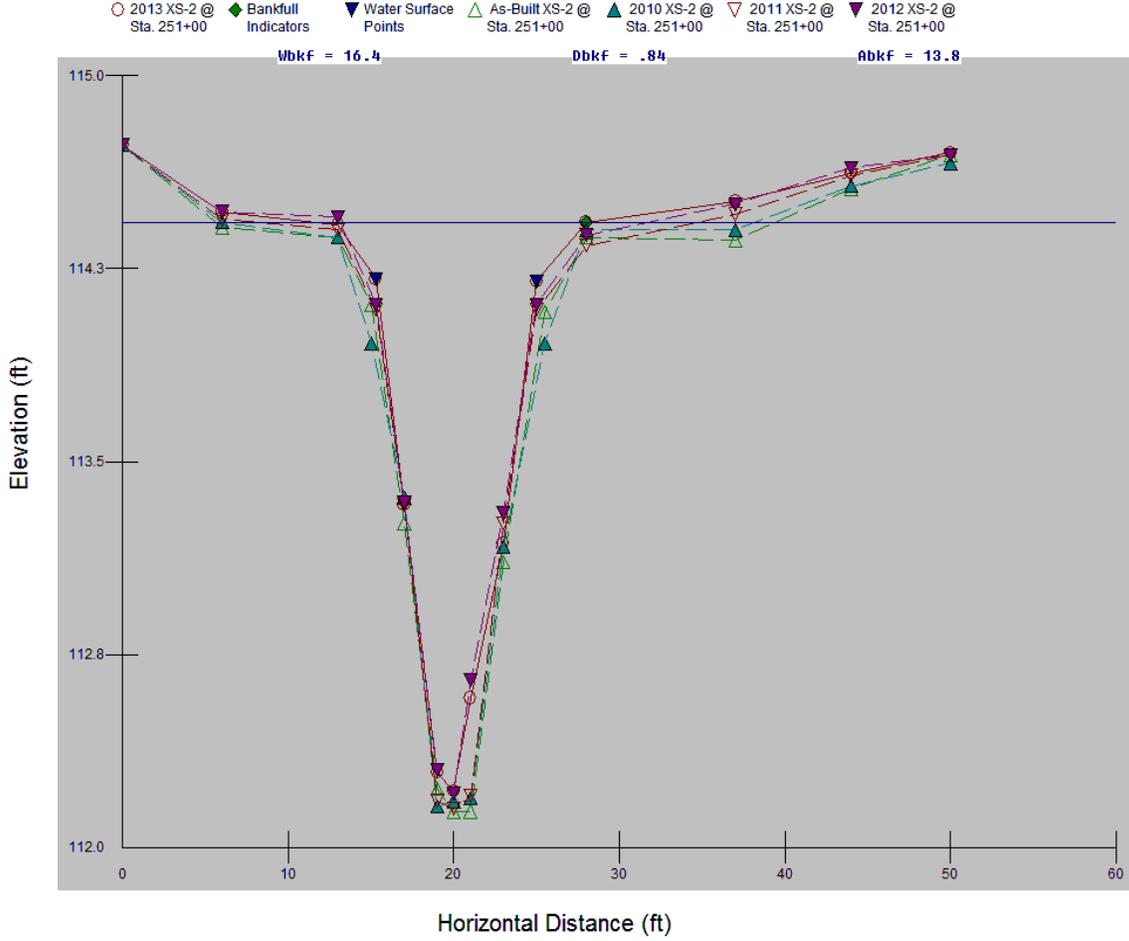
R-2554BA Site 4 XS-2 @ Sta. 251+00

Cross-Section #2 (Pool) Abbreviated Morphological Summary*					
	2010	2011	2012	2013	2014
Bankfull Cross Sectional Area (ft ²)	15.81	13.74	13.12	13.76	
Maximum Bankfull Depth (ft)	2.24	2.19	2.17	2.21	
Bankfull Mean Depth (ft)	0.85	0.94	0.9	0.84	
Bankfull Width (ft)	18.5	14.55	14.53	16.4

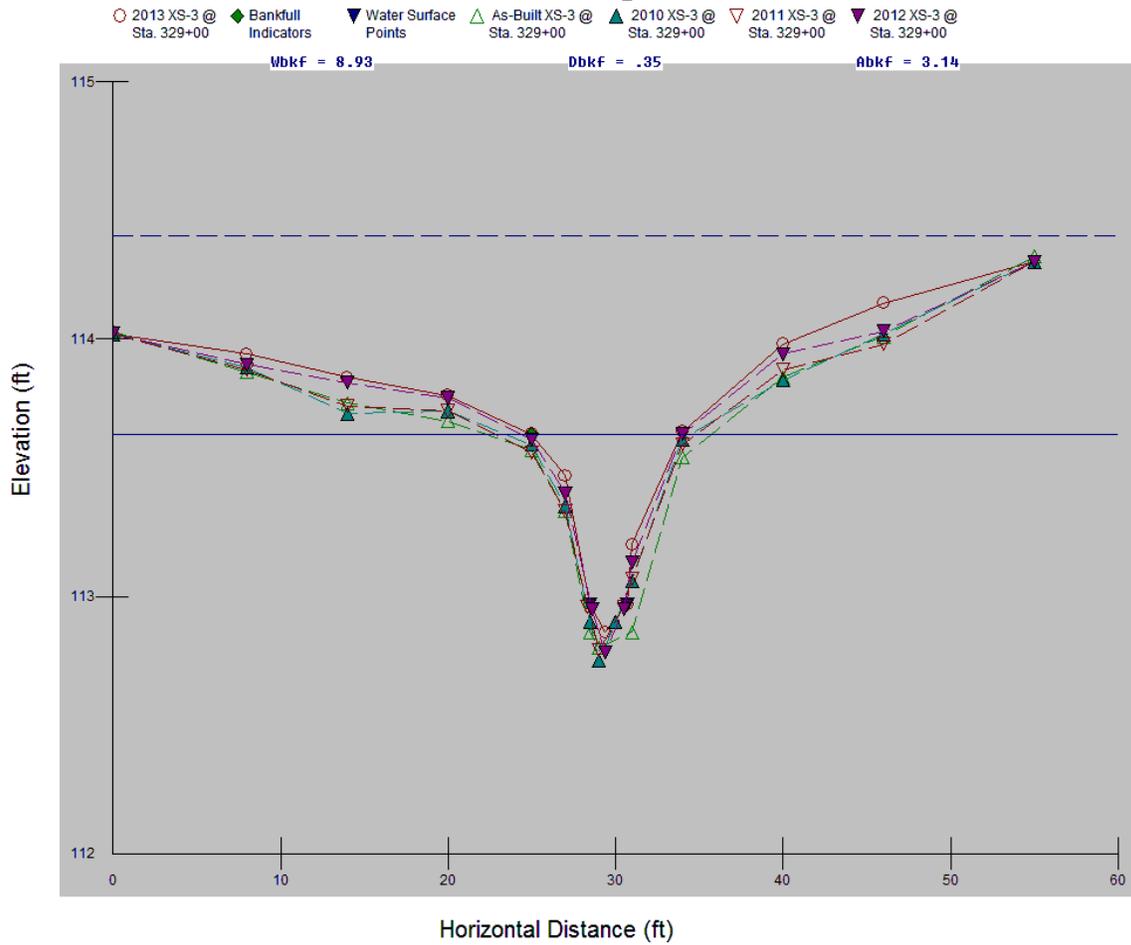
R-2554BA Site 4 XS-3 @ Sta. 329+00

Cross-Section #3 (Riffle) Abbreviated Morphological Summary					
	2010	2011	2012	2013	2014
Bankfull Width (ft)	8.89	8.83	8.88	8.93	
Bankfull Mean Depth (ft)	0.39	0.37	0.37	0.35	
Width/Depth Ratio	22.79	23.86	24	25.51	
Bankfull Cross Sectional Area (ft ²)	3.46	3.24	3.3	3.14	
Maximum Bankfull Depth (ft)	0.84	0.77	0.83	0.77	
Width of the Floodprone Area (ft)	55	55	55	55	
Entrenchment Ratio	6.19	6.23	6.19	6.16

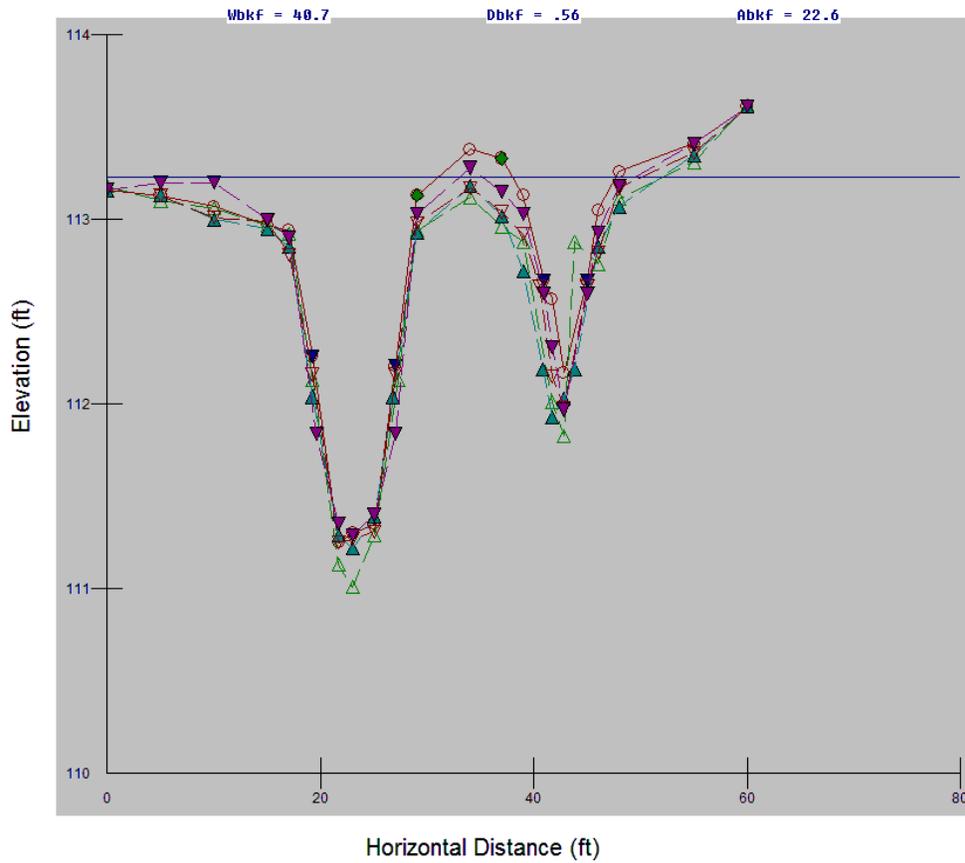
R-2554BA Site 4 XS-4 Pool @ Sta. 426+50 (Main) and Riffle @ Sta. 64+00 (Trib.)

○ 2013 XS-4 ◆ Bankfull Indicators ▼ Water Surface Points △ As-Built XS-4 ▲ 2010 XS-4 ▽ 2011 XS-4 ▾ 2012 XS-4

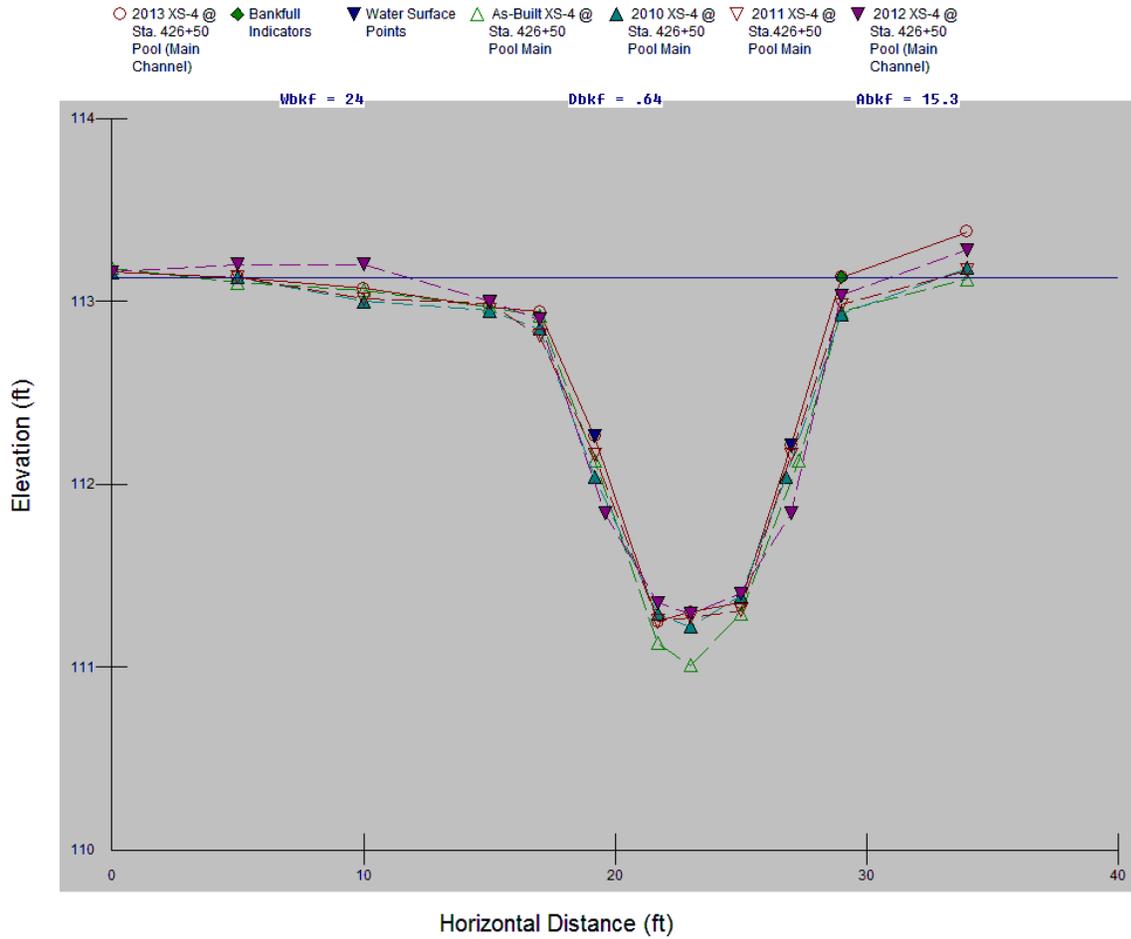
R-2554BA Site 4 XS-4 @ Sta. 426+50 Pool (Main Channel)

Cross-Section #4 (Main Pool) Abbreviated Morphological Summary*					
	2010	2011	2012	2013	2014
Bankfull Cross Sectional Area (ft ²)	12.89	13.36	14.5	15.14	
Maximum Bankfull Depth (ft)	1.71	1.73	1.74	1.88	
Bankfull Mean Depth (ft)	0.95	0.96	0.98	0.8	
Bankfull Width (ft)	13.6	13.89	14.75	19

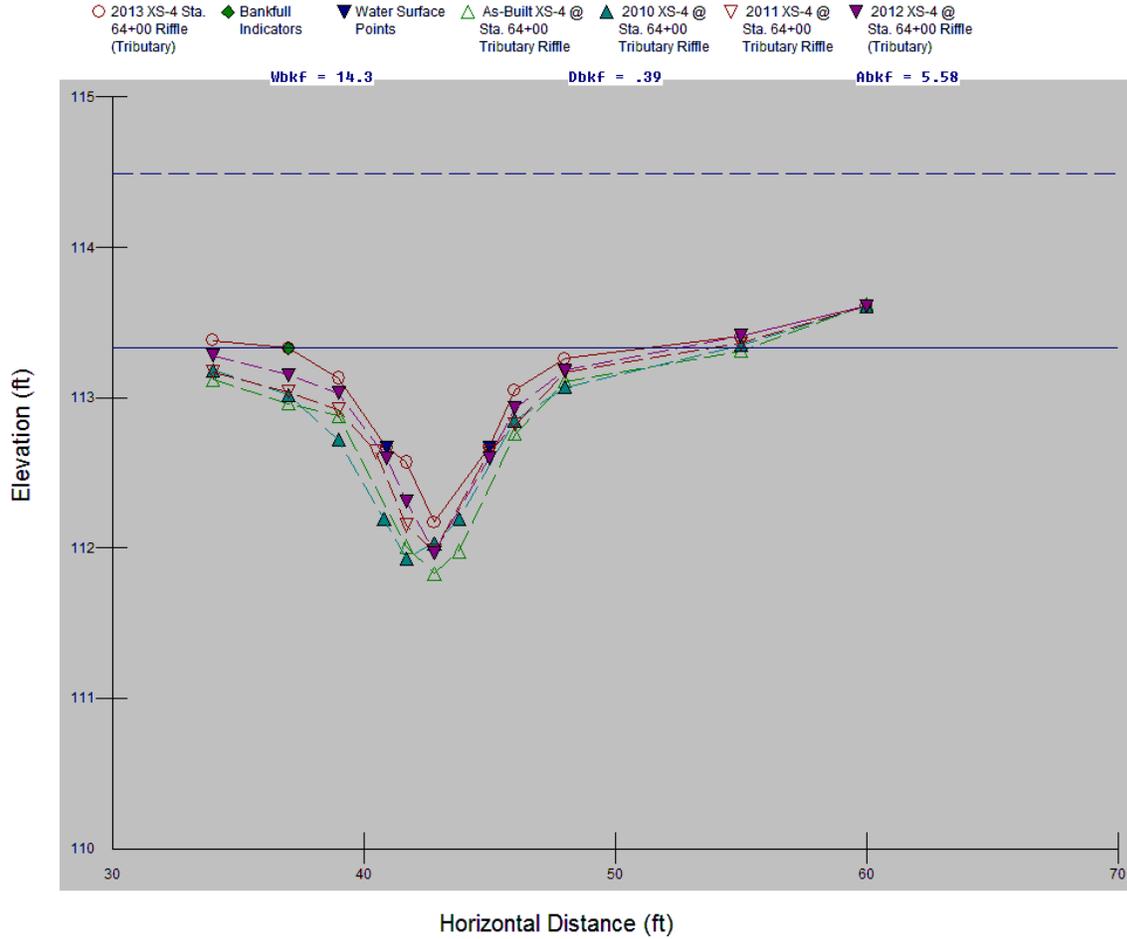
R-2554BA Site 4 XS-4 Sta. 64+00 Riffle (Tributary)

Cross-Section #4 (Tributary Riffle) Abbreviated Morphological Summary					
	2010	2011	2012	2013	2014
Bankfull Width (ft)	10.55	10.26	10.76	14.27	
Bankfull Mean Depth (ft)	0.52	0.43	0.46	0.39	
Width/Depth Ratio	20.29	23.86	23.39	36.59	
Bankfull Cross Sectional Area (ft ²)	5.47	4.41	4.91	5.58	
Maximum Bankfull Depth (ft)	1.09	1.06	1.18	1.16	
Width of the Floodprone Area (ft)	26	26	26	26	
Entrenchment Ratio	2.47	2.53	2.42	1.82

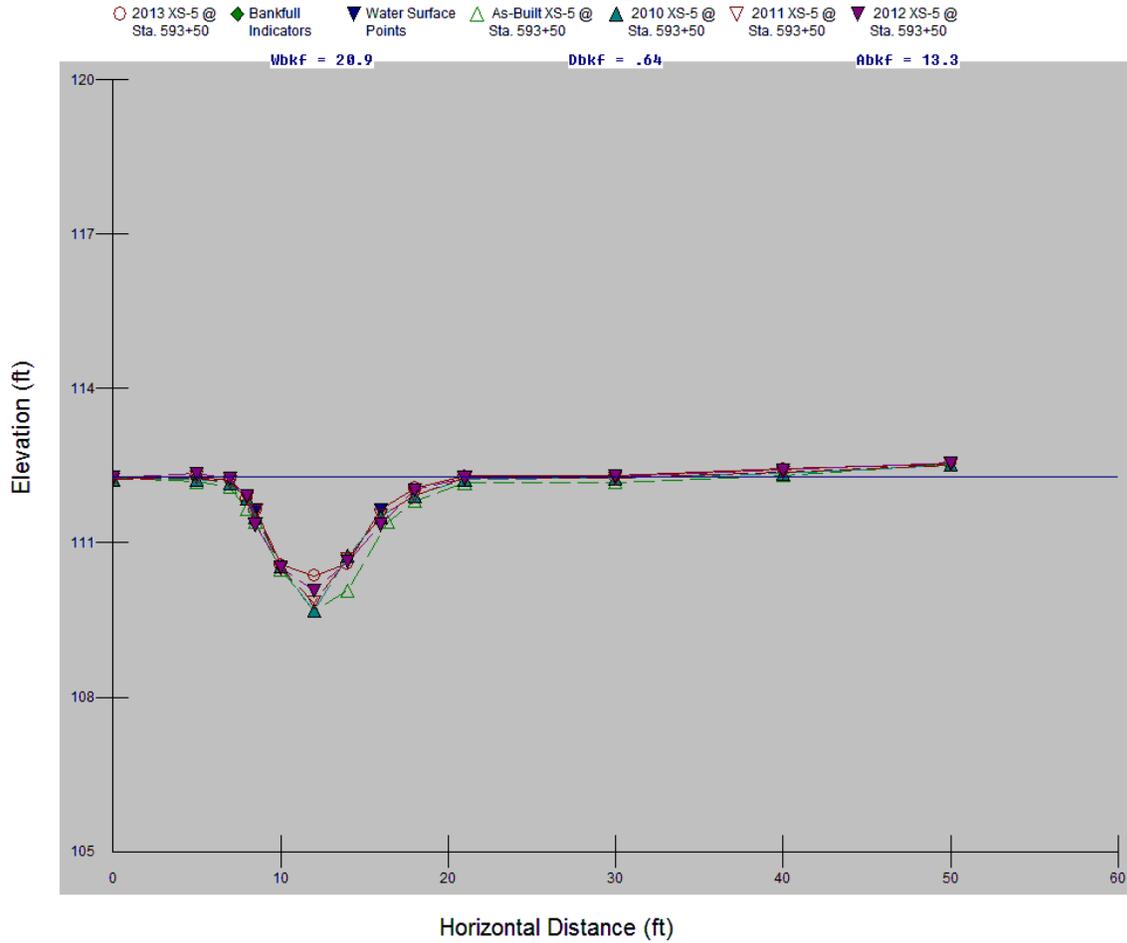
R-2554BA Site 4 XS-5 @ Sta. 593+50

Cross-Section #5 (Pool) Abbreviated Morphological Summary*					
	2010	2011	2012	2013	2014
Bankfull Cross Sectional Area (ft ²)	14.34	14.6	14.27	13.37	
Maximum Bankfull Depth (ft)	2.55	2.43	2.19	1.94	
Bankfull Mean Depth (ft)	0.9	0.91	0.99	0.84	
Bankfull Width (ft)	16	16	14.36	16

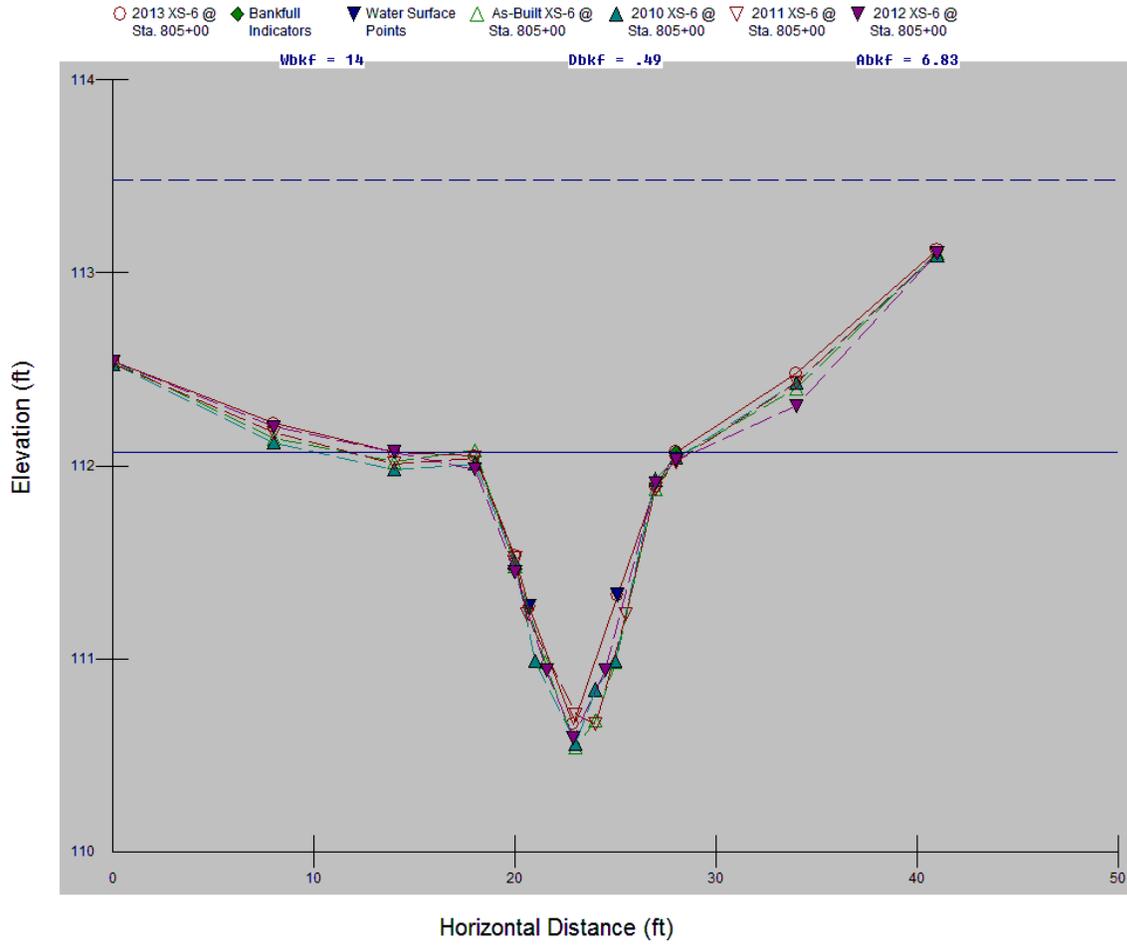
R-2554BA XS-6 @ Sta. 805+00

Cross-Section #6 (Riffle) Abbreviated Morphological Summary					
	2010	2011	2012	2013	2014
Bankfull Width (ft)	9.73	9.92	12.22	14	
Bankfull Mean Depth (ft)	0.75	0.72	0.59	0.49	
Width/Depth Ratio	12.97	13.78	20.71	28.57	
Bankfull Cross Sectional Area (ft ²)	7.28	7.1	7.26	6.83	
Maximum Bankfull Depth (ft)	1.45	1.36	1.44	1.41	
Width of the Floodprone Area (ft)	41	41	41	41	
Entrenchment Ratio	4.21	4.13	3.35	2.93

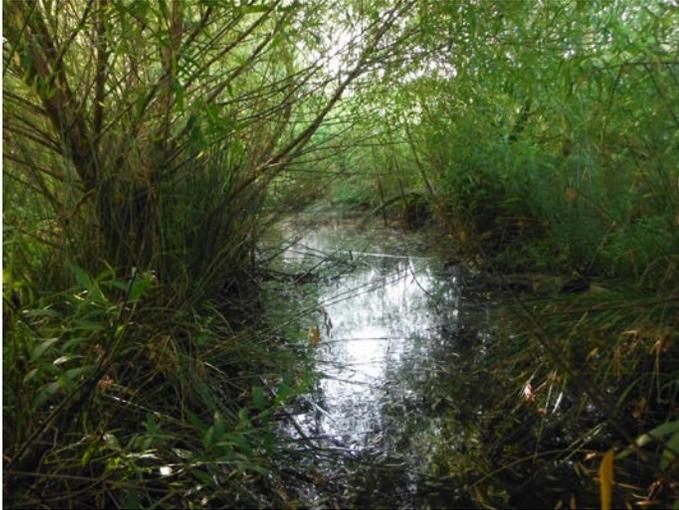
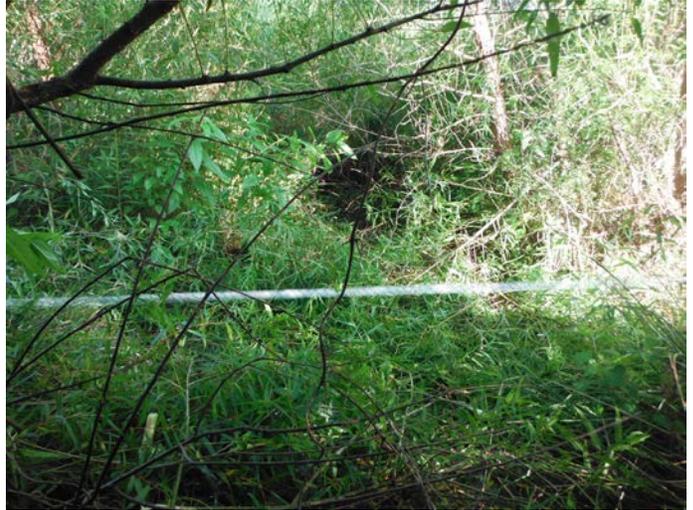
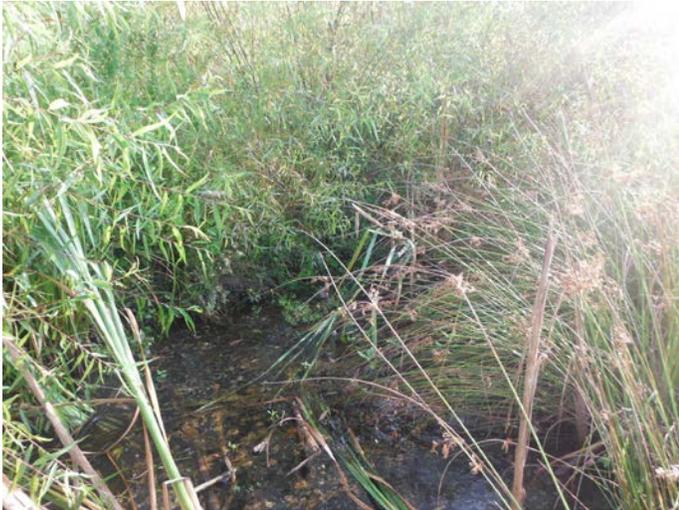
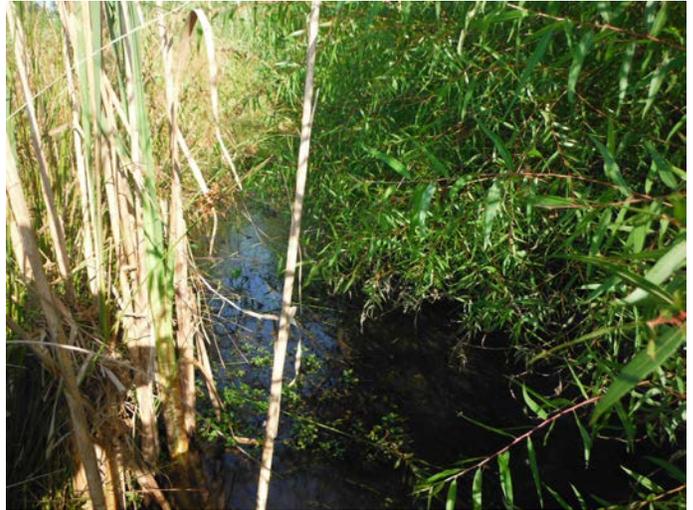
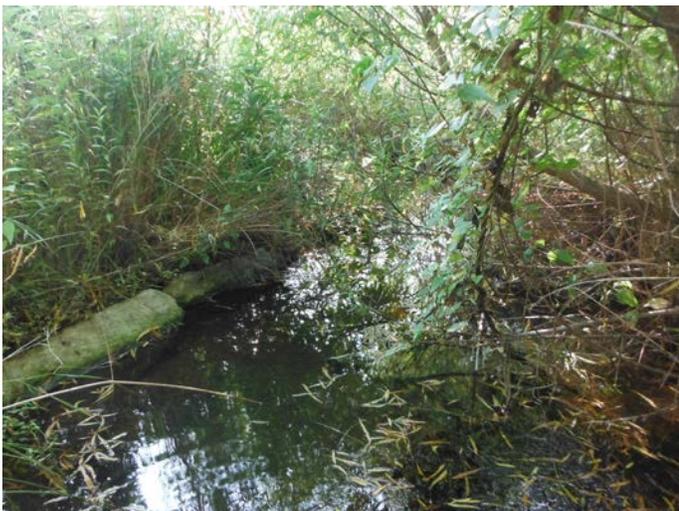
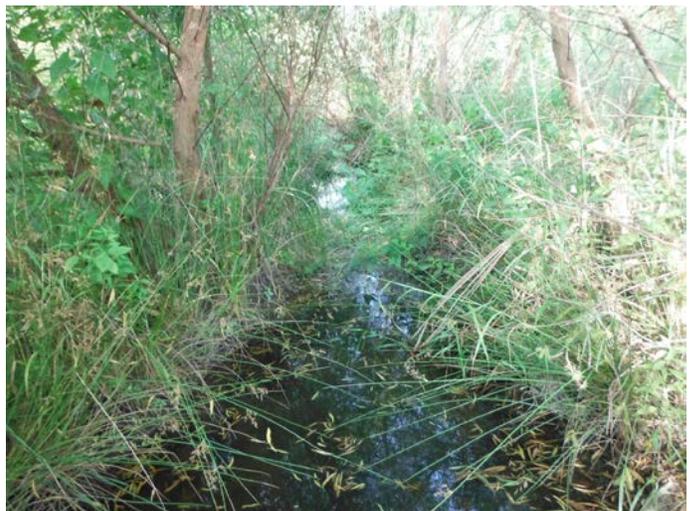
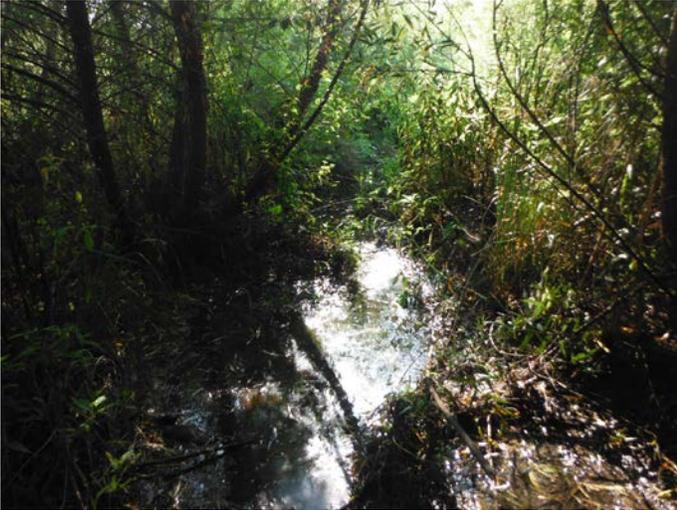
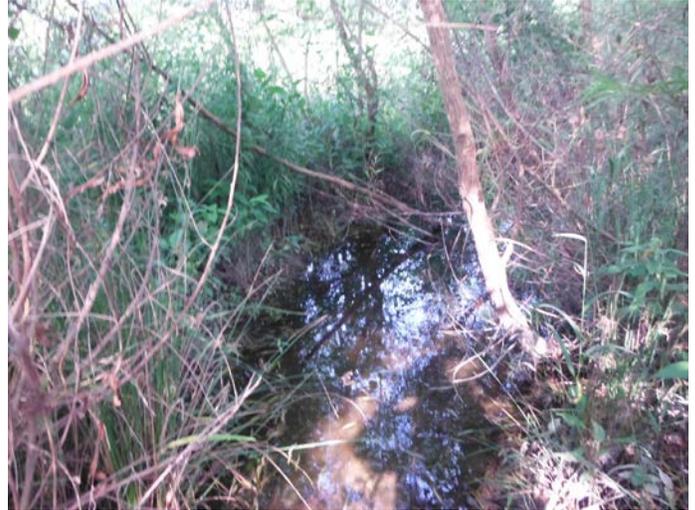
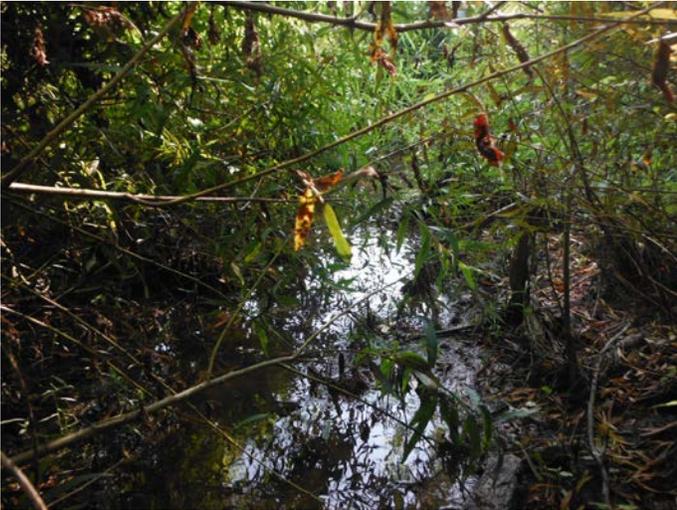
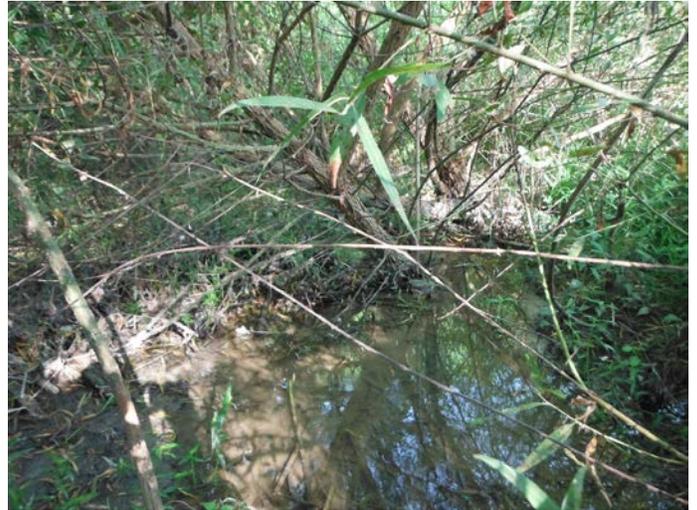
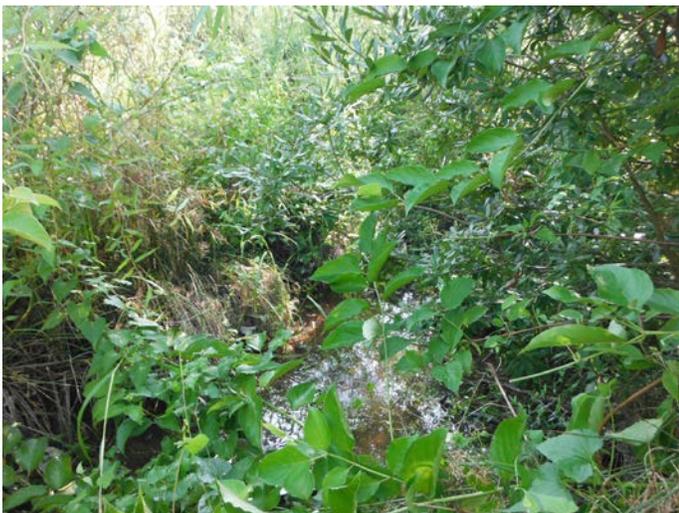
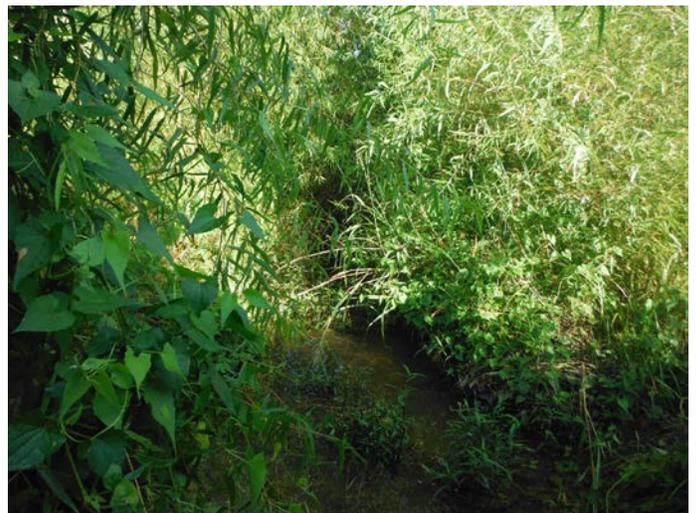
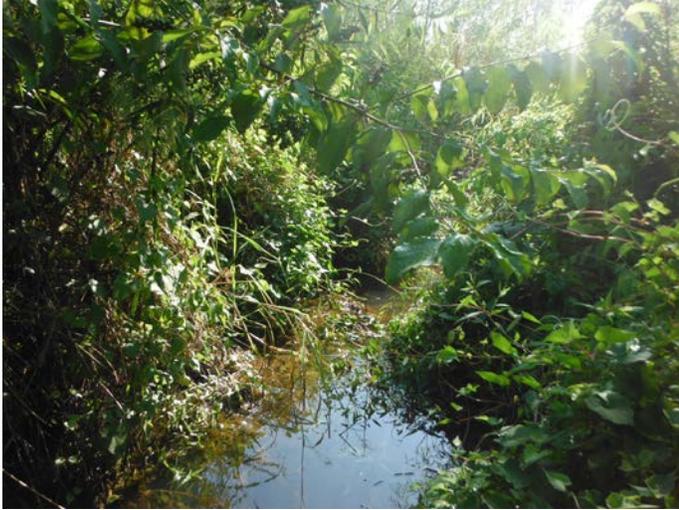
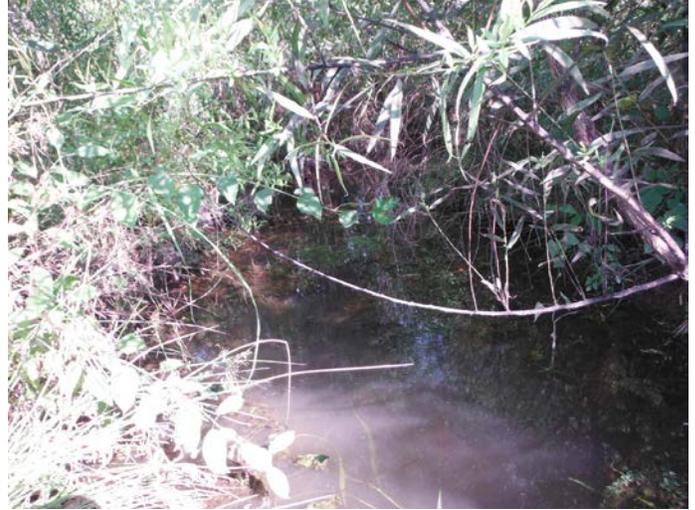
A visual inspection of the channel and photos taken from photo points 1 through 6 showed that the channel bed is stable throughout the stream relocation at this time.

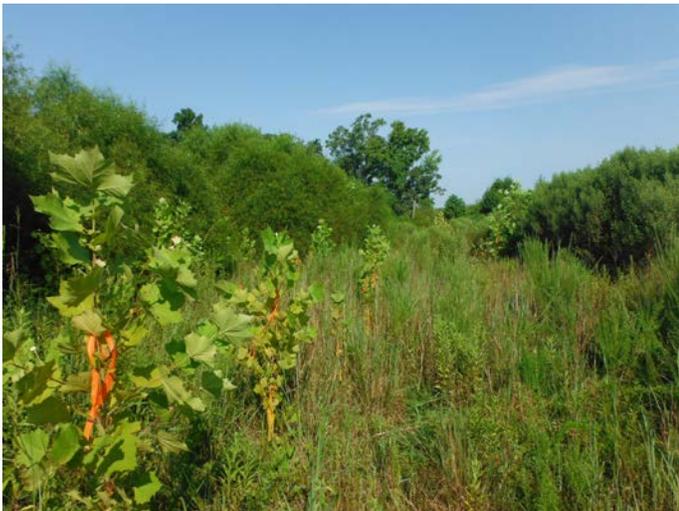
Vegetation Plot #1

Buffer Vegetation: One 50 ft. x 50 ft. vegetation plot and one 100 ft. x 25 ft. vegetation plot were set to determine the trees per acre in the buffer area.

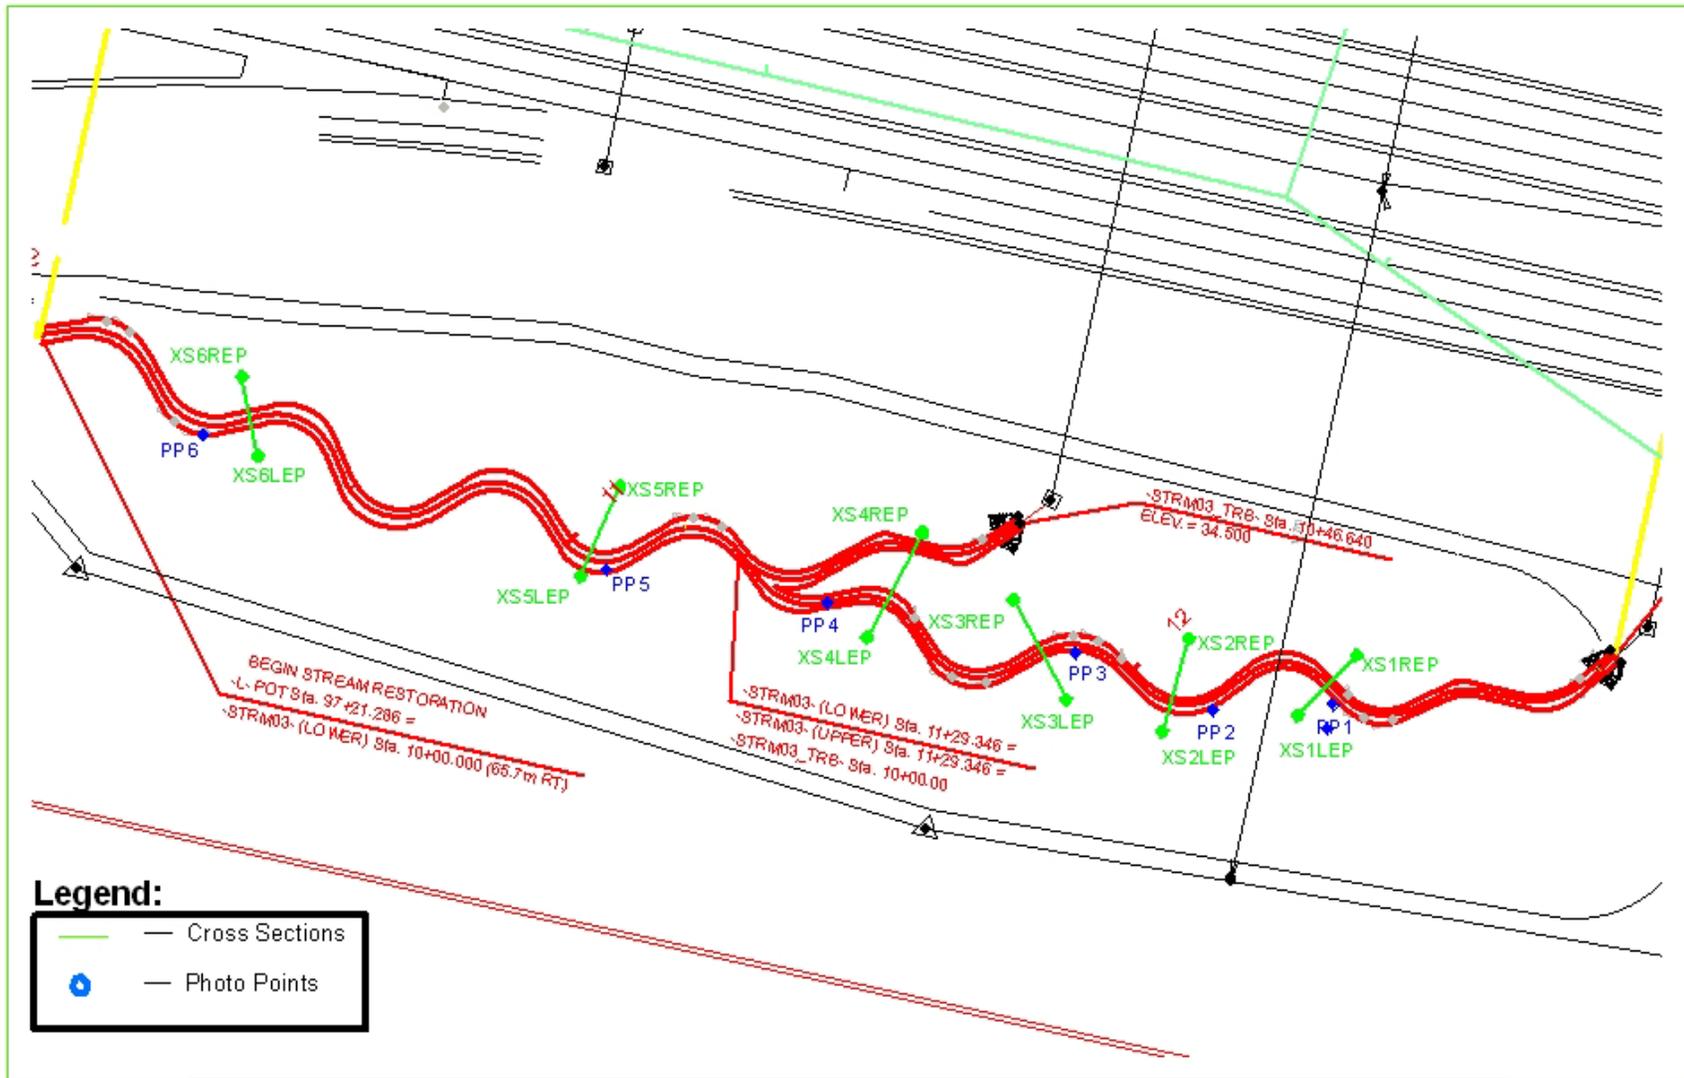
**Photo Point and Cross Section Locations
R-2554 BA UT to Smith Mill Run
Wayne County, North Carolina**

- ◆ Cross Section #1. UT to Smith Mill Run, Station 166+00 linear feet, midpoint of riffle
- ◆ Cross Section #2. UT to Smith Mill Run, Station 251+00 linear feet, midpoint of pool
- ◆ Cross Section #3. UT to Smith Mill Run, Station 329+00 linear feet, midpoint of riffle
- ◆ Cross Section #4. UT to Smith Mill Run, Station 426+50 linear feet, midpoint of pool (main channel) and Station 64+00 linear feet, midpoint of riffle (tributary)
- ◆ Cross Section #5 UT to Smith Mill Run, Station 593+50 linear feet, midpoint of pool
- ◆ Cross Section #6 UT to Smith Mill Run, Station 805+00 linear feet, midpoint of riffle
