ANNUAL REPORT FOR 2000

**Little McQueen Mitigation Site
Robeson County
Project No. 8.T461801
TIP No. R-2558**

Prepared By:
Natural Systems Unit & Roadside Environmental Unit
North Carolina Department of Transportation
December 2000

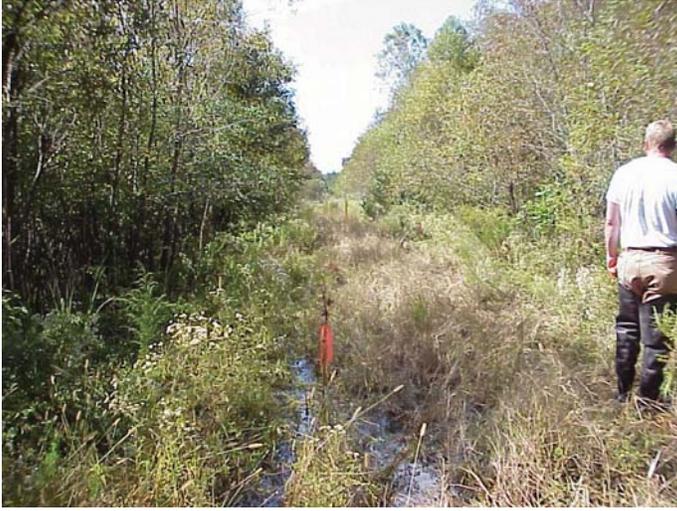
Photo 1 (Transect 1)

Transect 1 had 2-4" surface water and transect 2 had 10-15" surface water. Some beaver damage was observed in the adjacent wooded sections of the site. Also many cypress and gum seedlings were observed re-generating naturally along the paths throughout the site. No evidence of vehicle or foot traffic observed on NCDOT property. There are several large trees down across the monitoring transects. The culvert that was removed at Steven's Canal has made access extremely difficult.
