ANNUAL REPORT FOR 2012

Banks School Road Wetland Mitigation Site
Lenoir County
TIP No. R-2719A
COE Action ID: 200511238
DWQ: 20050787

Prepared By:
Natural Environment Section & Roadside Environmental Unit
North Carolina Department of Transportation
December 2012

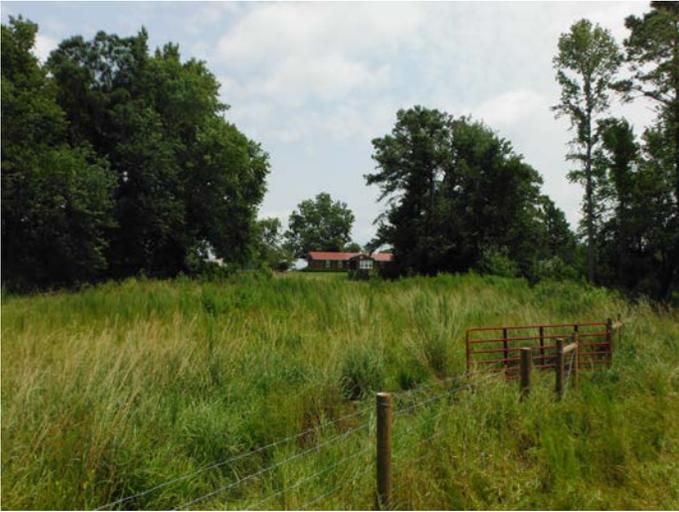
Photo Point #1 looking at Veg. Plot 1

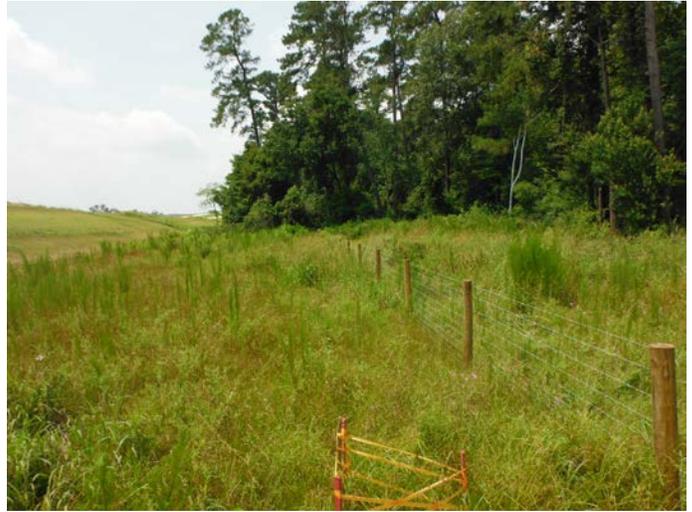
Site Notes: The control access fence was installed after the site was planted and set through Vegetation Plot #2. Some of the planted seedlings were disturbed due to the control access fence being set. The lower year one stem count in Vegetation Plot #2 reflects this disturbance but overall the planted seedlings are surviving across the site. Other species noted onsite included tulip poplar, sweetgum, fennel, *Scirpus* sp., *Juncus* sp., black willow, pine, cattail, red maple, wax myrtle, and various grasses. The buffer area planting has not been completed due to site prep work (mowing and herbicide application) that is scheduled to take place prior to planting. The buffer area will be planted between November 15, 2012 and March 15, 2013.

Photo Point #1 looking at Veg. Plot 2

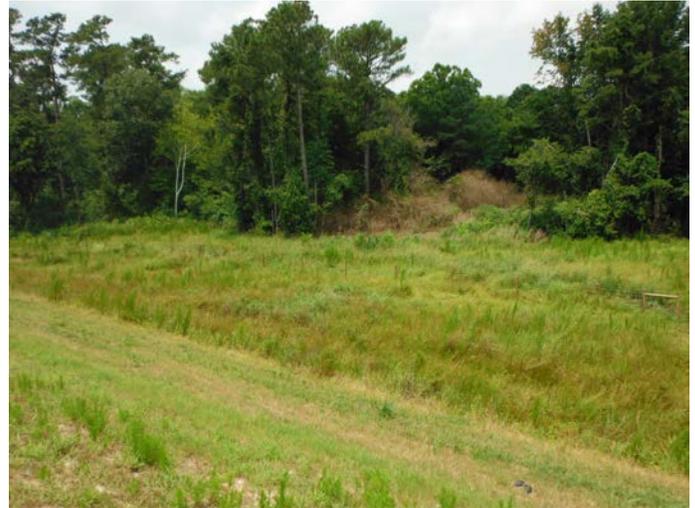
Overview of Site

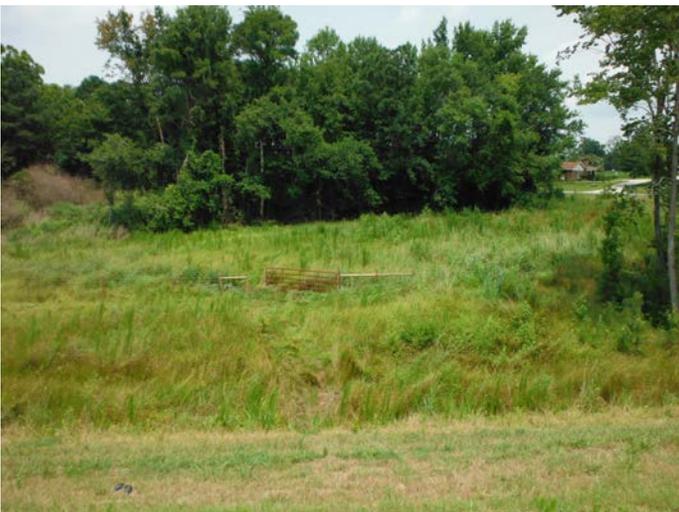
Overview of Site
