ANNUAL REPORT FOR 2013

Banks School Road Wetland Mitigation Site
Lenoir County
TIP No. R-2719A
COE Action ID: 200511238
DWR: 20050787

Prepared By:
Natural Environment Section & Roadside Environmental Unit
North Carolina Department of Transportation
December 2013

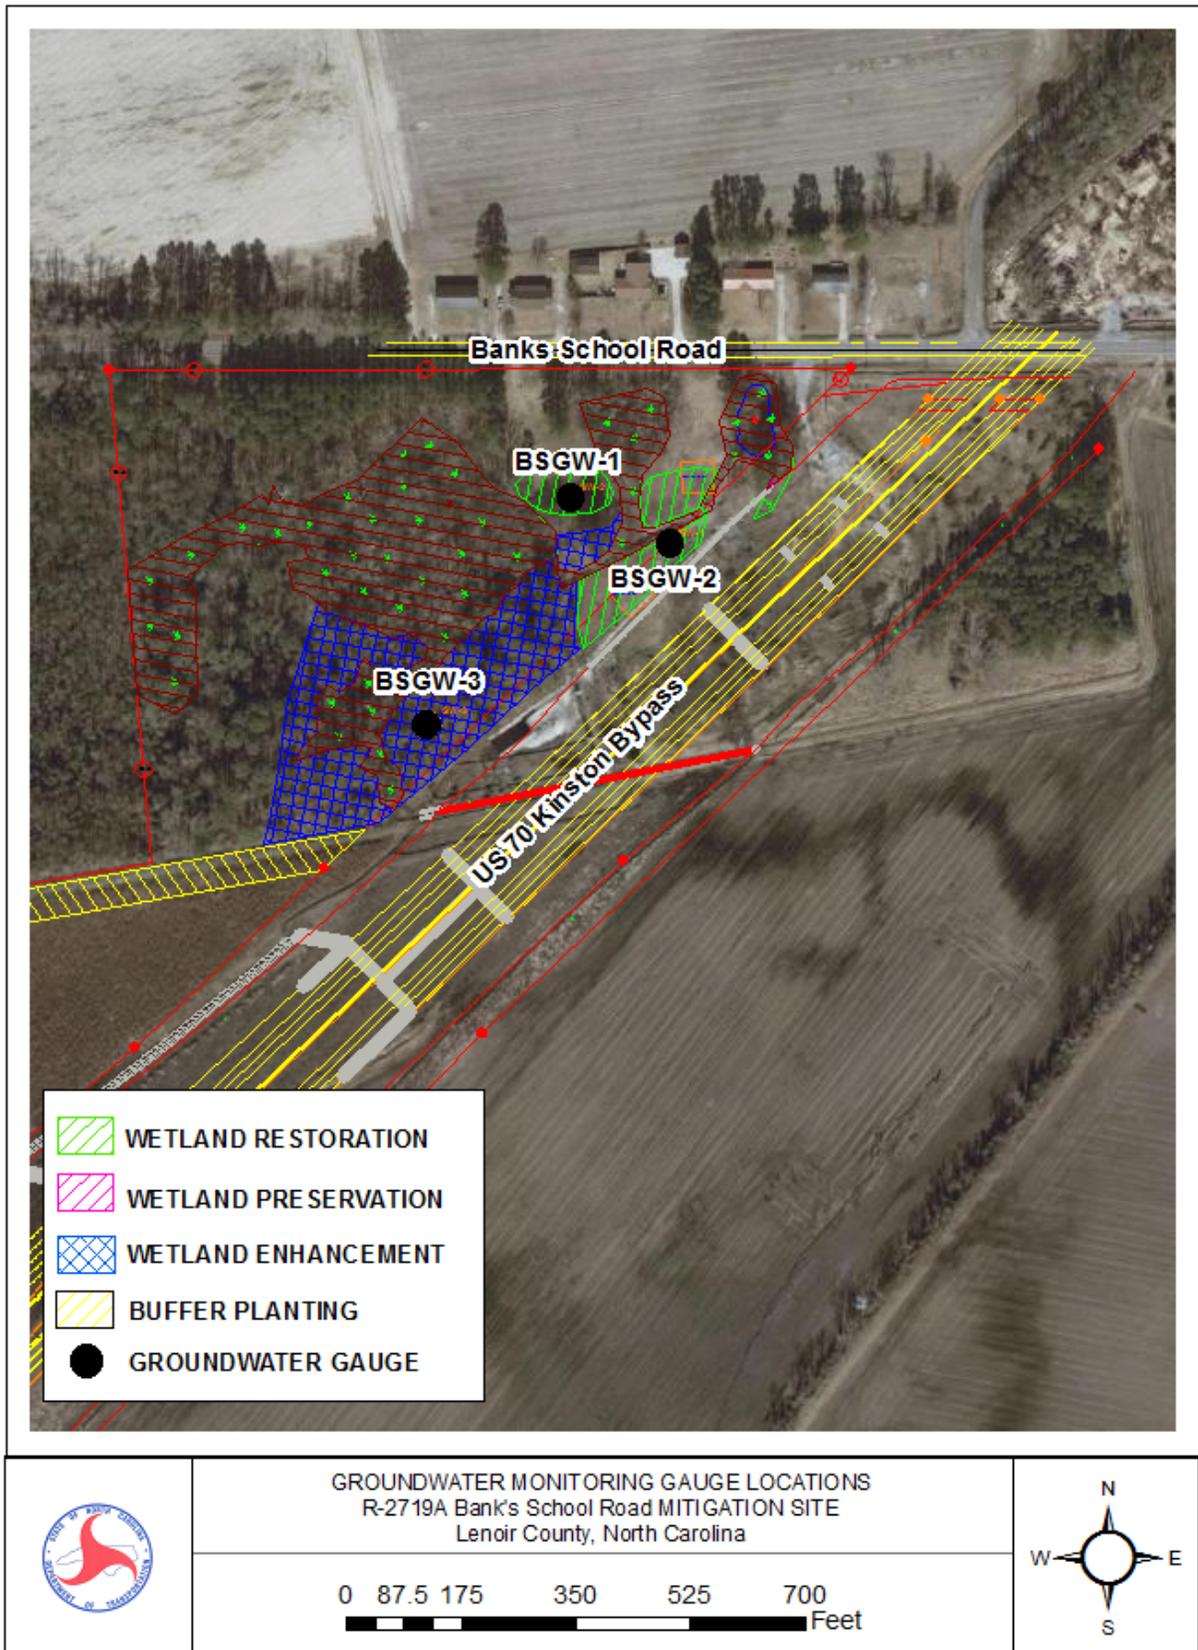
Figure 2. Monitoring Gauge Location Map

Three groundwater monitoring gauges are used to record site hydrologic data including two in the restoration area and one gauge in the enhancement area. The groundwater gauges are set to record daily water levels. The hydrologic response (groundwater) to rainfall events is evaluated using data provided by the North Carolina State Climate Office.

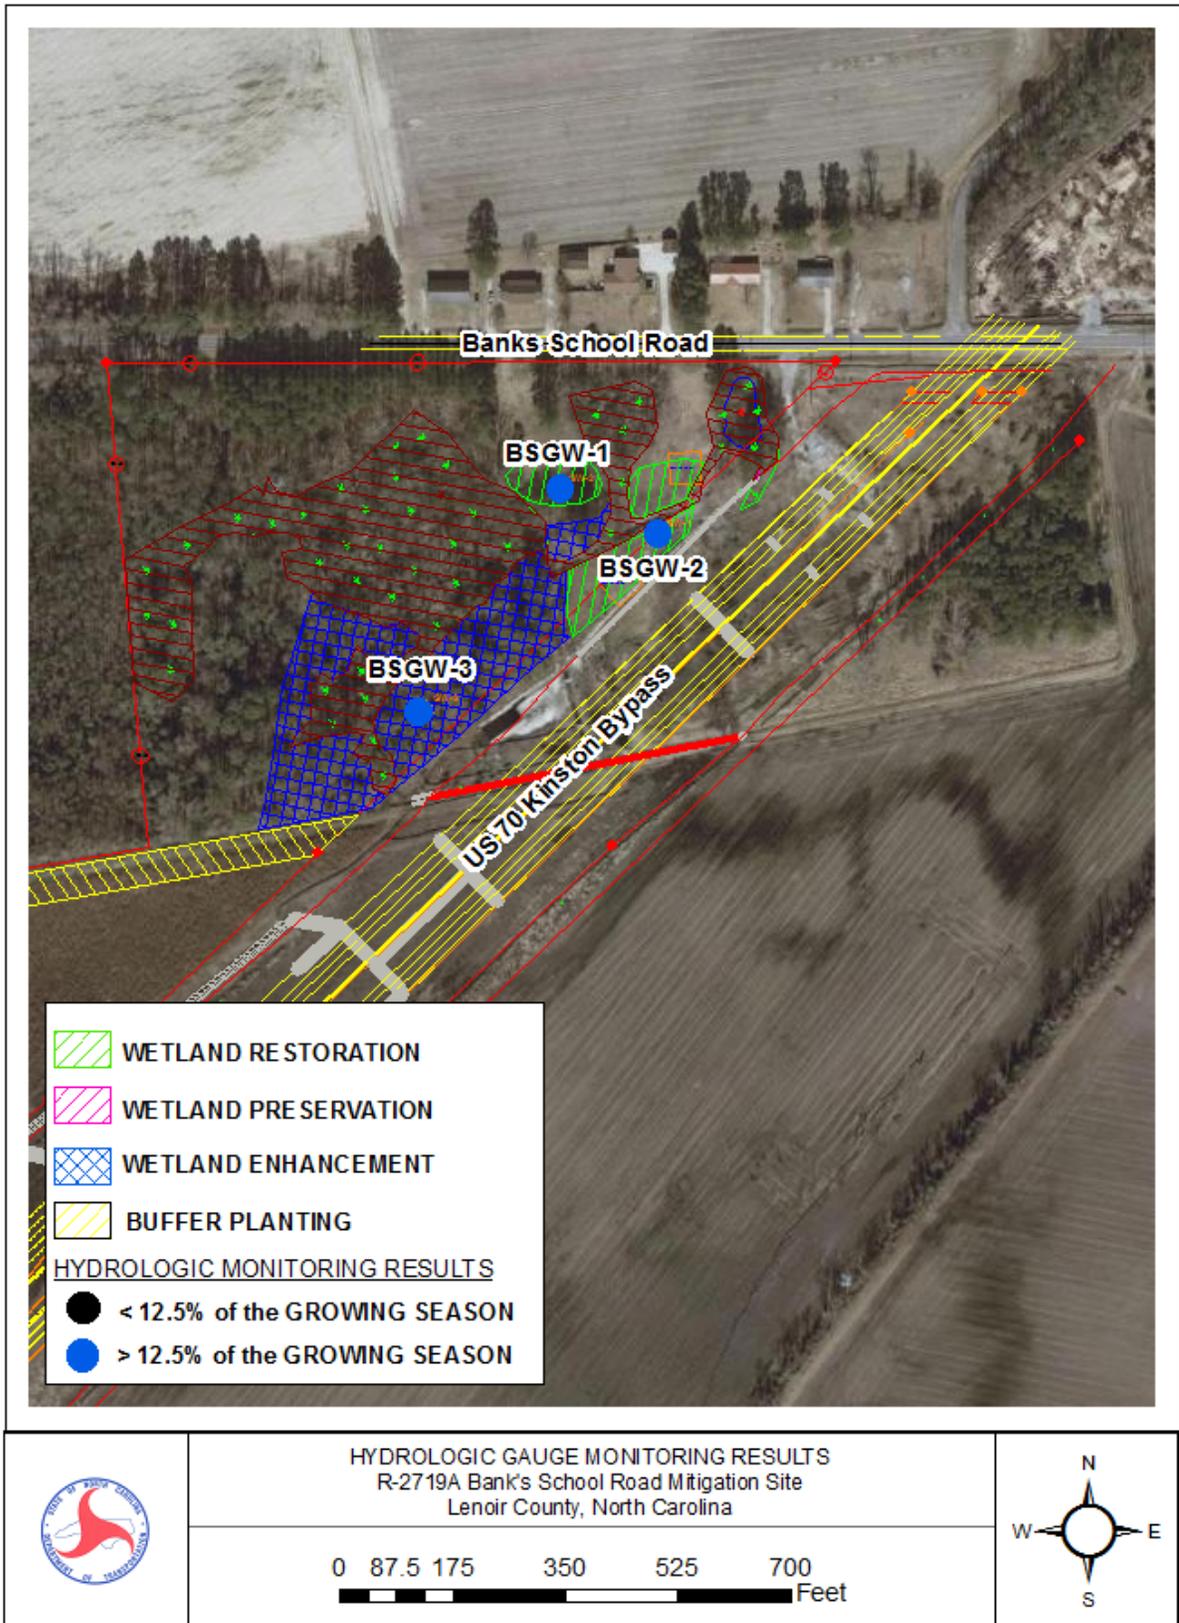
Figure 3. 2013 Hydrologic Monitoring Results

The total number of consecutive days that the groundwater was within twelve inches of the surface was determined for each groundwater monitoring gauge. This number was converted into a percentage of the growing season. Table 1 presents the hydrologic results for 2013. Figure 3 is a graphical representation of the hydrologic monitoring results for 2013.

Monitoring Gauge	< 5%	5 – 12.5%	> 12.5%	Actual %	Dates of Success
BSGW-1			X	44.3	Mar 17-May 16; June 13-Sept 19; Sept 21-Nov 15
BSGW-2			X	29.1	Mar 17-May 12; May 19-July 28; Sept 2-Oct 25
BSGW-3			X	12.7	March 17-April 16

The 2013 year represents the second year of hydrologic monitoring at the Banks School Road Mitigation Site. All three groundwater monitoring gauges met the jurisdictional criteria wetland hydrology (>12.5% of the growing season) during the 2013 growing season.

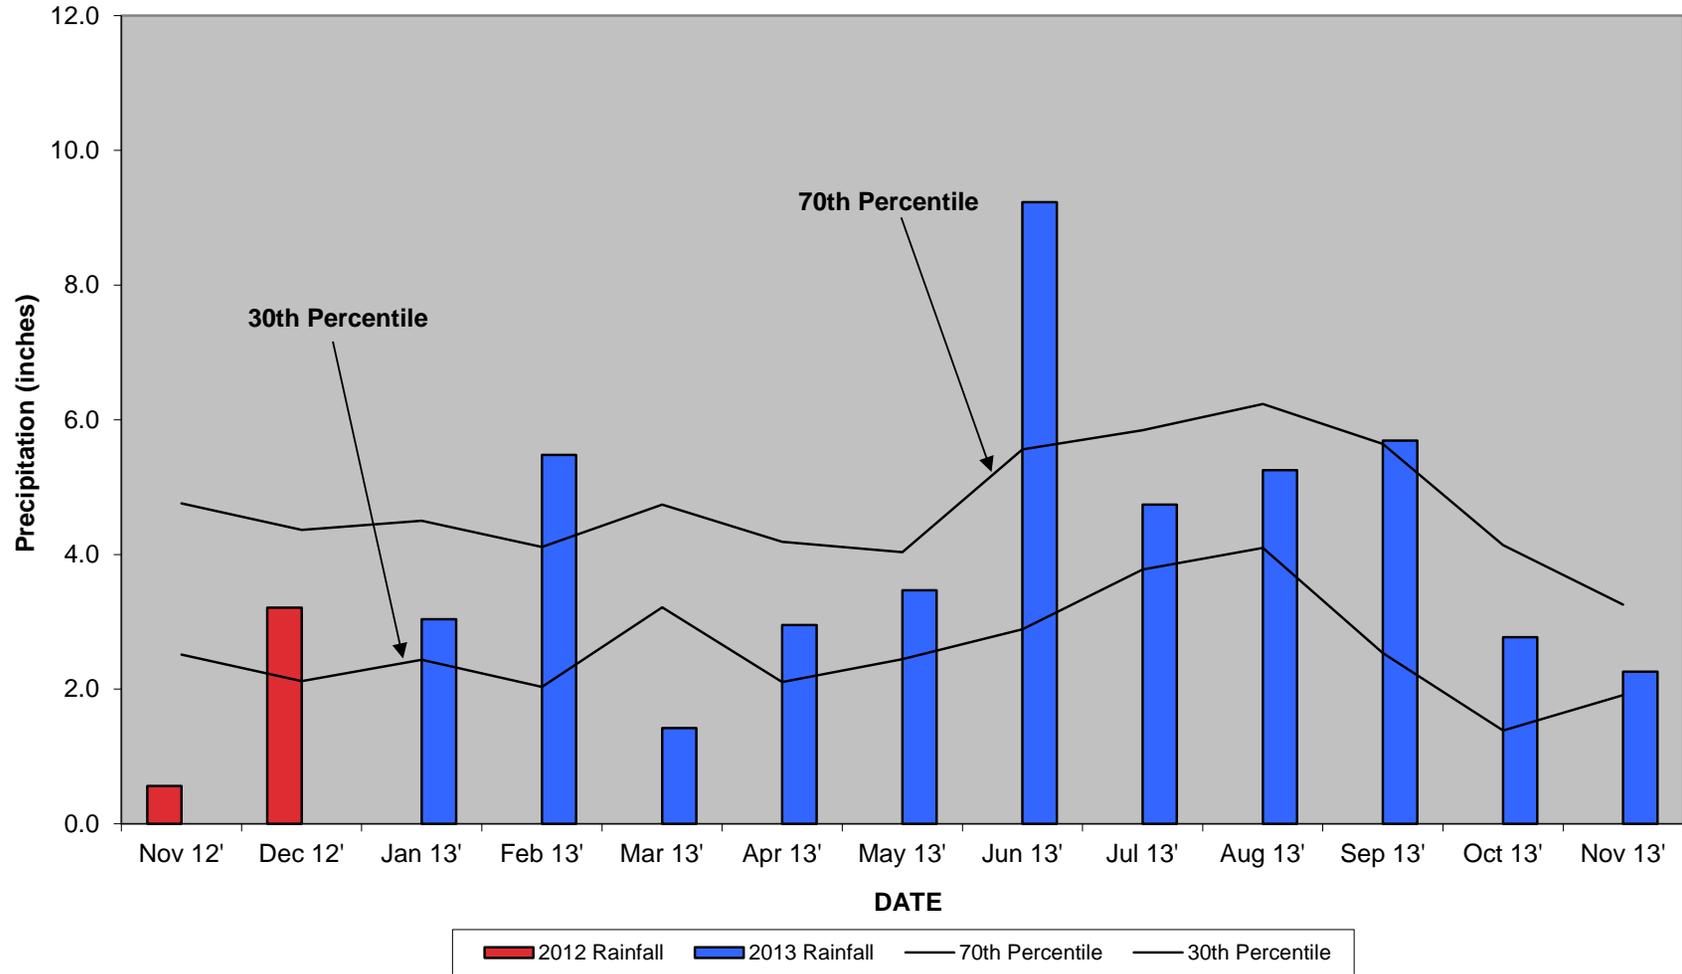
Figure 4. 30-70 Percentile Graph 2013

Figure 4 is a comparison of monthly rainfall for the period of January 2013 through November 2013 to historical precipitation (collected between 1983 and 2012) for the Kinston Agriculture Research Station in Lenoir County. This comparison gives an indication of how 2013 relates to historical data in terms of climate conditions. The NC State Climate Office provided all local rainfall information.

For the 2013-year, January, April, May, July, August, October and November experienced average rainfall. March recorded below average rainfall while February, June and September recorded above average rainfall. Overall 2013 experienced an average to above average rainfall year.

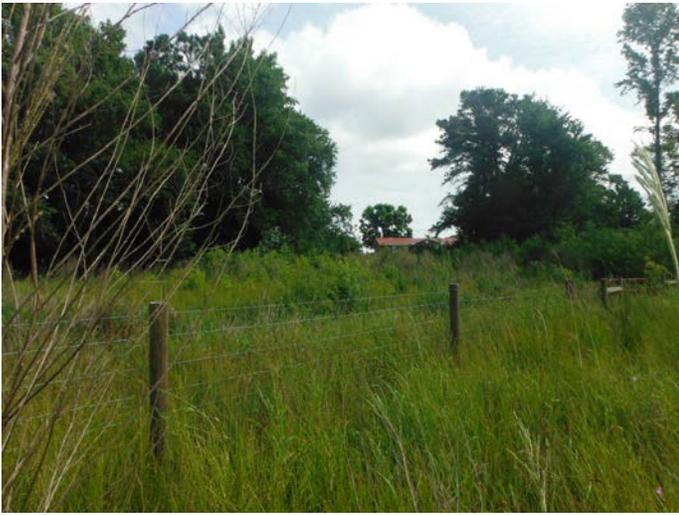
Photo Point #1 looking at Veg. Plot 1

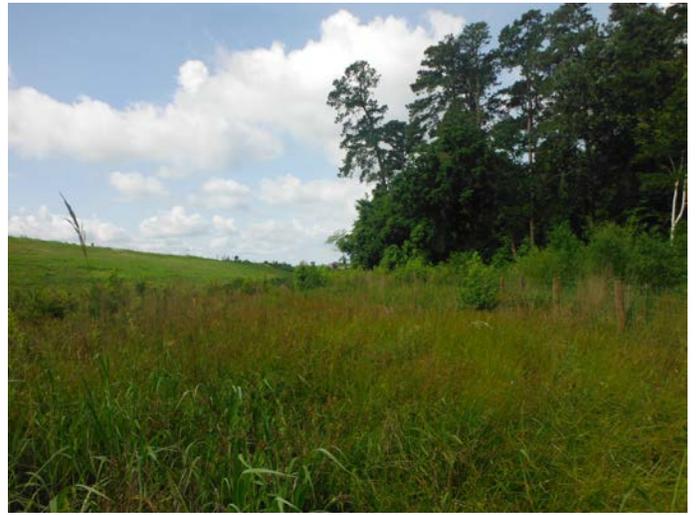
Site Notes: The control access fence was installed after the site was planted and set through Vegetation Plot #2. Some of the planted seedlings were disturbed due to the control access fence being set. The lower stem count in Vegetation Plot #2 reflects this disturbance but overall the planted seedlings are surviving across the site. Other species noted onsite included tulip poplar, sweetgum, fennel, *Scirpus* sp., *Juncus* sp., black willow, black berry, pine, cattail, red maple, wax myrtle, and various grasses.

Photo Point #1 looking at Veg. Plot 2
