# ANNUAL REPORT FOR 2004

**Crescent Road Mitigation Site**

**Project No. 8.2200101**

**TIP No. R-2719BA**

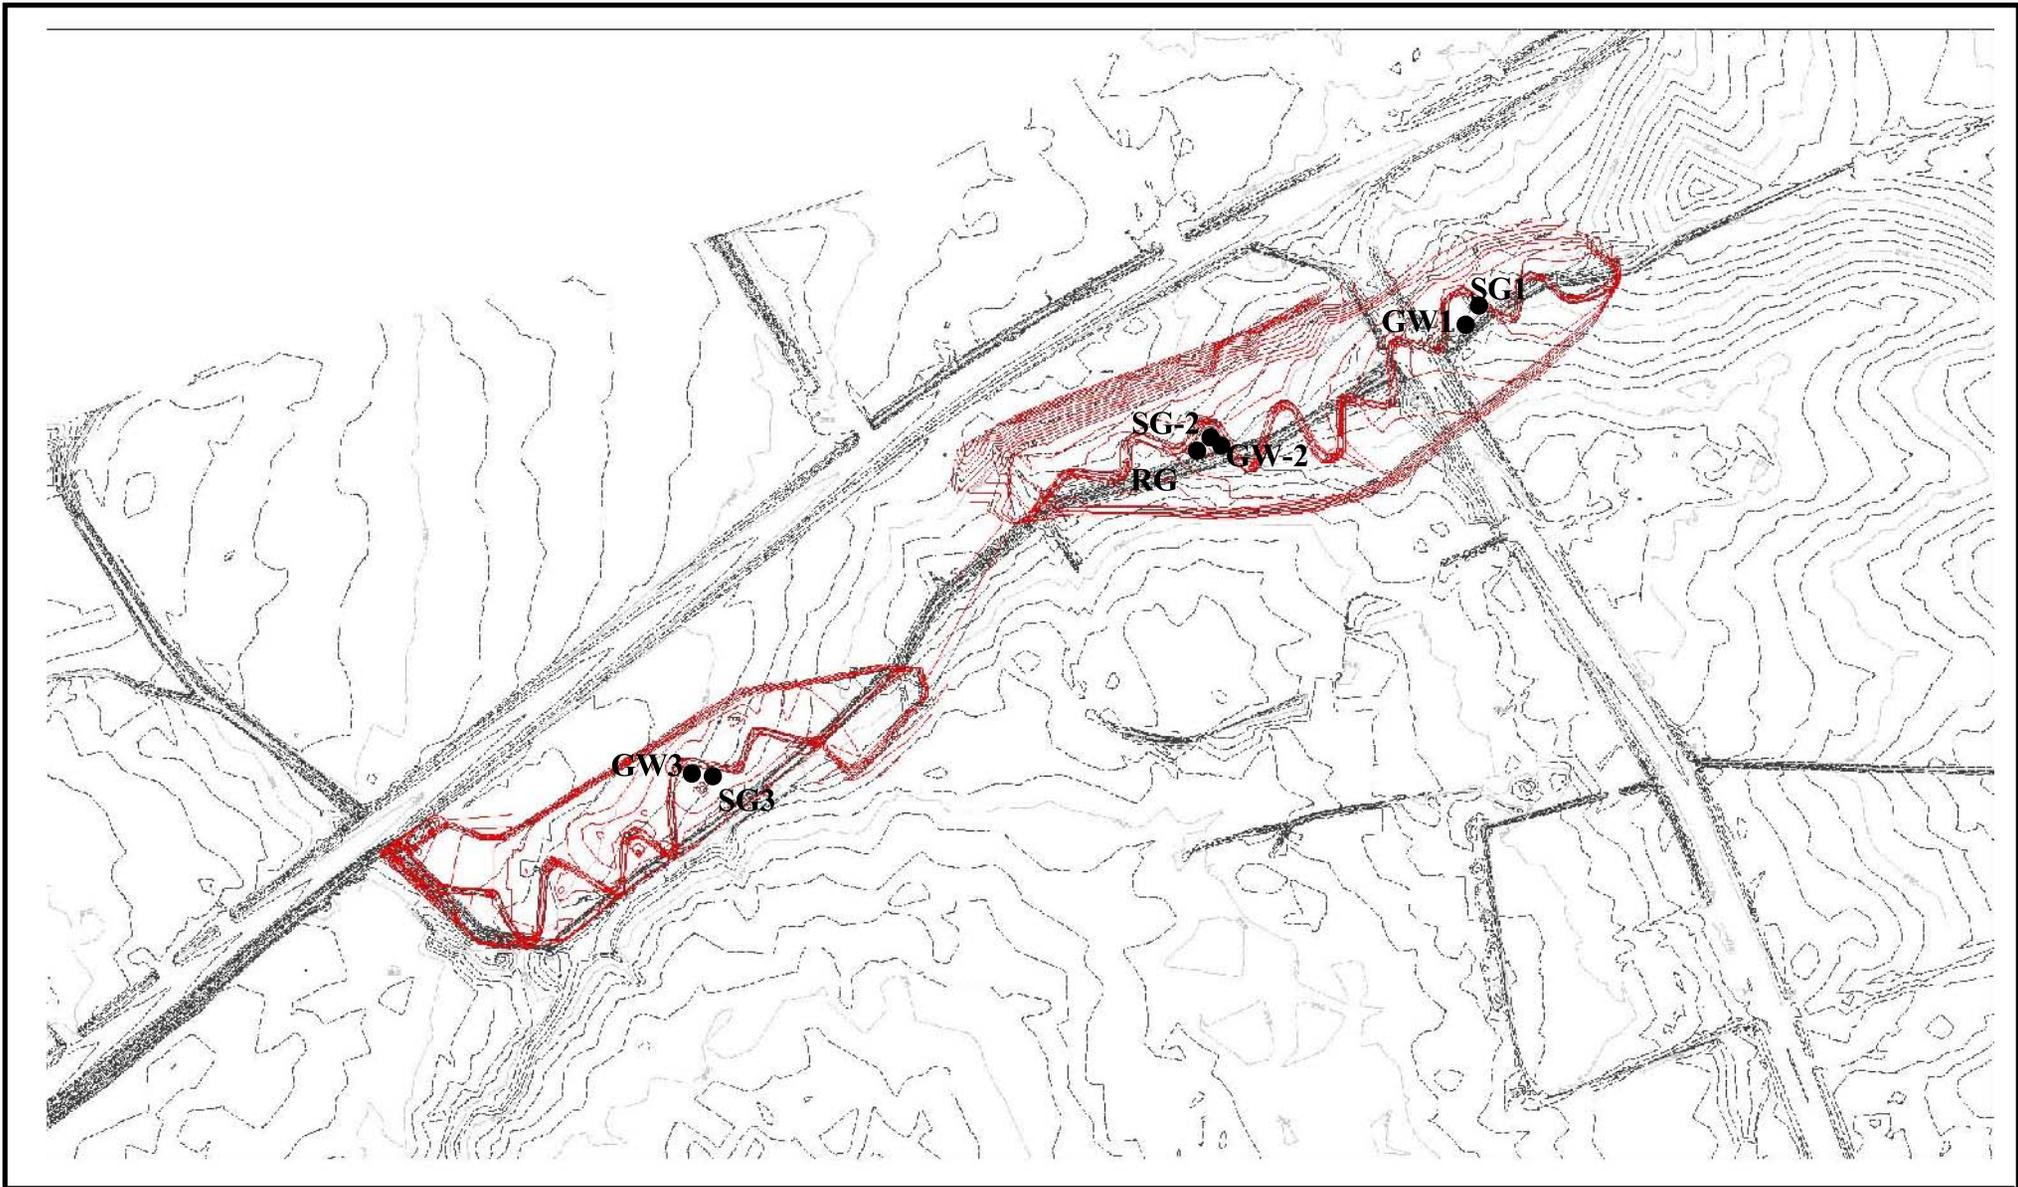
**Figure 2. Gauge Location Map**

Three groundwater and three surface water-monitoring gauges are used to record site hydrologic data. The groundwater gauges are set to record daily water levels, while the surface water gauges are set to record at 3-hour intervals. A rain gauge is also located on the site in order to get accurate site rainfall measurements. The hydrologic response (groundwater) to rainfall events is evaluated using this data.

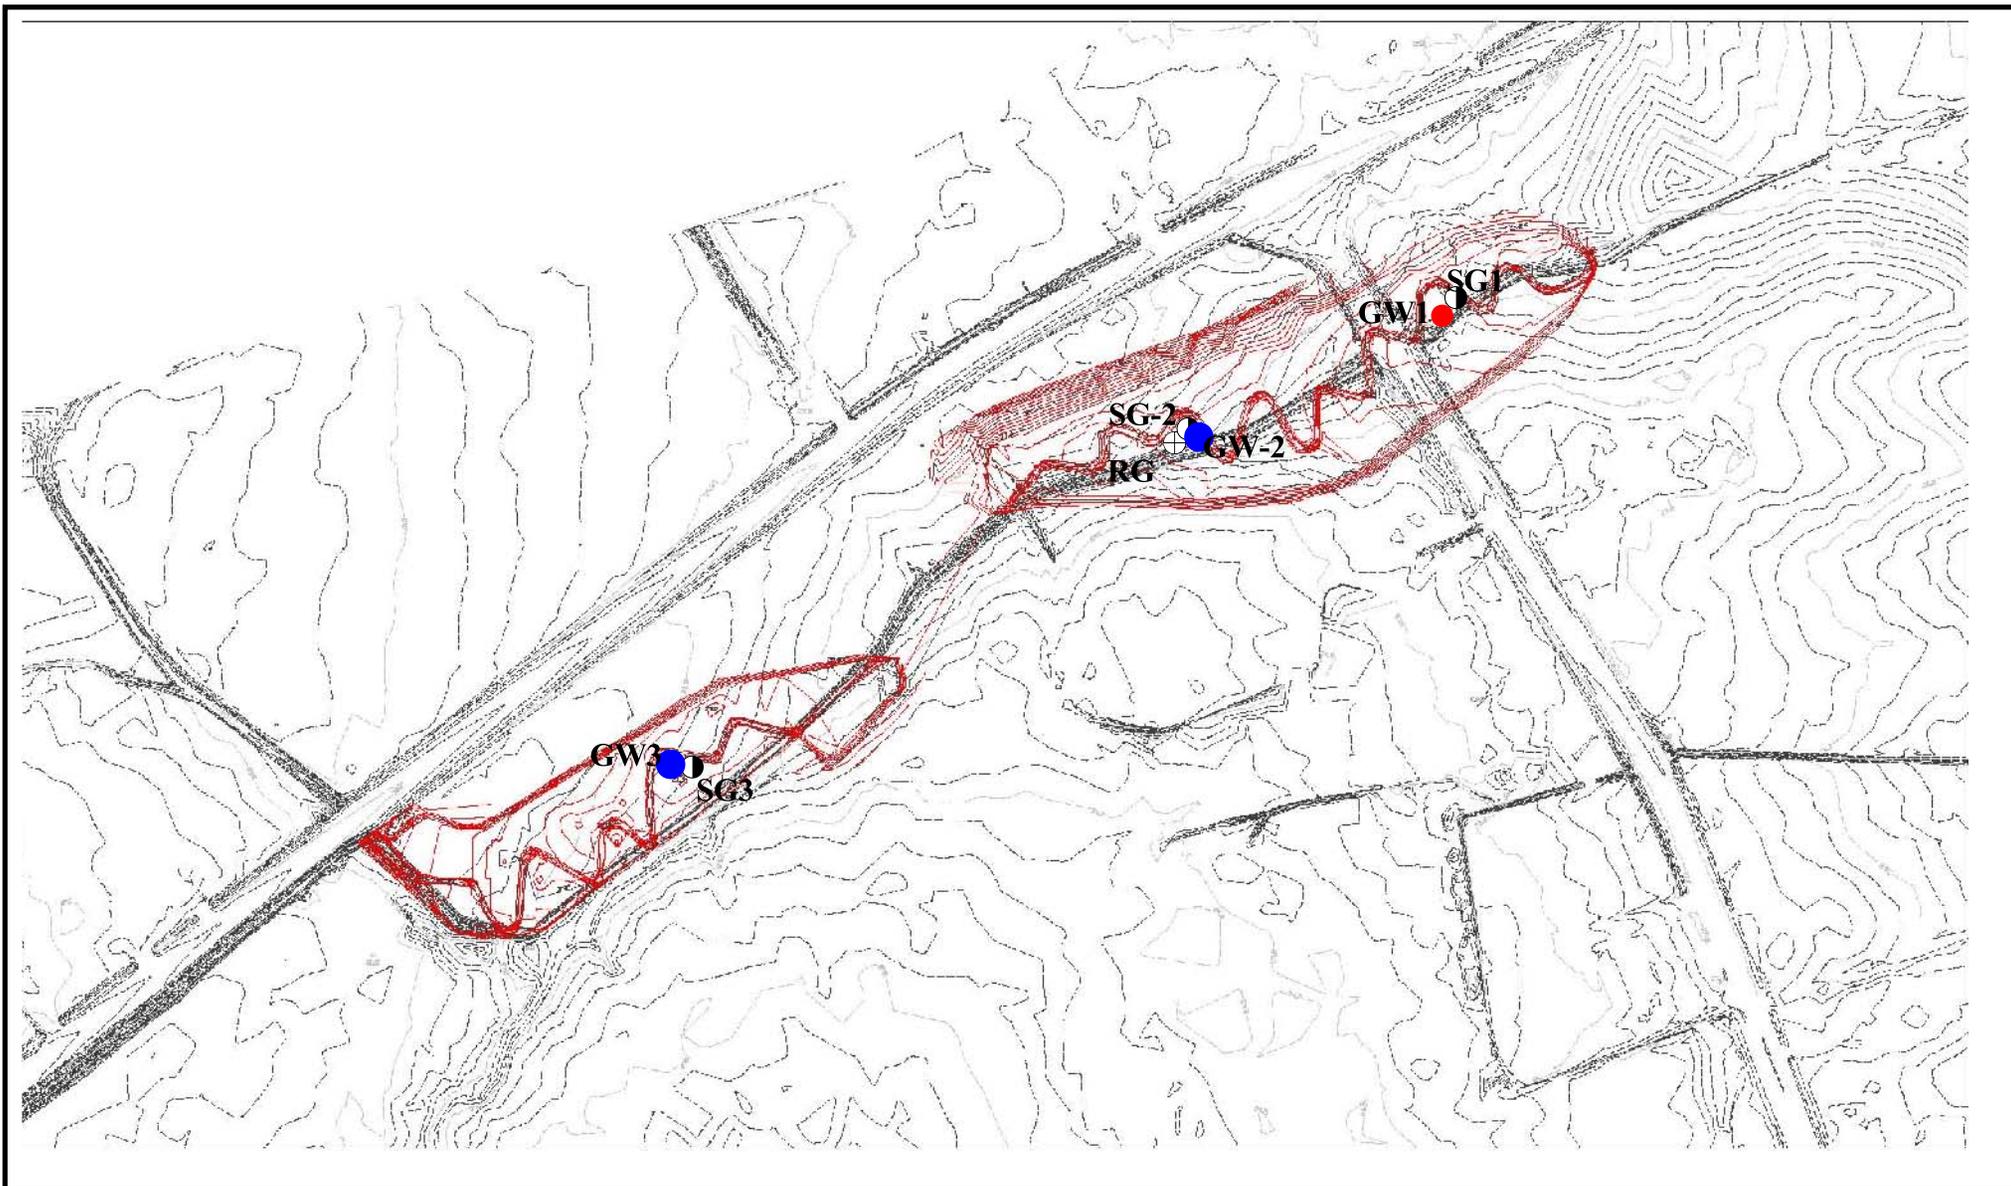
**Figure 3. 2004 Monitoring Gauge Results**

The total number of consecutive days that the groundwater was within twelve inches of the surface was determined for each groundwater-monitoring gauge. This number was converted into a percentage of the growing season. Table 1 presents the hydrologic results for 2004. Figure 3 is a graphical representation of the hydrologic monitoring results for 2004.

Monitoring Gauge	< 5%	5-8%	8-12.5%	>12.5%	Actual %	Dates of Saturation
CRGW-1			X		9.8	Aug 30-Sept 22
CRGW-2+				X	20.1	Aug 13-Sept 30
CRGW-3+				X	28.7	July 23-Sept 30

+ Gauge met success criterion during an average rainfall month (April, May, July, September, and October).

The 2004-year represents the second full growing season that hydrologic data has been collected on the Crescent Road Mitigation Site. Two of the three groundwater-monitoring gauges met the jurisdictional criteria for wetland hydrology (>12.5% of the growing season). The third gauge reported saturation for 9.8% of the growing season. All three surface water gauges showed periods of inundation during the 2004 monitoring year. All of the groundwater and surface gauges were not downloaded after September 30, 2004; therefore no hydrologic data is available.

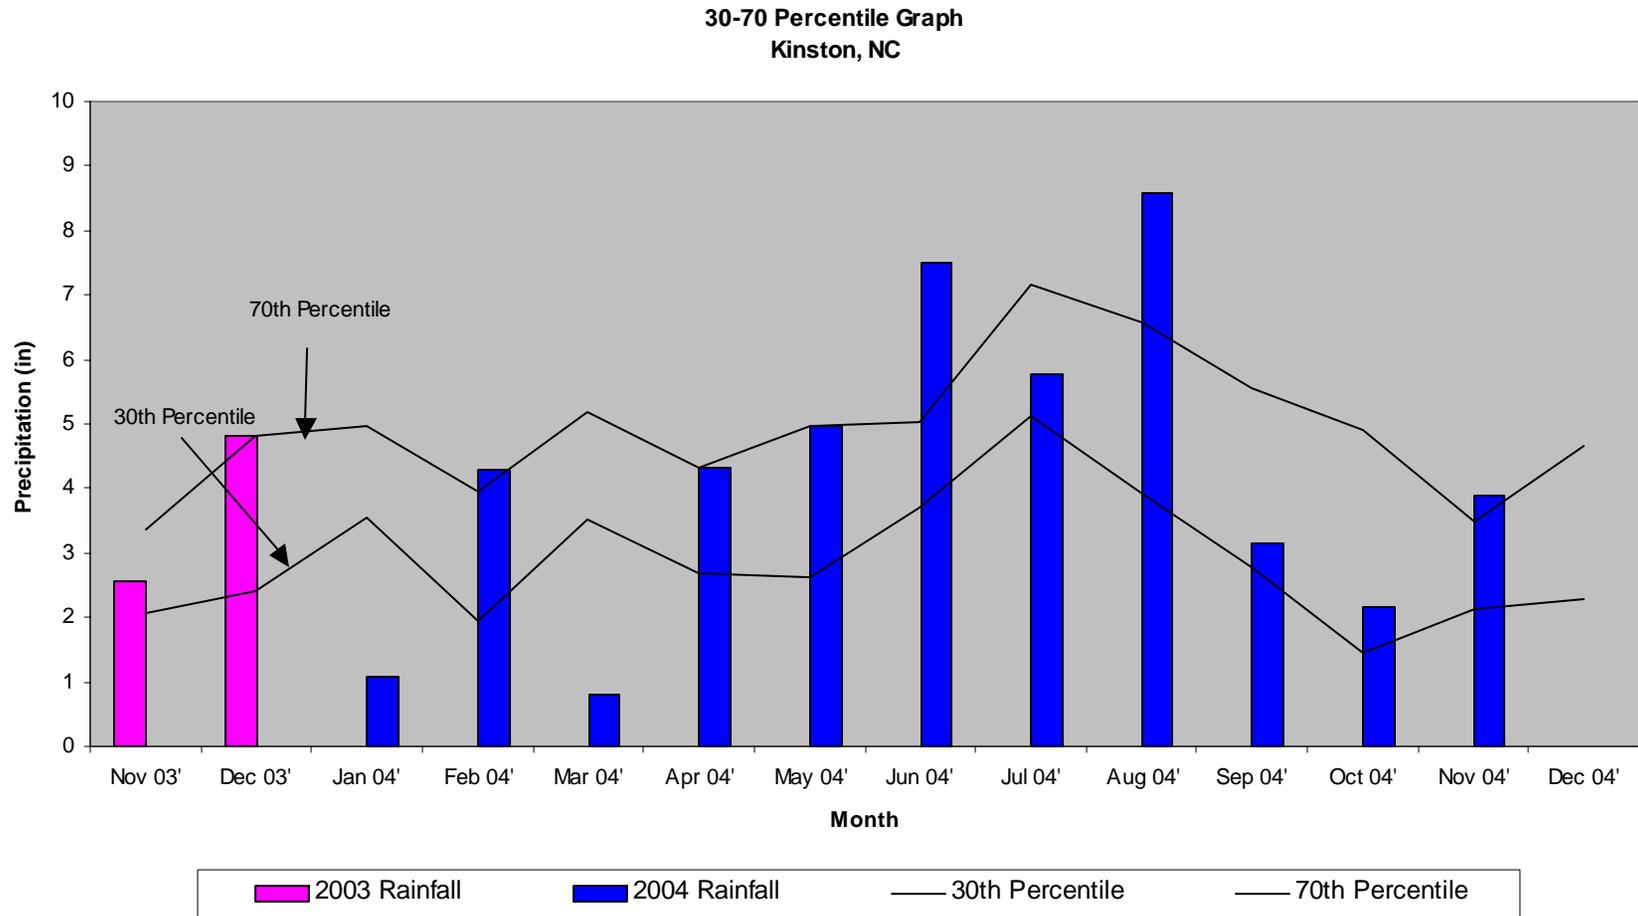
**Figure 4. 30-70 Percentile Graph, Kinston, NC**

Figure 4 is a comparison of monthly rainfall for the period of November 2003 through November 2004 to historical precipitation (collected between 1973 and 2004) for Kinston, North Carolina. This comparison gives an indication of how 2004 relates to historical data in terms of climate conditions. The NC State Climate Office provided all of the local rainfall information.

For the 2004-year, December (03'), February, June, August, and November experienced above average rainfall. The months of January and March recorded below average rainfall for the site. November (03'), April, May, July, September, and October experienced average rainfall. Overall, 2004 experienced an average to above average rainfall year.
