ANNUAL REPORT FOR 2006

**Unnamed Tributary to Briery Run Mitigation Site
(Crescent Road Site)
Lenoir County
TIP No. R-2719 WM**

Prepared By:
Natural Environment Unit & Roadside Environmental Unit
North Carolina Department of Transportation
December 2006

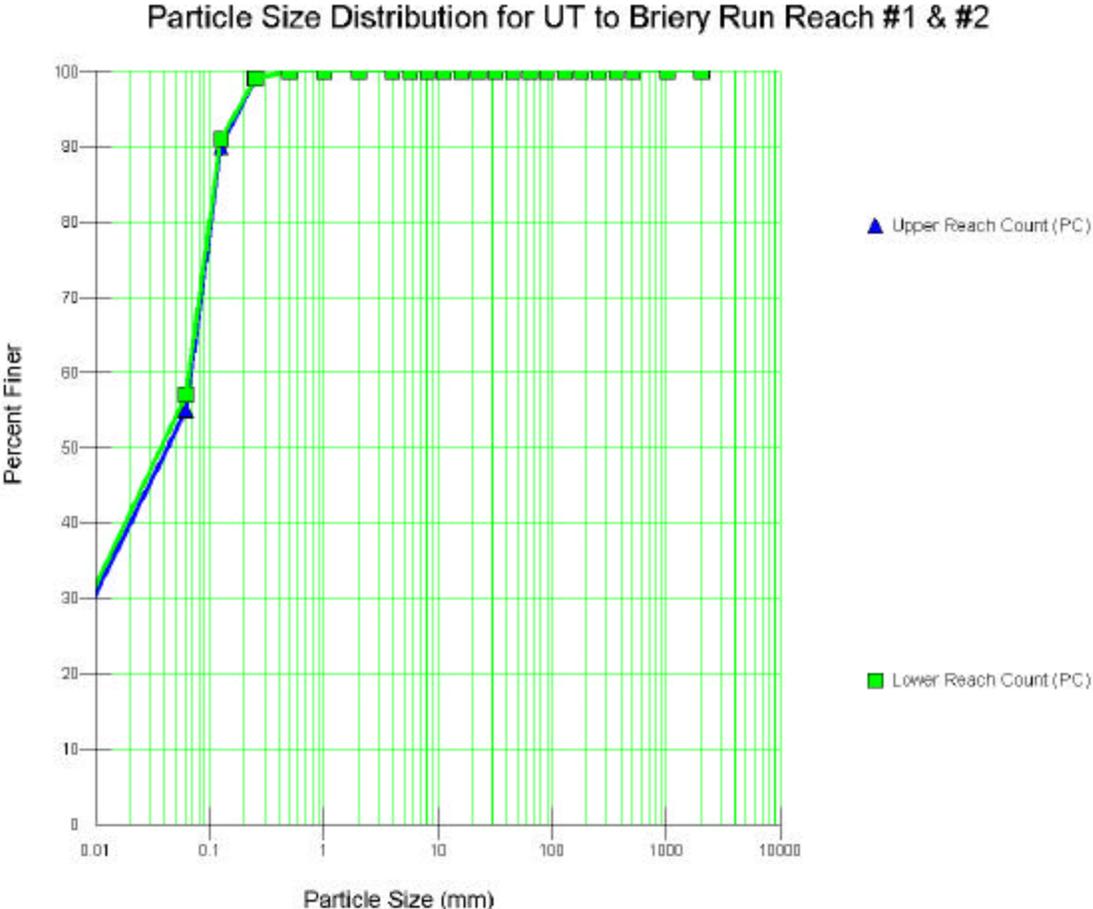
CHART 1. PARTICLE SIZE DISTRIBUTION FOR REACH 1 & REACH 2	9
-----------------------------------------------------------------	---

Pebble counts were taken at each cross section as a means to determine the extent of change in bed material during the monitoring period. Pebble counts taken at riffle sections were utilized to classify the stream. Existing data indicated the unnamed tributary was a sand-bed stream. The pebble counts taken during the Year 2006 monitoring period noted that the D_{50} (50 percent of the sampled population is equal to or finer than the representative particle diameter) for the riffle sections of the unnamed tributary was approximately 0.06 mm, which remains indicative of a sand-bed stream.

The graph depicting the 2006 particle size distributions for Reach #1 and Reach #2 of UT to Briery Run are presented below.

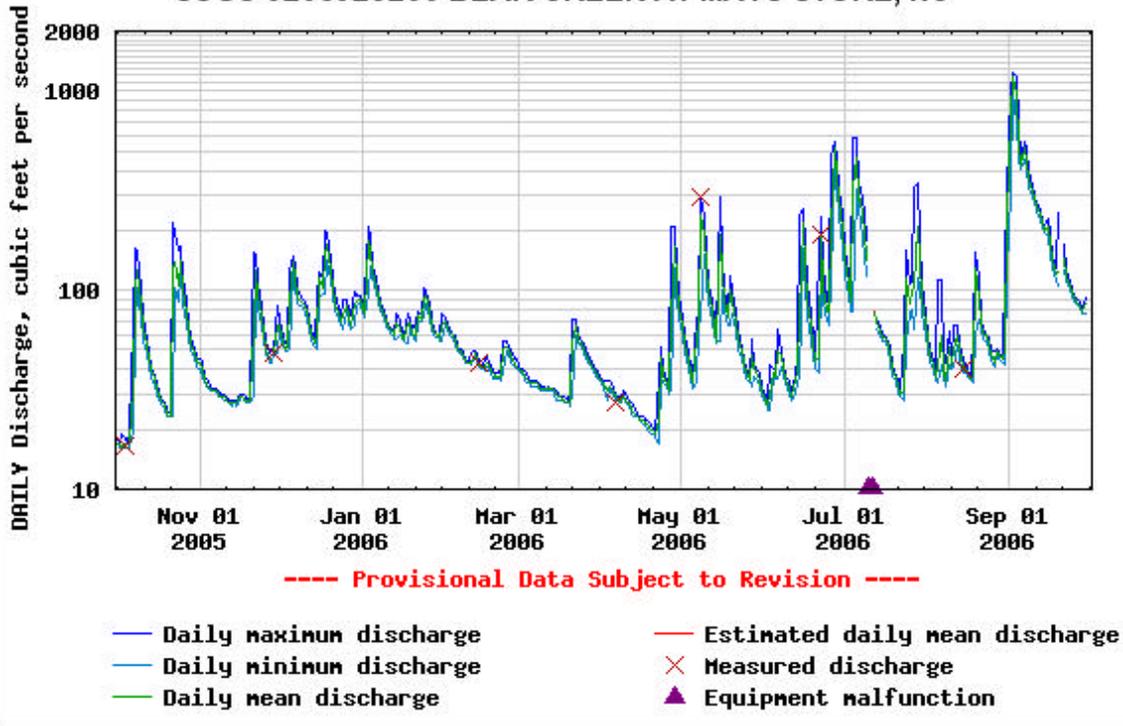
USGS 0208925200 BEAR CREEK AT MAYS STORE, NC

The Bear Creek gage was utilized for this report since it is the smaller of the two gages (57.7 square-mile drainage area as compared to the 2,692 square-mile drainage area associated with the Neuse River). The Bear Creek gage more accurately reflects hydrology and precipitation in the project area. It is situated in USGS Hydrologic Unit 03020202. Datum of the gage is 50 feet above sea level NGVD29. Based on the drainage area associated with the gage, the correlated bankfull discharge according to the NC Coastal Plain Regional Curves (USACE, 2003) is between 200 and 500 cubic feet per second (cfs). A review of peak flows was conducted for the period between October 2002 and October 2004, as well as January 2005 through January 2006. According to the graph, there were approximately eight bankfull events documented between 2002 and 2004 and two additional events during this monitoring period. This gage has met and exceeded the hydrological requirements in between 2001 and the current period. The USGS graphs depicting the peak flows occurring during 2006 is presented below.

Overall, both reaches of the unnamed tributary remain stable. There is extensive growth of vegetation throughout the stream corridor, both within and outside of the bankfull limits associated with the channel. All nine of the cross sections along the unnamed tributary remain stable. Based on information obtained from the USGS, the Crescent Road Site has met the required monitoring protocols for hydrology as it relates to bankfull events.
