Monitoring Data Record

Project Title: Talecris access road project COE Action ID: 201000775
 Stream Name: UT Neuse River (Talecris Site) DWQ Number: 20100310
 City, County and other Location Information: Turn onto Talecris access road off of Powhatan Road in Clayton, NC.
 Date Construction Completed: February 2011 Monitoring Year: (1) of 3
 Ecoregion: _____ 8 digit HUC unit 03020201
 USGS Quad Name and Coordinates: NC-Powhatan N 35.62287, W 78.41307

UT to Neuse River

(Talecris Site)

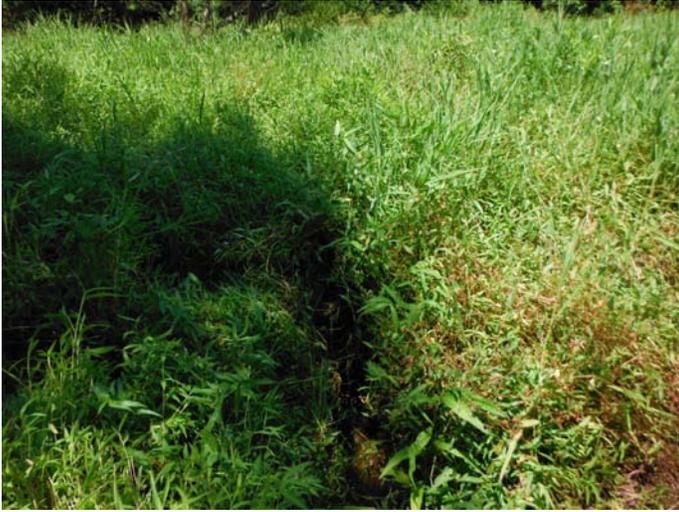
PP #4 (Upstream)

UT to Neuse River (Talecris Site) is stable for the Year 1 monitoring evaluation. A headcut was noted approximately 12 feet upstream of Photo Point #4 but this area remains stable at this time. NCDOT will continue to monitor channel stability at the UT to Neuse River.

Date Inspected 8/4/11	12 feet upstream of PP #4	Station Number	Station Number	Station Number	Station Number
Structure Type					
Is water piping through or around structure?					
Head cut or down cut present?	Headcut has formed upstream of PP#4				
Bank or scour erosion present?					
Other problems noted?
