SUBJECT: Carteret County, Extension of Bridges Street between Arendell Street and NC 24 in Morehead City, TIP No. U-2226, State Project No. 9.8022831, Wetland Mitigation As-Built Report

As-Built Report of Wetland Mitigation  
Bridges Street Extension, Morehead City  
TIP Project Number U-2226  
Carteret County  
North Carolina Department of Transportation  
Raleigh, North Carolina

Prepared By:  
Permits and Wetland Mitigation Unit  
Planning and Environmental Branch  
North Carolina Department of Transportation  
September 18, 1996

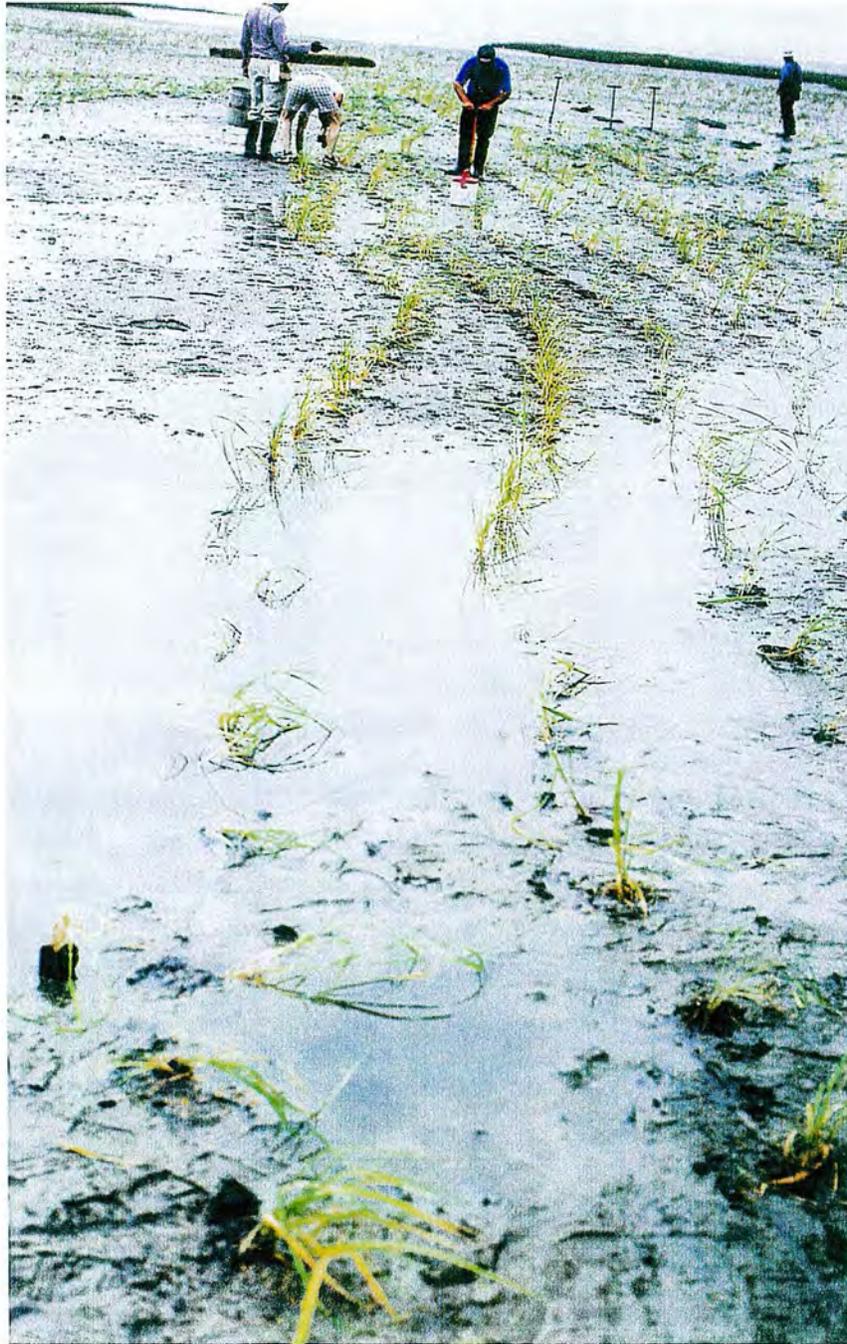
Photo 1. Establishment of smooth cordgrass on mitigation site, May 7, 1996.

Approximately 65,000 smooth cordgrass plants were delivered and planted over the interval of May 6-June 4, 1996, by personnel within NCDOT's Roadside Environmental Unit. Plants were established on the island designated as Site A (Figure 2). Planting consisted of establishing the plants on a 2-foot (0.6 m) grid by opening a hole in the substrate with a dibble (tree planting bar), inserting the plant material, and kicking the hole shut. Approximately one ounce (28 grams) of slow release fertilizer was placed in each hole with the plant.

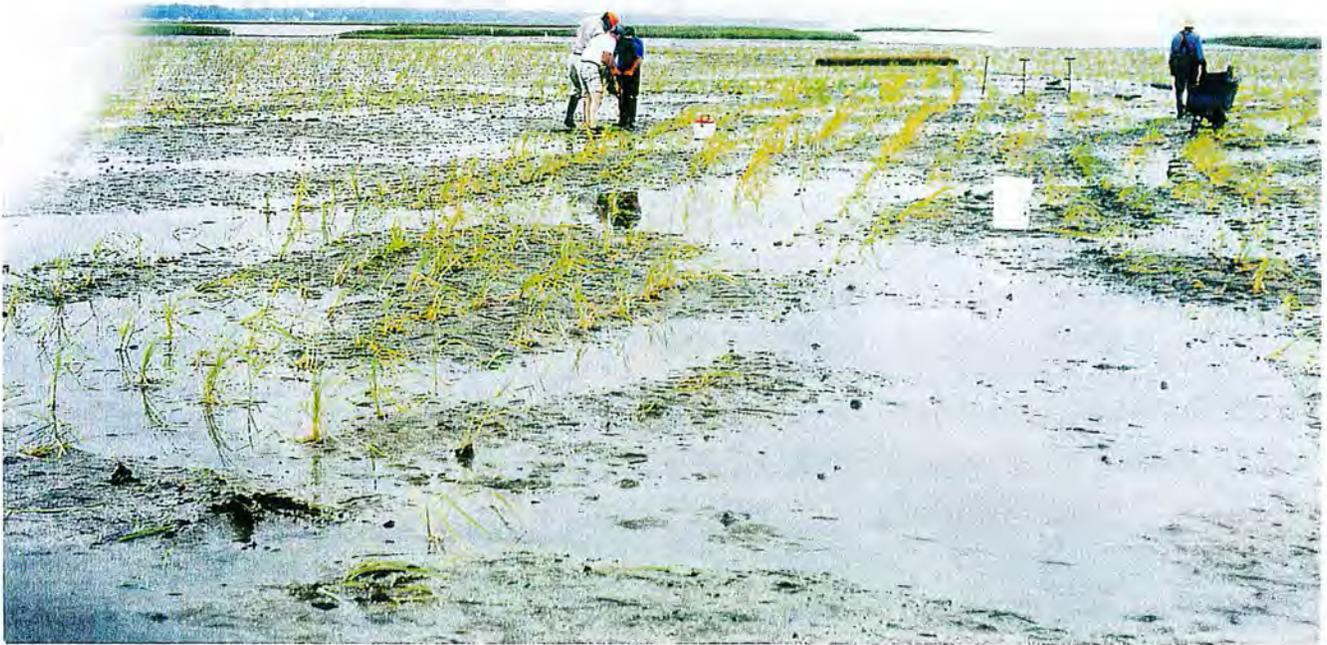
Photo 2. Establishment of smooth cordgrass on mitigation site, May 7, 1996.

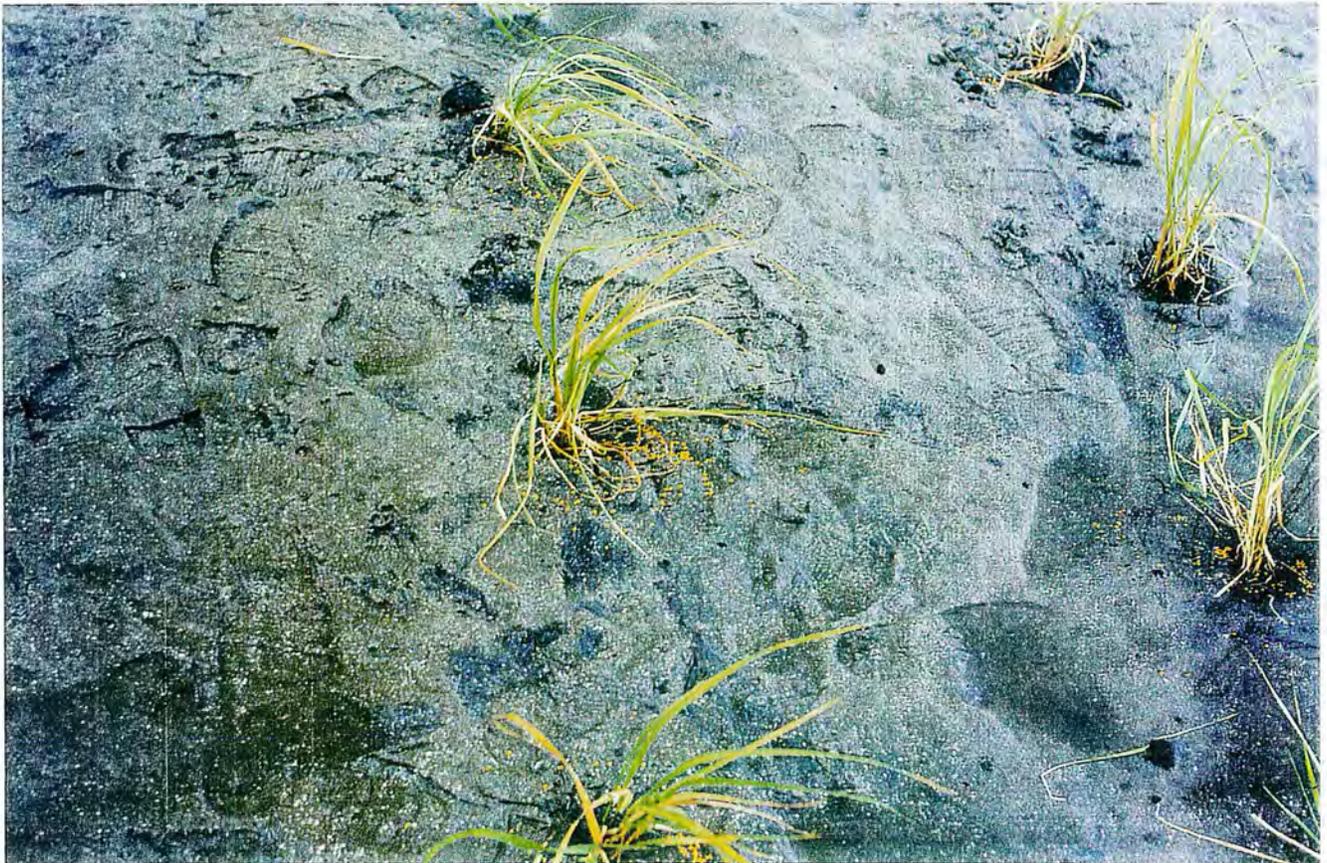
Photo 3. Individual plants immediately after establishment, May 7, 1996. Note fertilizer near plants.

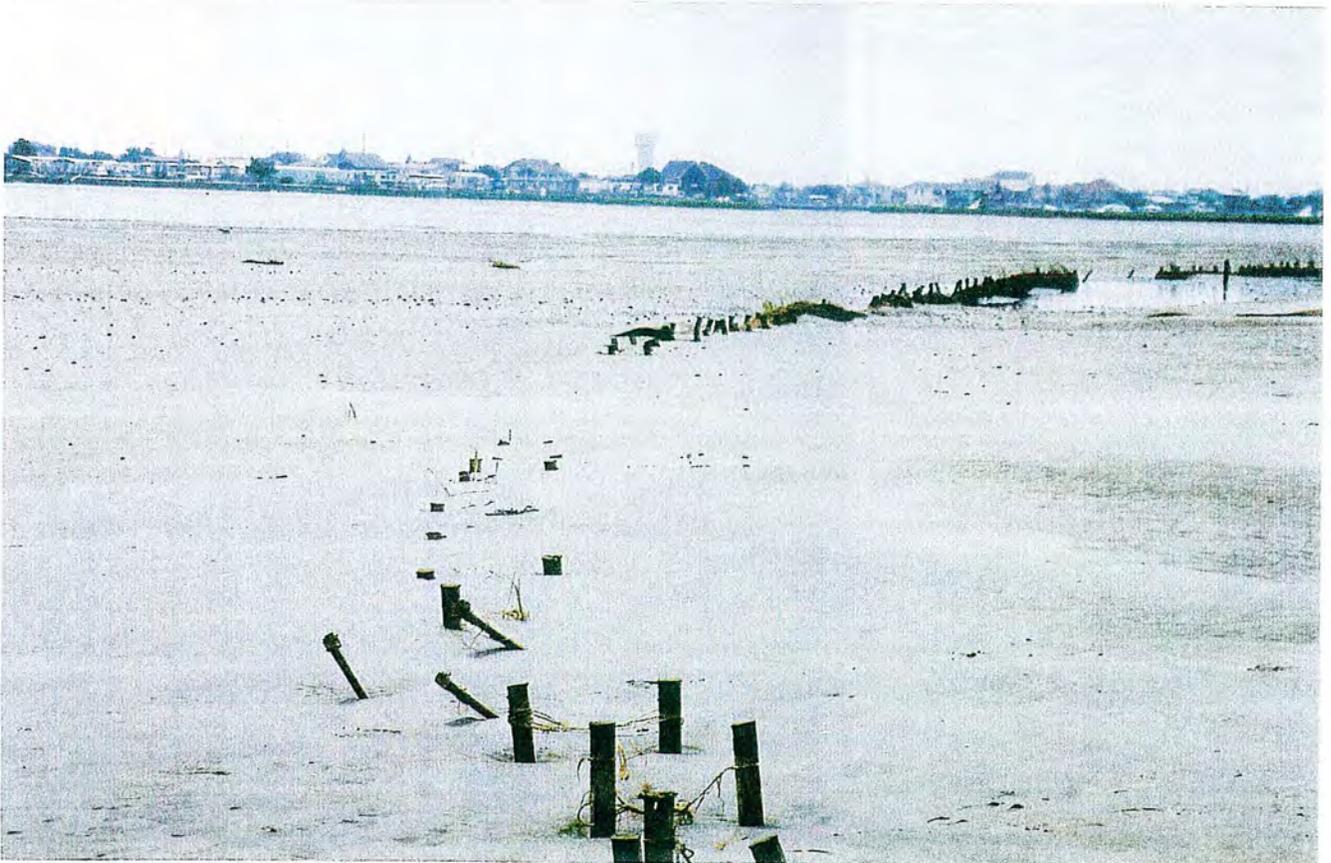
Photo 9. Biolog on east side of mitigation site approximately one month after establishment.

east and south perimeter of the mitigation site at the time smooth cordgrass was planted. The purpose of these was to reduce wave impacts and aid in the accretion of sand on the mitigation site. In addition, seven biolog baffles were established at an angle to the axis of the biologs along the east perimeter. All biologs were installed in 20 ft (3 m) sections in shallow trenches and held in place with pairs of wooden stakes driven into the substrate. Strong cord was used to secure each pair of stakes together, passing over the biolog. Details of the installation are shown in Photos 4 through 6.

Hurricane Bertha passed through the area on July 12, 1996. Damage to the site appeared to be minimal, although it was not possible to separate the effects of the hurricane from those associated with previous wave action. Sand had been deposited along the east side of the planted area, behind the biolog. The elevation of the new surface was level with or above the biolog and the some sections of biolog were below the surface. The sand had covered irregular portions of the planted area, but it was not possible to determine the total area and depth of sand accretion. On the date the site was surveyed, smooth cordgrass appeared to be absent from these areas. However, plants were observed growing in nearby sections of biolog; considering the dynamic nature of the system, the apparent increase in elevation, and the presence of nearby plants, these areas are expected to be colonized by smooth cordgrass over time.

It appears that the installation of biologs resulted in significant accretion of sand on the mitigation site. This method may be of interest to other individuals and organizations attempting to reduce erosion and/or stabilize shorelines in the intertidal zone, provided the material is suitably secured.

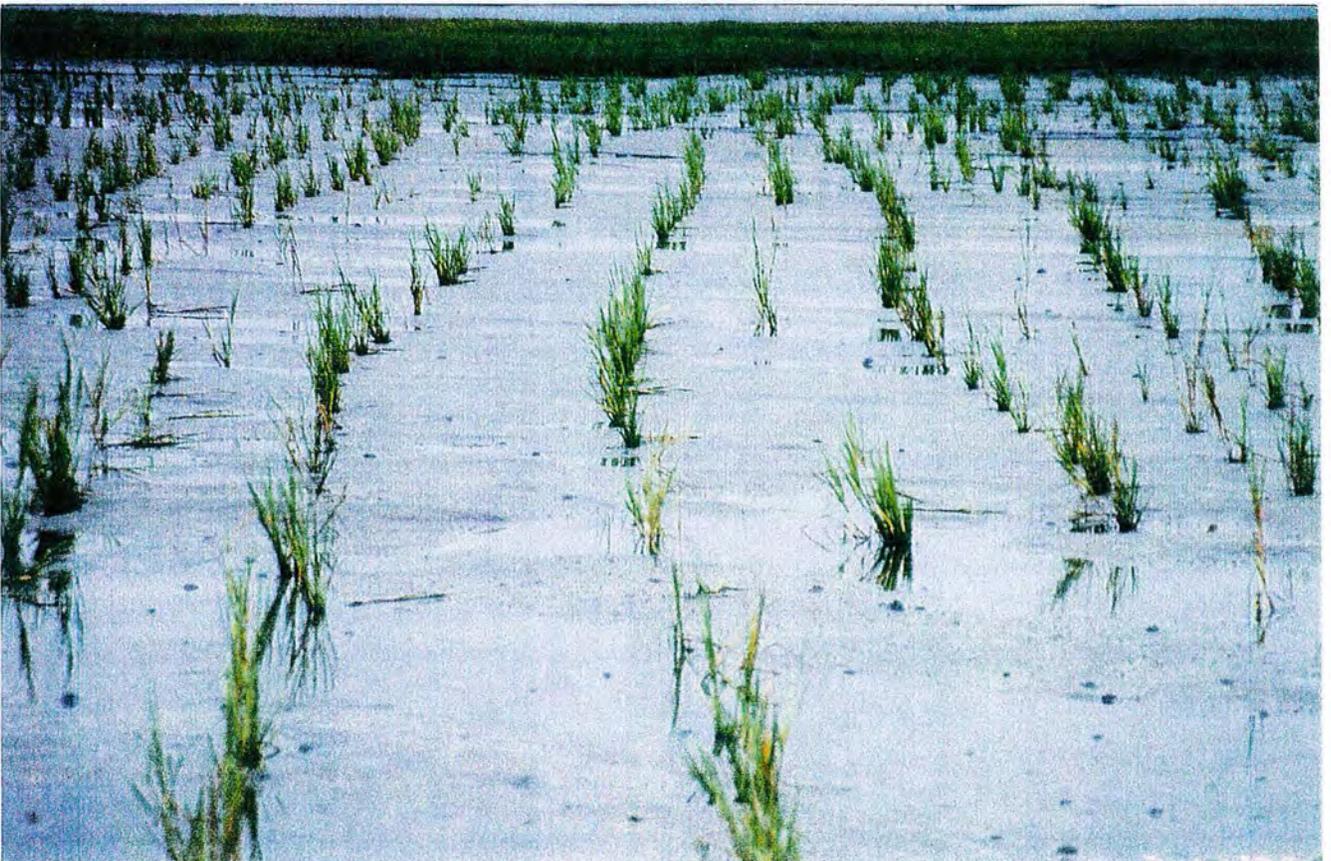
Photo 10. Smooth cordgrass approximately one month after establishment.

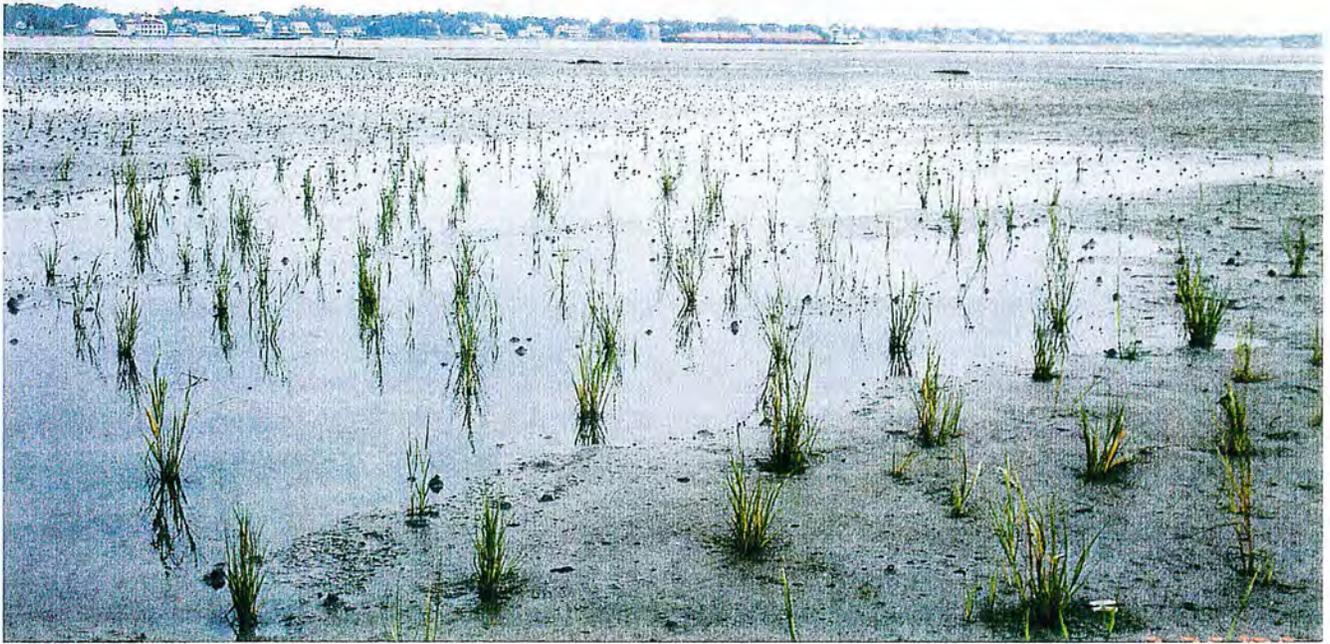
Photo 11. Smooth cordgrass approximately one month after establishment.

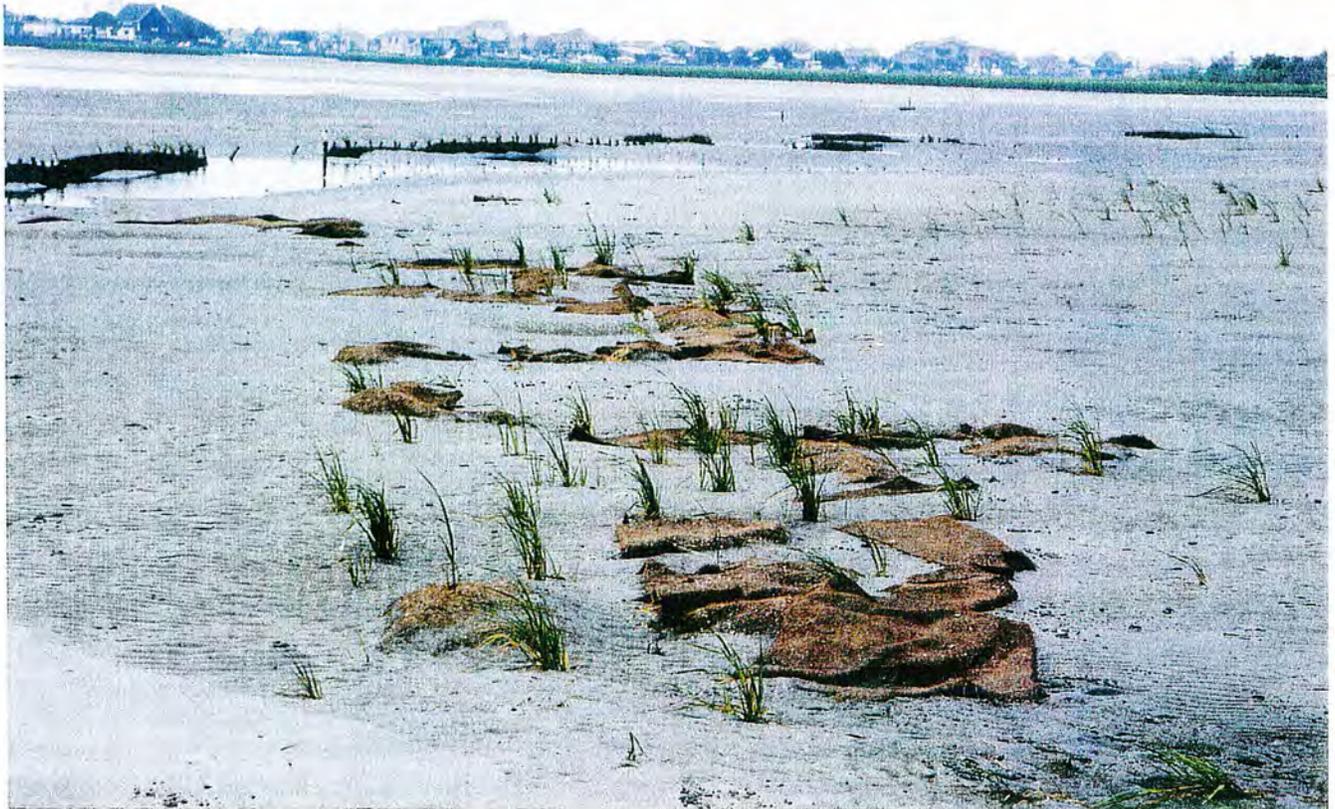
The biomats did not survive the combined effects of the hurricane and normal tide cycles. On the date that the site was surveyed (July 25, 1996) to determine as-built conditions, only small fragments of the biomats were visible because of a combination of partial destruction and sand accretion. Thus, the configuration of these mats was impossible to determine. The condition of the biomat located at the north part of the planted area is shown in Photo 12.

Photo 12. Biomat approximately one month after establishment.

Approximately 2,800 ft<sup>2</sup> (260 m<sup>2</sup>) of 1/4 in (6 mm) thick fiber "biomat" (also manufactured by Bon Terra, Inc.) was installed at two locations in the planted area near the east perimeter. The biomat was installed in two sections, each 14 ft x 100 ft (4.25 m x 30.5 m) and was secured to the surface with 12 inch (30.5 cm) wire staples. One section was installed in the northern portion of the planted area and the other was installed in the southern portion. The purpose of these mats was to prevent erosion in planted areas adjacent to existing marsh.
