**MILL BRANCH
STREAM AND WETLAND
MITIGATION FEASIBILITY STUDY**

Columbus County, North Carolina

TIP No. R-0513 WM

**North Carolina Department of Transportation
Office of Natural Environment**

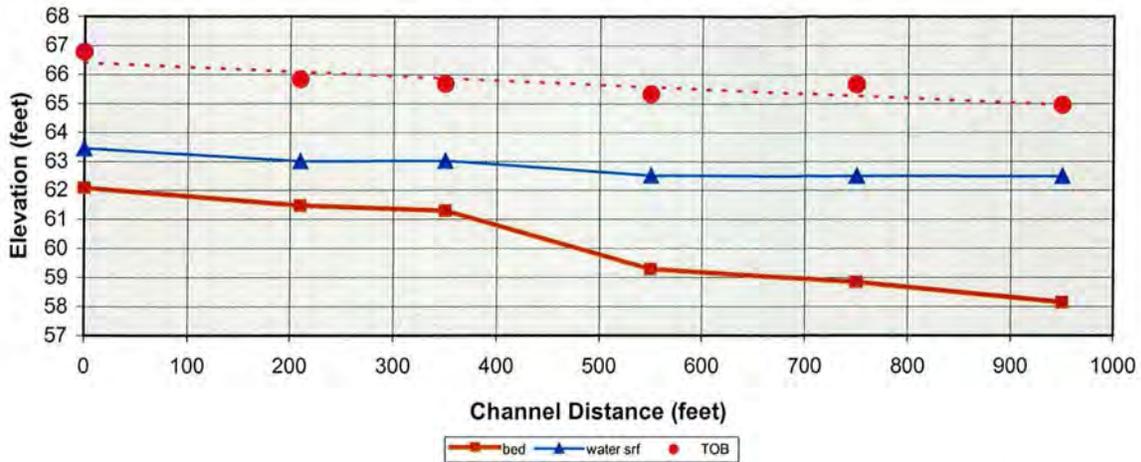
Graph 1. Mill Branch Water Surface

During site inspections it was noted that the water in Mill Branch seemed to be stagnant east of the HWY 701 culvert. A thick layer of detritus in the bottom of Mill Branch indicates that water flow is stagnant or very slow flowing. Preliminary water surface elevations (Graph 1) obtained on Mill Branch suggest that water is backed up from a point further downstream, causing low flow or stagnate conditions within the channel. An examination of Mill Branch upstream (west of HWY 701) of the Hall Property revealed flowing water in the entire reach. **This flowing water provides evidence that water is backed up from a point downstream (east) of the study area.**

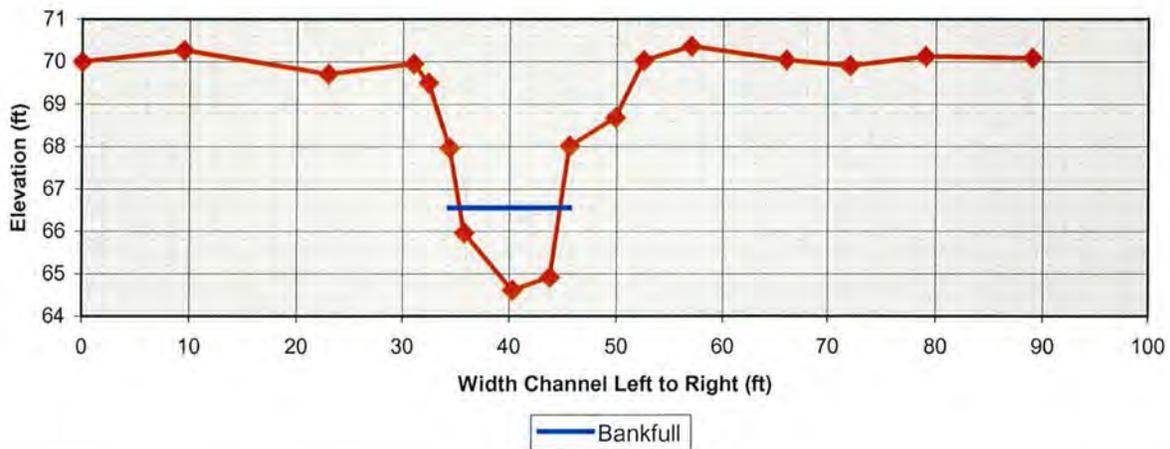
Graph 2. Mill Branch Cross-section

Cross-Sectional Area	Width	Maximum Depth	Bank Height	Width Flood-Prone	Mean Depth	Width-to-Depth Ratio	Entrenchment Ratio	Bank-Height Ratio
12.8 sq. ft	9.4 ft	1.9 ft	4.9 ft	15.5 ft	1.4 ft	7	1.7	2.6

The blue line on the graph indicates calculated bankfull from the Coastal Plain Regional Curve. Classification of Mill Branch was based strictly off of the Regional Curve because bankfull indicators could not be located in the field.

A Rosgen Level 1 stream assessment of Mill Branch was completed to help determine its stability and restoration potential. Only one cross-section (Graph 2) of Mill Branch was required to classify the entire reach because of the channel's uniform pattern, profile and dimension. The location of the cross-section is shown in Exhibit 5. No bankfull indicators were observed while conducting the cross-sectional measurements. The Coastal Plain Regional Curve developed by EcoScience for the Mid-Atlantic Coastal Plain Ecoregion was utilized to help determine where bankfull should reasonably be located. The drainage area of Mill Branch where the cross-section was conducted is approximately 900 acres (1.4 square miles). The bankfull cross-sectional area was calculated to be approximately 12.7 square feet using the Coastal Plain Regional Curve.

Water was filling the channel well above where bankfull should be based on the Regional Curve, suggesting that water is backed up in the channel from a point downstream. Beaver dams located in and downstream of the study area are believed to be the main cause of water backing up in the channel.

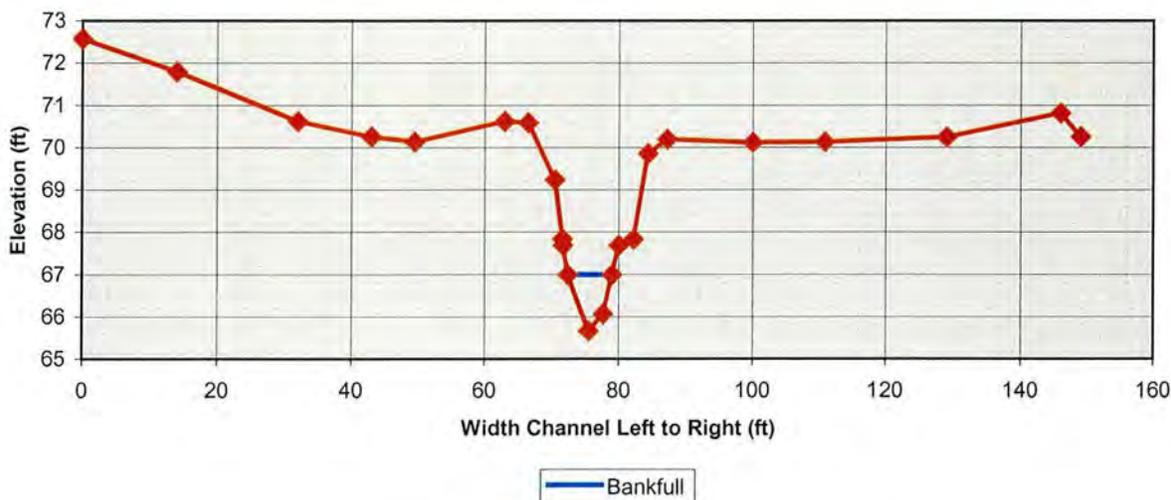
Graph 3. Unnamed Tributary Cross-section 1

Cross-Sectional Area	Width	Maximum Depth	Bank Height	Width Flood-Prone	Mean Depth	Width-to-Depth Ratio	Entrenchment Ratio	Bank - Height Ratio
5.1 sq ft	6.6 ft	1.3 ft	4.5 ft	9 ft	0.8 ft	8.3	1.4	3.5

A Rosgen Level 1 stream assessment of the unnamed tributary was completed to help determine its stability and restoration potential. Two cross-sections were completed (Graphs 3 and 4) to classify the tributary. The drainage area of the unnamed tributary where Cross-section 1 was conducted is approximately 135 acres (0.21 square miles). The bankfull cross-sectional area was calculated to be approximately 3.1 square feet using the Coastal Plain Regional Curve.

Stream Classification - The existing stream is an entrenched straitened channel with a low width-to-depth ratio. The estimated sinuosity of the tributary is 1.1 because the channel has been straightened and follows its valley in a relatively straight line with the exception of some abrupt bends. The measured cross-section parameters yield a **Rosgen G** classification for both cross-sections completed on the unnamed tributary.

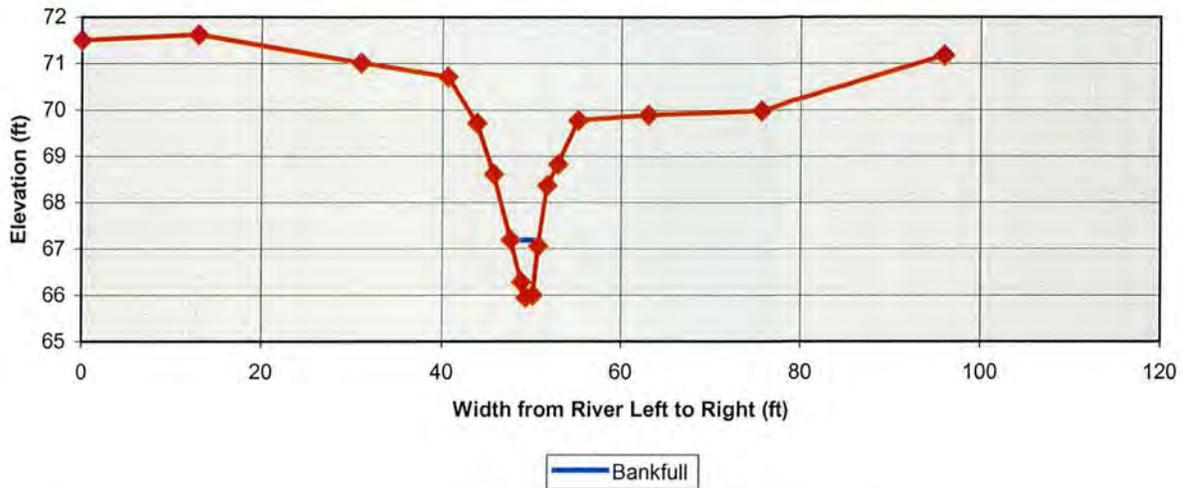
Graph 4. Unnamed Tributary Cross-section 2

The drainage area of the unnamed tributary where Cross-section 2 was conducted is approximately 110 acres (0.17 square miles). The bankfull cross-sectional area was calculated to be approximately 2.6 square feet using the Coastal Plain Regional Curve.

Cross-Sectional Area	Width	Maximum Depth	Bank Height	Width Flood-Prone	Mean Depth	Width-to-Depth Ratio	Entrenchment Ratio	Bank-Height Ratio
2.4 sq. ft	3.2 ft	1.2 ft	3.8 ft	6 ft	0.8 ft	4	1.9	3.2

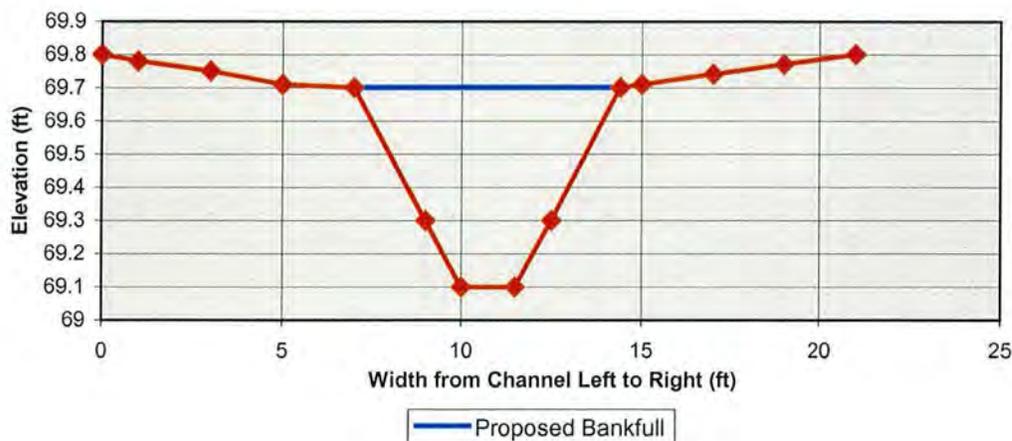
**Graph 5. Unnamed Tributary
Priority I Proposed Cross-section**

Graph 5 depicts a proposed cross-section for the Priority I restored channel. Proposed cross-section measurements were obtained by utilizing the Coastal Plain Regional Curve with an assumed drainage area of 122 acres (0.20 square miles). The proposed cross-section will provide an approximate view of the new channel's dimensions. It is noted though, that these measurements are only approximations of what the channel's dimensions may be and will change upon data collection at reference sites prior to design.

Cross-sectional Area	Width	Depth	Entrenchment Ratio	Bank-Height Ratio
2.7 square feet	7.4 feet	0.4 feet	> 3	1

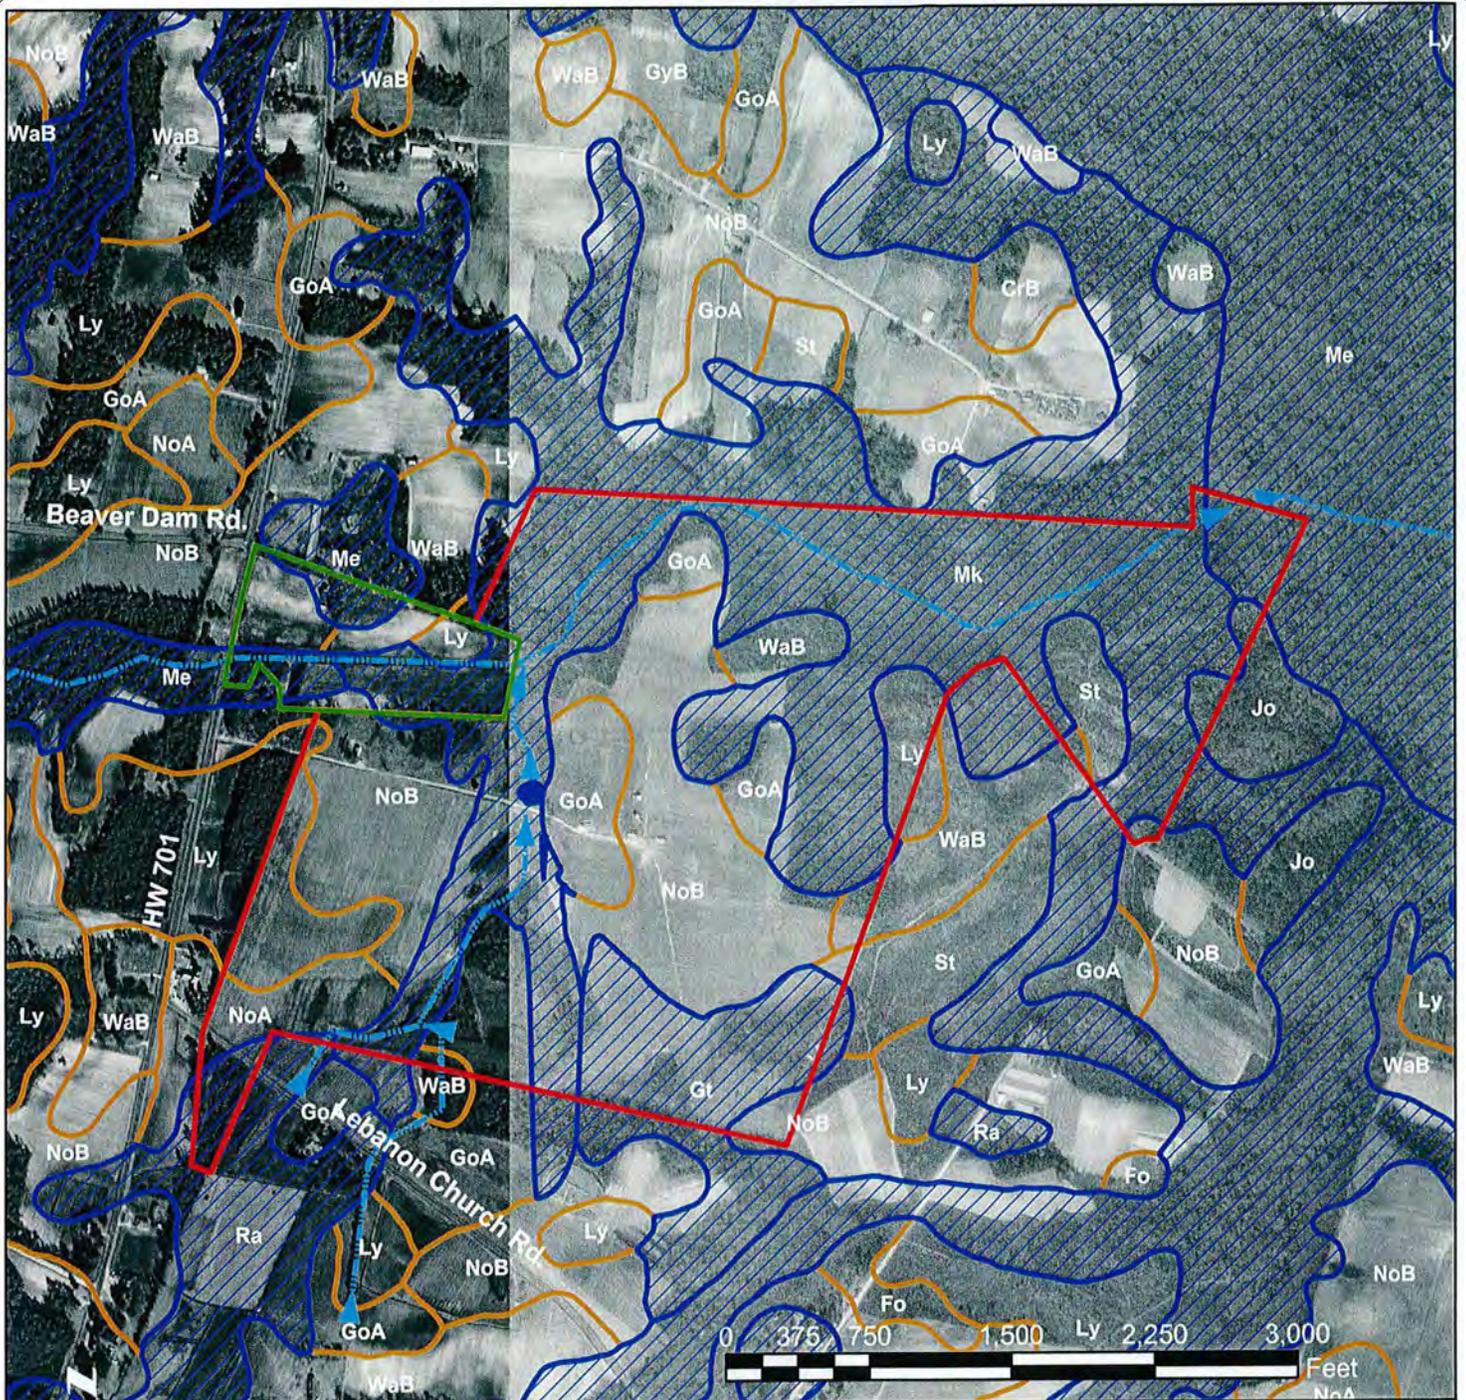
Exhibit 2

Hydric Soils	Nonhydic Soils
Mk: Muckalee sandy loam	GoA: Goldsboro fine sandy loam
Me: Meggett fine sandy loam	LyB: Lynchburg fine sandy loam
Gt: Grifton fine sandy loam	NoB: Norfolk loamy fine sand
	WaB: Wagram loamy fine sand

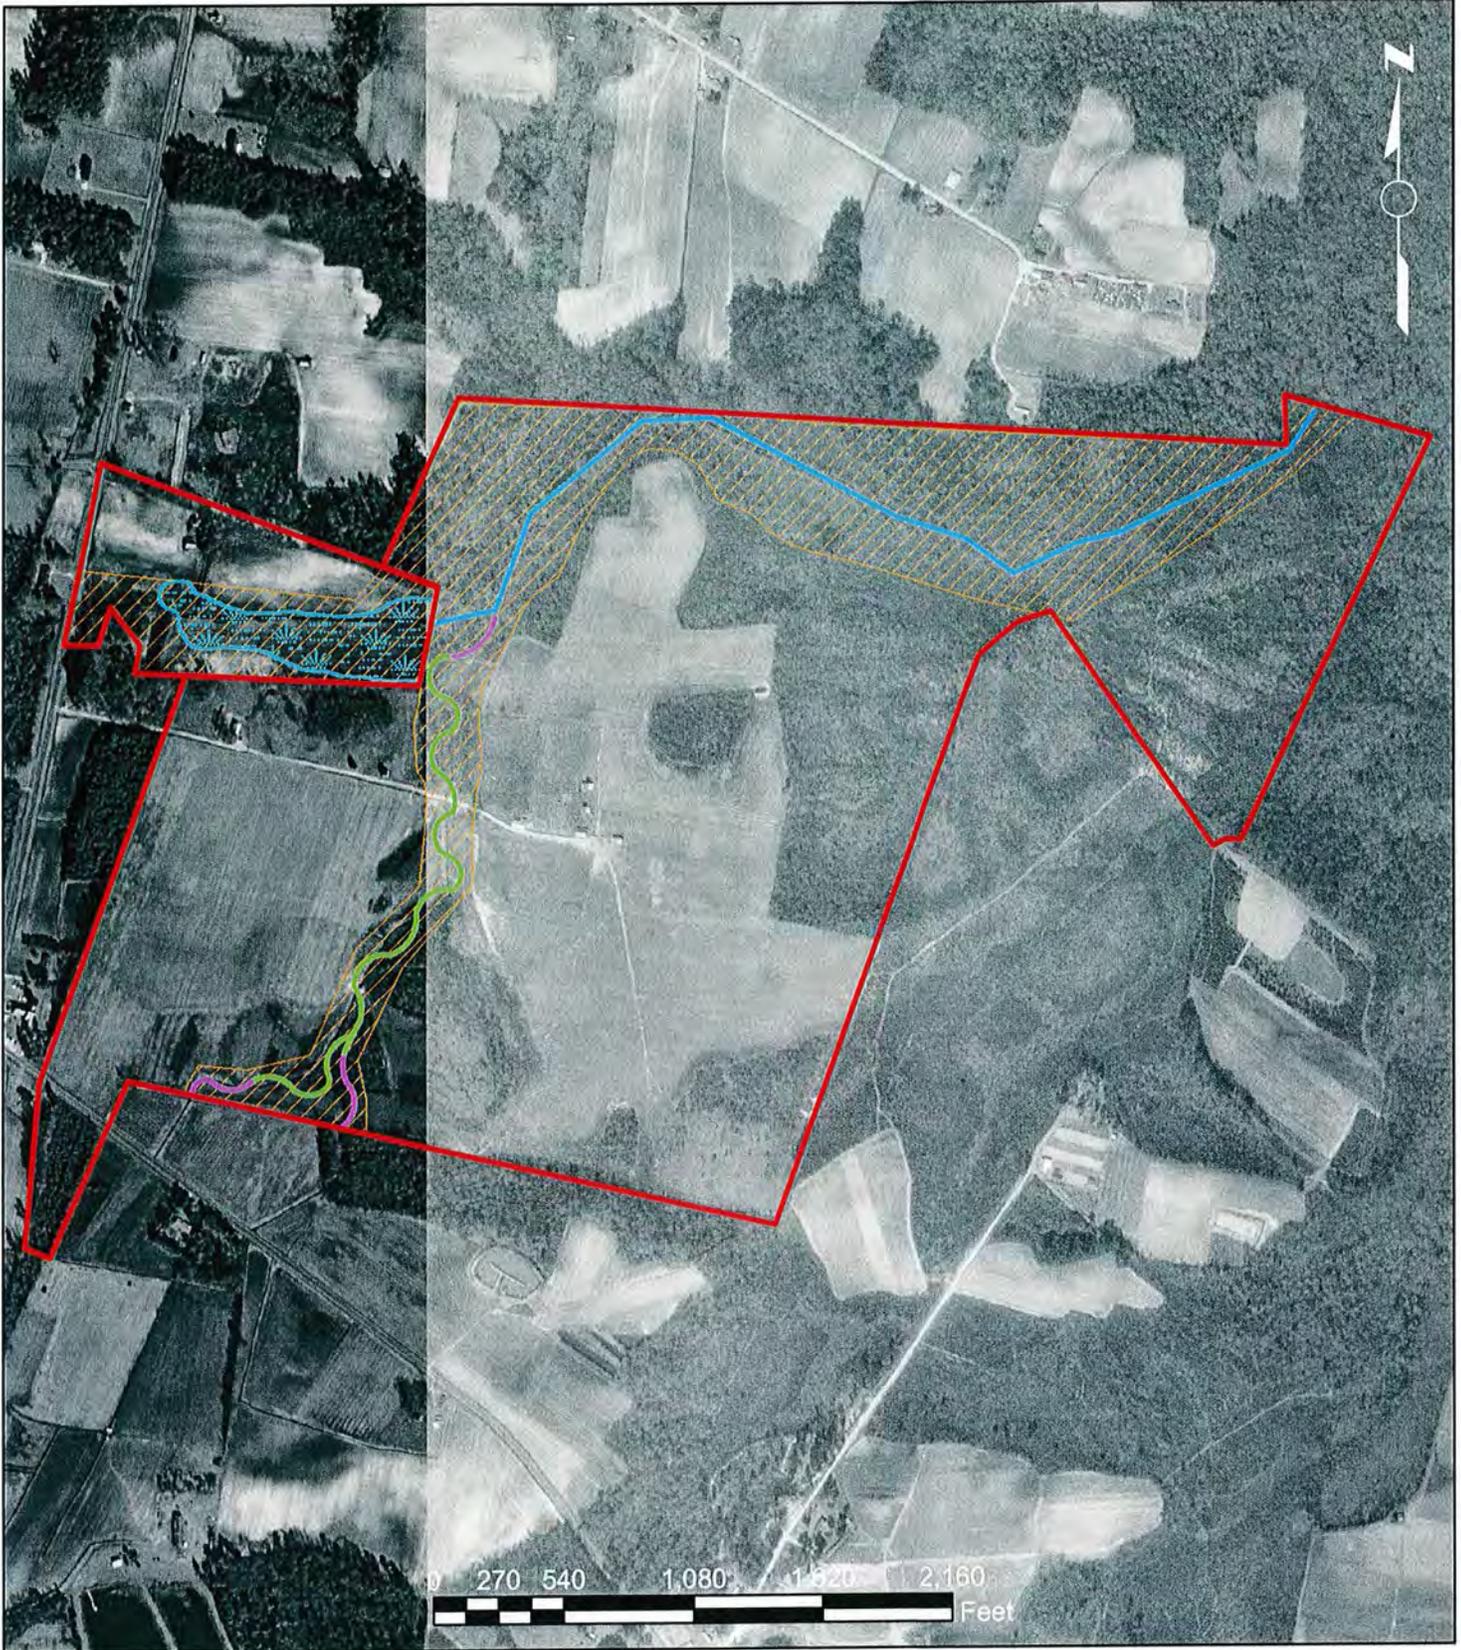
- Jones Property
- Hall Property
- Priority I Restoration
- Priority II Restoration
- Created Wetland
- Conservation Easement
- Stream Preservation

The recommended restoration methodology is described below. Exhibit 6 shows a plan view of the conceptual recommendations.

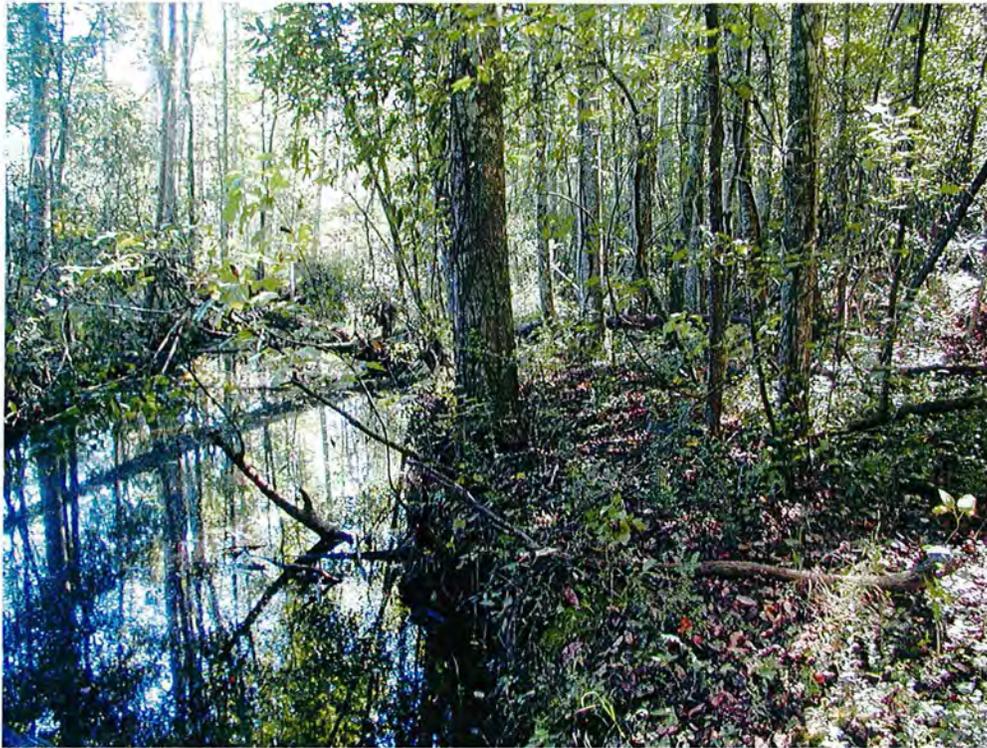
Photograph 1. A forested buffer is located adjacent to both banks of Mill Branch on the Jones Property.

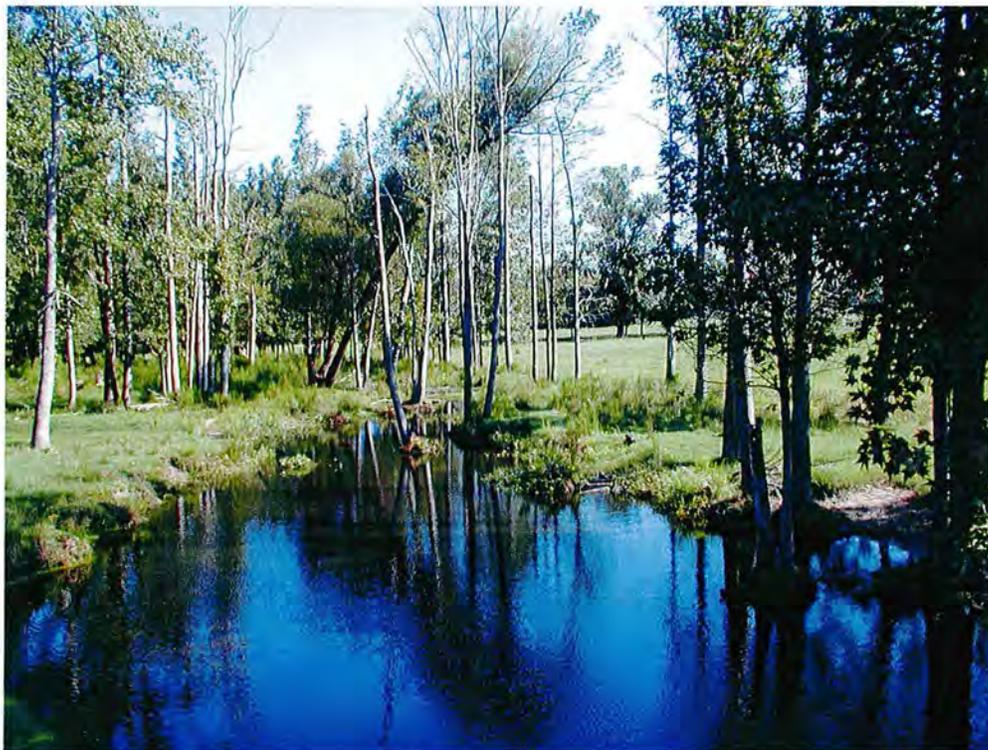
Photograph 2. A dammed section of the unnamed tributary north (downstream) of the access road has created a pond used by cattle.

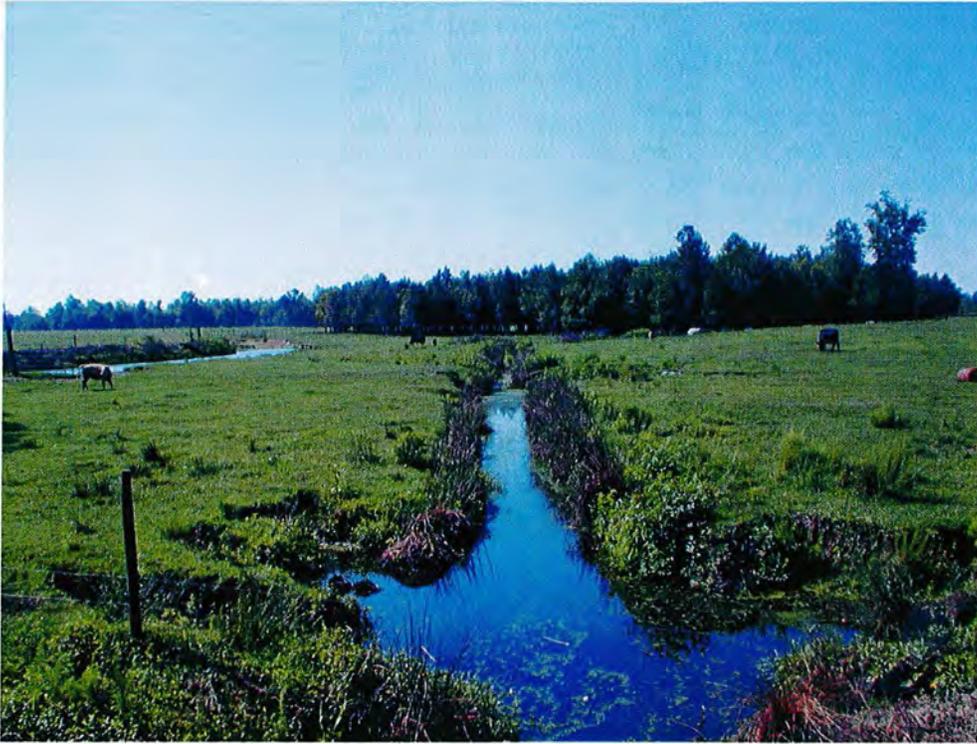
Photography 3. The pond immediately downstream is backing water up in the unnamed tributary.

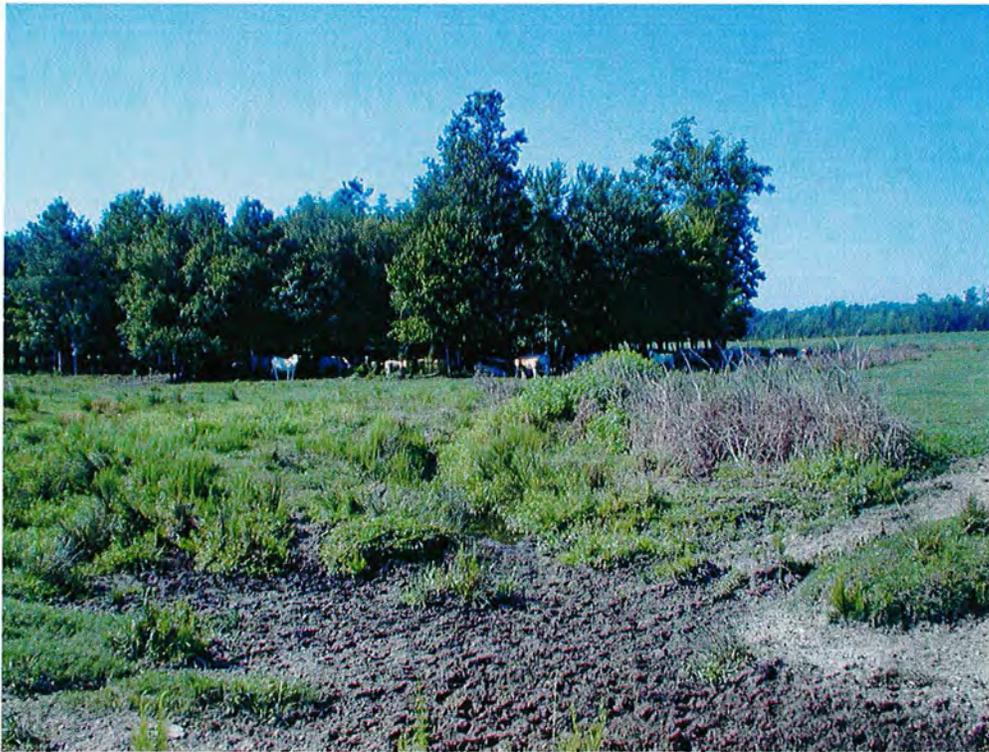
Photograph 4. Cattle crossings in the unnamed tributary have caused over widening and bank instability.

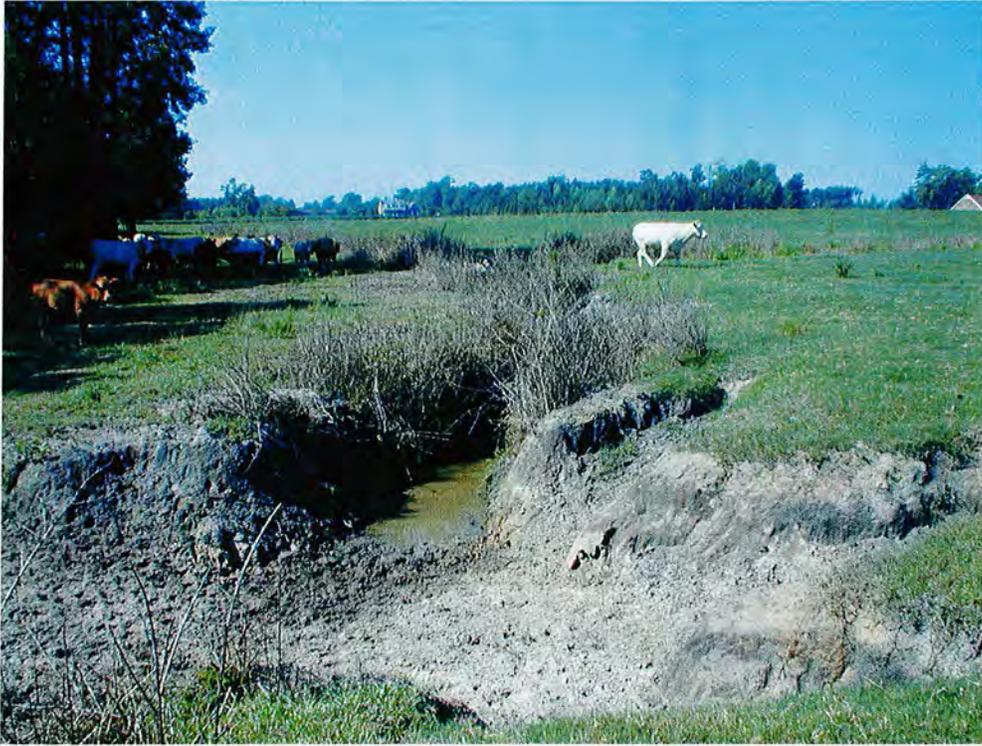
Photograph 5. Cattle crossings in the unnamed tributary have caused overwidening of the stream and severe bank degradation.

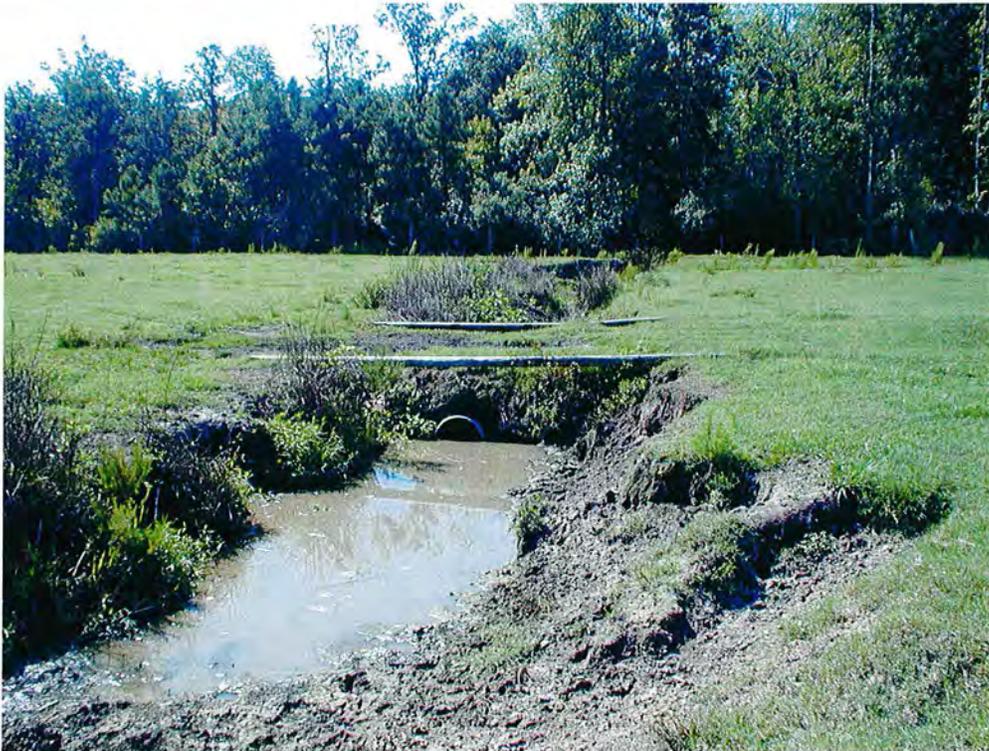
Photograph 6. A pipe culvert utilized for a cattle crossing is located upstream on the unnamed tributary.

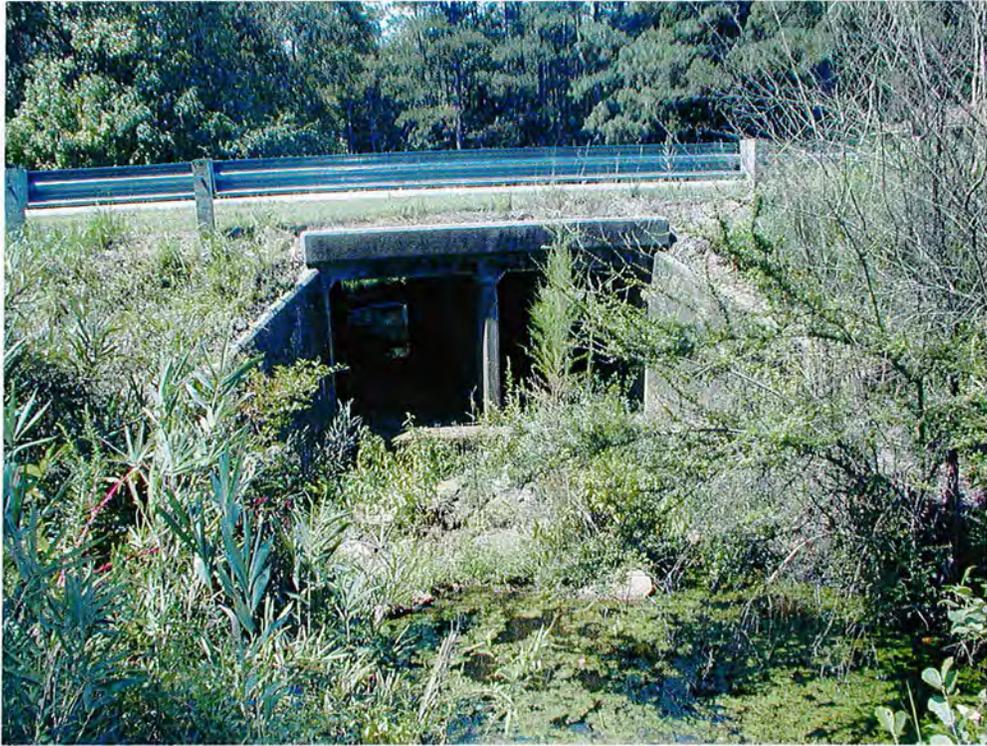
Photograph 7. Water is stagnant downstream of the culvert crossing under HWY 701 on the Hall Property.

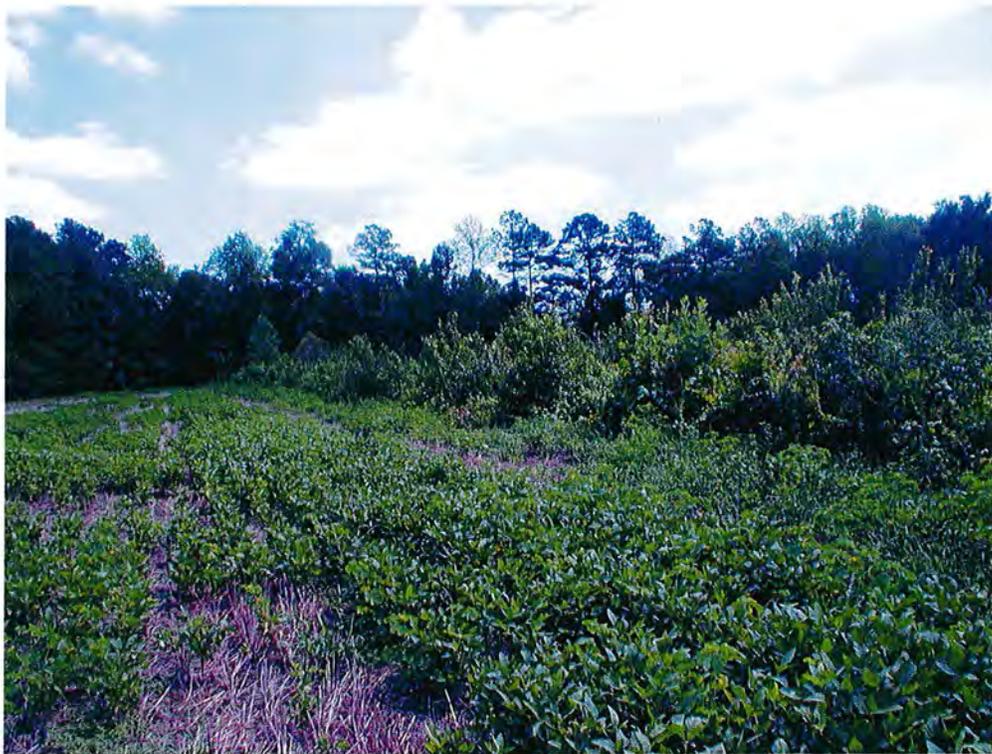
Photograph 8. Agricultural fields are adjacent to both banks of Mill Branch on the Hall Property. Young, thick vegetation is growing on Mill Branch's banks.

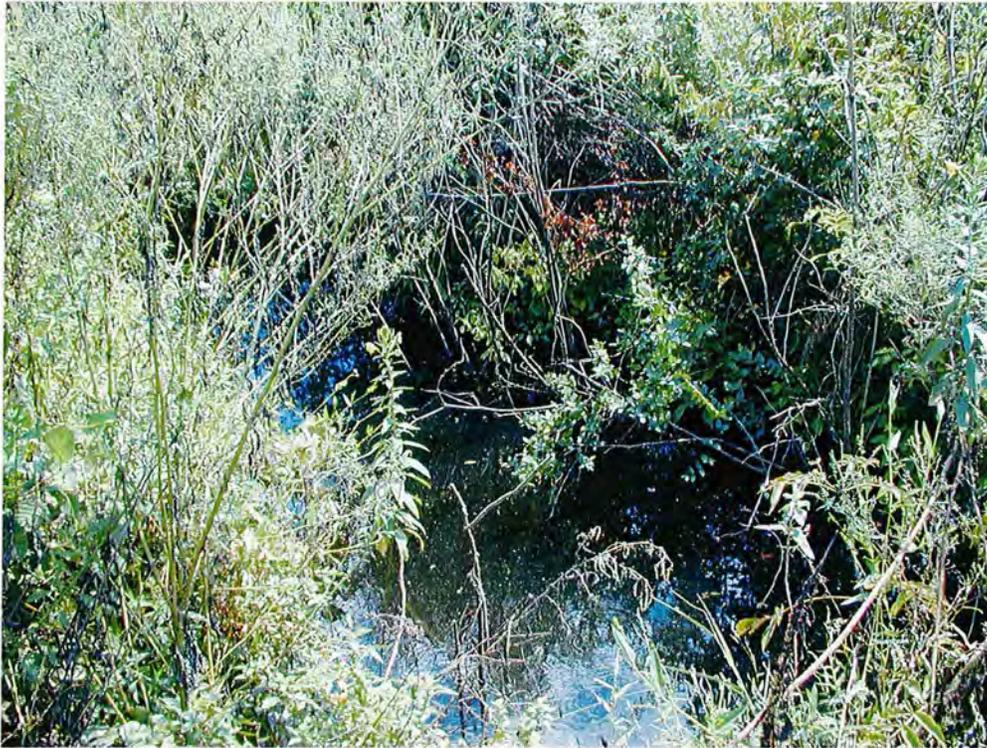
Photograph 9. Thick vegetation along the entire reach of Mill Branch does not allow a clear picture of channel dimensions.

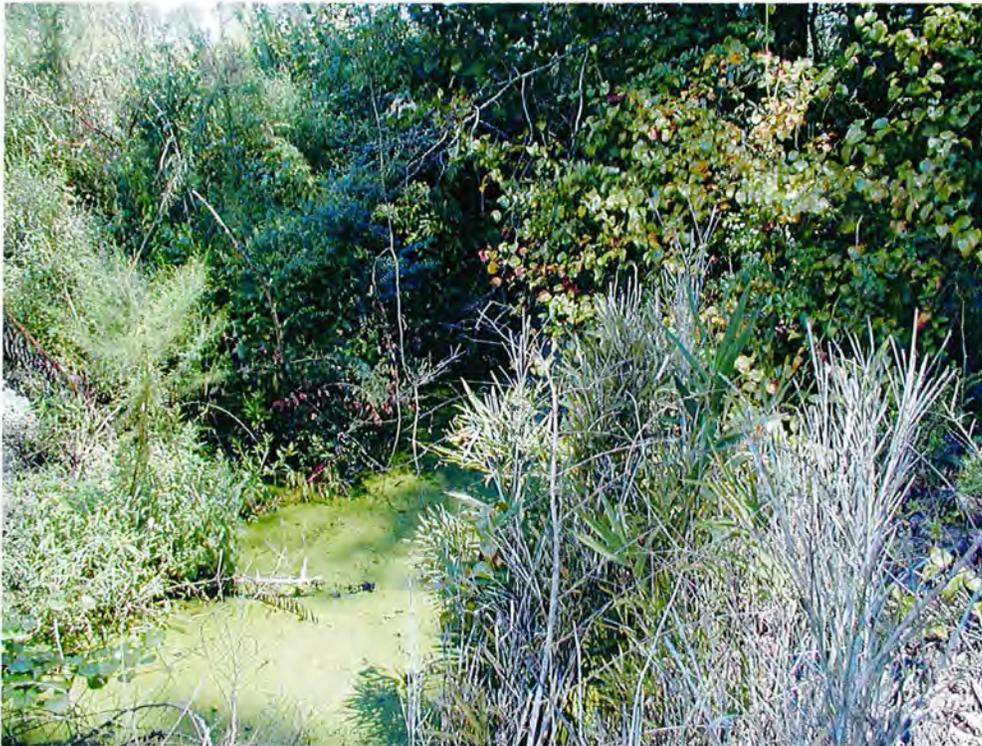
Photograph 10. Duckweed is evidence of low flow or stagnant water in Mill Branch.
