**B-2963 FLOOD STORAGE AND WETLAND
MITIGATION PLAN**

**TIP Project No. B-2963
State Project No. 8.2352201
FA Project BRSTP-1107 (4)**

**North Carolina Department of Transportation
Project Development and Environmental Analysis Branch**

December, 2003

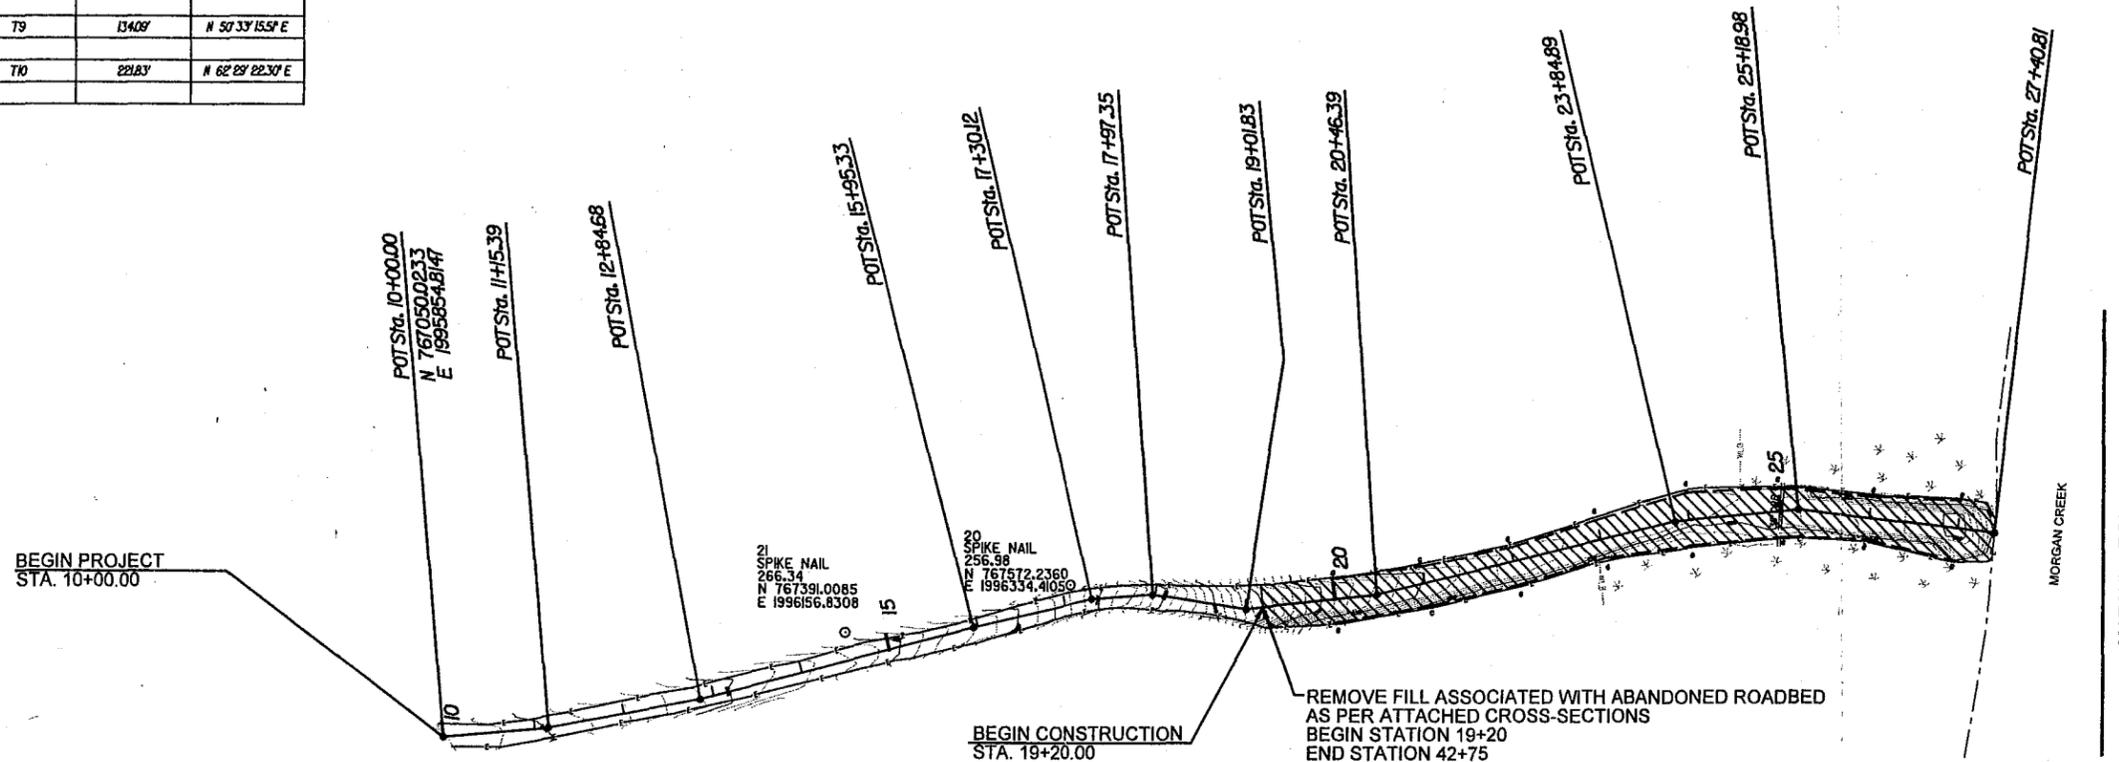
Exhibits 2.4.1 and 2.4.2 show the plan view of the fill removal areas for the west and east portions of the project, respectively. Exhibits 2.4.3 and 2.4.4 show the existing and proposed profile of the west and east portions of the project, respectively. Exhibits 2.4.5 and 2.4.6 show example cross-sections for the west and east portions of the project, respectively.

When the Mitigation Plan is implemented, approximately 2,560 cubic yards of fill will have been removed from the west portion of the Mitigation Site. Approximately 4,850 cubic yards will have been removed from the east portion of the Mitigation Site. In total, approximately 7,400 cubic yards will be removed below the 240-foot contour within the Jordan Lake Property. Using the 1:1 ratio established by the USACE, the B-2963 Mitigation Site will provide approximately 7,400 cubic yards of flood storage mitigation. This is approximately equal to the 7,330 cubic yards of mitigation required by the B-2963 project.

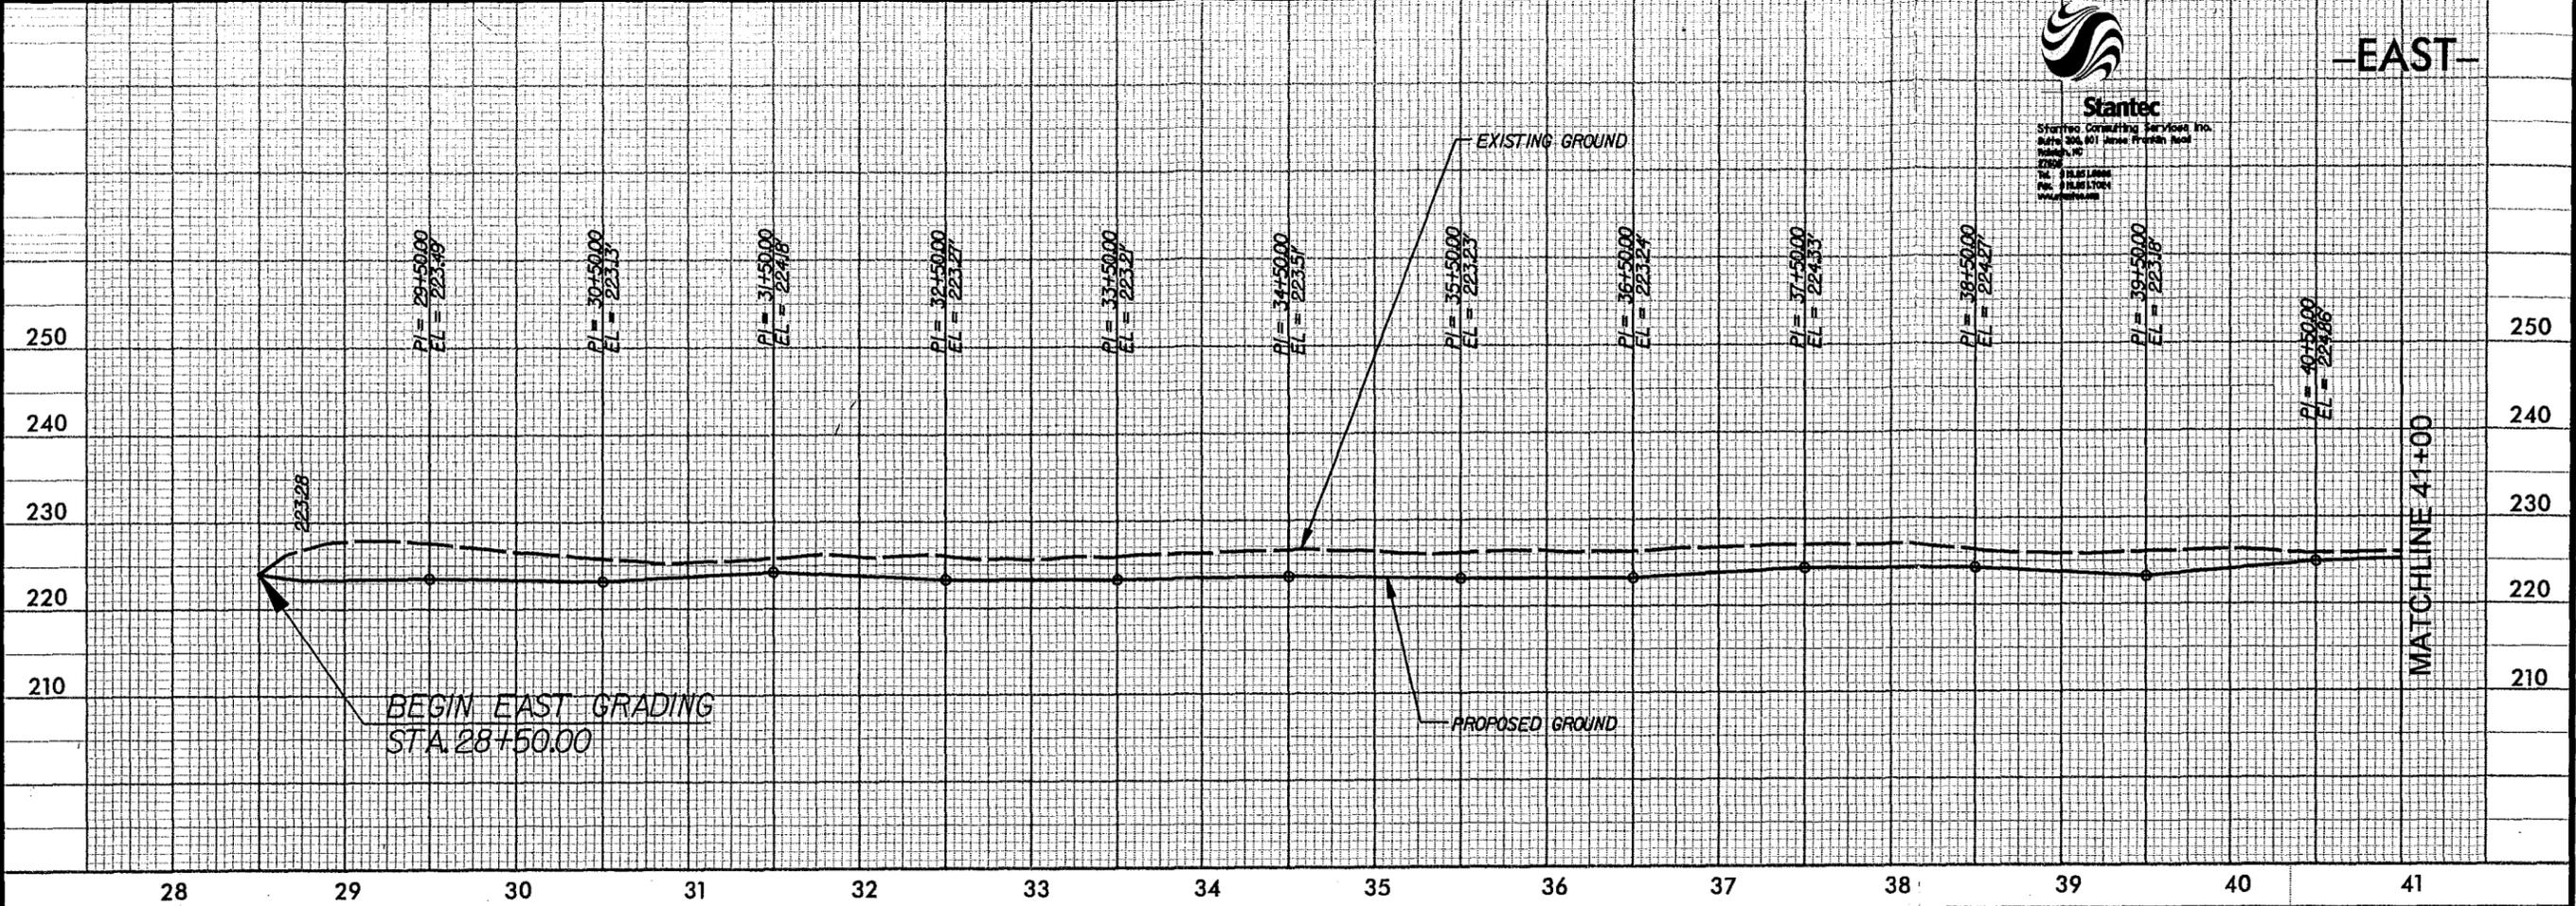
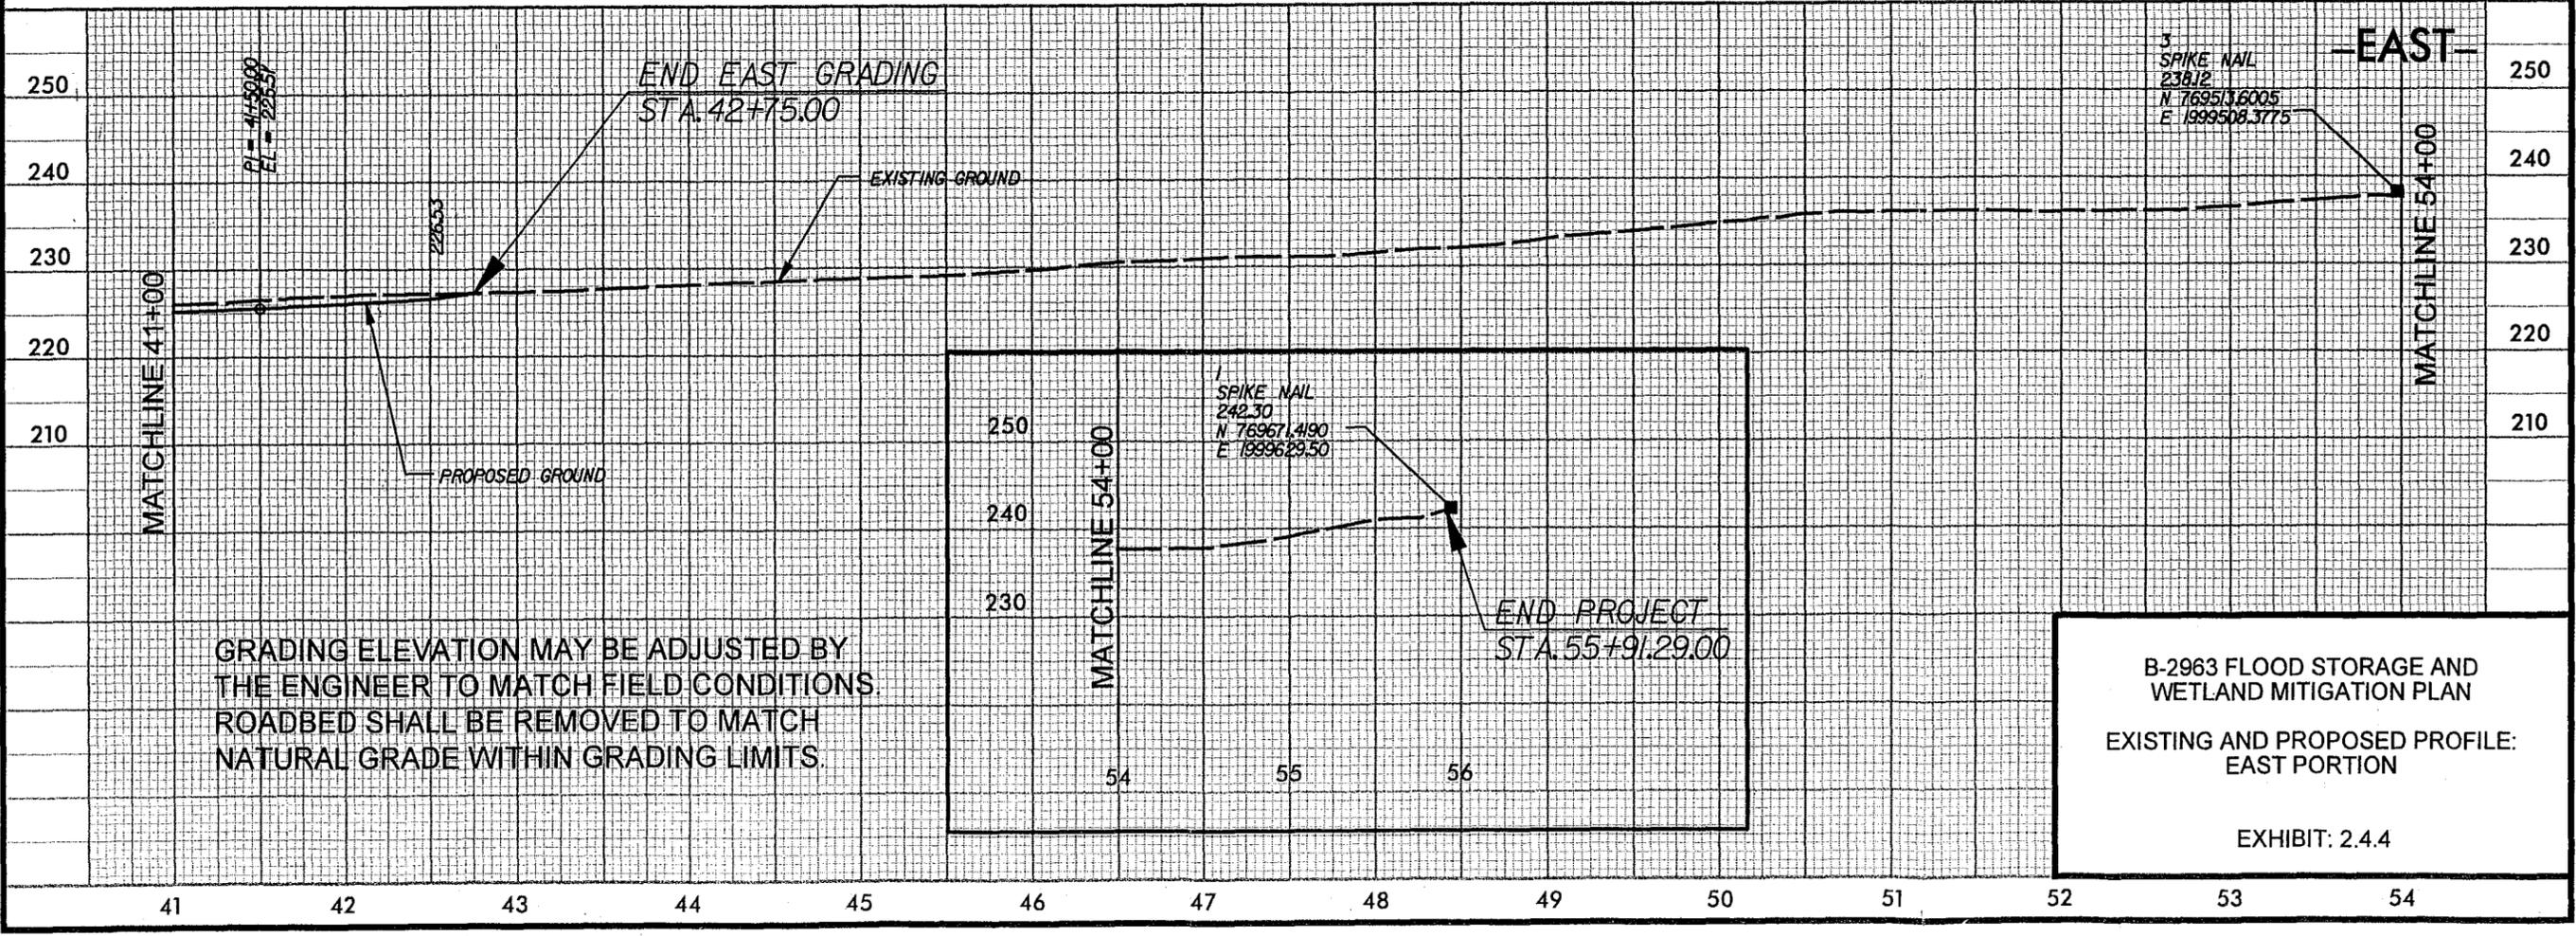
B-2963 FLOOD STORAGE AND WETLAND MITIGATION PLAN
EXISTING AND PROPOSED PROFILE: EAST PORTION
EXHIBIT: 2.4.4

GRADING ELEVATION MAY BE ADJUSTED BY THE ENGINEER TO MATCH FIELD CONDITIONS. ROADBED SHALL BE REMOVED TO MATCH NATURAL GRADE WITHIN GRADING LIMITS.

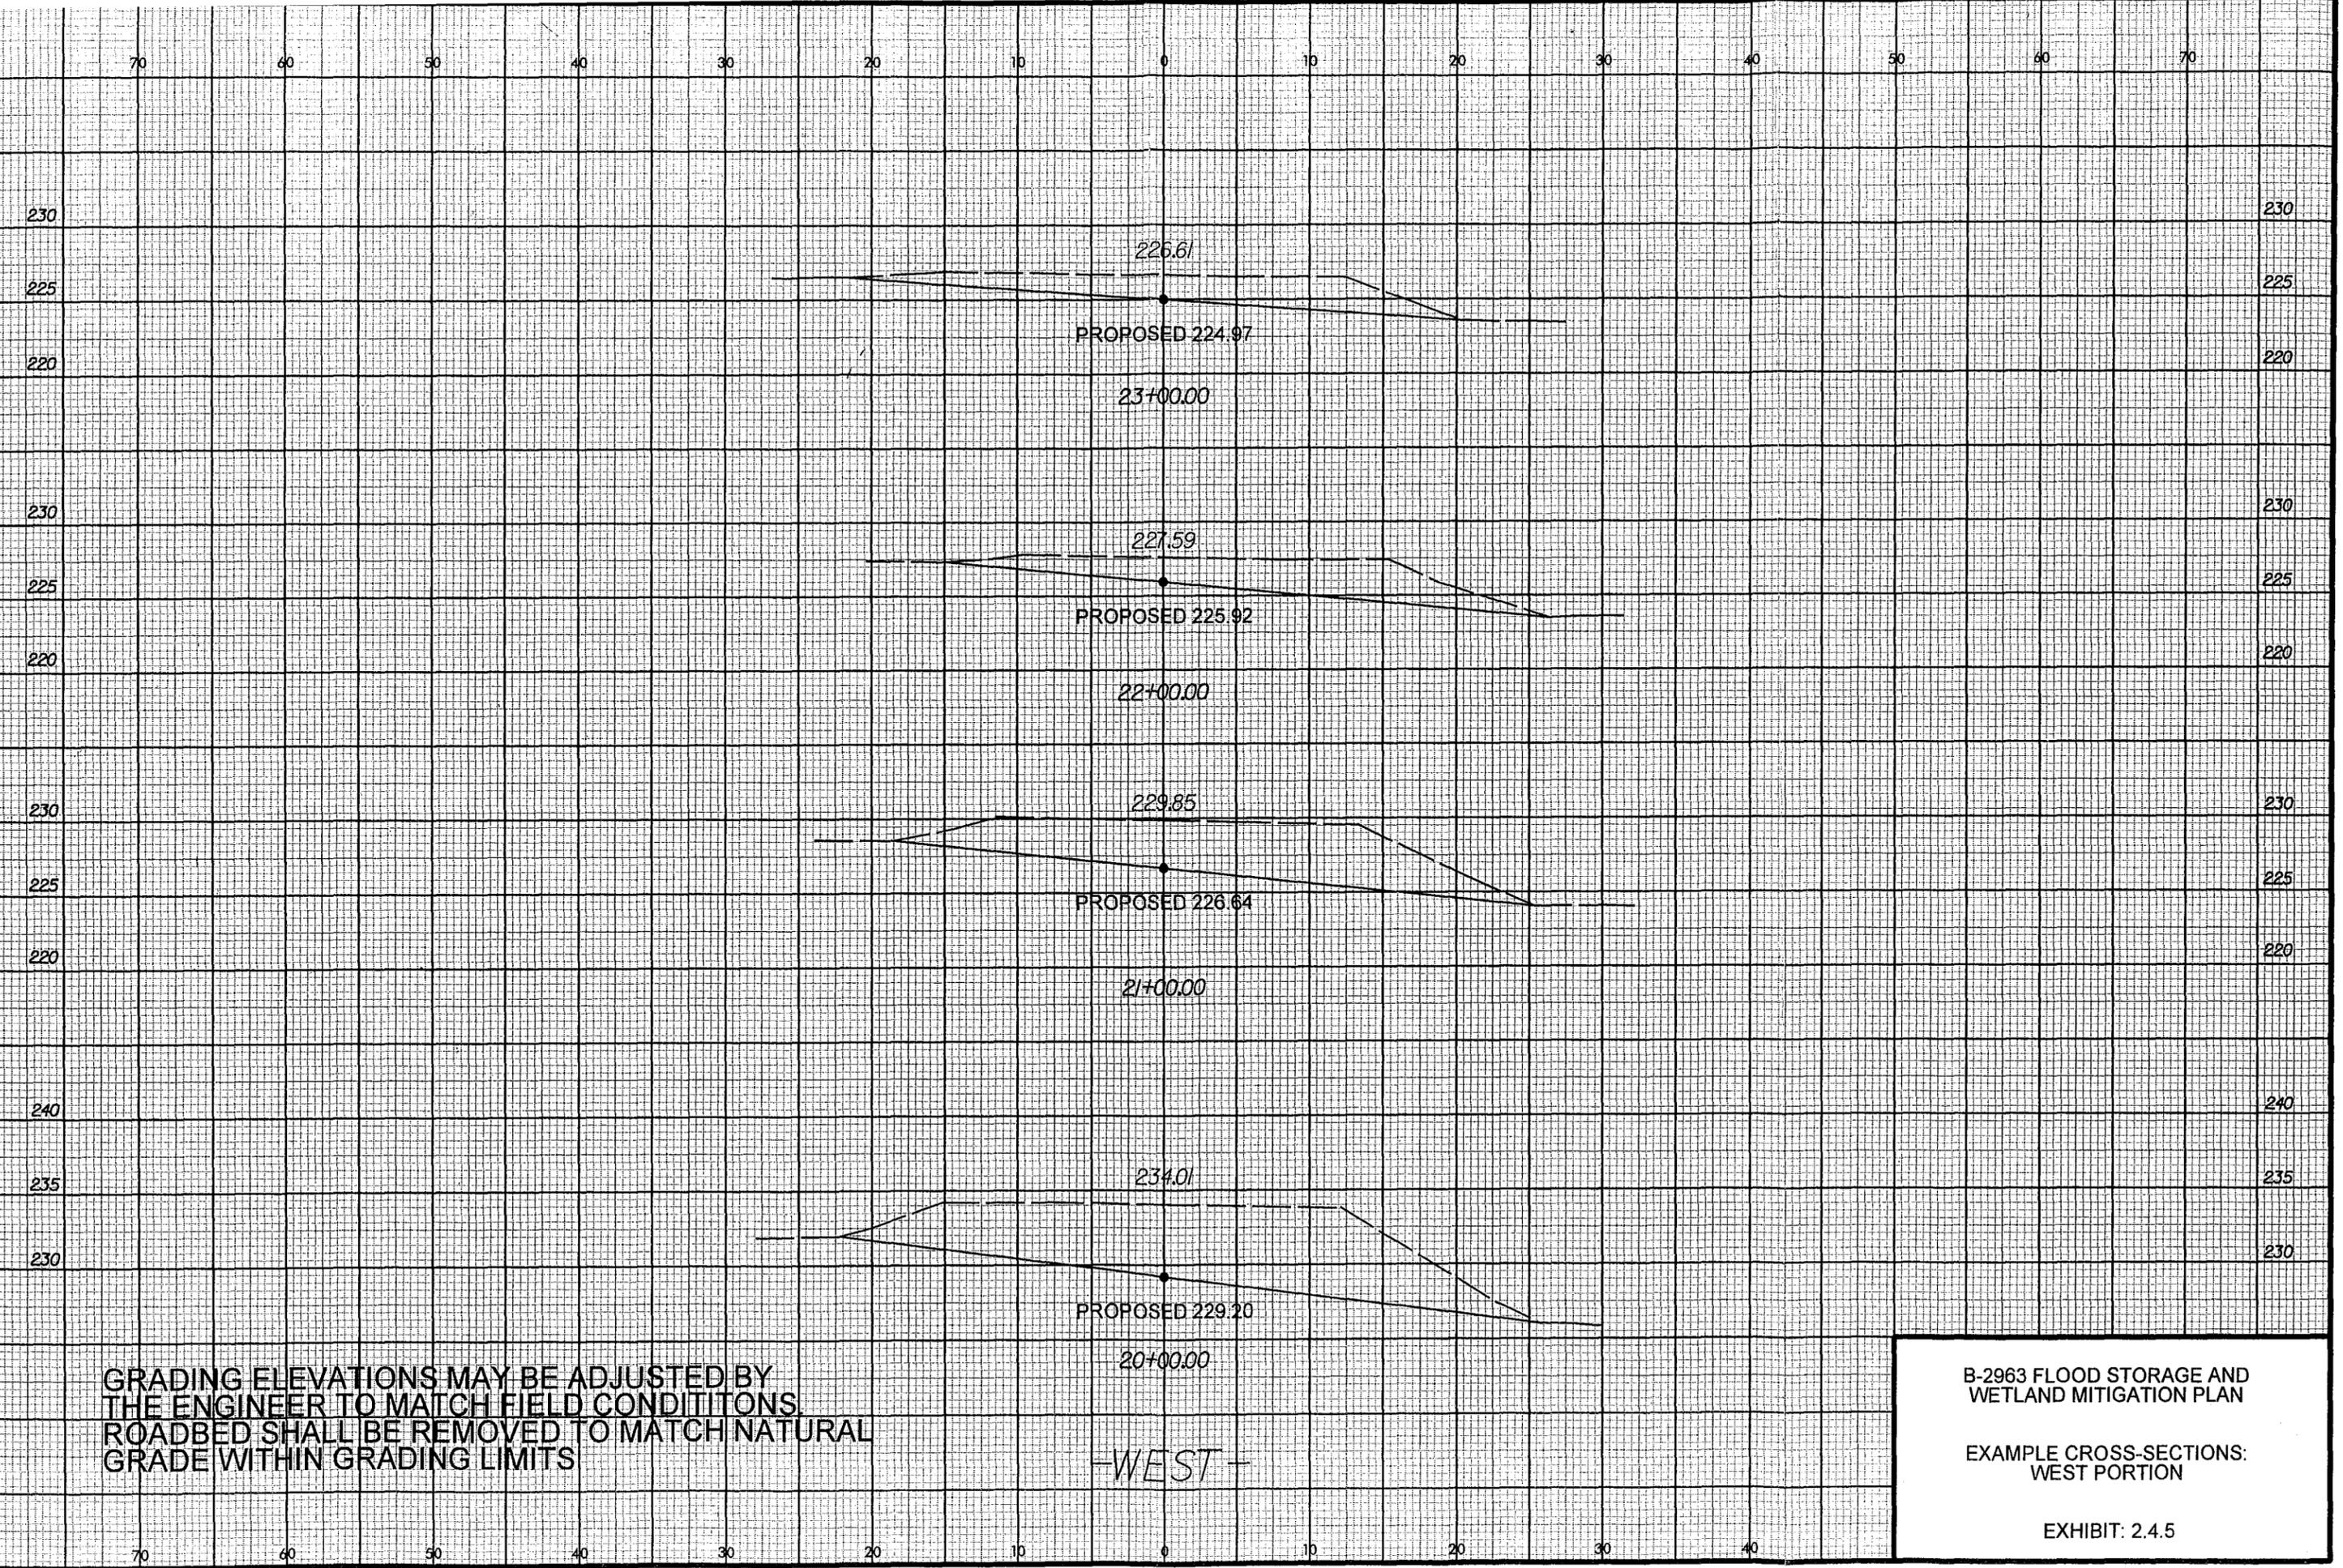
EXHIBIT: 2.4.5

GRADING ELEVATIONS MAY BE ADJUSTED BY THE ENGINEER TO MATCH FIELD CONDITIONS. ROADBED SHALL BE REMOVED TO MATCH NATURAL GRADE WITHIN GRADING LIMITS.

EXAMPLE CROSS-SECTIONS: WEST PORTION

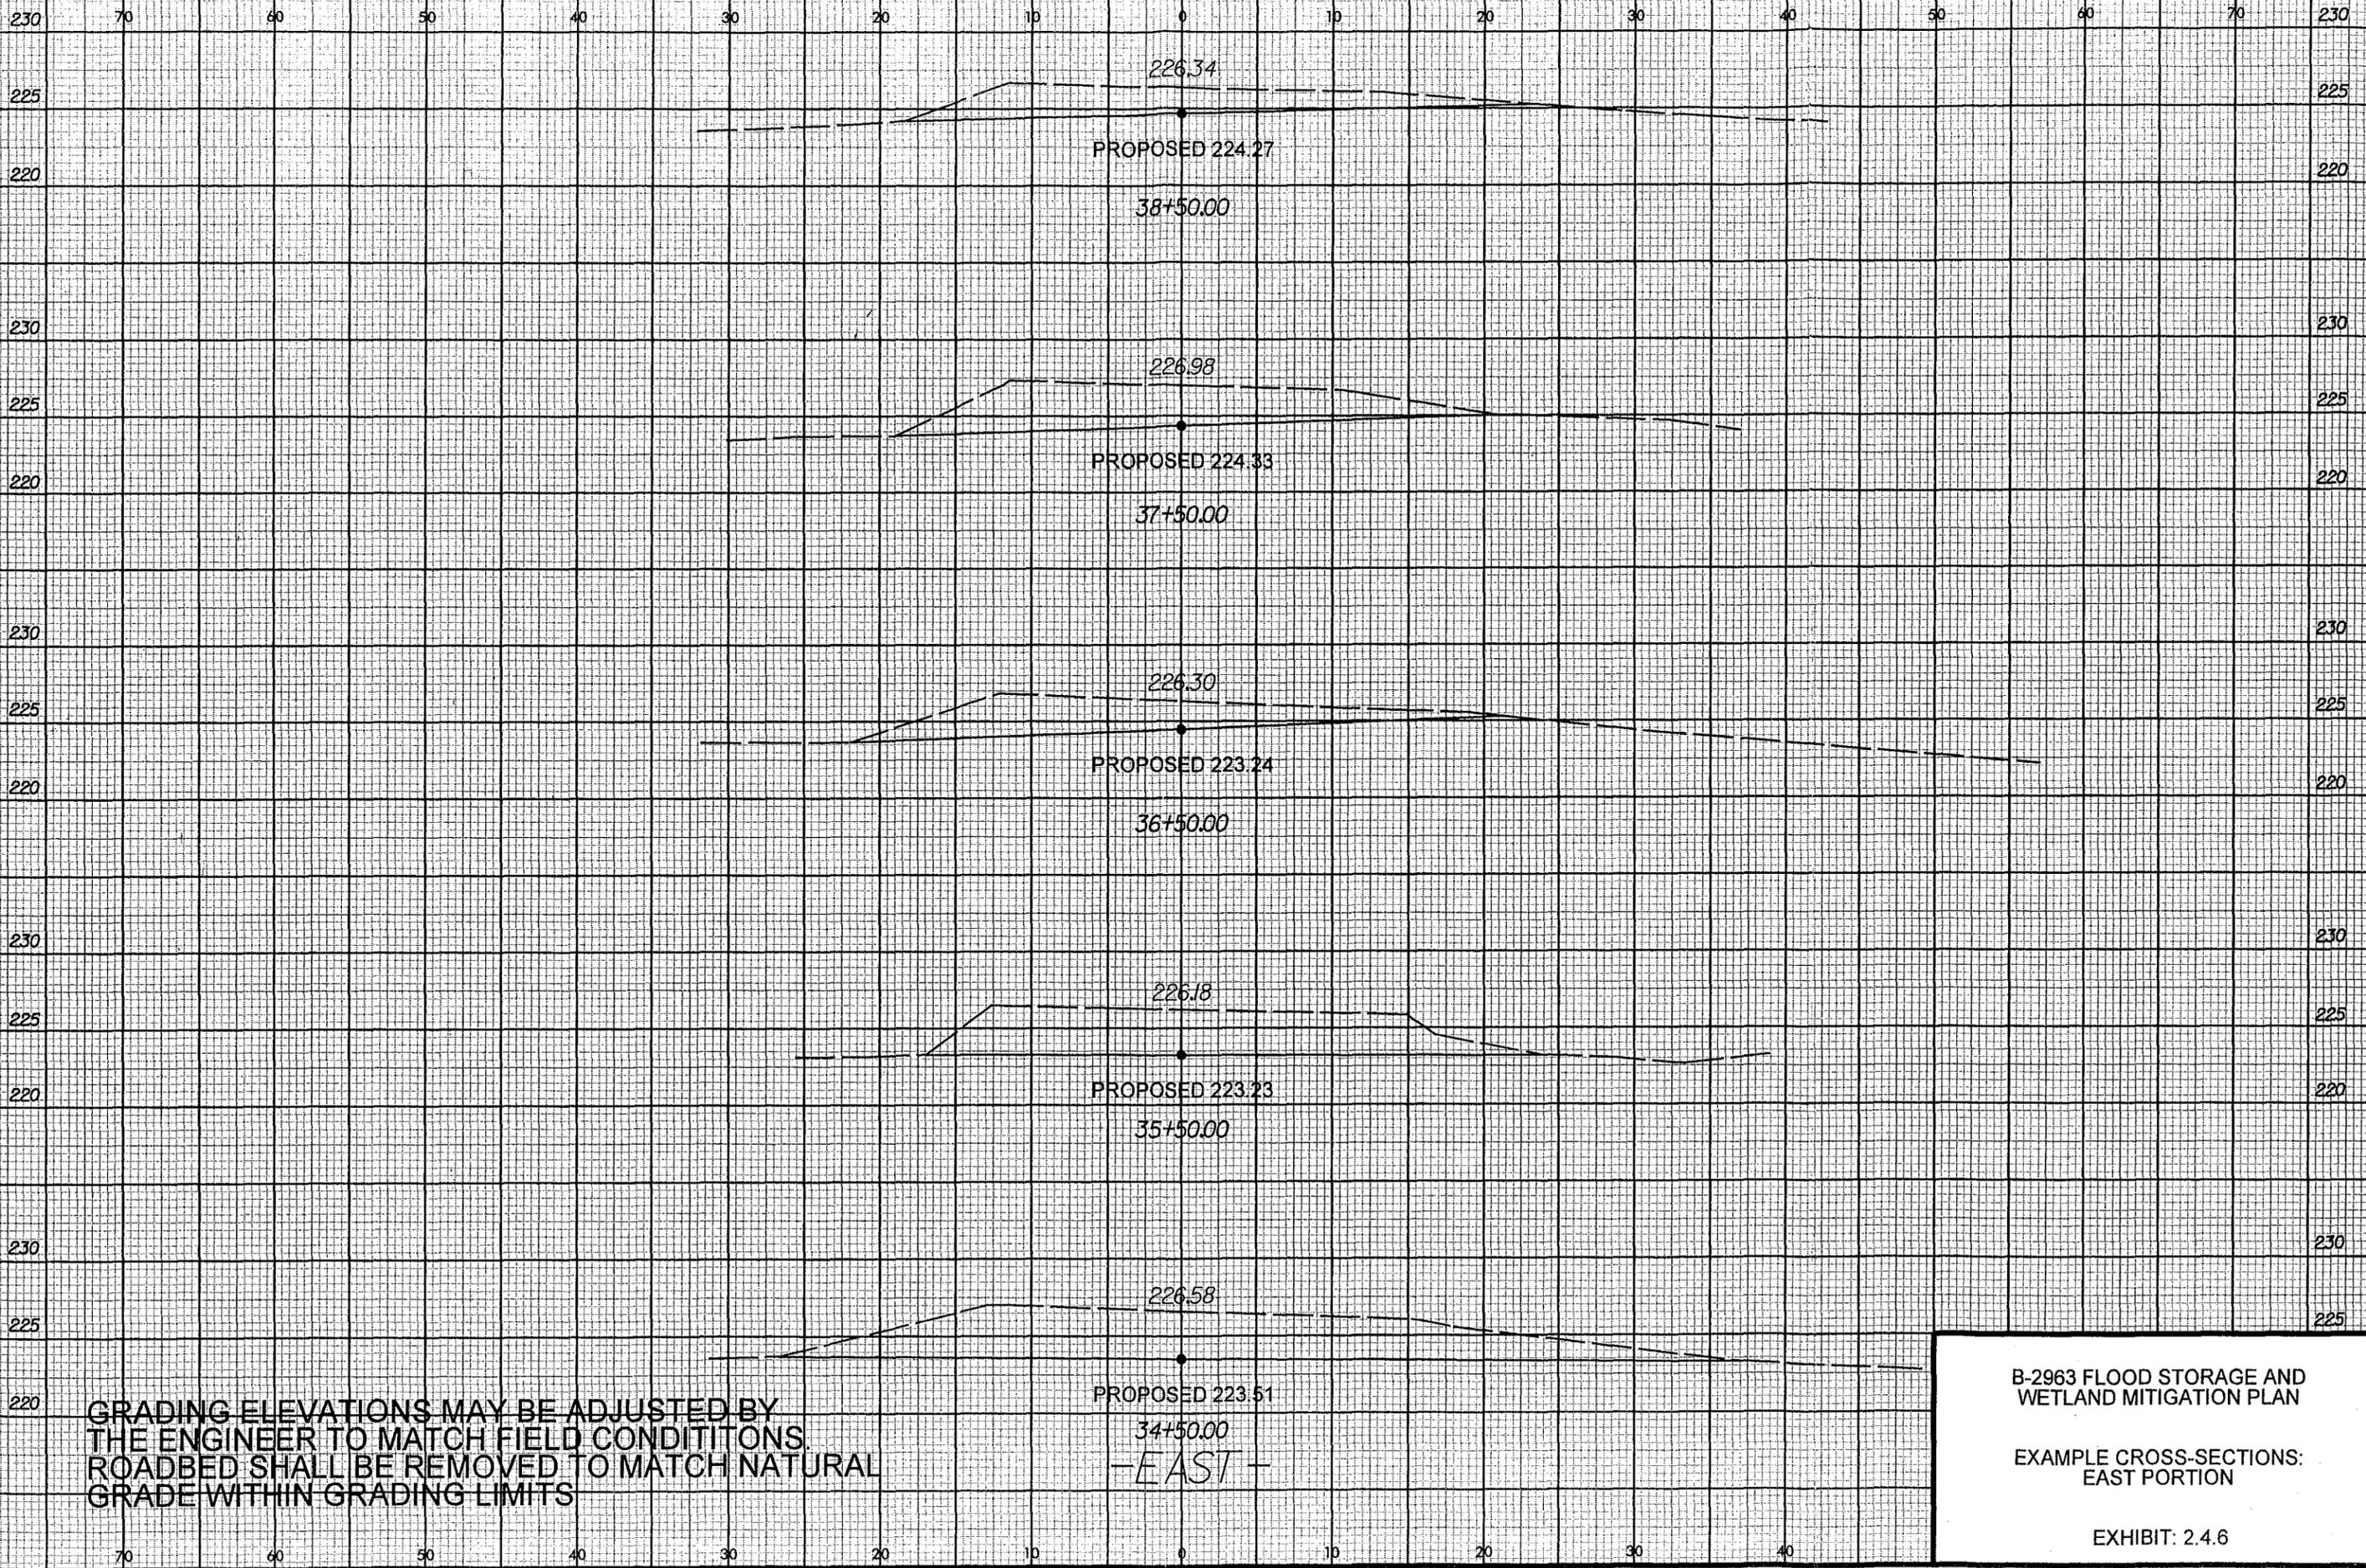
GRADING ELEVATIONS MAY BE ADJUSTED BY THE ENGINEER TO MATCH FIELD CONDITIONS. ROADBED SHALL BE REMOVED TO MATCH NATURAL GRADE WITHIN GRADING LIMITS.

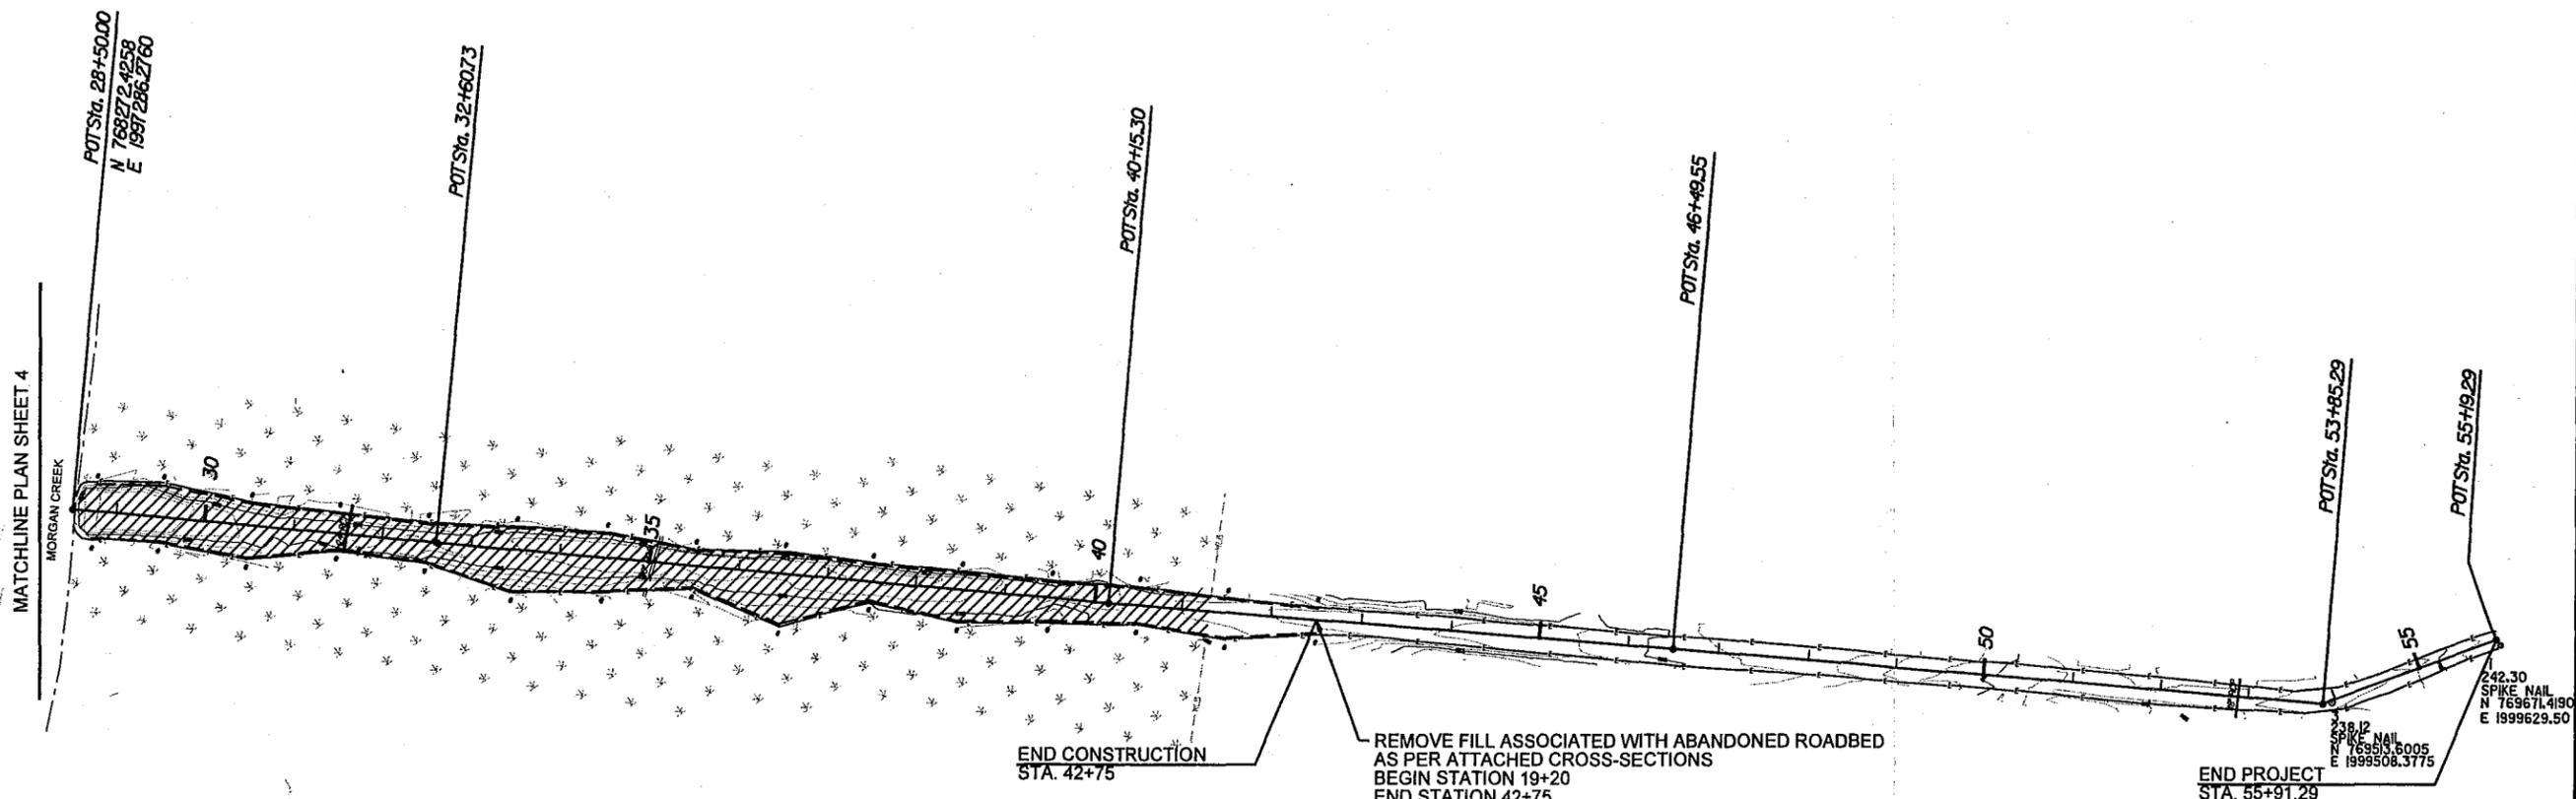
END CONSTRUCTION
STA. 42+75

REMOVE FILL ASSOCIATED WITH ABANDONED ROADBED
AS PER ATTACHED CROSS-SECTIONS
BEGIN STATION 19+20
END STATION 42+75

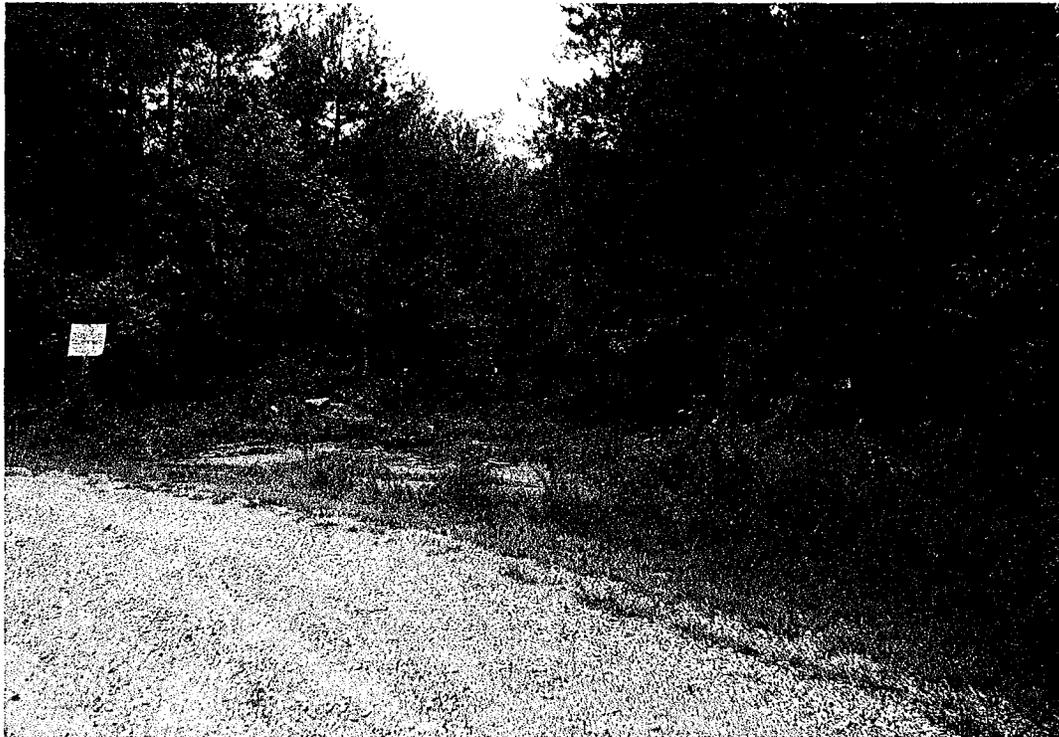
Photo 2. View of the access point for the east portion of the Site. Orange flagging is hanging from the gate that blocks the entrance to the Mitigation Site.

When the road was abandoned, the asphalt was removed but the compacted roadbed was left in place. Access to the abandoned portion of Old Farrington Road was blocked on the west with a steep embankment and on the east with a gate. (Appendix B, Photo 2). With the asphalt removed and vehicular traffic blocked, vegetation has invaded the roadbed. The vegetative

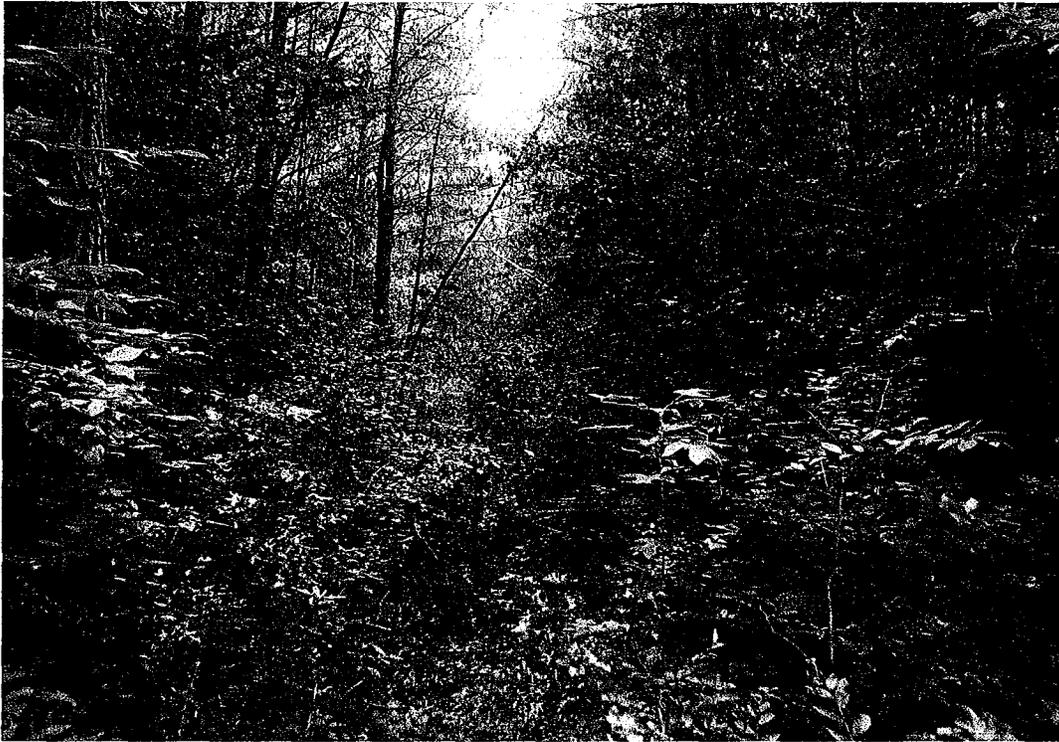
Photo 5. Old roadbed on the east portion of the site. Early successional hardwood species are beginning to establish on the roadbed.

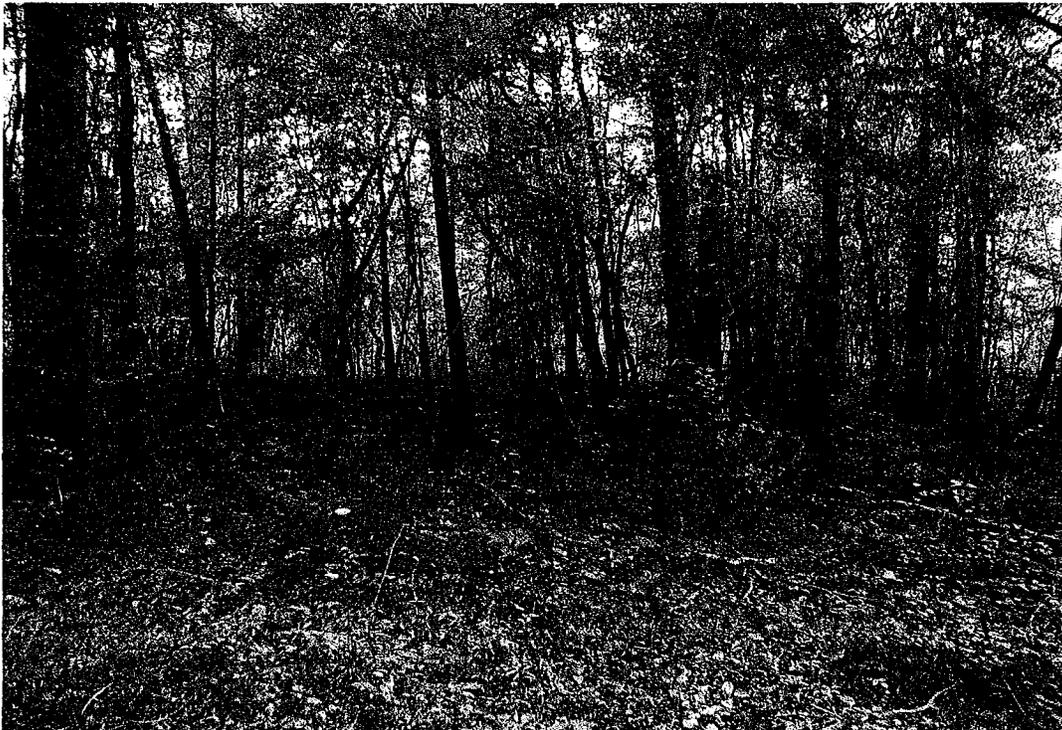
Photo 6. View of the old roadbed on the east portion of the site from the adjacent Piedmont Bottomland Hardwood Forest. The photo was taken at the easternmost portion of the Mitigation Site, where the roadbed was nearly level with the adjacent ground.

The roadbed for Old Farrington Road is approximately 25-feet wide and was sufficient to support a 2-lane roadway. At the extreme east of the Mitigation Site the roadbed is nearly level with the adjacent ground. As the roadbed continues to the west, towards Morgan Creek, the amount and elevation of fill increases to two to three meters above the adjacent ground.

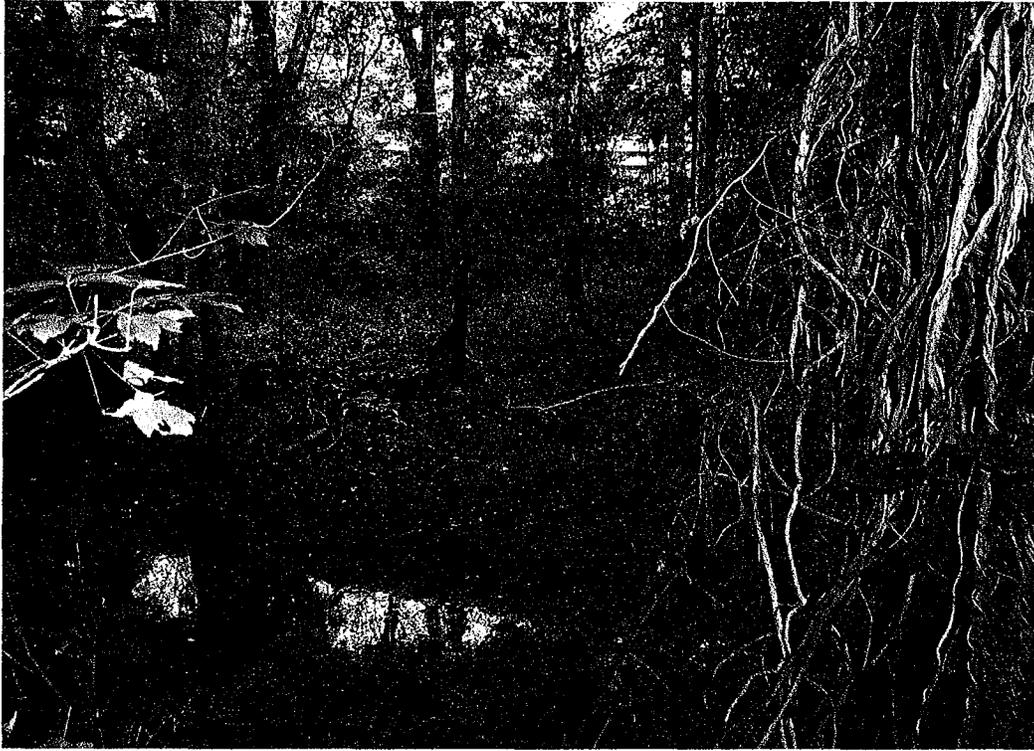
Photo 7. View of the Piedmont Bottomland Hardwood Forest facing south from Old Farrington Road in the western portion of the site.

A Piedmont Bottomland Hardwood Forest community is present on both the eastern and western portions of the Mitigation Site. In the western portion of the Mitigation Site, the community occurs on both sides of the old roadbed (Appendix B, Photo 7). In the eastern portion of the Mitigation Site, the community is present only to the south of the old roadbed. The Piedmont Bottomland Hardwood Forest community includes: red maple, sweet gum, river birch, willow oak (*Quercus phellos*), green ash (*Fraxinus pennsylvanica*), ironwood (*Carpinus caroliniana*), Virginia creeper (*Parthenocissus quinquefolia*), lizards tail (*Saururus cernuus*), and false nettle (*Boehmeria* sp.).

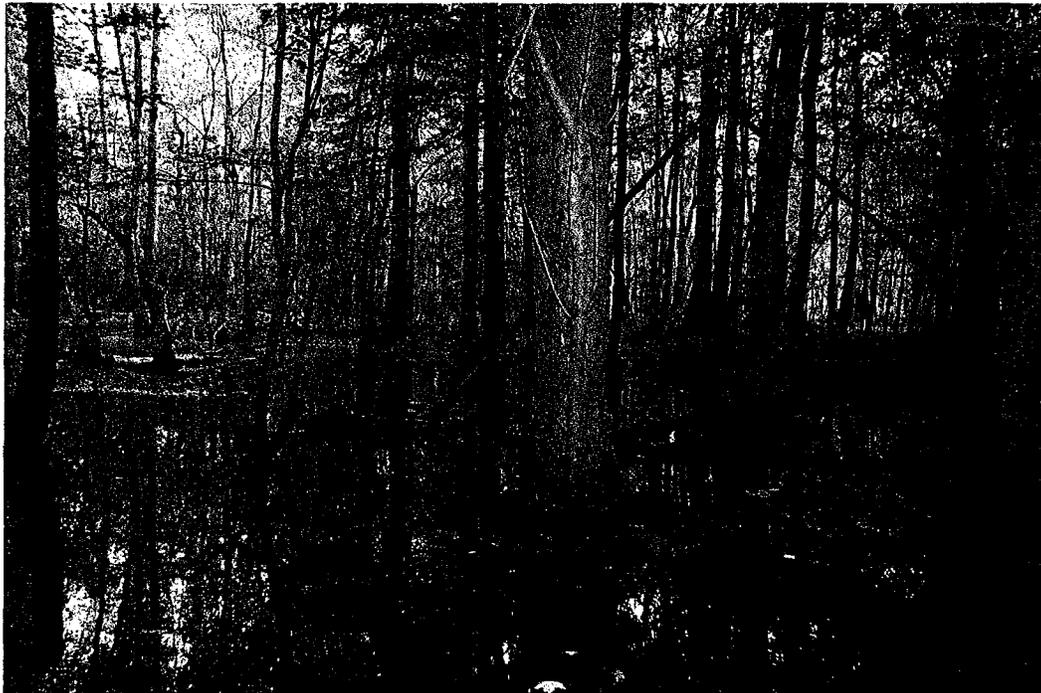
Photo 8. View of the Piedmont Swamp Forest north of Old Farrington Road. The removal of fill associated with the old roadbed will likely drain this portion of the Site, allowing it to transition back towards a Piedmont Bottomland Hardwood Forest Community.

While a Piedmont Bottomland Hardwood Forest originally dominated the flood plain of Morgan Creek, the hydrology of the Mitigation Site has been altered by the construction of Old Farrington and Farrington Roads. These two roads have inhibited the drainage of the area between the two roads east of Morgan Creek. Frequent standing water has caused the Piedmont Bottomland Hardwood Forest in this area to transition toward a Piedmont Swamp
