**Former Asphalt Testing Lab  
420 Sugar Lake Road  
Pittsboro, North Carolina**

April 2013

Prepared by: Chris Niver, P.G., CHMM  
North Carolina Department of Transportation

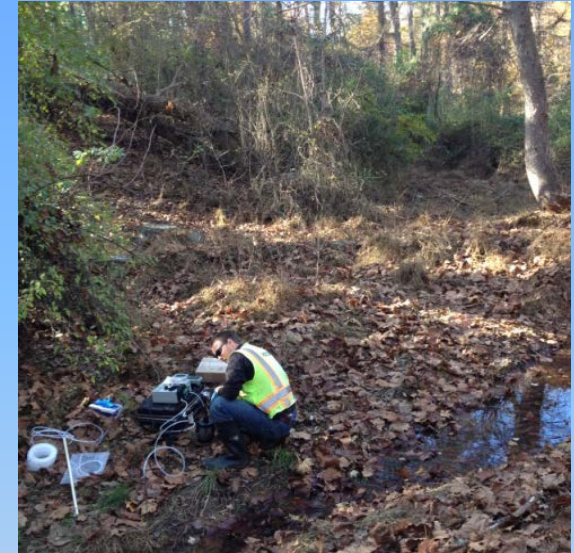
Investigation (1997-present)	Remediation (2002-present)
100+ soil samples analyzed	P&T started in 2002 and provide hydraulic control
25 groundwater monitoring wells installed	AS/VE System installed in 2003
29 groundwater monitoring events conducted	Treated six million+ gallons of groundwater
450 + groundwater samples analyzed	Removed ~13 lbs of TCE from groundwater
Thermal imaging to assess surface water	SVE pilot test conducted in April 2012
Fracture trace analysis and borehole geophysics	Electrical Resistance Heating (ERH) Bench test completed February 2013

- 100+ soil samples analyzed
  - 25 groundwater monitoring wells installed
  - 29 groundwater monitoring events conducted
  - 450+ groundwater samples analyzed
  - Thermal imaging to assess surface water
  - Fracture trace analysis and borehole geophysics
- NCDOT Remediation Activities**
- Air Sparge/Soil Vapor Extraction (AS/SVE) System installed 2002
  - Pump & Treat system started in 2003 to provide hydraulic control
  - Treated six million gallons of groundwater
  - Removed ~13 lbs of TCE from groundwater
  - SVE pilot test conducted in April 2012
  - Electrical Resistance Heating bench-scale test planned for winter 2012-2013

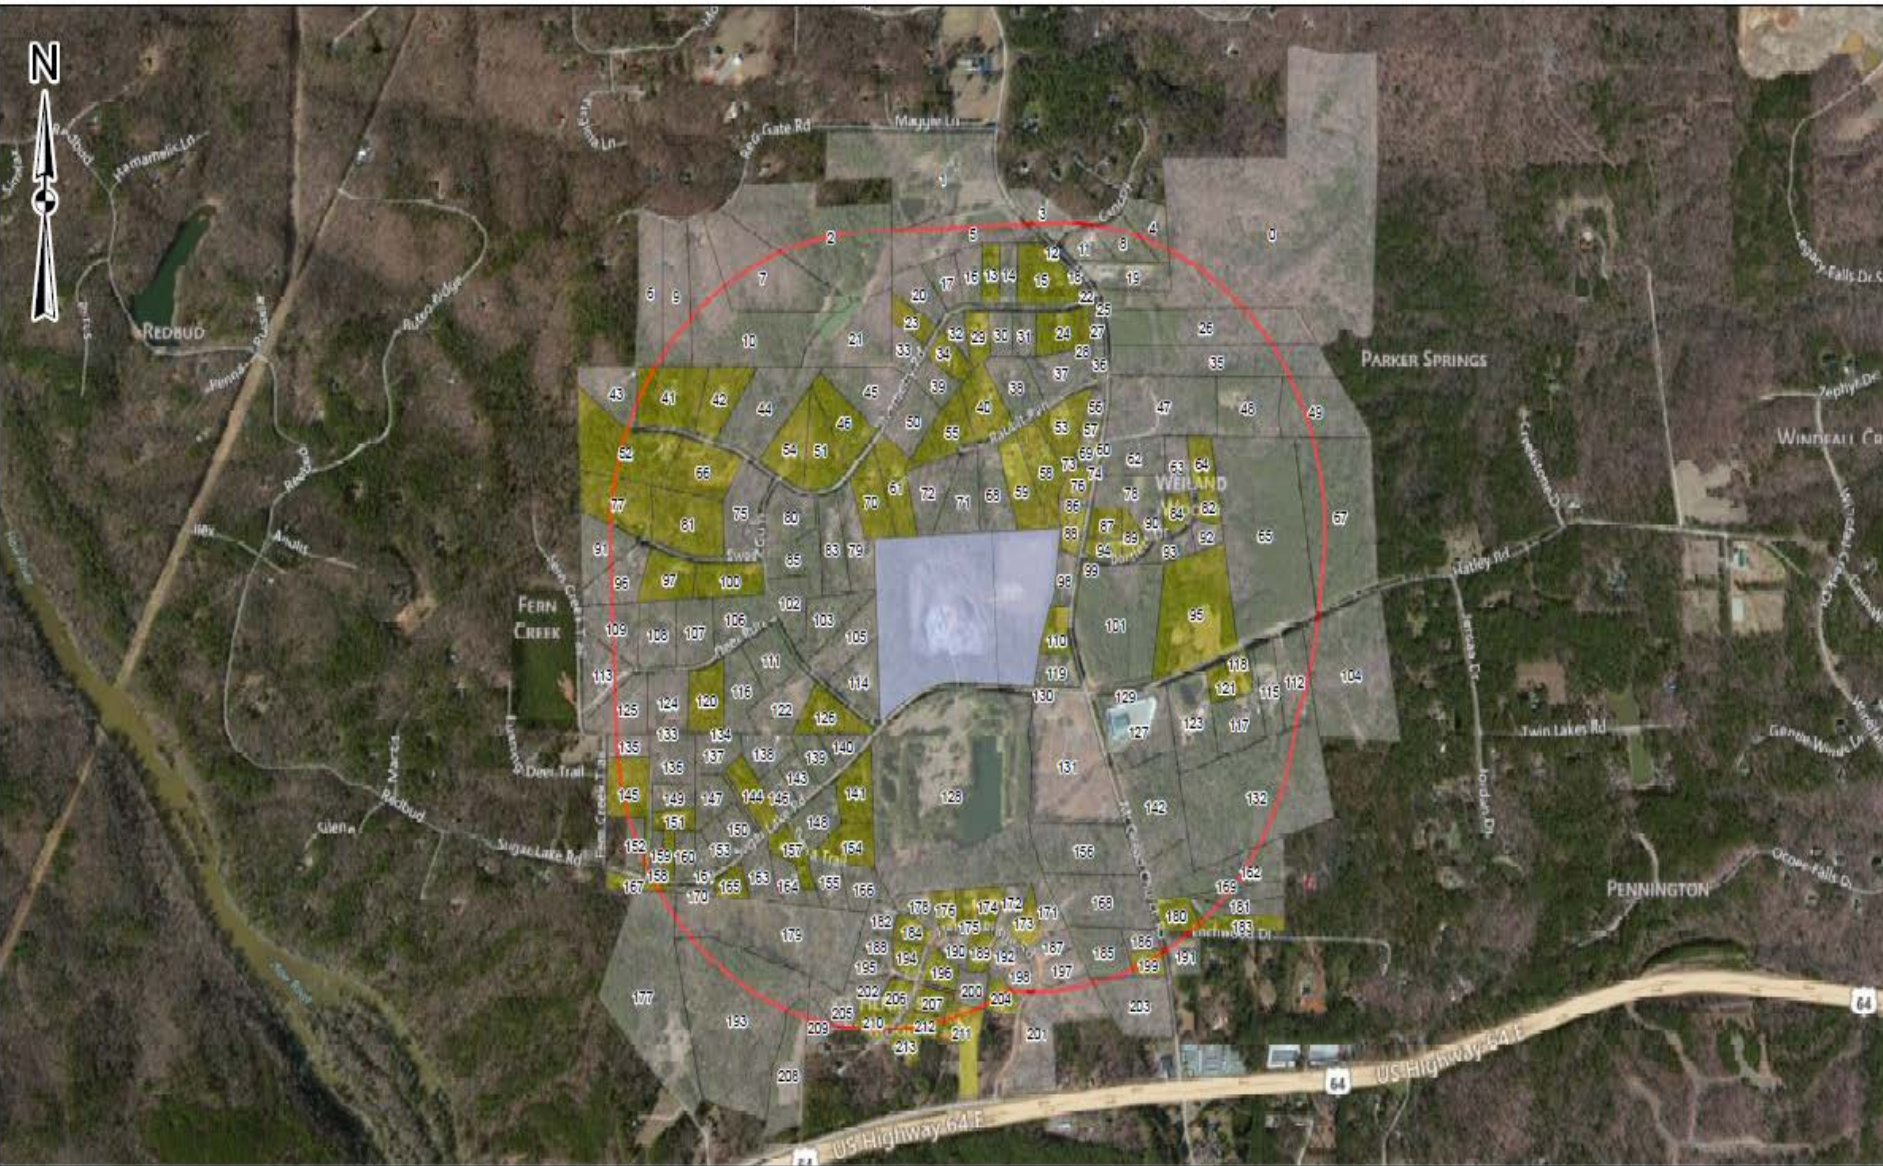
**Properties within Half-Mile Radius  
Former Asphalt Testing Site No. 6-48  
North Carolina Department of Transportation  
Pittsboro, North Carolina**

Potable Wells	Vapor Intrusion	Surface Water
1996 – first well survey completed	No structures above impacted soil	30 surface water samples collected for analysis
2012 – most recent update of well survey	Nearest structure 100 feet from impacts	2003-2011: no 2B exceedances during continuous system operation
52 wells w/in 1500 feet	No vapor intrusion pathways	10 detects of target compounds in surface water (Historically when groundwater system not operating)
97 wells w/in ½ mile		Dry in Summer
2 wells closest to site are sampled regularly		
No compounds detected (Installing 2 POE Carbon Systems)

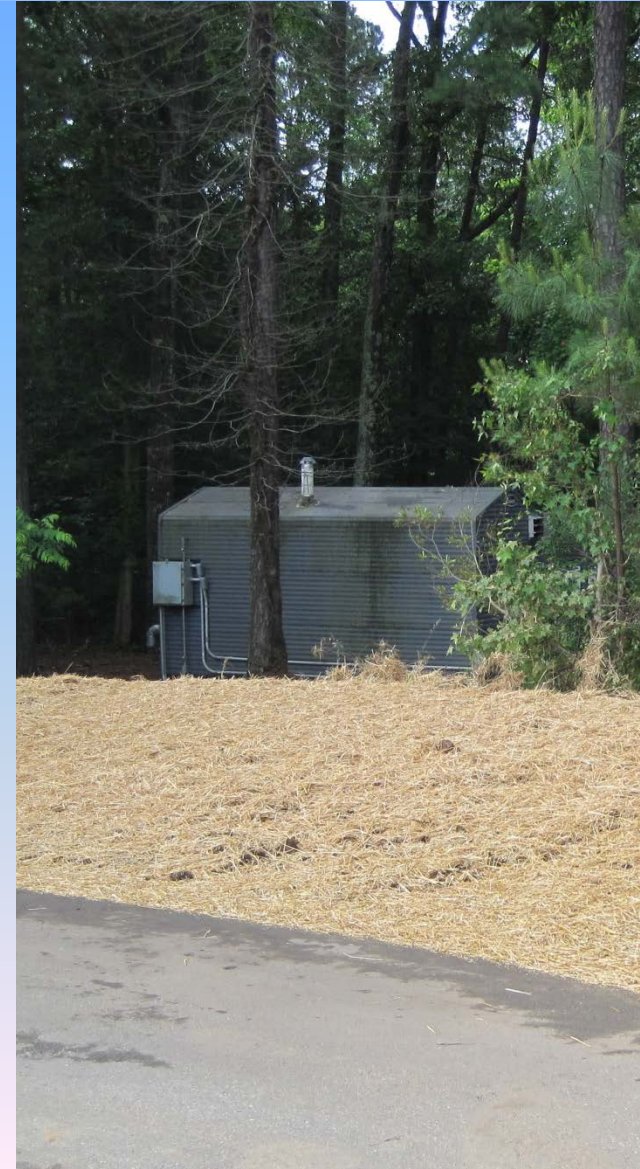
- Continue operation of pump and treat system
- Remediate source area soils
  - Electrical Resistance Heating (ERH)
- Evaluate groundwater and surface water trends
  - monitor sentinel wells
  - monitor potable wells
- Groundwater Feasibility Study
  - optimize pump and treat
  - supplemental in-situ (bioremediation)
  - monitored natural attenuation

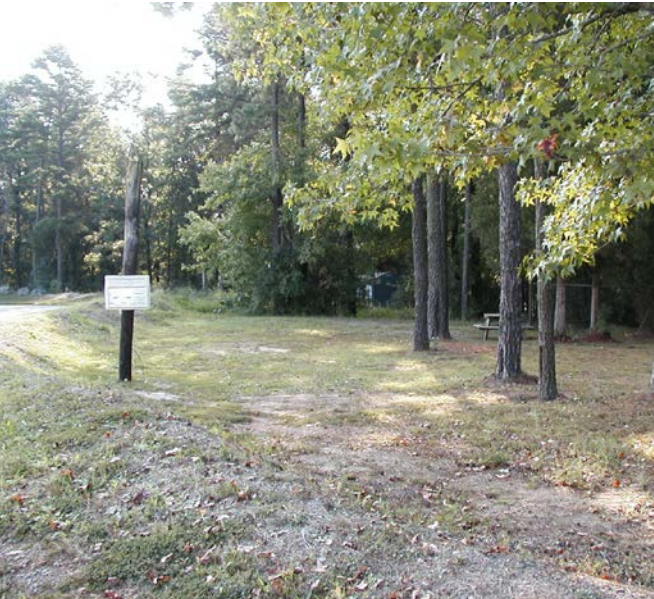
- 7,000 CY requires treatment
  - 1,000 CY Hazardous
    - ~600 ft<sup>2</sup> area
    - near former lab
  - 6,000 CY Non-hazardous
    - ~4,800 ft<sup>2</sup> area
    - extends to water table
