Case Studies: Long Term Performance of Highway Slopes Stabilized with Recycled Plastic Pin

Dr. Sahadat Hossain, P.E.
Professor, Civil Engineering, The University of Texas at Arlington
Dr. Sadik Khan, P.E. (JSU)
Ashrafuzzaman Khan (UTA)
Asif Ahmed (UTA)

Recycled Plastic Pin to Stabilize Shallow Slope Failure

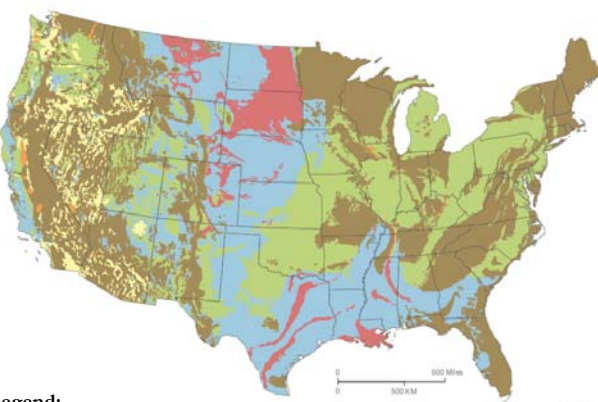
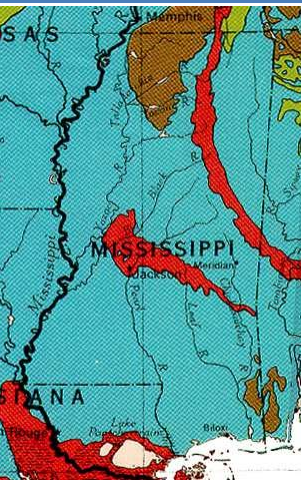
Expansive Clay in US

- Red:** Clay having high swelling potential
- Blue:** Less than 50% of clay contents having high swelling potential
- Orange:** Clay content having slight to moderate swelling potential
- Green:** Less than 50% of clay contents having slight to moderate swelling potential
- Brown:** Little or no swelling clay
- Yellow:** Insufficient data

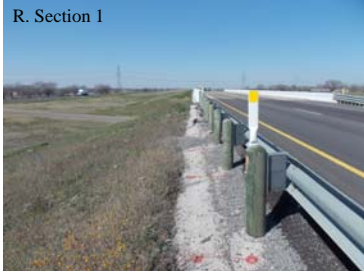
R. Section 1

Settlement at Control Section

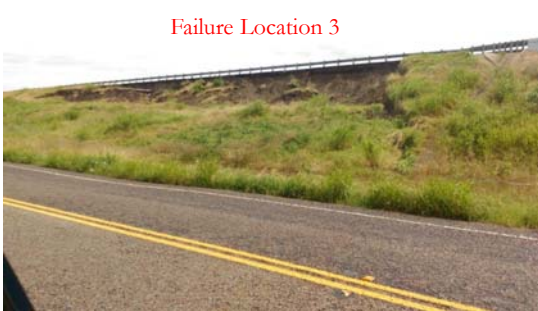
Failure Location 2

Failure Location	Time
Failure Location-1	October 2013
Failure Location-2	October 2013
Failure Location-3	June 2015
Failure Location-4	June 2015

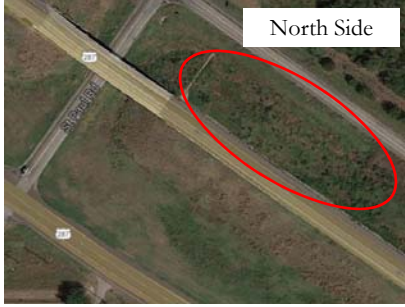
Soil Nailed Wall

Reconstruction of Northbound Slope

September 2015

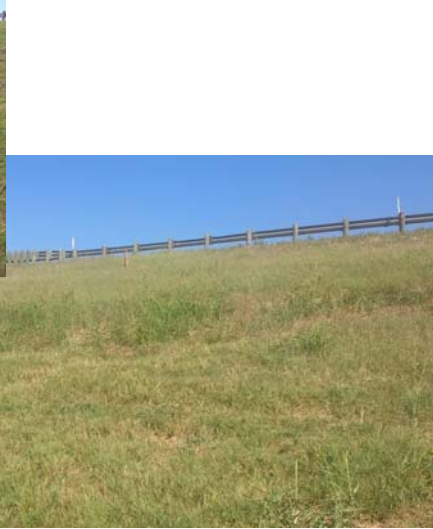
Southbound slope (RPP stabilized)

Comparison between RPP Stabilized Slope and Reconstructed Control Slope
