# History and Repair of Buffalo's Sinkhole in Hickory, North Carolina

Gary Taylor, PE and Matt Snyder, PE – RK&K

### **Presentation Summary**

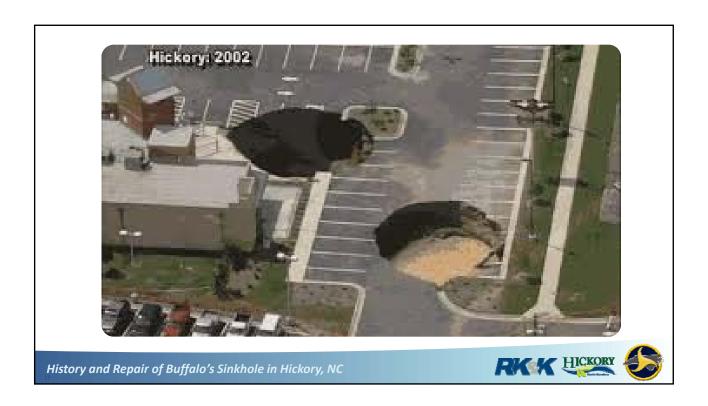
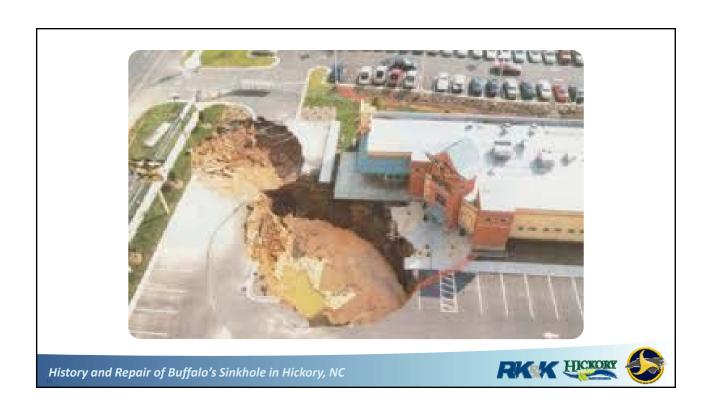
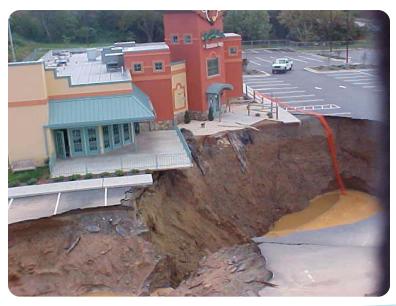
## First failure

- Original owner attached pipe to DOT's RCBC under US 70.
- March 8, 2001: Land purchased by Buffalo's developer
- October 2001: Buffalo's Southwest Cafe opens for business.
- Aug. 17, 2002: Two sinkholes open at Buffalo's on U.S. 70, SE, after a record rainfall. One of the sinkholes swallows a yellow Corvette. U.S. 70 was also closed for several days, due to flooding from the culvert under the road.
- Nov. 2002 to April 2003: Sinkhole repaired.
- July 2003: Buffalo's reopens.

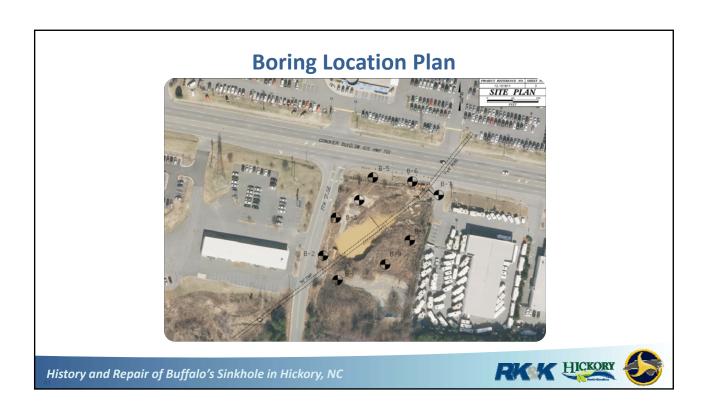
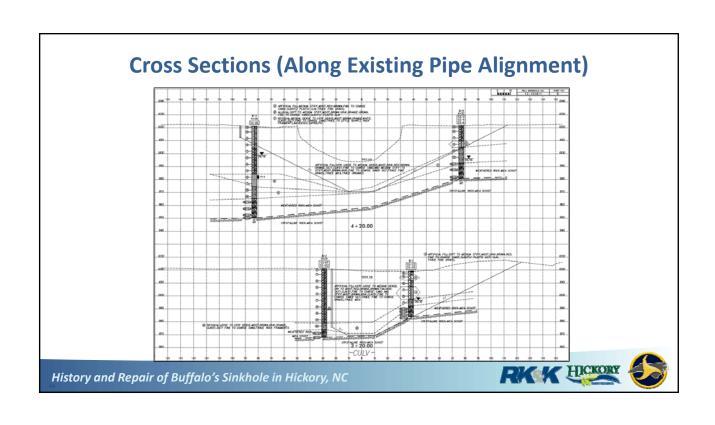
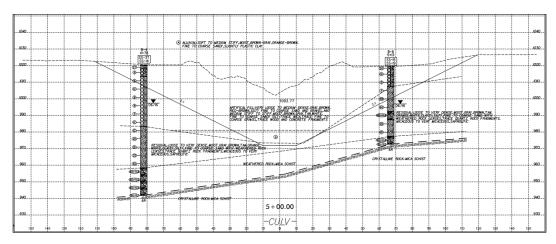
### **Summary of Subsurface Exploration**

- Approximately 40-ft of artificial fill/embankment material encountered on north and west portions of site from construction of US 70 & 7<sup>th</sup> Street and development of site
- Alluvial deposits
- Weathered rock/rock (mica schist) elevation drops from southeast to northwest portions of site

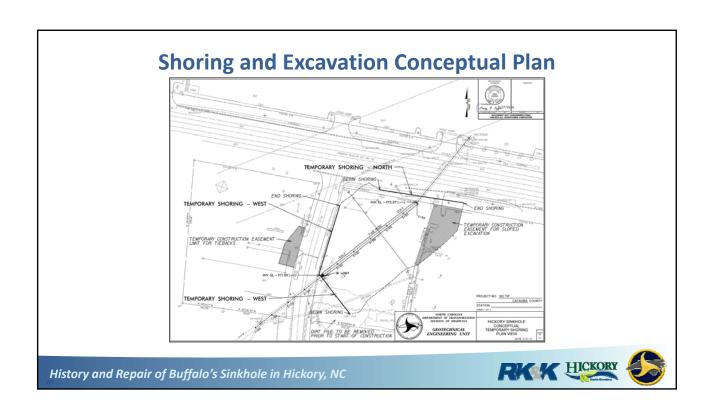
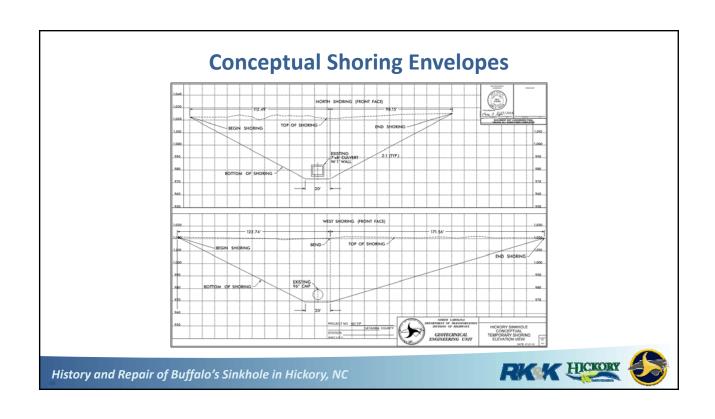
### **Shoring and Excavation Conceptual Plan Summary**

- Combination of temporary shoring and sloped excavation to minimize impacts on surrounding properties, 7<sup>th</sup> Street and US 70
- Temporary shoring options
  - 1) Anchored soldier piles with lagging or sheet piles
  - 2) Soil nail wall
- Temporary slopes at 2(H): 1(V)
- Temporary construction easements for sloped excavation and tieback/nail installation

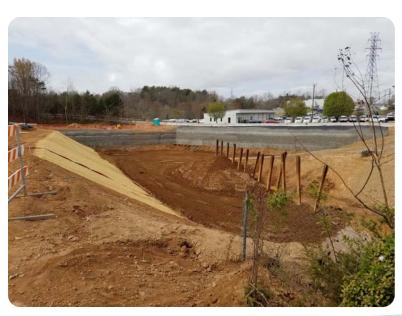
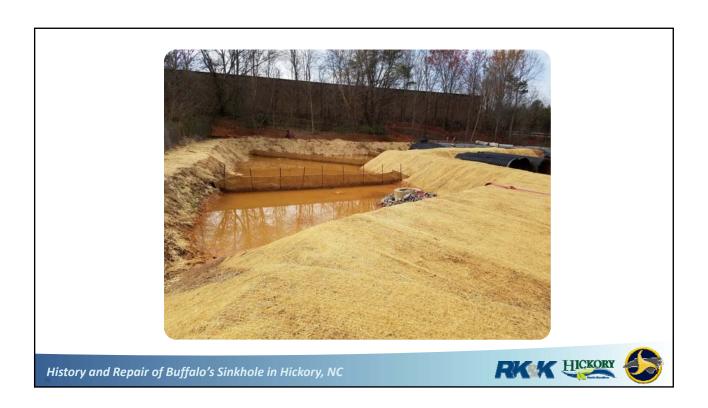
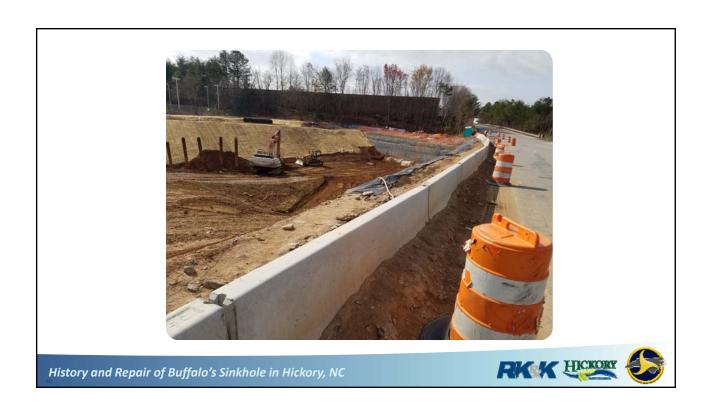
### **Dewatering Plan**

- Avoid submerging the shotcrete facing during a storm event
- Repeatedly submerging the shoring system could have detrimental effects on the shoring system
- Minimize US 70 flooding during storm event
- Primary and backup pumping
- Keep water in hole pumped down
- Keep water in stand pipe pumped down
- Pump water from standpipe into storm drain
- Pump water from hole to stilling basin
