# Settlement & Vibration Monitoring for Transmission Line Foundation Installation

R. Heath Forbes, P.E. – S&ME, Inc.  
William M. Camp, III, P.E. – S&ME, Inc.

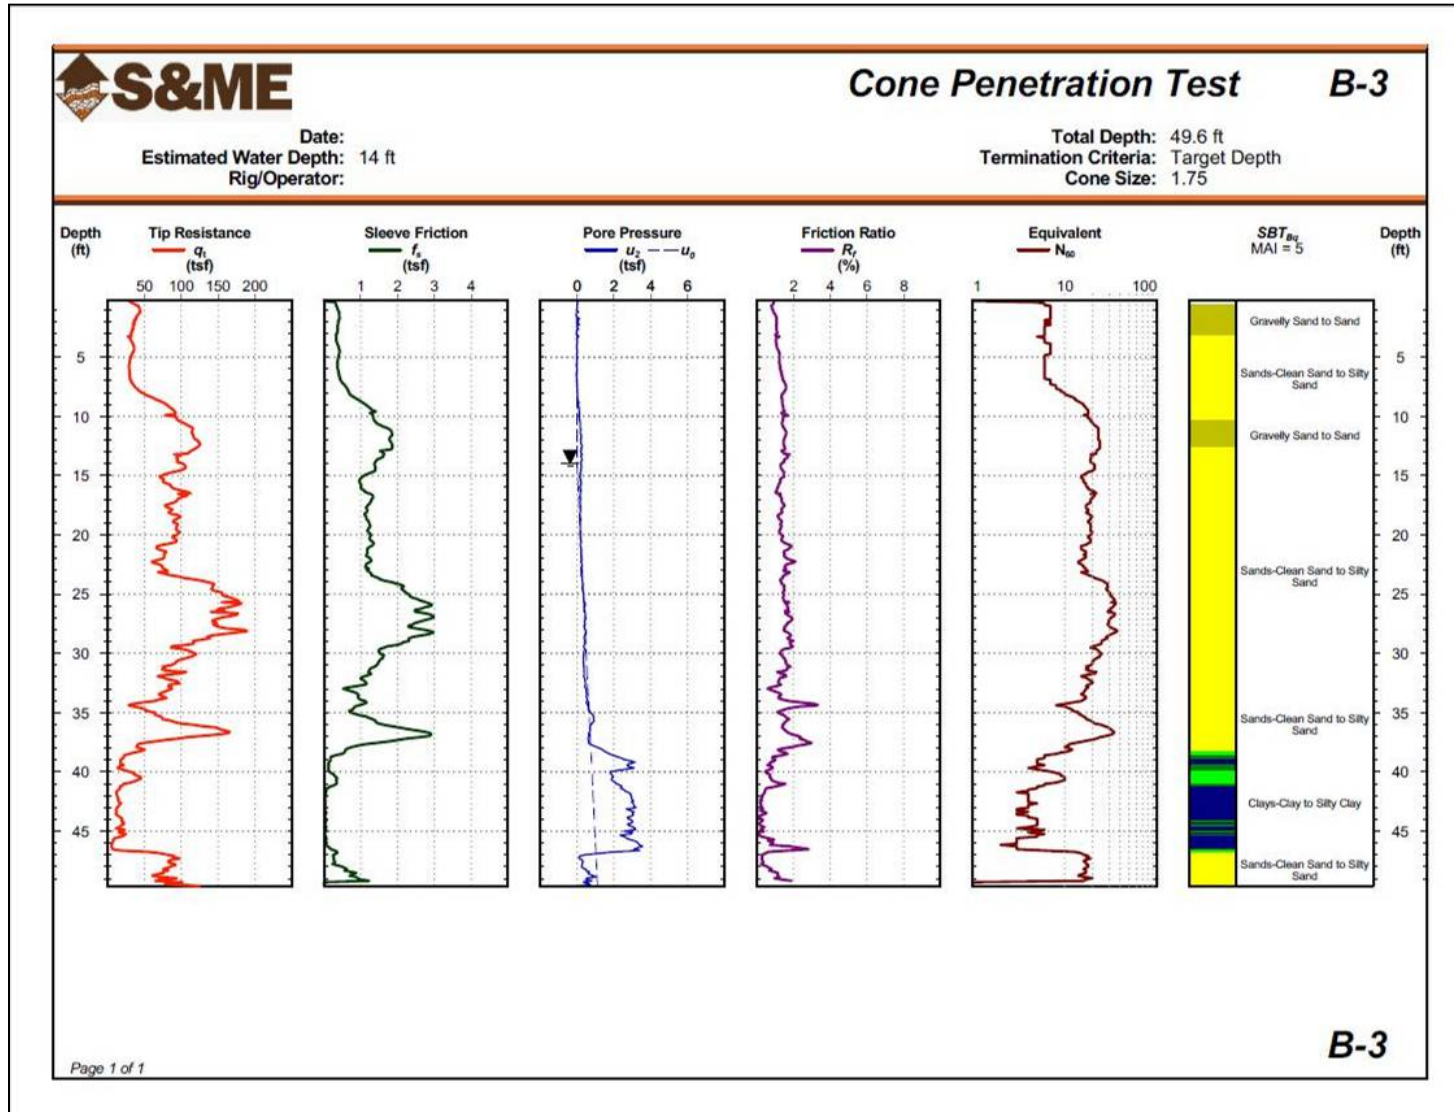
# Example CPT Logs

- A widely-spaced exploration consisting of 20 Cone Penetrometer Test (CPT) Soundings was performed.
- Generally loose to medium dense slightly silty to silty sands within upper 40 to 50 feet.
- Tip stresses in the sands were generally 15 to 150 tsf.
- Groundwater was encountered at depths of 9 to 15 ft below ground surface.

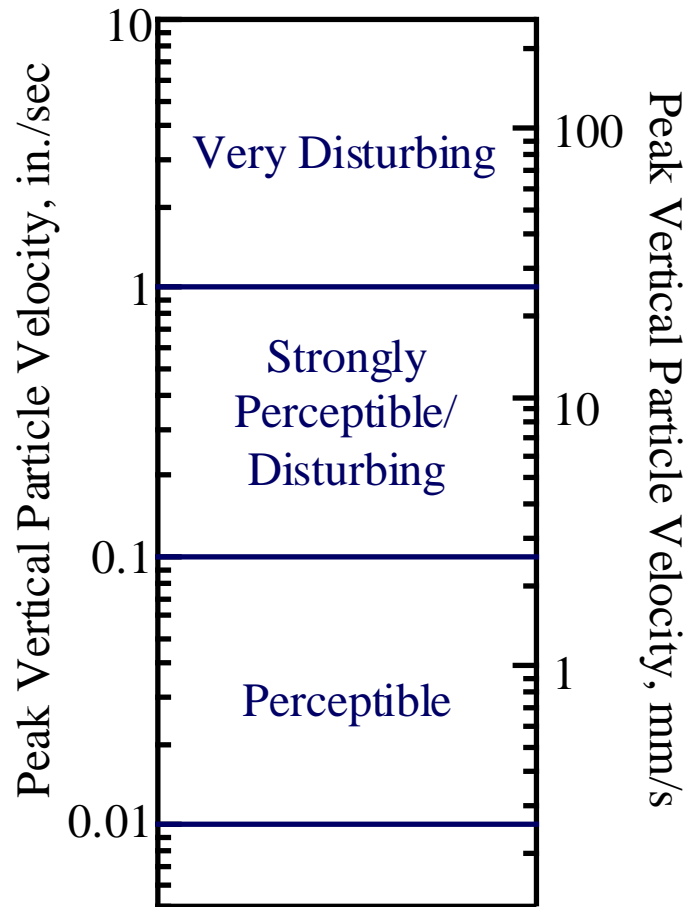
# Human Perception Thresholds

- People sense or respond to very low vibrational intensities.
- Noise is often more disturbing than the vibration alone.
- Combination of noise and vibration draw attention to existing damage previously unnoticed.

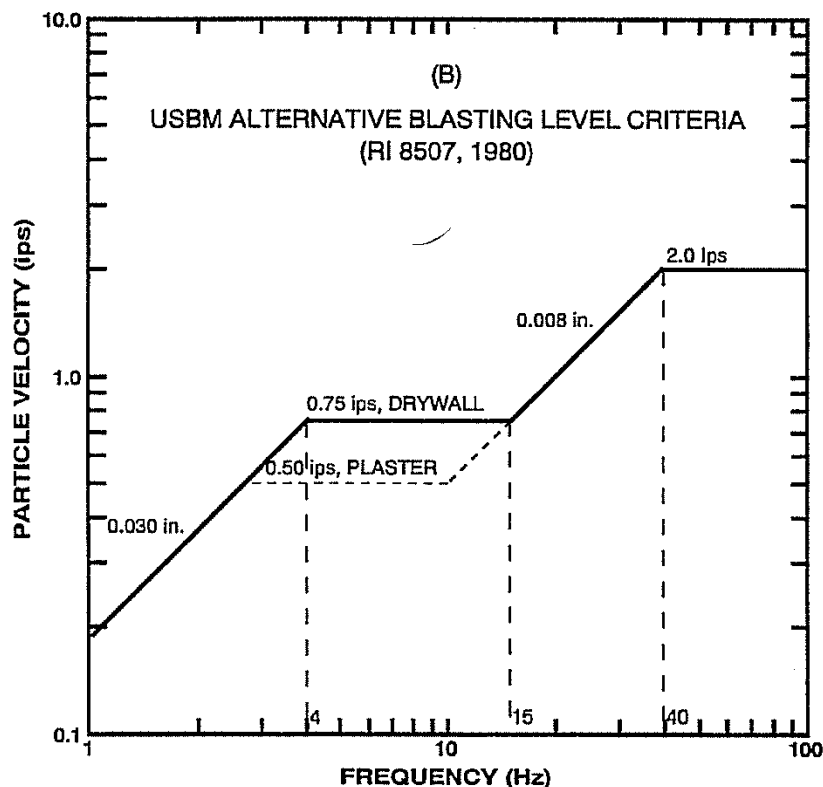
# USBM Criteria

- USBM Report of Investigation 8507 (Siskind et al., 1980)
- Adopted by AASHTO and many others
- Limit corresponds to the development of hairline cracks in plaster or drywall joints (i.e., not structural damage)

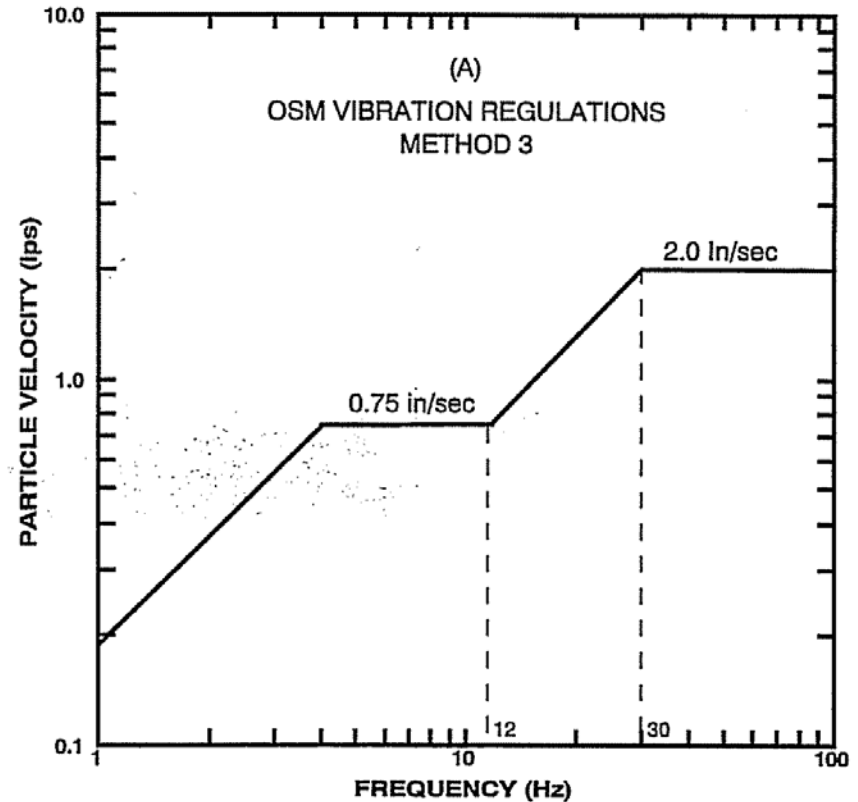
# OSMRE Criteria

- OSMRE 1987 – Office of Surface Mining and Reclamation and Enforcement (Rosenthal et al., 1987).
- Similar to USBM criteria
- Does not distinguish between construction material types.

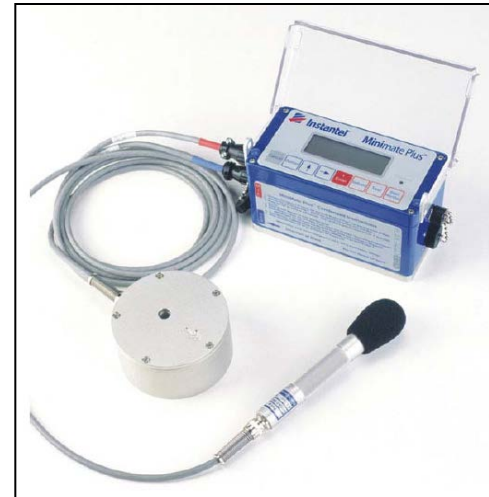
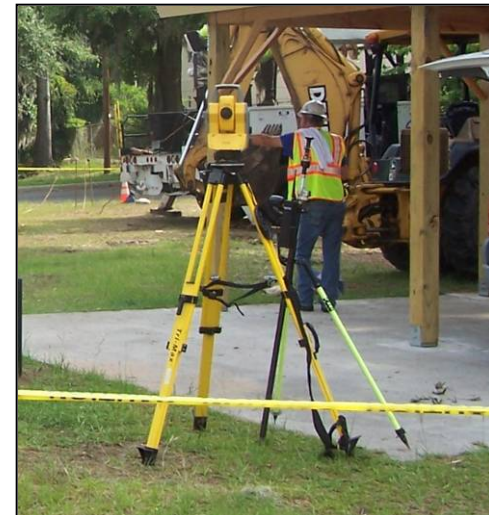
# Monitoring Equipment

- Instantel Blastmate and Minimate Seismographs
  - Triaxial geophone array
  - Measured PPV and Hz in three directions – longitudinal, transverse, and vertical.
- Trimble 5603 Robotic Total Station with Recon Datalogger

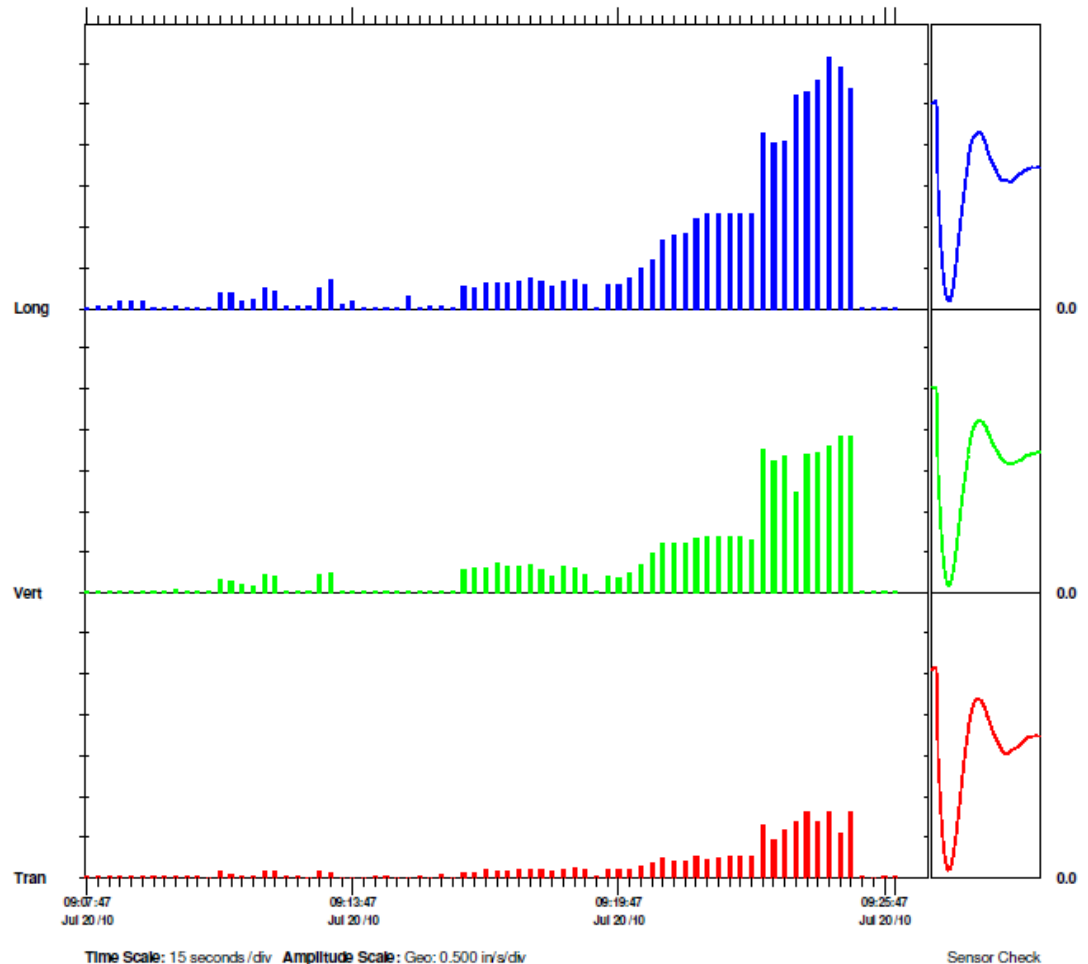
# Vibration Data - Histogram

Tran	Vert	Long	
PPV	0.810	1.91	3.06	in/s
ZC Freq	24	24	28	Hz
Date	Jul 20 /10	Jul 20 /10	Jul 20 /10	
Time	09:24:32	09:25:02	09:24:32	
Sensor Check	Passed	Passed	Passed	
Frequency	7.6	7.3	7.6	Hz
Overswing Ratio	3.2	3.8	3.4	
Peak Vector Sum	3.49 in/s on July 20, 2010 at 09:24:32

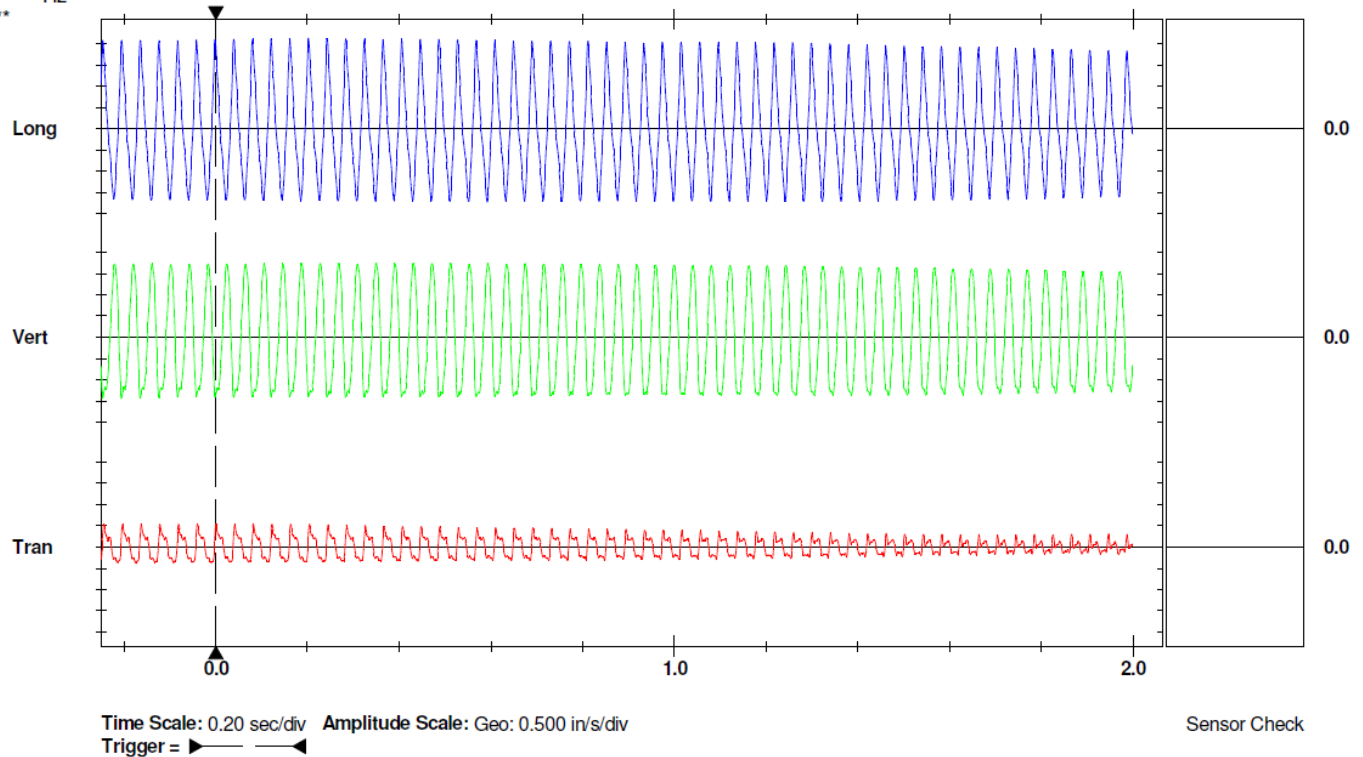
# Vibration Data - Waveform

Tran	Vert	Long	
PPV	0.545	1.75	2.13	in/s
ZC Freq	24	26	28	Hz
Time (Rel. to Trig)	-0.244	0.350	0.202	sec
Peak Acceleration	0.610	1.02	1.01	g
Peak Displacement	0.00277	0.0108	0.0104	in
Sensor Check	Disabled	Disabled	Disabled	
Frequency	***	***	***	Hz
Overswing Ratio	***	***	***	
Peak Vector Sum	2.57 in/s at 0.202 sec

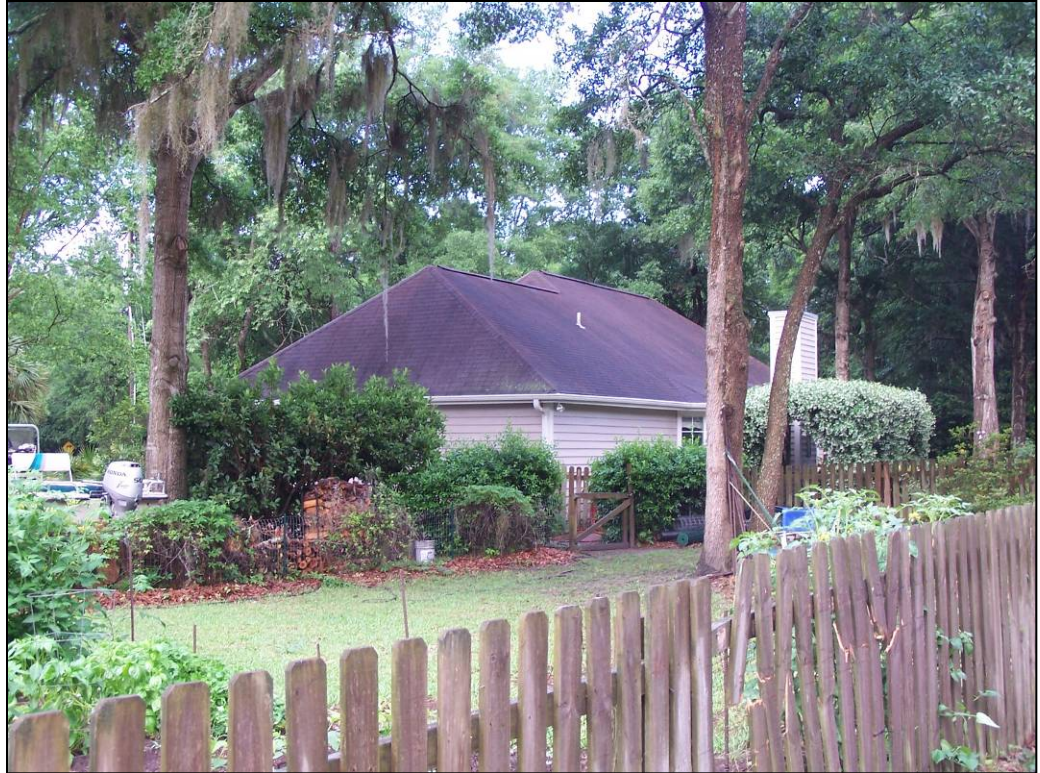
# Claim #1

- Alleged damage to front porch slab.
- Structure located 60 feet from foundation.
- Measured PPV of 0.48 ips at 20 Hz.
- Investigation by others determined alleged damage was existing – claim dismissed.

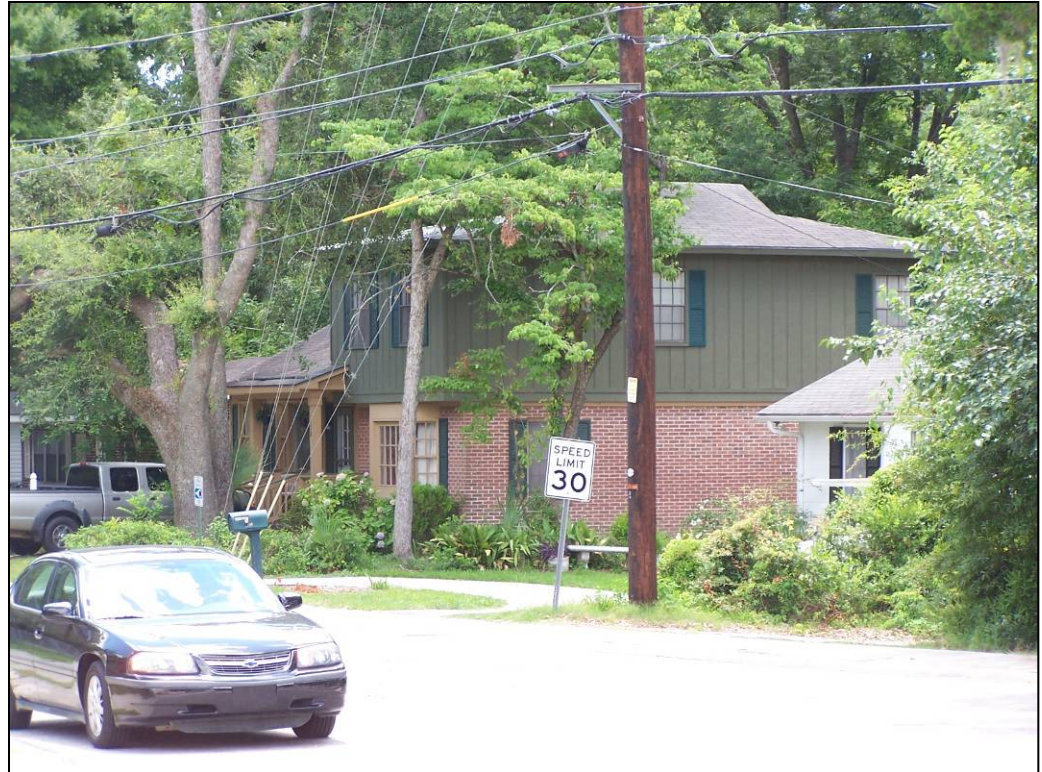
# Claim #2

- Alleged damage to structural foundation.
- Structure located more than 200 ft from foundation.
- Measured PPV of 0.24 ips at 24 Hz at monitor 113 ft from foundation.
- Alleged damage was existing – claim dismissed.

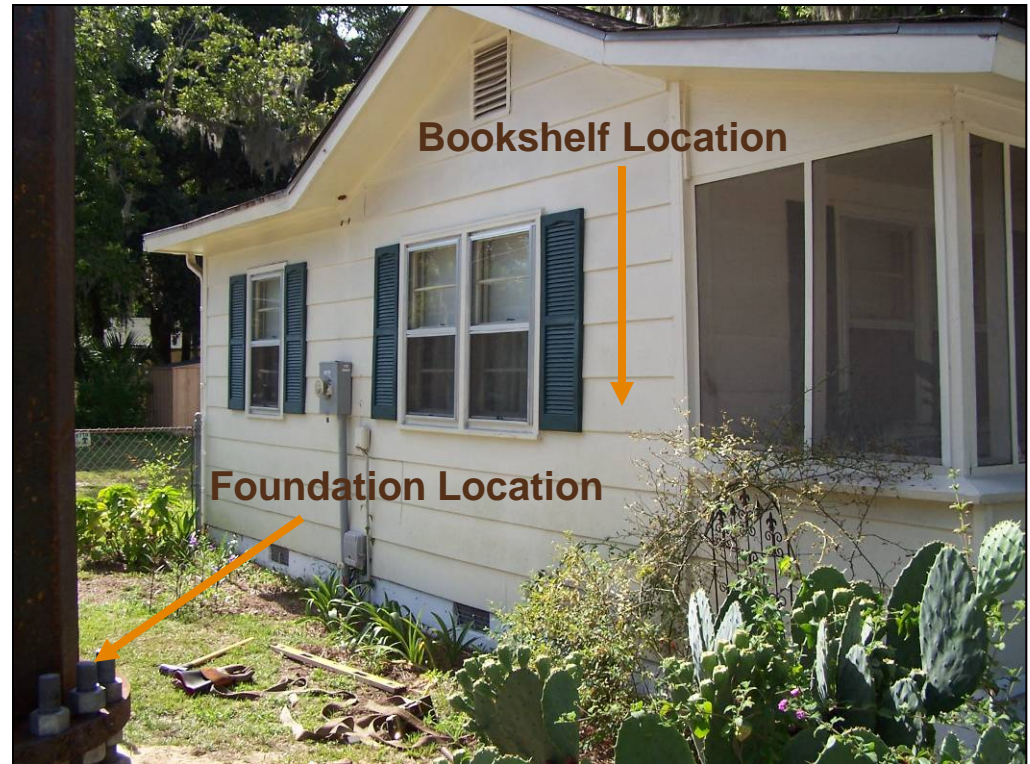
# Claim #3

- Alleged damage to china, glassware, and artwork which fell off a bookshelf along an exterior wall adjacent to construction.
- Structure located 8 ft from foundation.
- Measured PPV of 3.06 ips at 28 Hz.

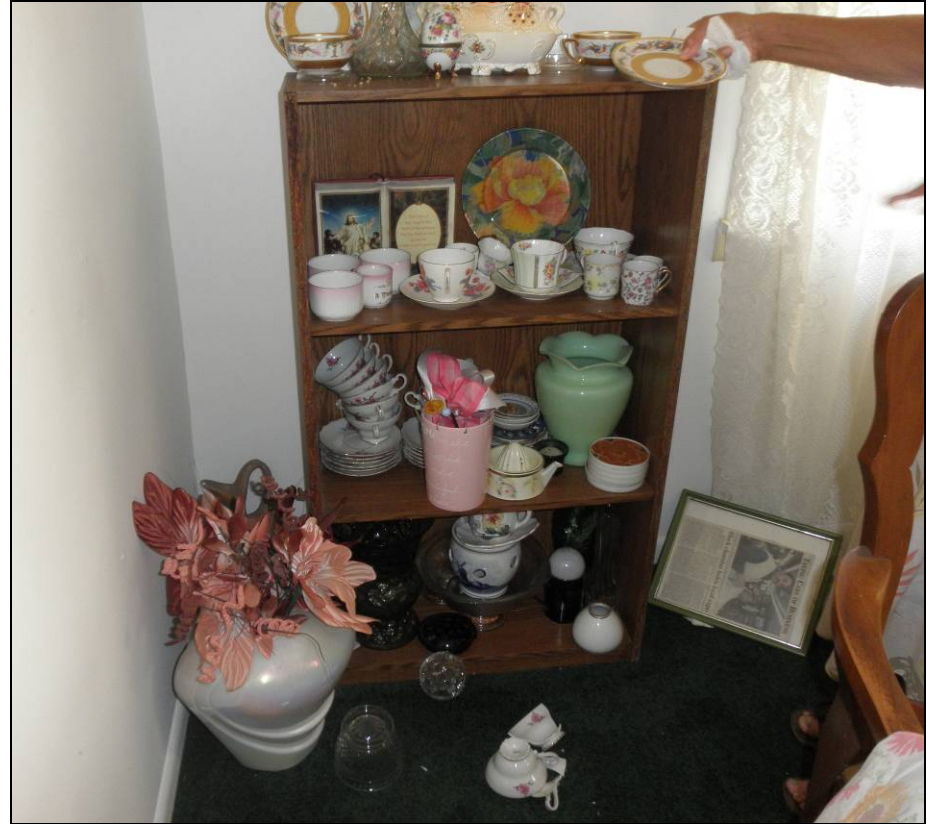
# Claim #3

- Investigation performed by others immediately after foundation installation.
- Claim deemed legitimate.
