Stabilization of Shallow Slope failure on Expansive Clay using Recycled Plastic Pin

Dr. Sahadat Hossain, P.E.

Dr. Mohammad Sadik Khan, P.E.

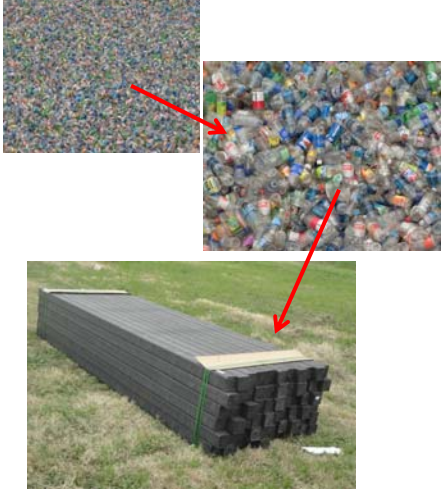
What is Recycled Plastic Pin?

- **Recycled Plastic Pin (RPP)**
 - Mainly Polymeric Materials
 - Fabricated from Recycled Plastics
- **Advantages**
 - Commercially Available
 - Use of RPP Reduces Waste Volume
 - Resistant to Biological Exposure
- **Typical Composition**
 - HDPE : 55-90%
 - LDPE : 5-10%
 - PP, PET, PS : 1% - 10%
 - Misc. : 0 – 5%

A 10' long RPP can replace 500 Soda Bottles

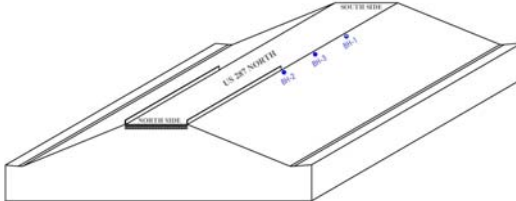
Site Investigation: Soil Boring

Bore Hole Location	Depth of Sample	Liquid Limit	Plasticity Index
BH-1	5	48	25
BH-1	10	60	33
BH-1	15	72	48
BH-1	20	64	38
BH-2	5	49	26
BH-2	10	67	38
BH-2	15	73	45
BH-2	20	61	35
BH-2	25	62	37
BH-3	5	52	27
BH-3	10	61	34
BH-3	15	79	51
BH-3	20	58	32
BH-3	25	62	40

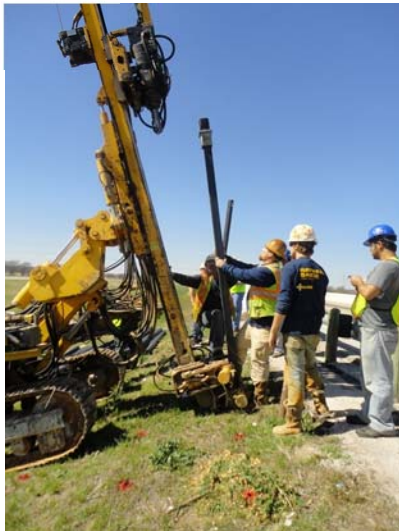
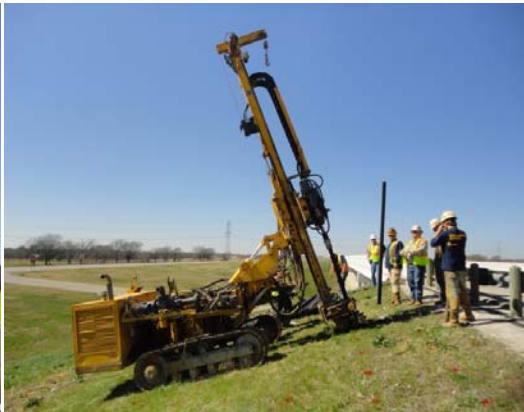
Installation of RPP: Reinforced Section 1 and Reinforced Section 2

- Equipment: Klemm 802 Drill Rig
- Hammer Type: KD 1101

Section	No. of RPP	Installation Time(Day)	Start Date	Finished Date
Reinforced Section 1	192	2	March 01, 2011	March 03, 2011
Reinforced Section 2	225	2	March 04, 2011	March 05, 2011
Reinforced Section 3	238	3	Feb 29, 2012	March 6, 2012

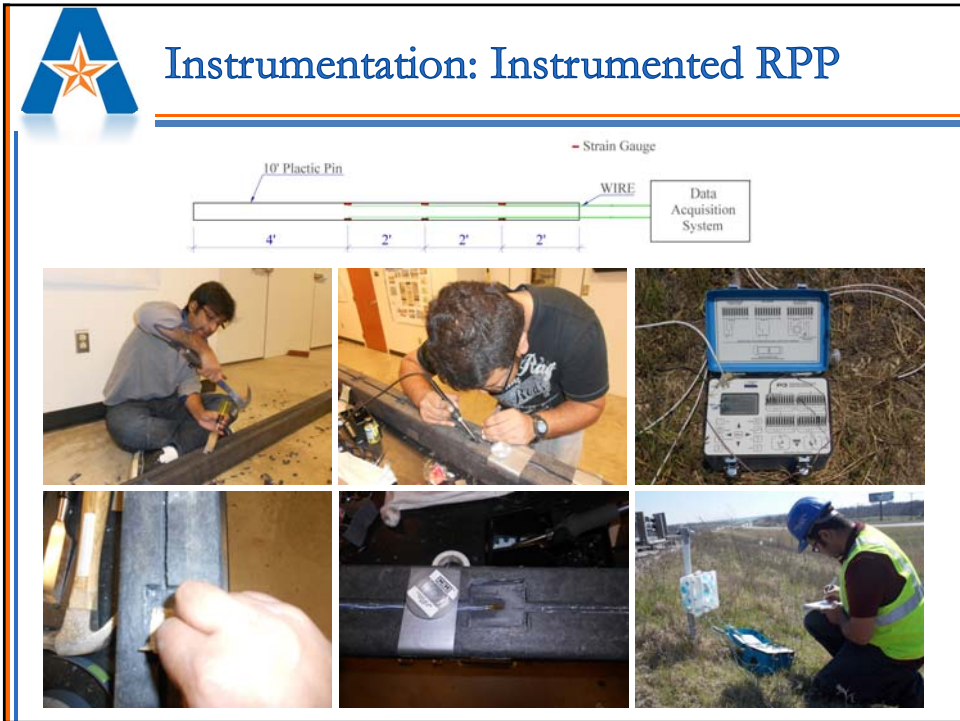
Instrumentation

- Rain Gauge
- Instrumented RPP
- Surveying
- Inclinator
- Moisture Sensor
- Water Potential Probe
