Soldier Pile Wall Failure on US 21 in Blue Ridge Mountains

Nate Beard, P.E.
Matt Birchmier, P.E.

US 21, Wilkes County, NC

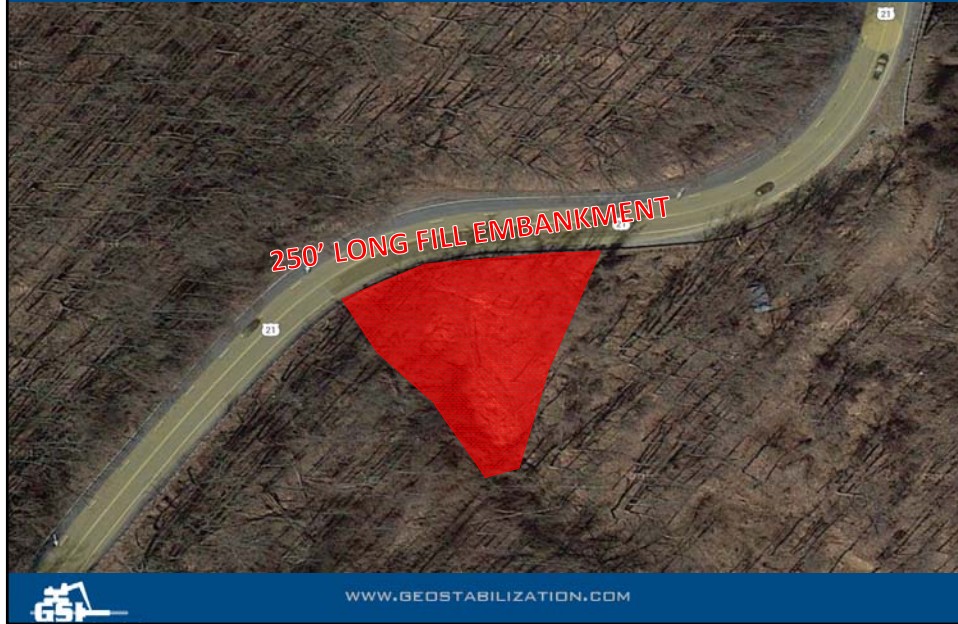
May 31, 2013

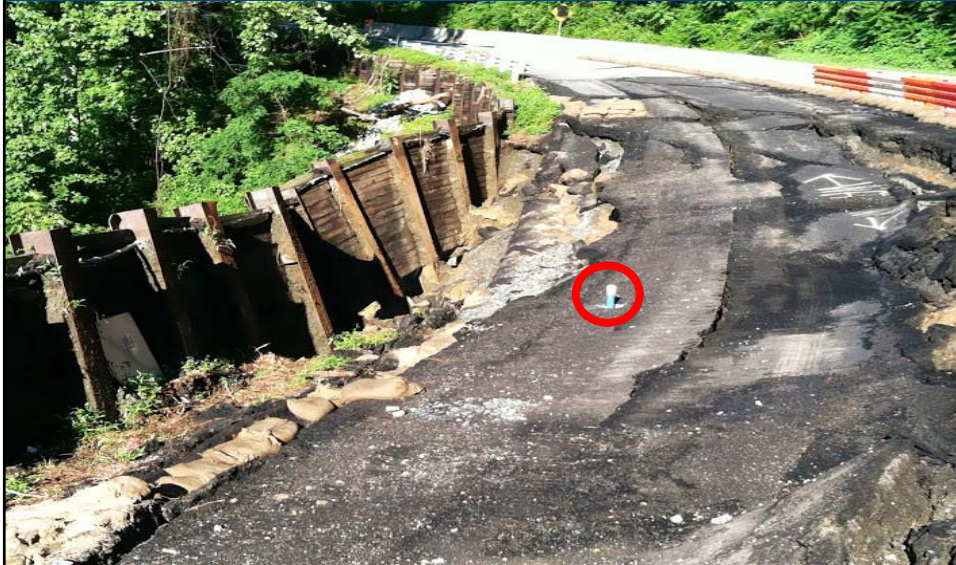
July 8, 2013 (+5 weeks)

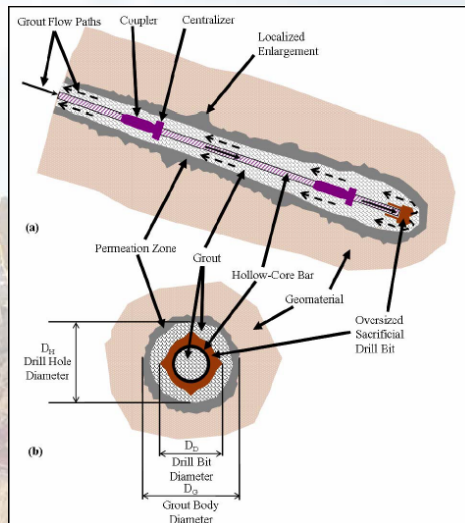
Drilled Soil Nails

- Suitable for collapsing soil
- Suitable for actively moving landslides
- High installation rates
- High pullout capacity
- High bending/shear capacity
- Suitable for rock and soil
- FHWA design guidance

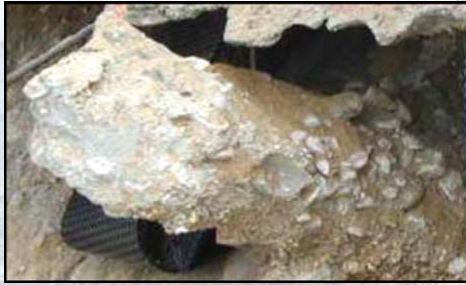
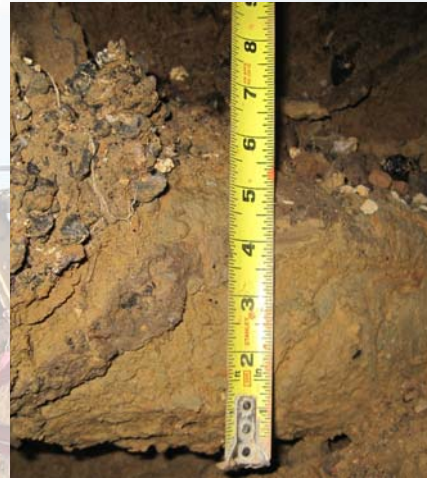
Drilled Soil Nails

- 3-inch drill bit generated a 6-inch diameter grout body
- Soil nail bar ~1-inch dia.

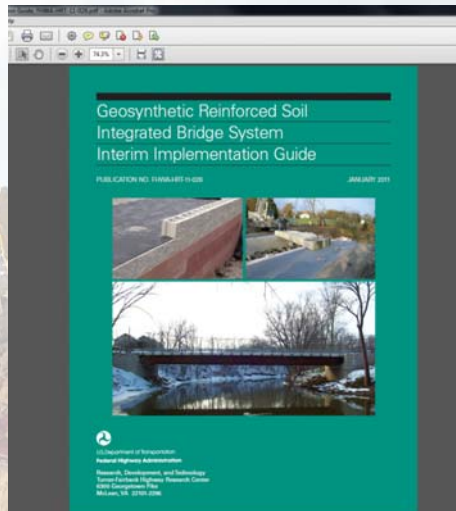
GCS/GRS

- GRS - Geosynthetic Reinforced Soil
 - An engineered fill of closely spaced (< 12") alternating layers of compacted granular fill material and geosynthetic reinforcement

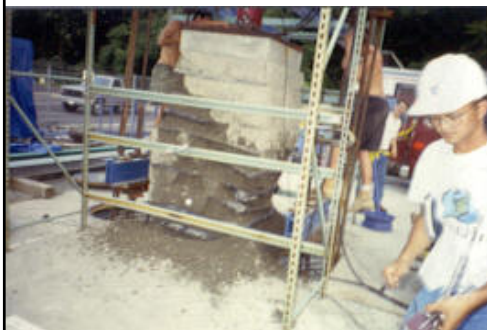
FHWA Mini-Pier Experiment

$T_{ult} = 100 \text{ lbs/in}$ (silt fence material)
Failure @ 400kPa

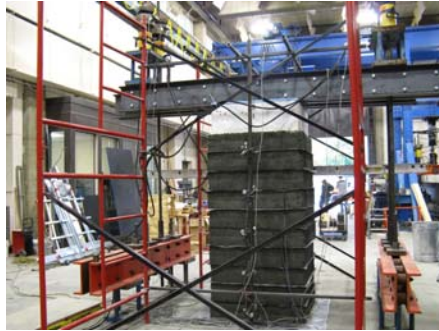
Pre-

Performance Test

2,400 lb/ft @ 8" Spacing, No CMU Facing, <0.5% strain
18,000 lb/ft shown in Post-Picture

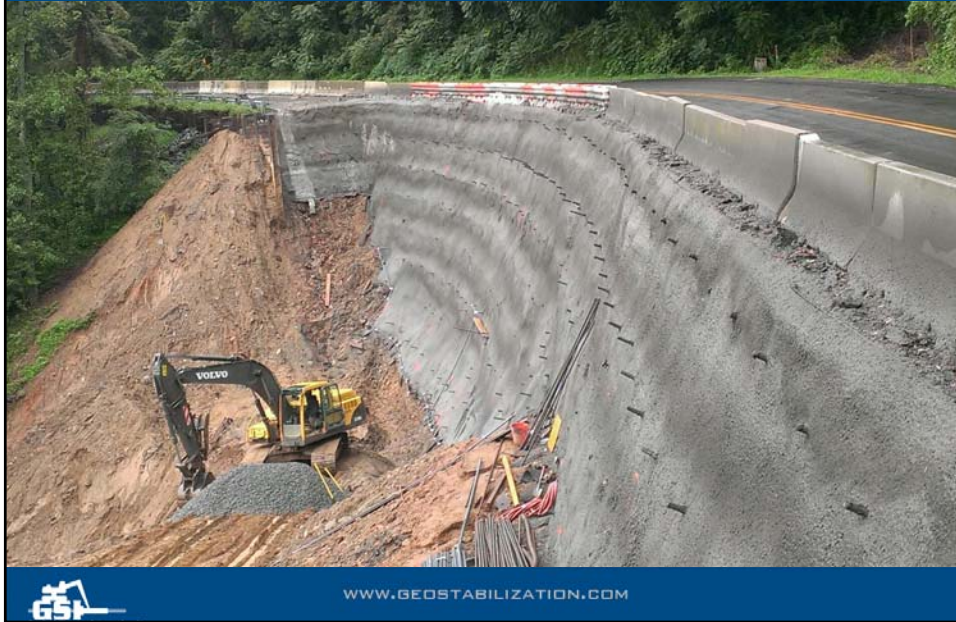
8,710 LF of Soil Nailing

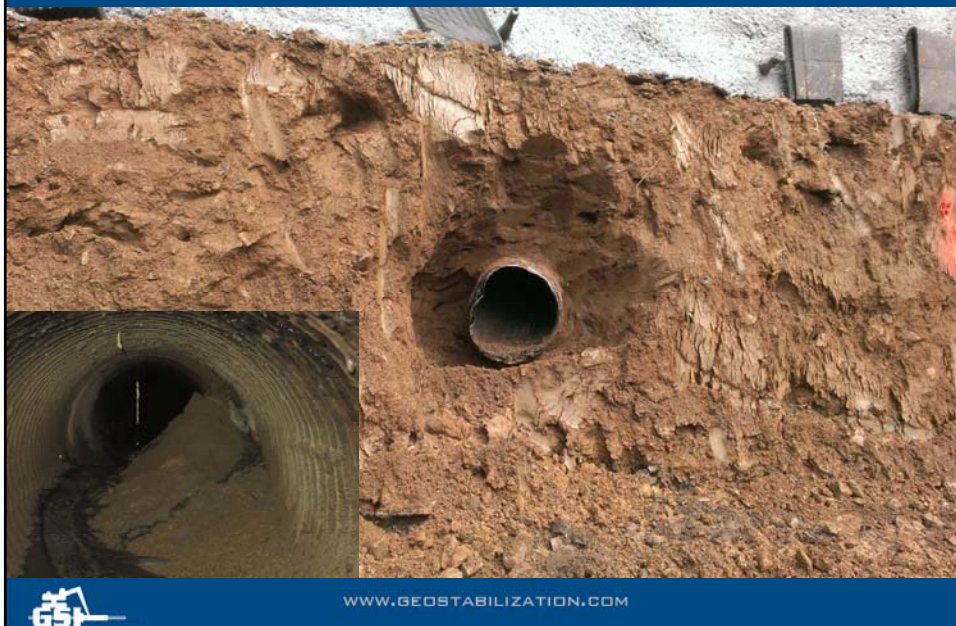
18" Cross Culvert

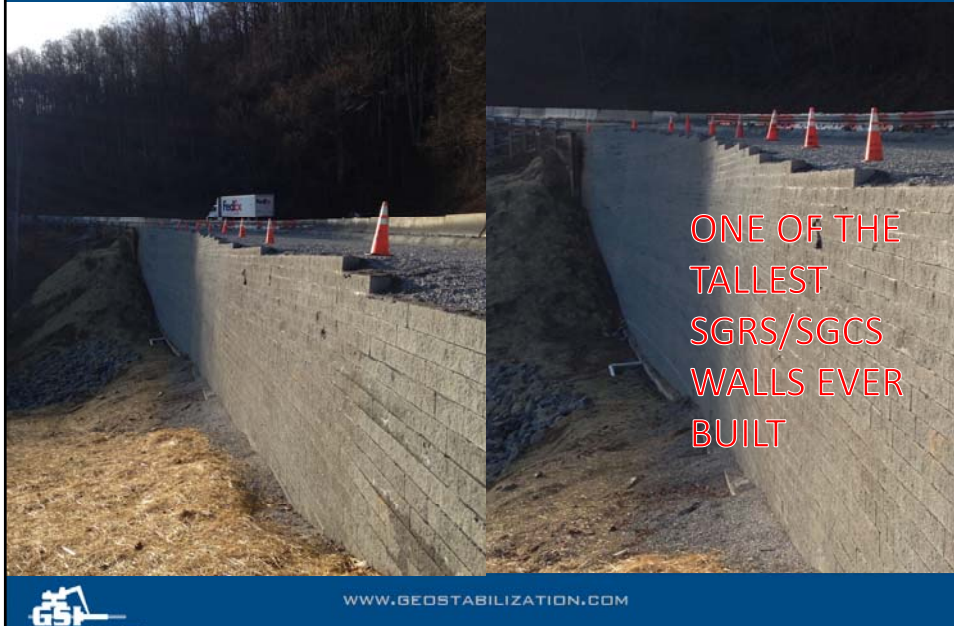
NCDOT Built 8,000 SF Shored GRS Wall
