### **Presentation Topics**

- 1. Project Description
- 2. Site Introduction / Characteristics
- 3. Seepage Challenges
- 4. Dam-Related Improvements Overview
- 5. Spillway Improvements
- 6. Road Widening / Dam Armoring
- 7. Construction Update

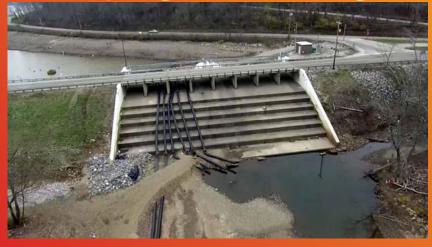
- Round the clock observations and monitoring complete.
- Roadway reopened to traffic
- Seepage area protected.
- Pool level lowered.
- Siphons installed and ready for operation.
- Design of long-term repairs in the works
