**ERI-60-3.100 Bridge in Erie
County, Ohio
Part I: Drilled Shafts for Slope
Stabilization and Bridge Support**

10th Geo³T² Conference

**ERI-60-3.100 Bridge in Erie
County, Ohio
Part II: Instrumentation and Long-
term Monitoring**

- ❖ Plan and execute instrumentation and monitor load testing of Piers 1 and 2.
- ❖ Study the temperature effect on massive pours
- ❖ Determine the soil and bedrock p-y curves.
- ❖ Determine load-deformation characteristics of the drilled shaft.
- ❖ Measure the actual lock off load in the anchors.
- ❖ Monitor the Piers and the slope during service life.

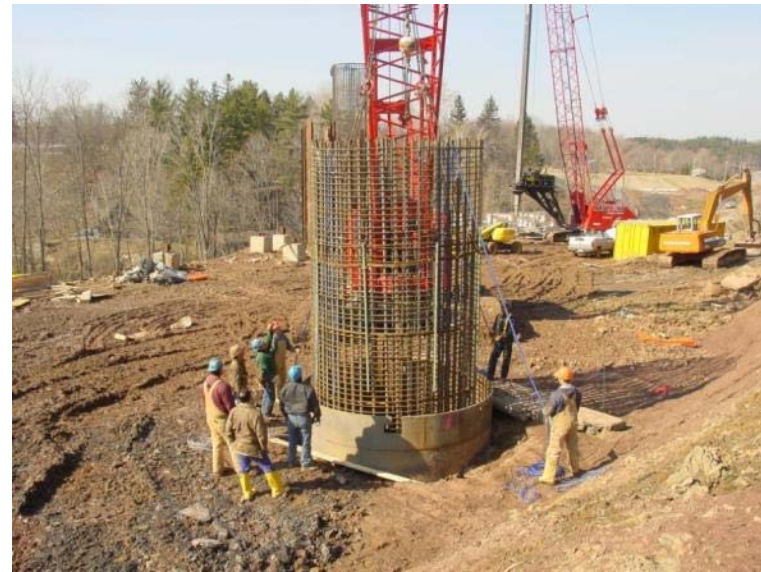
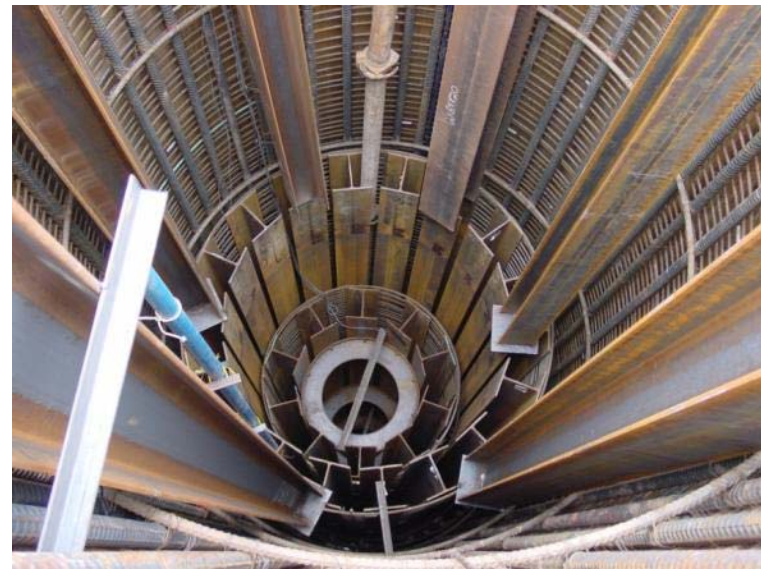
- Auger drilled through Bedford shale in one day, 12'-6" diameter (40' deep)
- Steel casing installed above bedrock, 12'-0" diameter
- Core barrel drilled through hard shale in 5 days, 11'-6" diameter (40' deep)

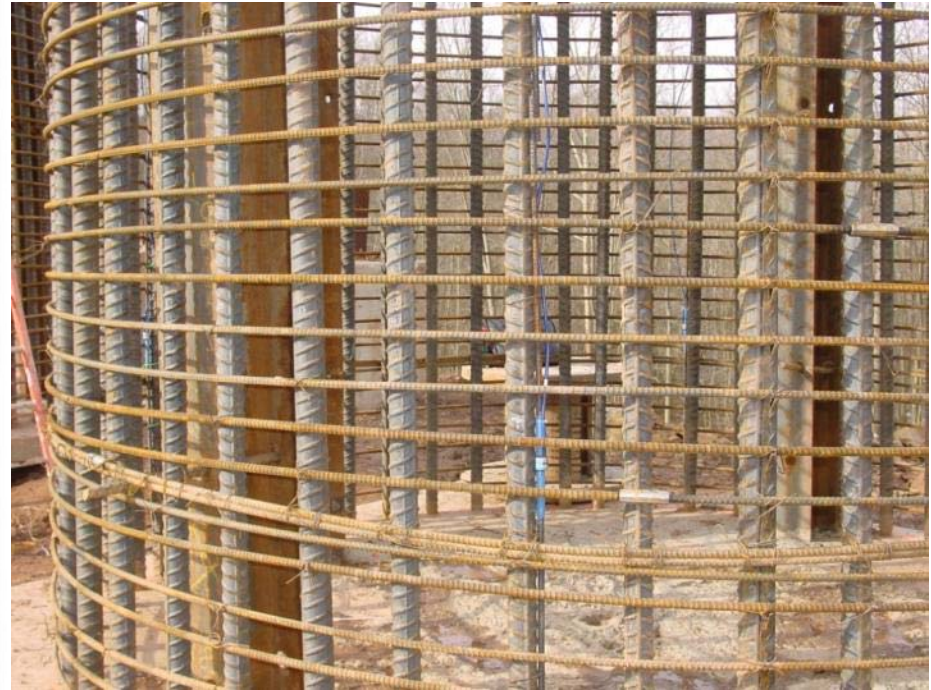
Pier 2
2 inclinometers

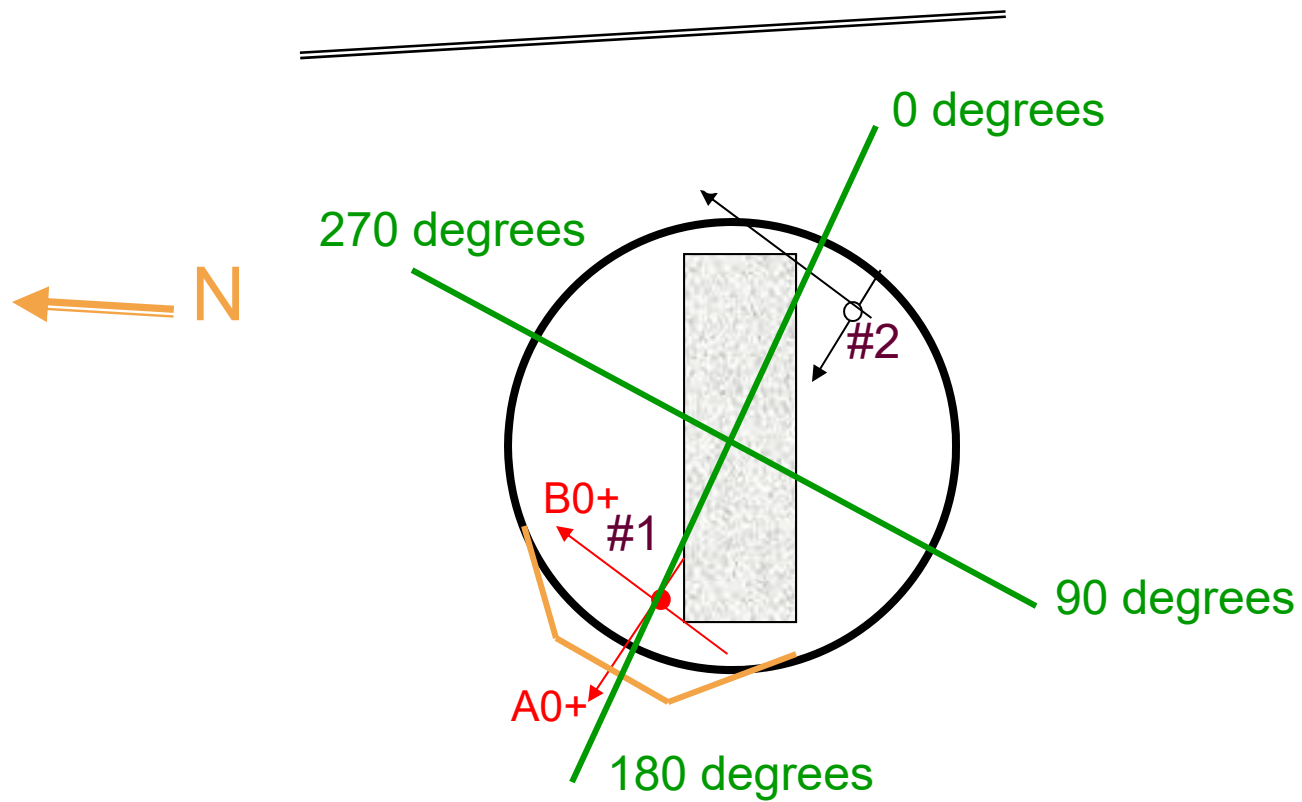
Temperature monitoring in Pier 1

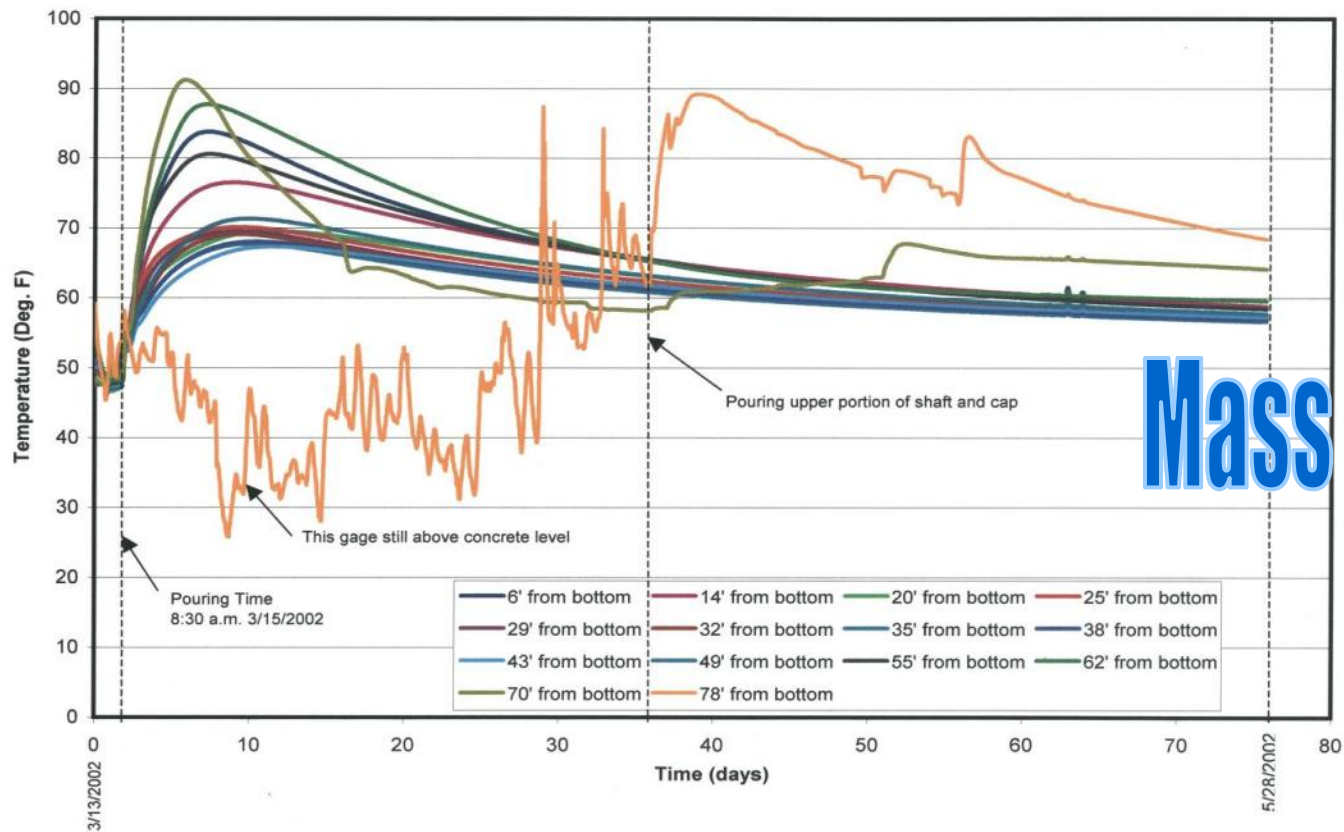
Temperature monitoring in Pier 1

Temperature vs Time Caisson #1, 60.5 ft from bottom

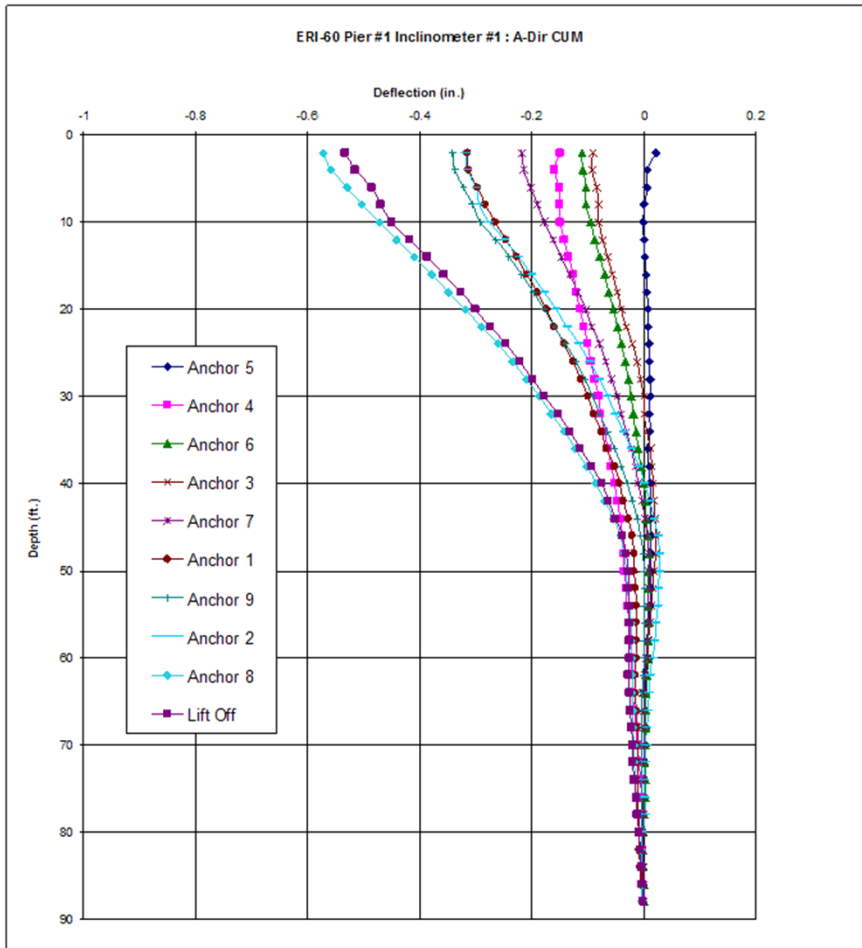
Deflection with depth during Tensioning of Pier 1

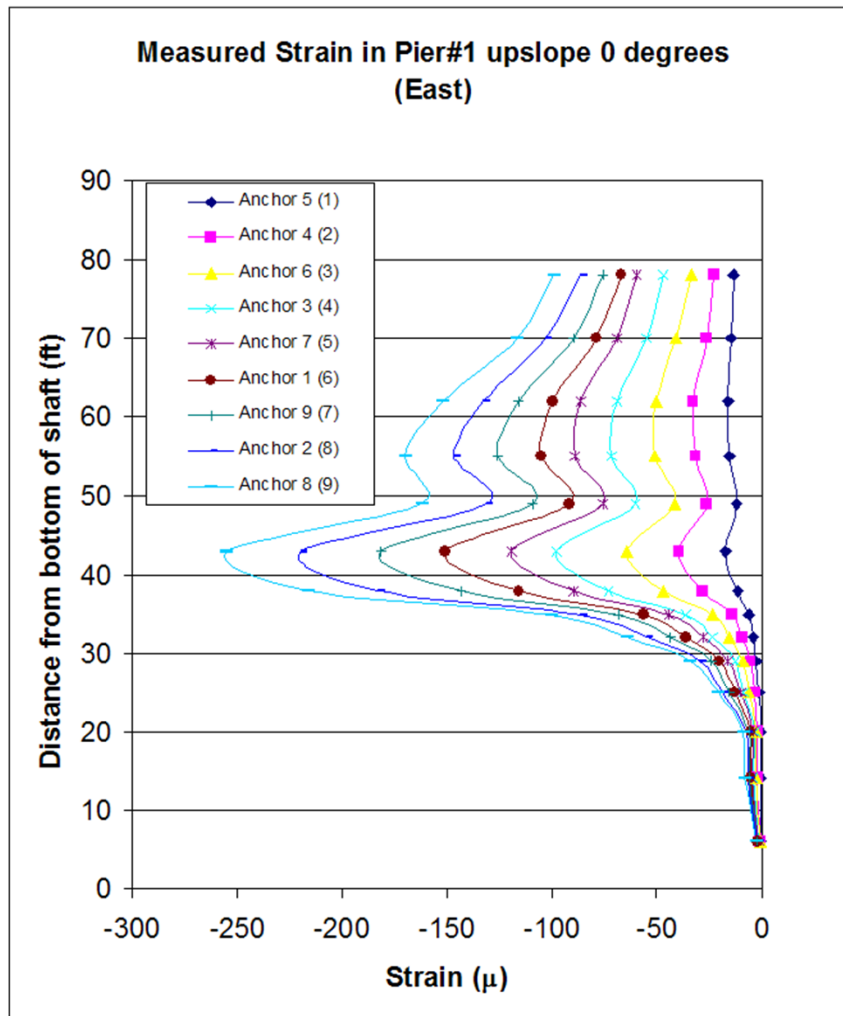
Strains during anchor tensioning in Pier 1

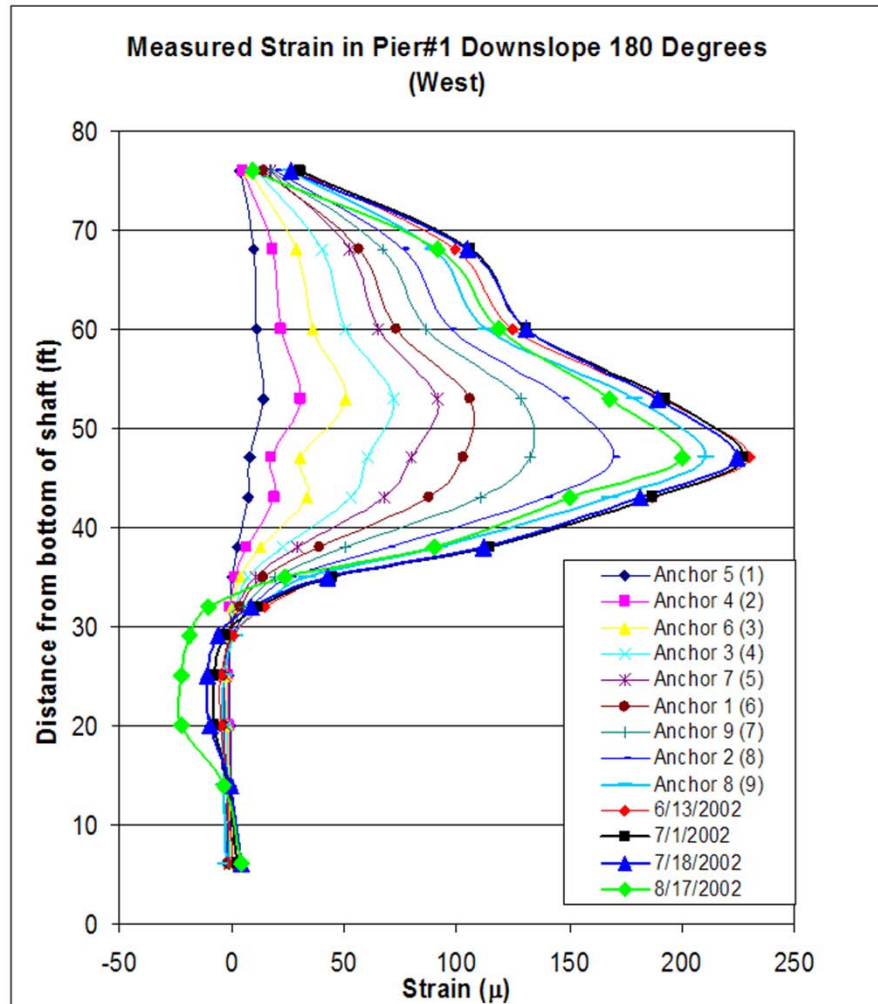
Strain vs. Time in Pier 1 (East-West Direction)

- The instrumentation and monitoring added a valuable input in understanding the behavior of the piers and slope during construction and over the 16 years of monitoring.
- The deflection and strain build up is still going on as shown in the time plots.
- The monitoring is helping ODOT decide on the status of the structure and how safe it is.

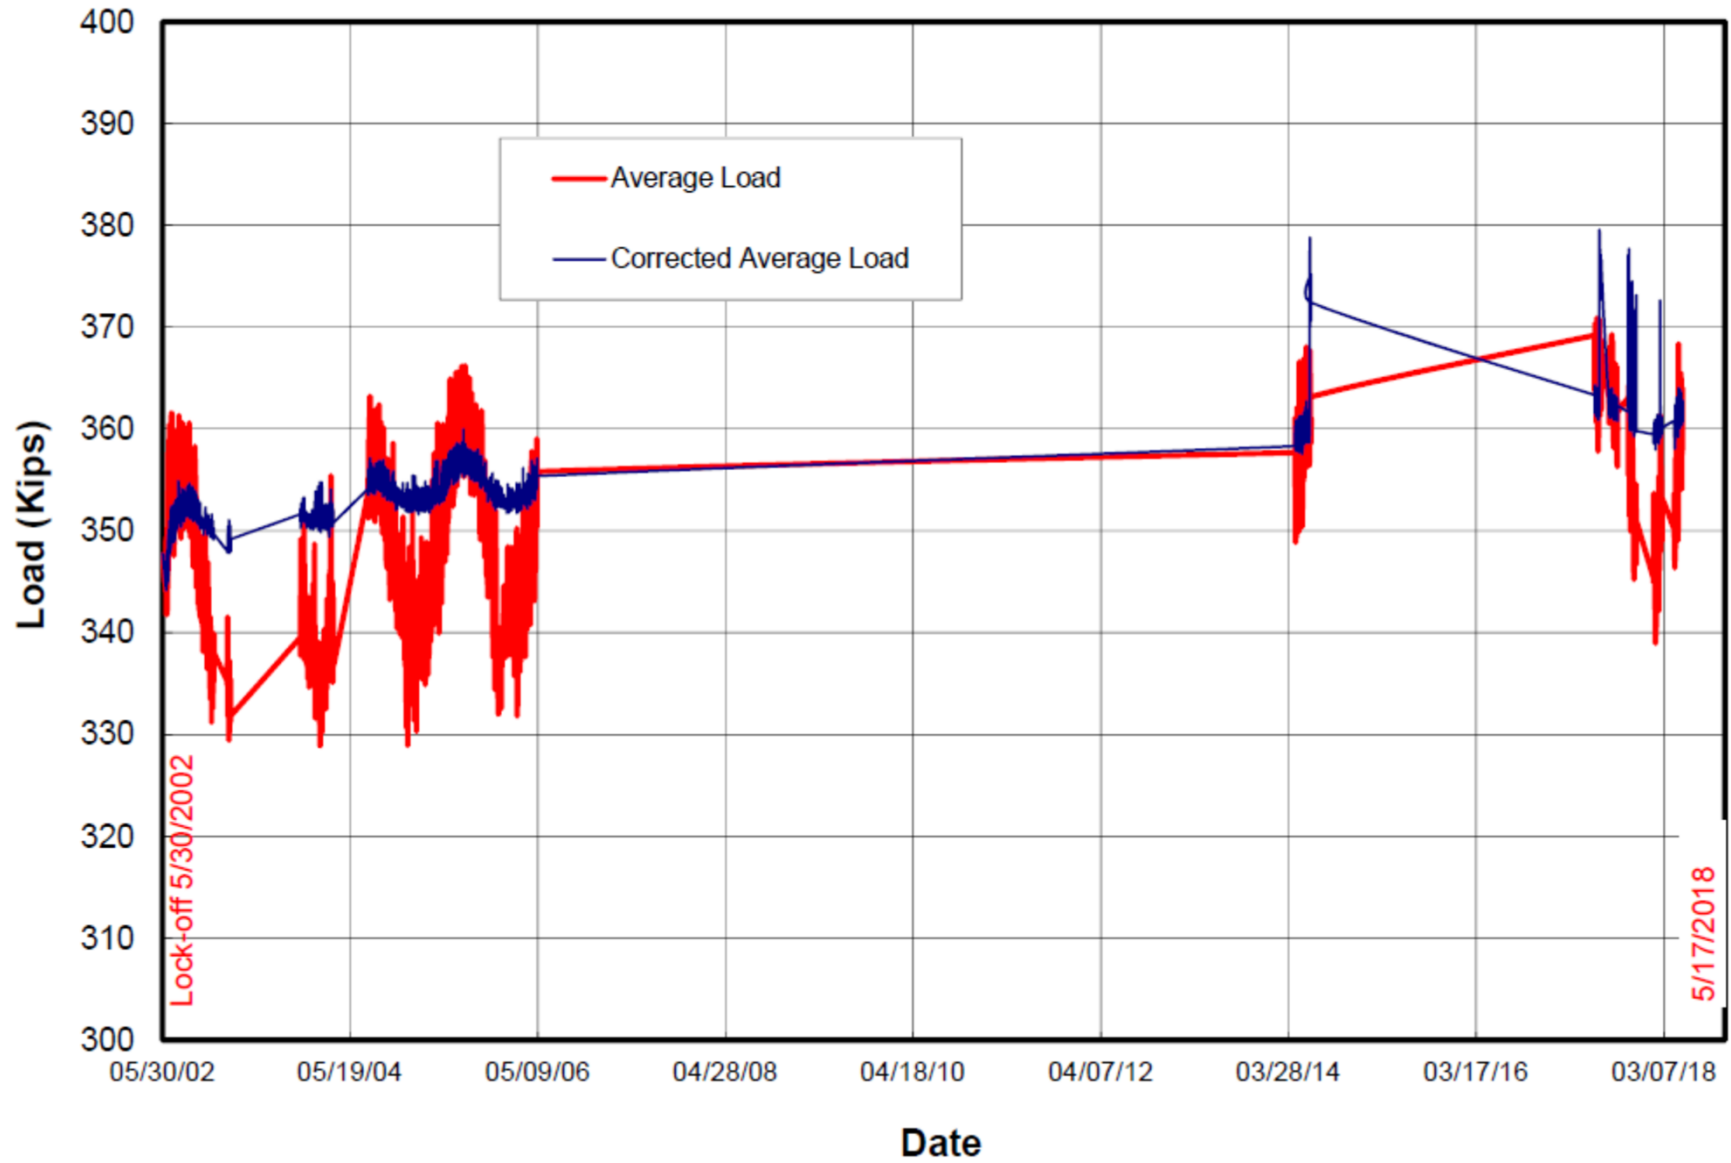
ERI-60: Load Cells Monitoring at Pier#1 (5/30/2002 ~ 5/17/2018)
