▶ **NCDOT Geo3T2, Cary, North Carolina,
April 9, 2019**

Geotechnical Evaluation of a Pedestrian Bridge Using Aquatic Resistivity Imaging to Supplement Drilling Data

**Presented by: John Z. Ding, P.E.
Warren T. "Ted" Dean, P.G.**

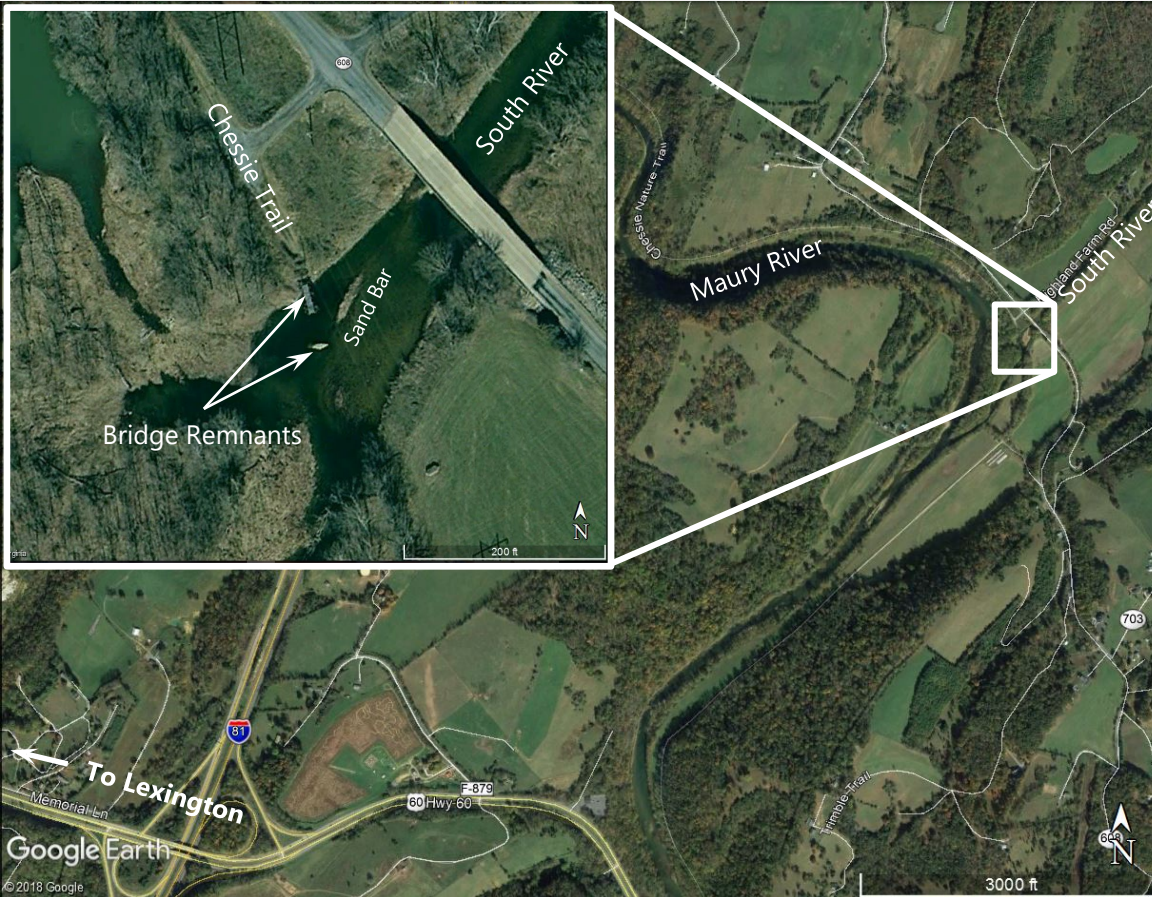
Project Overview

- ❖ Pedestrian bridge over the South River destroyed by flooding in 2003.
- ❖ A Virginia Military Institute (VMI) project with USDOT grant to re-build.

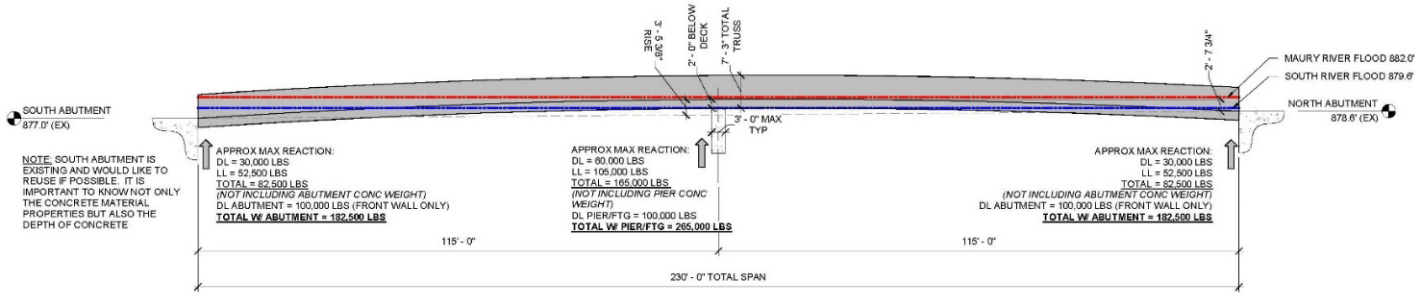
2 SPAN - OPTION 1 - EX ABUTMENT HEIGHTS REMAIN AND CAMBER ENTIRE SPAN @ 1.5% TO HAVE 3.5 FEET RISE AT CENTER

❖ 2-Span Option

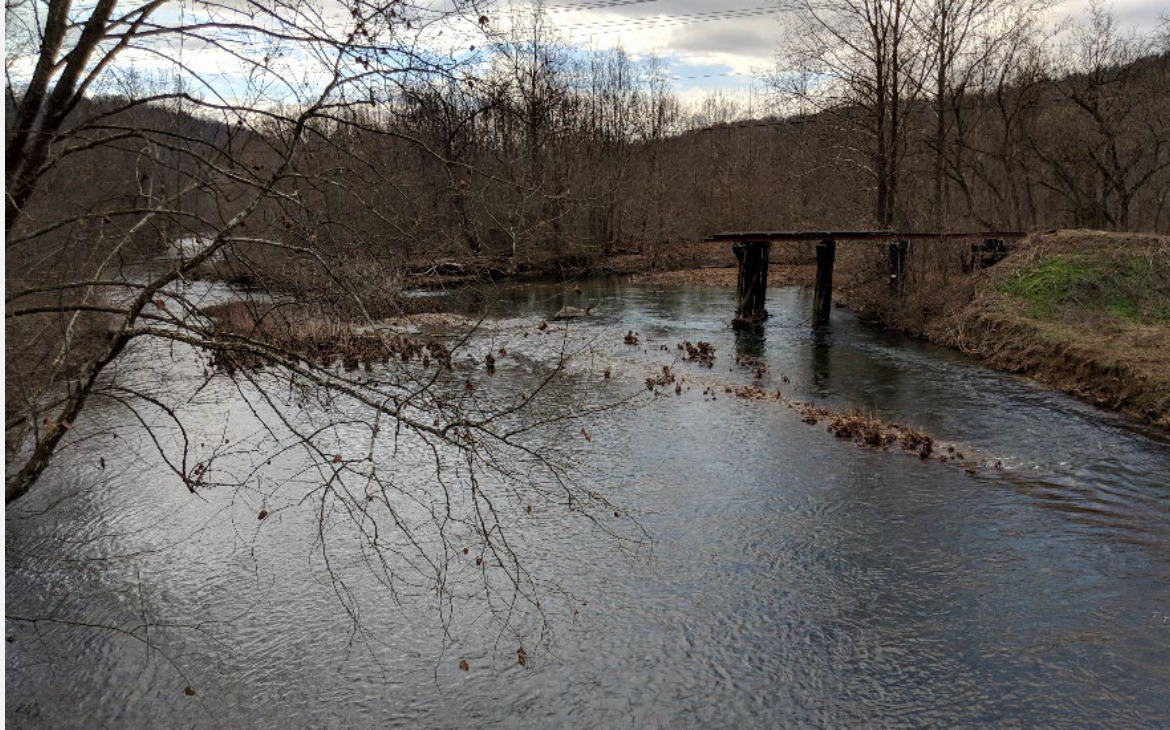
Geotechnical Challenges

- ❖ One planned boring in the river can't be performed
 - ❖ Barge Drilling is not applicable
 - ❖ ATV/Truck mounted drill rig is not able to access

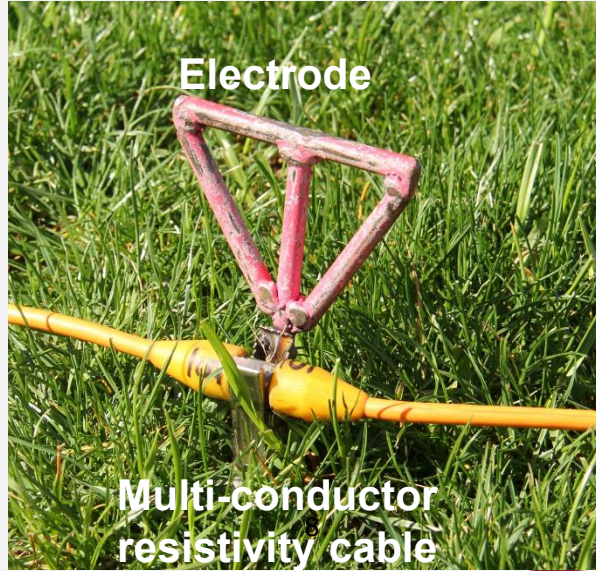
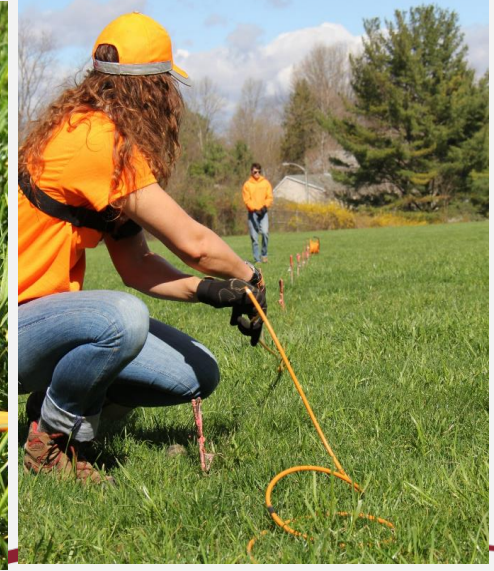
Electrode

Multi-conductor
resistivity cable

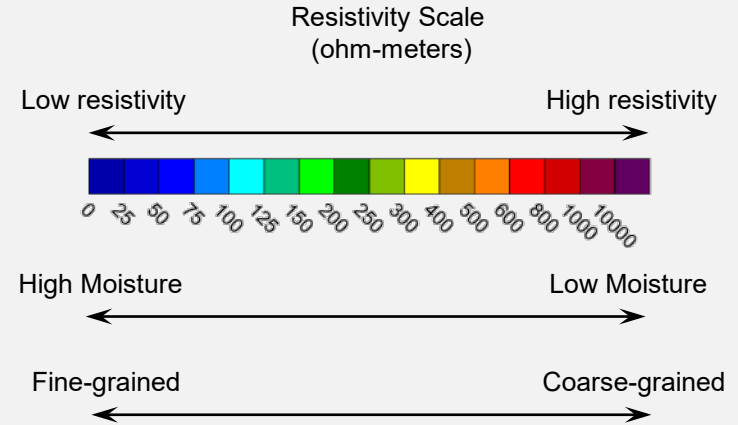
Factors that Affect Resistivity

- ▶ Moisture content
- ▶ Material grain size

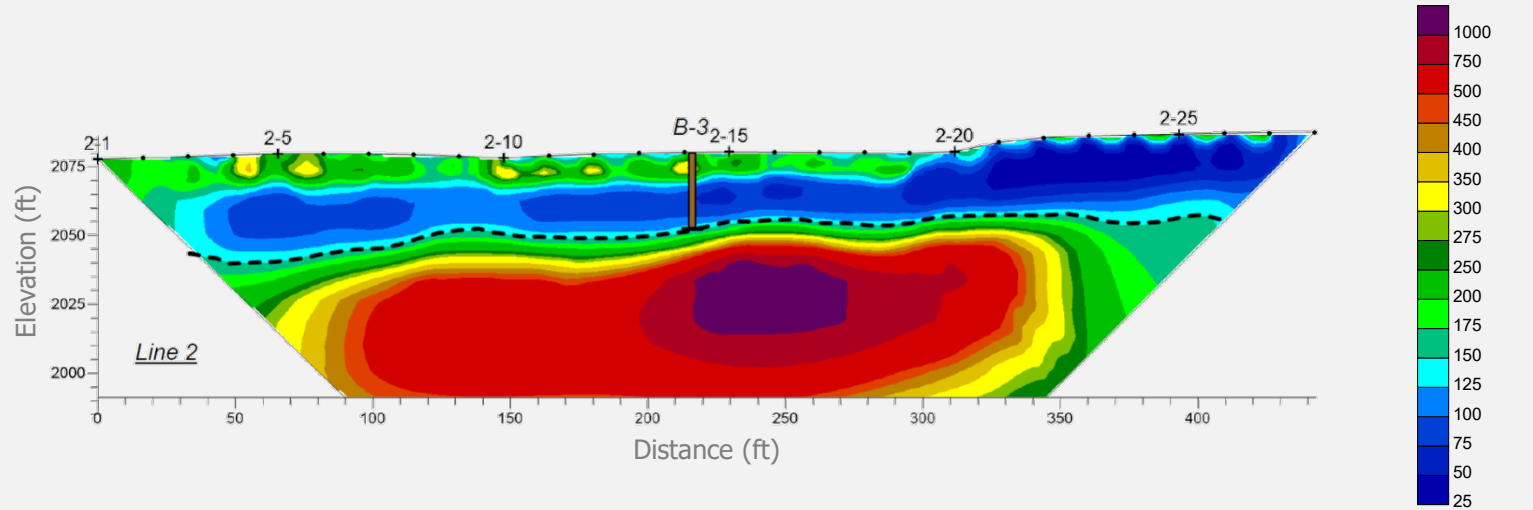
Resistivity Model

B-2 = boring ID

= soil

= auger refusal

= estimated top of bedrock
