# Tensioning of Loose Rock Boulders Underneath a Parking Deck with Spider Mesh

Frank Amend, PE, Geobrugg North America  
Kevin Day, Foundation Repair Services

4/5/2013

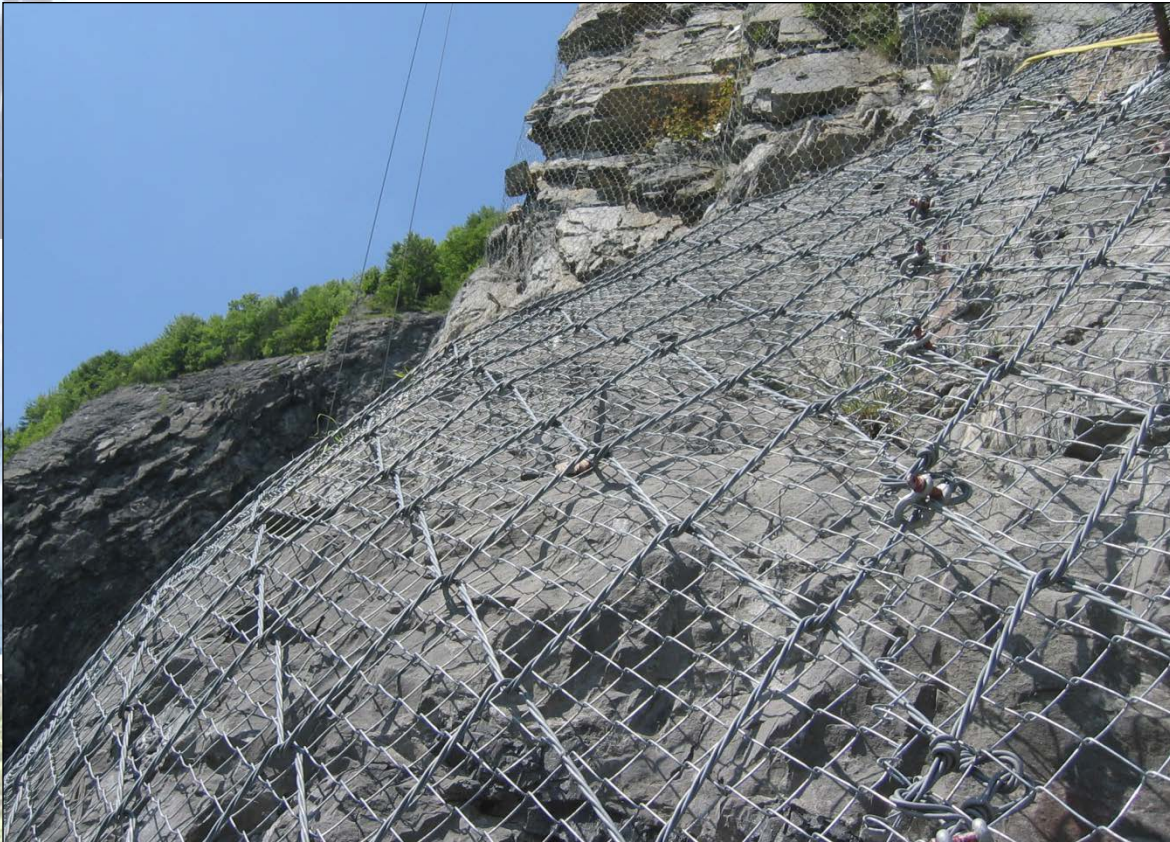
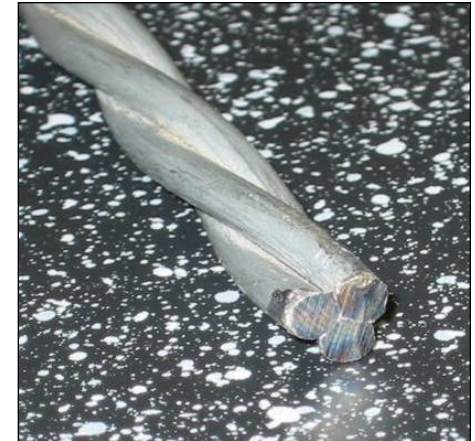
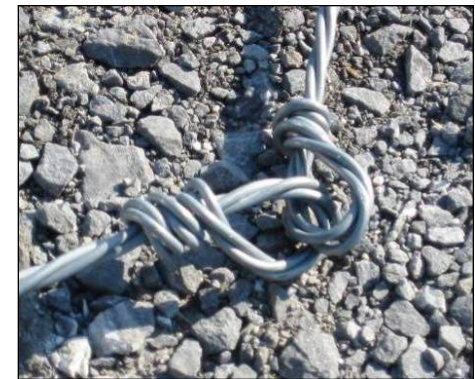
# SPIDER® - construction

Chain-link net made from 1x3 spiral rope (4 mm high-tensile wire)  
Breaking Load = 7.5 tons/ft

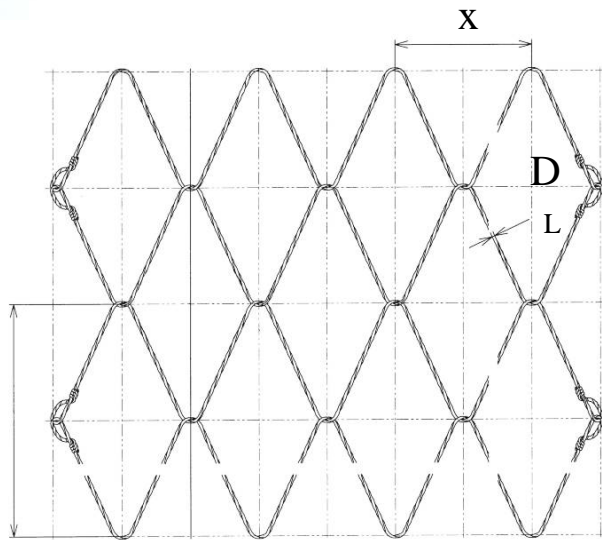
# SPIDER® - construction

Mesh width	$x = 11.5 \text{ in } (+/- 5\%)$
Mesh length:	$y = 19.7 \text{ in } (+/- 5\%)$
Strand diameter:	$D_L = 0.339 \text{ in}$
Wire diameter:	$D_w = 0.157 \text{ in}$
Spiral rope construction:	1 x 3
Mesh edges:	strand ends noddled
Tensile strength wire:	$> 256 \text{ ksi}$
Corrosion protection:	5% alu / 95% zinc
Coating:	$> 0.0256 \text{ lb/ft}^2$

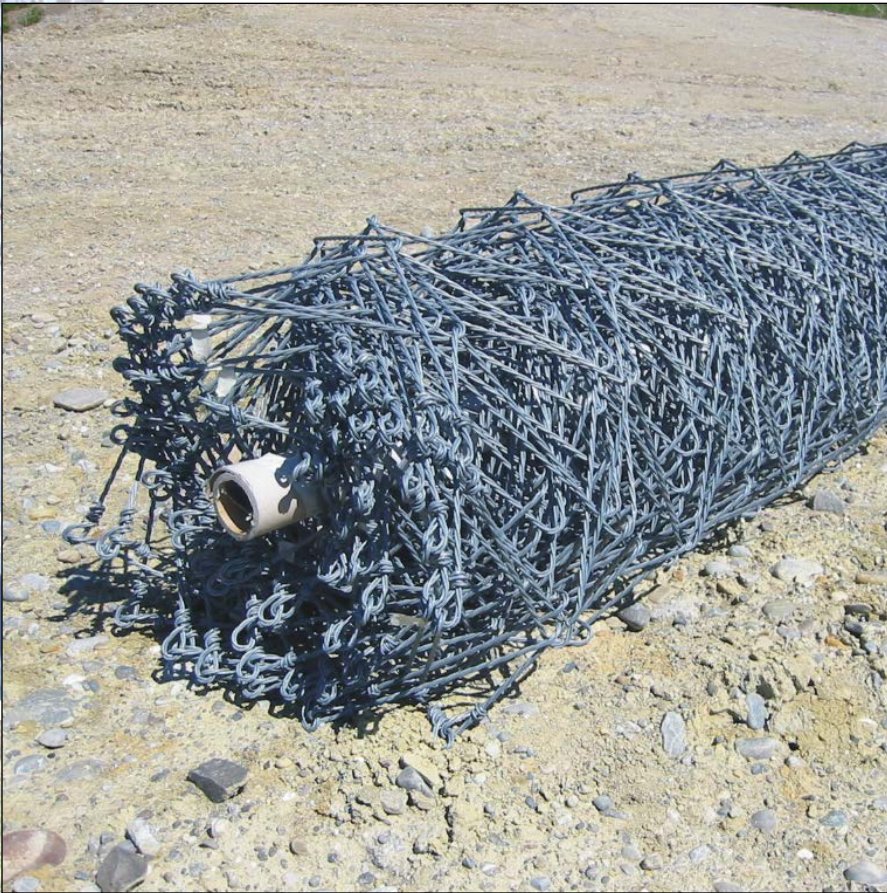
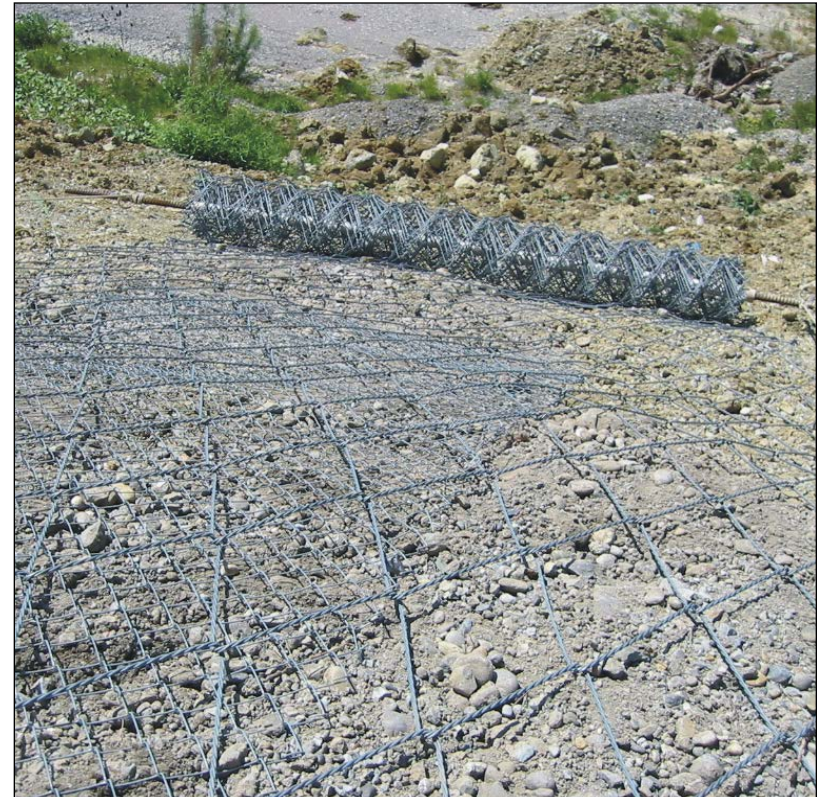
# SPIDER® S4-230 spiral rope net

Size of a standard SPIDER® roll: 11.5-ft x 66-ft (420 lbs)

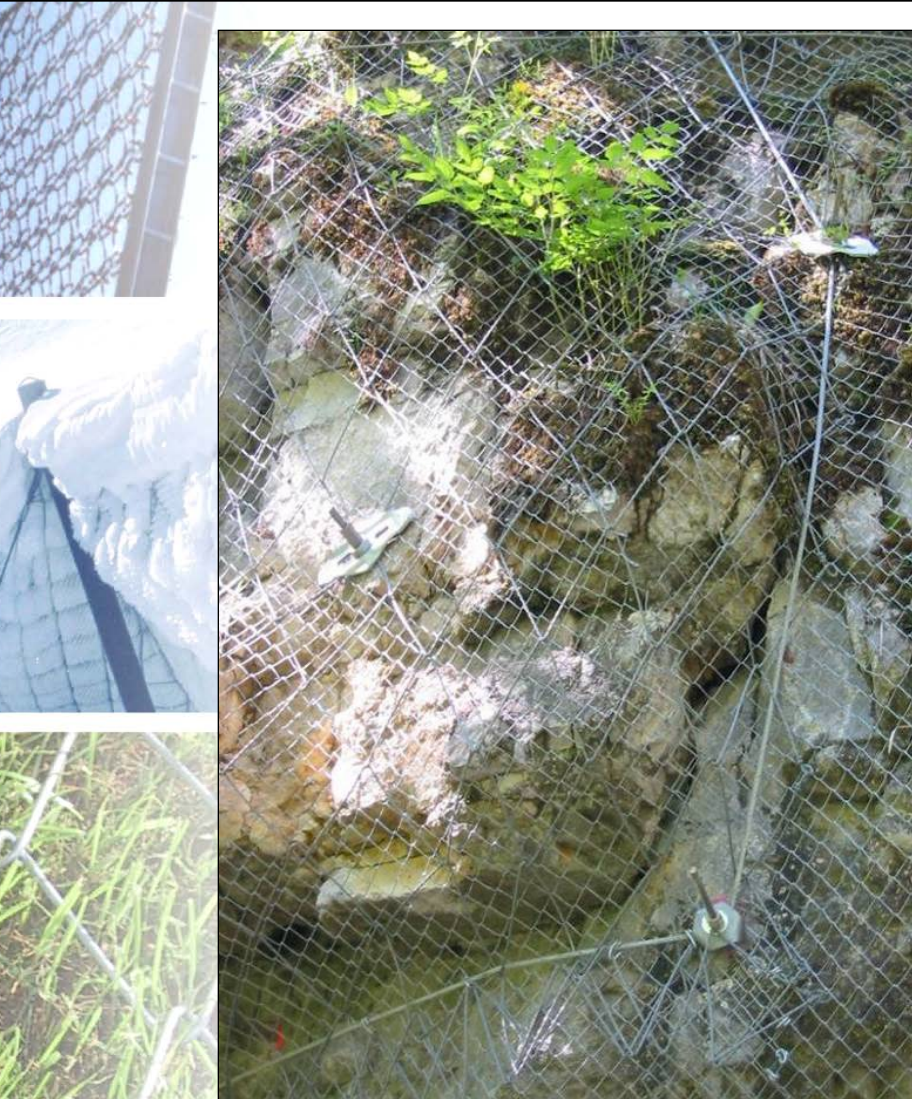
## System components

- SPIDER® S4-230 spiral rope net
- System spike plates
- Anchors
- Boundary ropes
- Shackles
- Secondary mesh (optional)

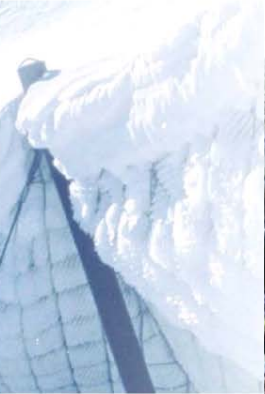
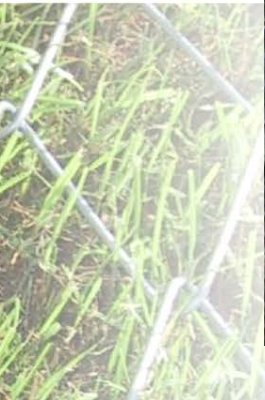
# Boulder Wall Below Parking Deck

- Boulder wall beneath a parking deck was beginning to fail because lack of maintenance of drainage on upper side. Upper retaining wall and boulder wall were leaning and pushing the entire parking deck laterally. If movement continued, the large boulders could strike the columns, and cause the parking deck to collapse.

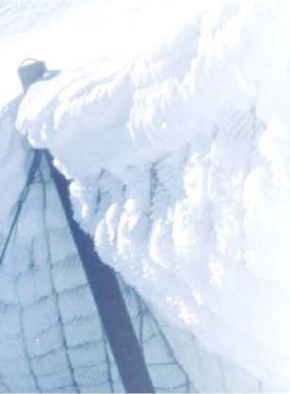
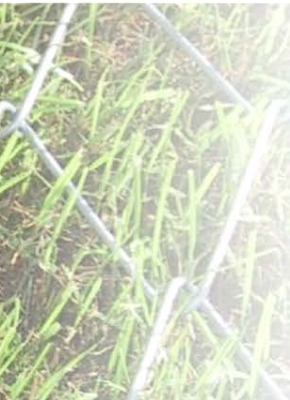
# Before Construction

Scarp Lines appearing here

Column Height 40'

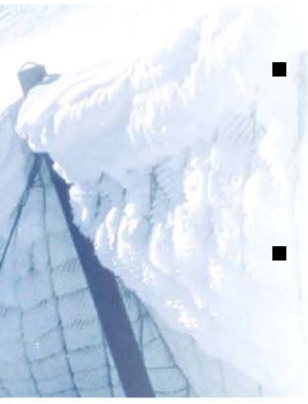
- A photograph showing a large, dark-colored Geobrugg SPIDER net installed over a field of large, light-colored boulders. The net is anchored to a retaining wall on the left side.

- A unique design was employed that involved anchoring to the existing retaining wall to prevent further movement and then encapsulating the boulder field with a high tensile net before pinning the net against the boulders themselves.

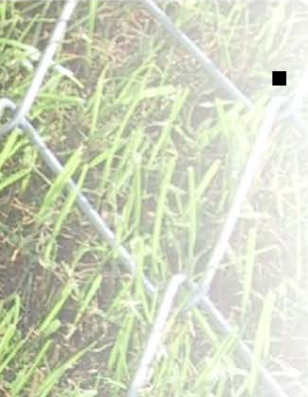
- A close-up photograph of the Geobrugg SPIDER net, showing its high-tensile, diamond-shaped mesh structure and the way it is anchored to a metal post.

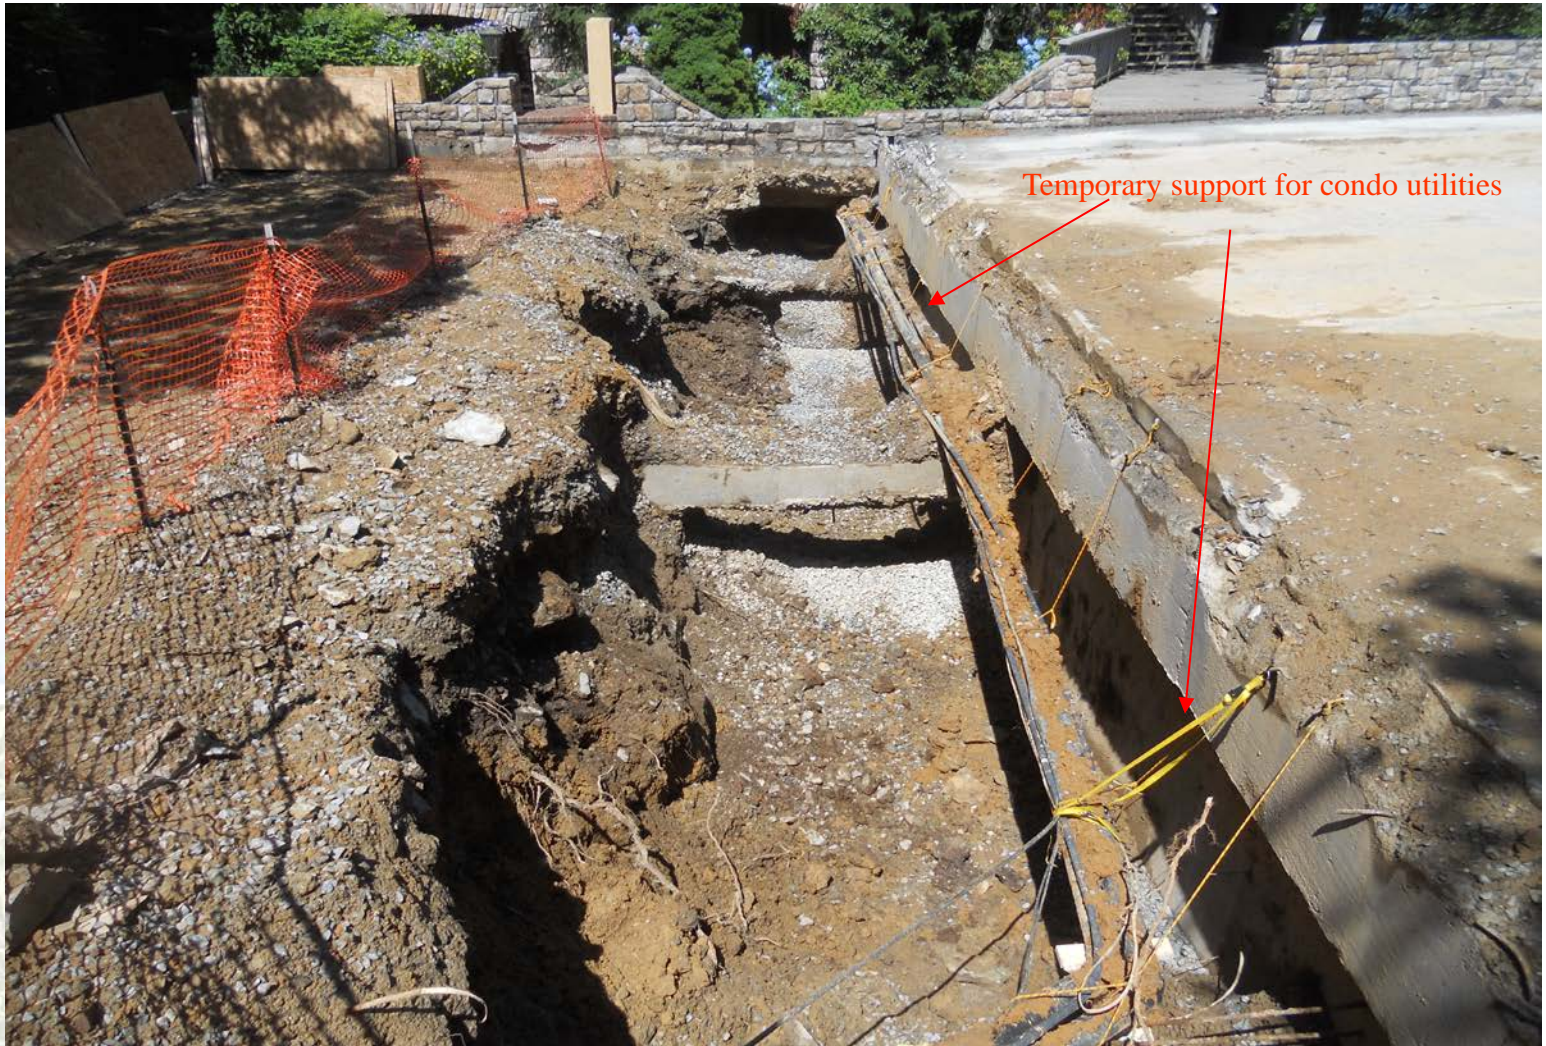
# Upper pit

- Evacuated an 8' deep pit on the uphill side of the existing retaining wall on which the boulders were stacked.
- Titan 30/16 bars were then drilled into the bedrock at a batter and stubbed out just before the wall itself.
- Then the wall was cored so the tiebacks could be extended through the wall and secured against two (2) 15" channel whalers and bearing plates placed on the outside of the retaining wall.

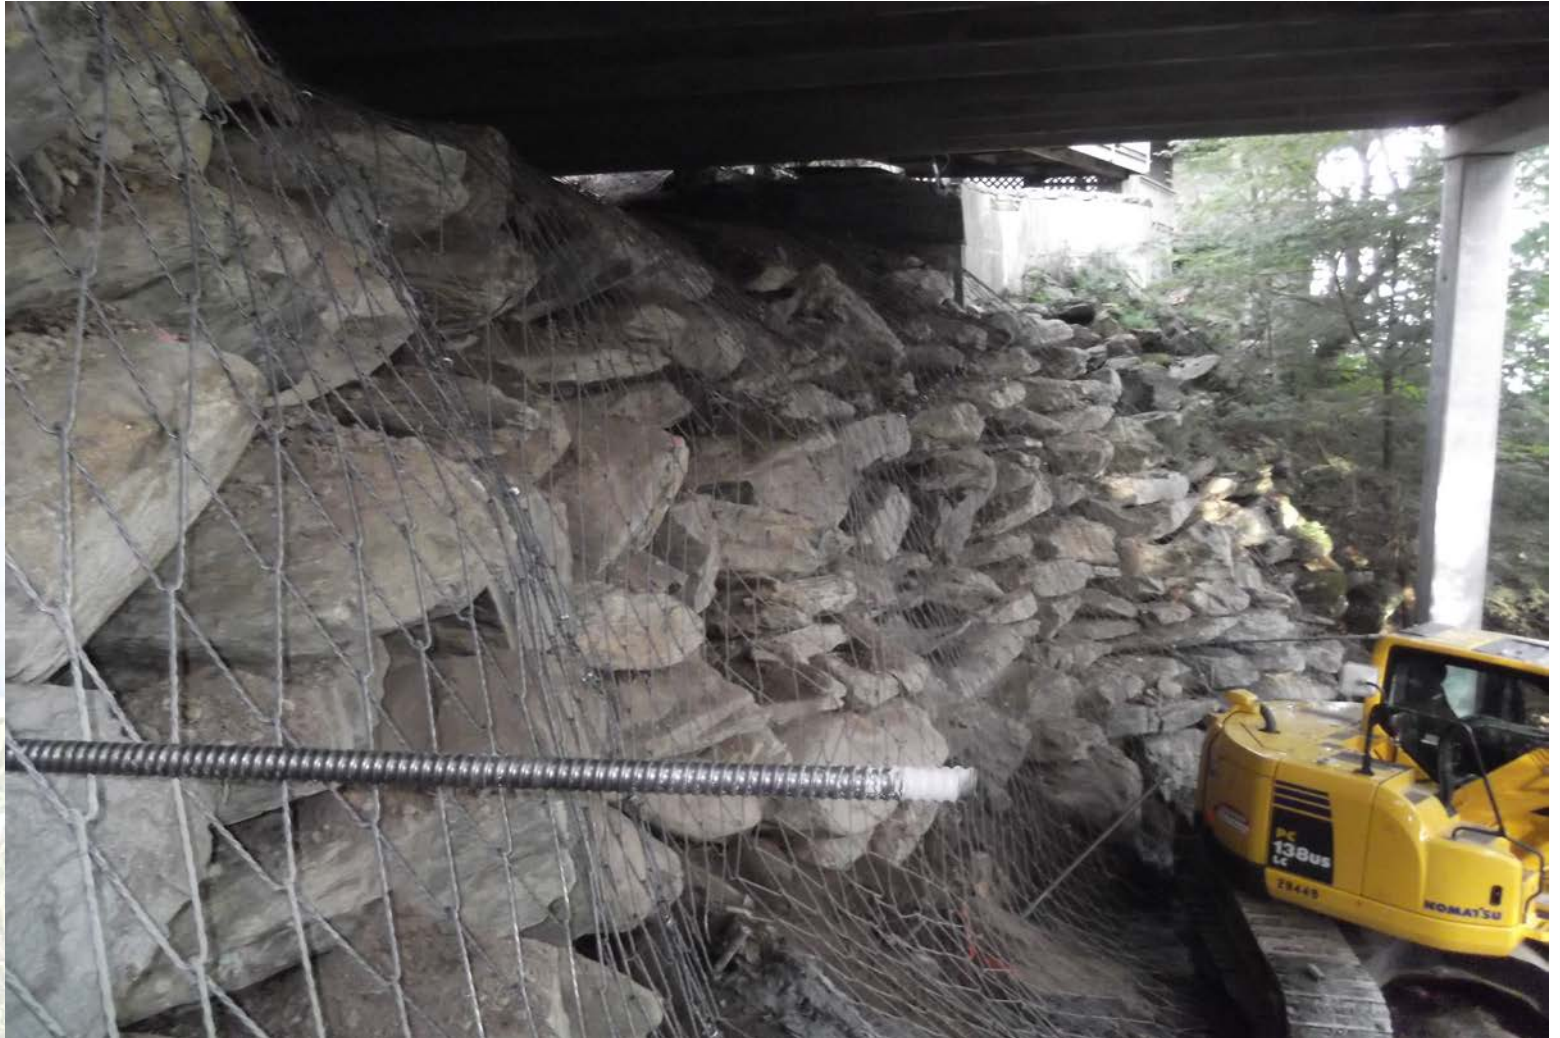
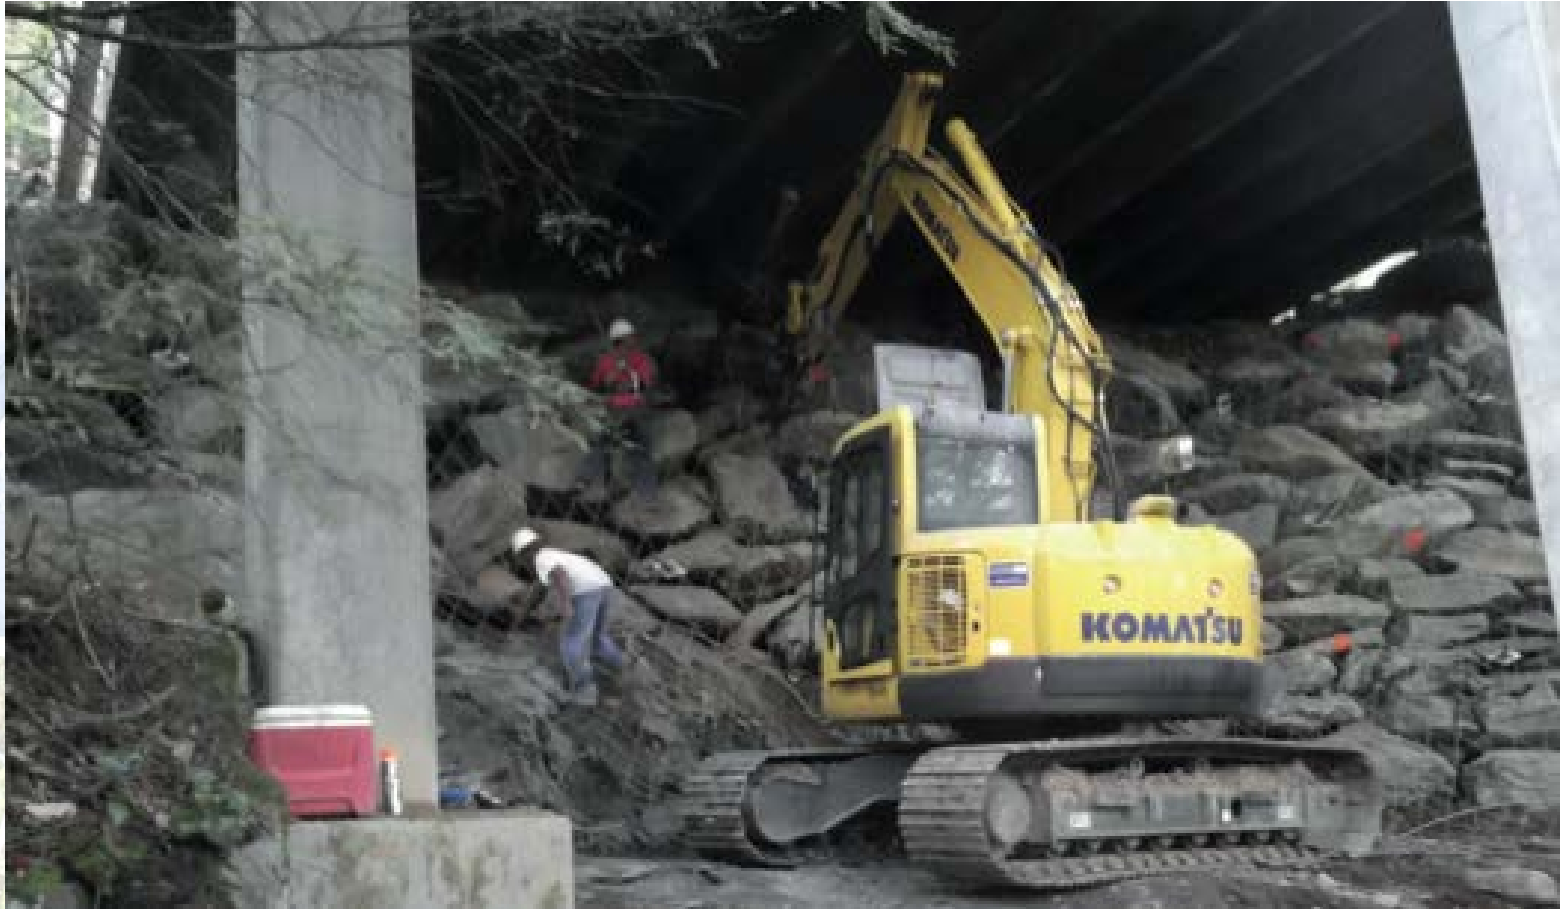
# Drilling Titan bars in boulder field

- Drilled the remaining Titan 30/16 and Titan 40/20 hollow bar injection anchors throughout the middle section of the boulder wall.
  - As the anchors were installed and reached their capacity, the spike plates were added and secured against the SPIDER® net.
  - The anchors were placed at roughly 8' centers and in all approximately seventy (70) anchors were used.
  - The rock anchors were drilled five to ten feet into rock to develop their design capacities.
- A boundary rope was added around the perimeter of the SPIDER® net and all the Spike plates were tightened to the design torque against the net to secure the whole system.

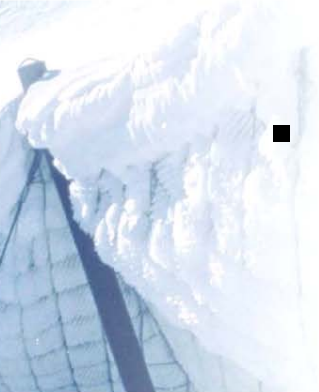
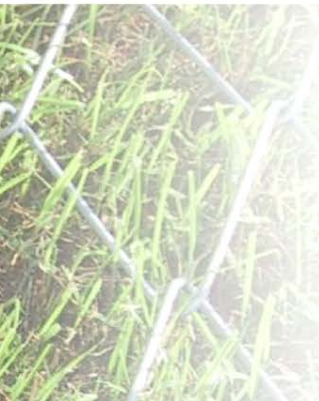
- Additionally a 1" diameter rod was drilled and epoxy doveled into each of the three (3) 2'x 2' parking deck support columns
- This rod was then tied into a rock anchor before turnbuckles were used to tension the rod.
- After the prerequisite torque was applied, a sag rod perpendicular to the parking deck tied into the tie rod.

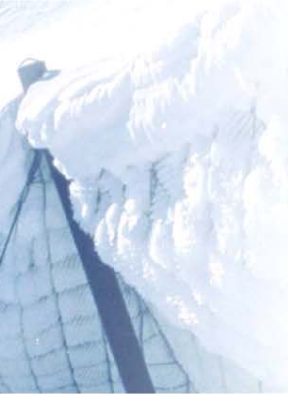
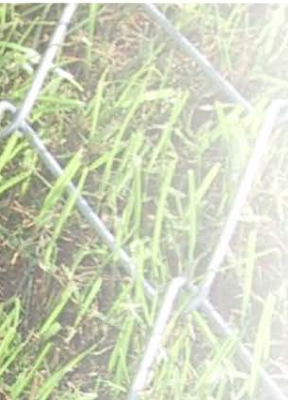
# Spike Plates and Boundary Rope

- Build an access road to the underside of the deck – very difficult
- Attached the SPIDER® net to the bottom channel whaler's row of anchors above the boulders and draped the net over the rock face
- Drilled rock anchors down each side and along the bottom of the boulder wall
- Secured the SPIDER® net along the boulder field's perimeter.

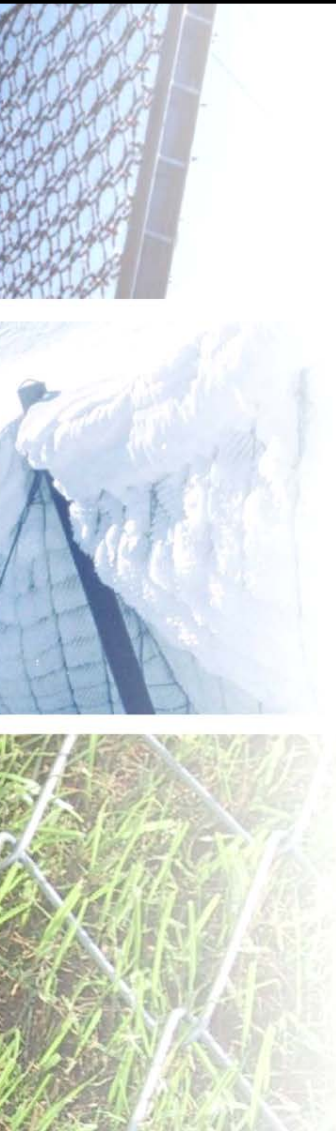
# Earthquake!!!

- The earthquake happened the day after all the spike plates were tensioned and several of the installation contractors employees were standing on the parking deck
- The condos and parking deck started to rock back and forth.
- Due to the flexibility of the SPIDER® net and the fact that the system was securely tensioned to the bedrock behind the slope, the entire system was elastic enough that the boulders and columns below the parking deck were kept in place – nothing sheared and nothing moved.
- A more rigid system, such as shotcrete facing or a cast in place wall, probably would not have fared so well under the same circumstances.
- We considered the entire project to have been tested and to be a success!”
