Anatomy Of A Bridge Failure

GEO3T2 Conference

The Project - Bridge Overpass, Chesapeake, Virginia

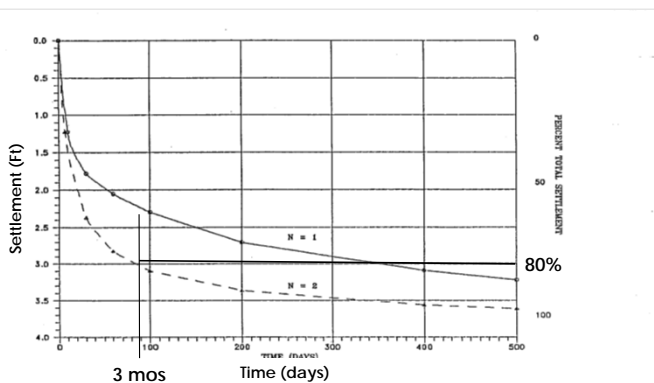
Estimated Time of Embankment Settlement

SCALE	APPROVED BY	DRAWN BY
DATE	SAB	JEC
7-10-87		PROJECT
Chesapeake Roadways - Route 17		NK7-1580
Chesapeake, Virginia		
Settlement v.s. Time		DRAWING NUMBER
		5

- “Embankment settlements of 2.5 to 3.5 ft are predicted”.
- “While the time required for the total completion of primary settlement is in years, 80% is likely to occur in the first 3 months”.
- “Typically in non-homogenous clays with potential sand lenses, settlement rates in the field are usually faster than predicted”.
- “It may be possible to accelerate settlement by installing wick drains...”

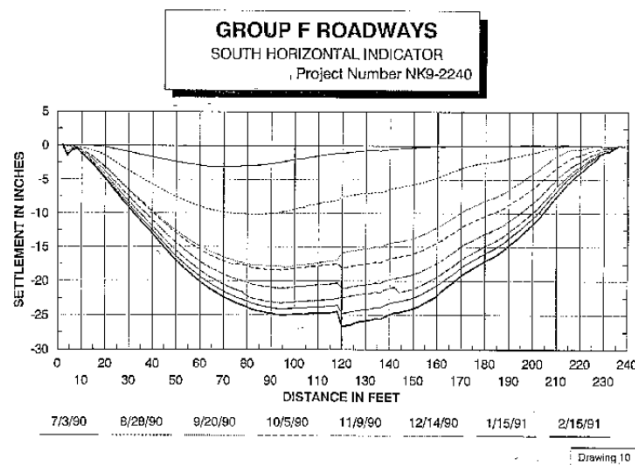
Field Data – Horizontal Indicator

- "Horizontal indicators indicate that the (vertical) settlement is still occurring".
- "Horizontal movement continues...may still be experiencing plastic flow".
- "While pore water pressures have reduced, values indicate consolidation is still occurring".
- "Construction of the overpass bridge and pier foundations can proceed".

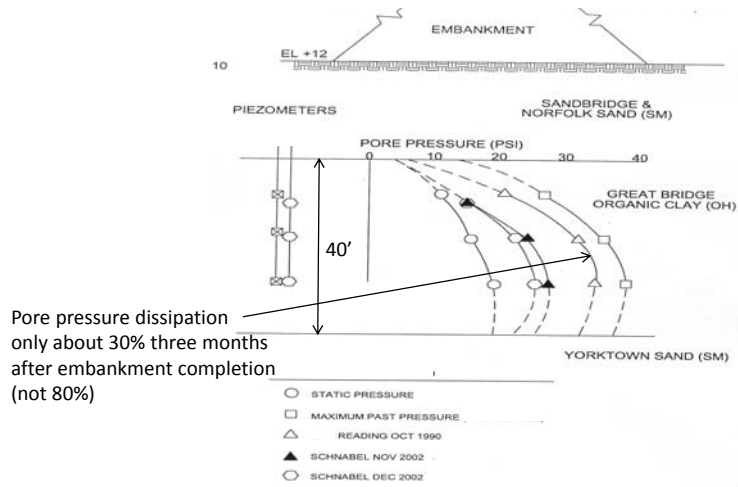
Pore Pressures in Organic Clay Layer

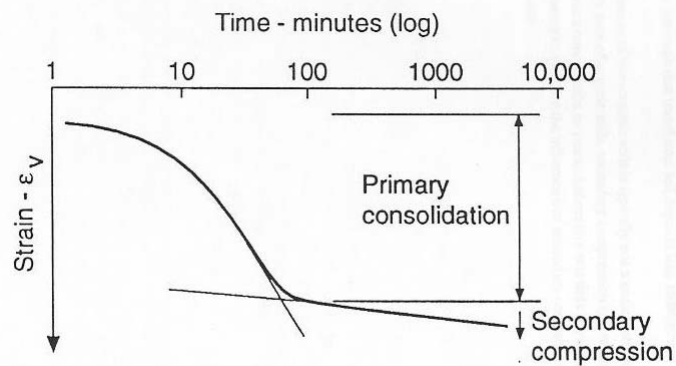
Semi-log Plot of a Typical Laboratory Consolidation Time Curve

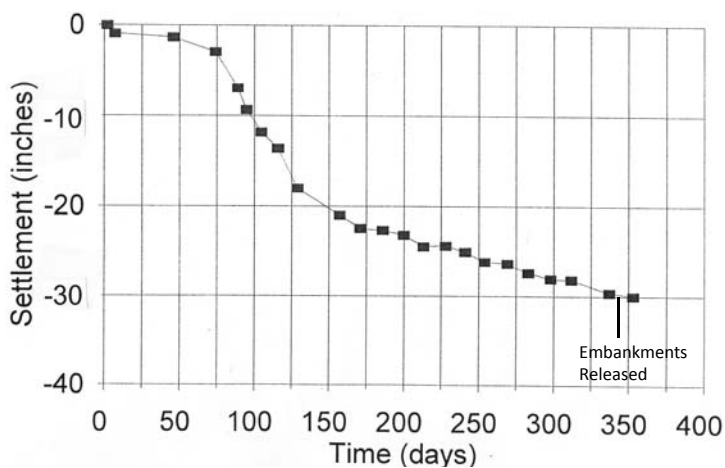
Field Data - *Arithmetic* Time-Settlement Plot Of Embankment

- Using the least conservative method to predict consolidation may not always be the best choice.
- If you plot field consolidation data **arithmetically** you just might come to the wrong conclusion.
- You cannot ignore redundant field performance data no matter how bad the news is.
- If you inspect a bridge and it seems to be falling apart – you have to ask “why?”

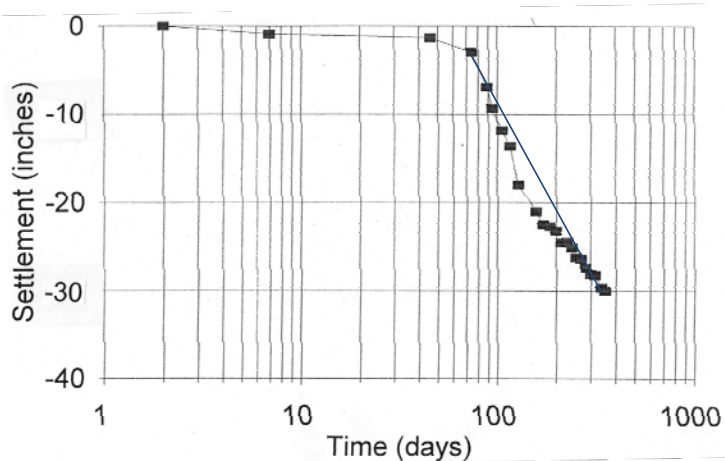
Semi-log Plot of Embankment Time-Settlement Data

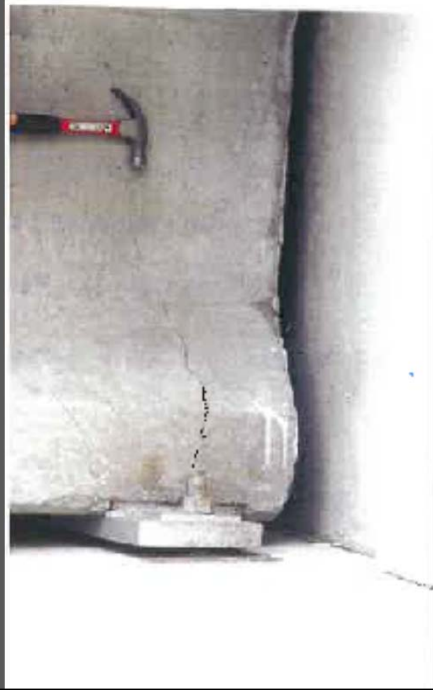
Vertical crack on
beam web above
bearing plate

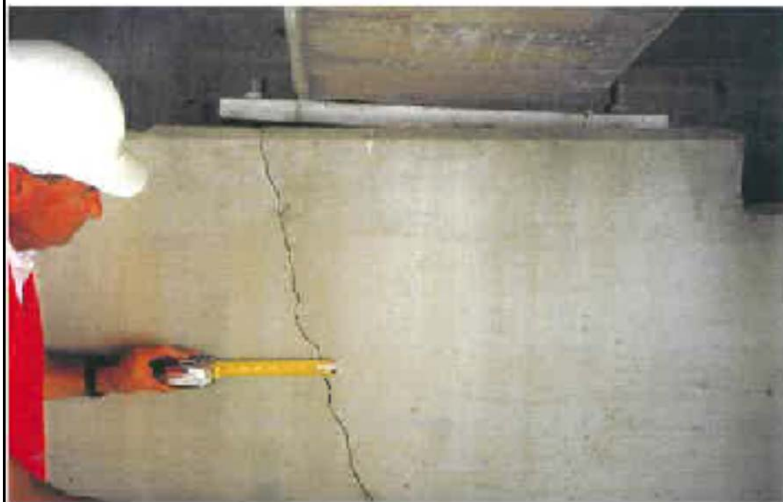
Diagonal Stress Crack in Under Beam

Cracked and Grouted Beam

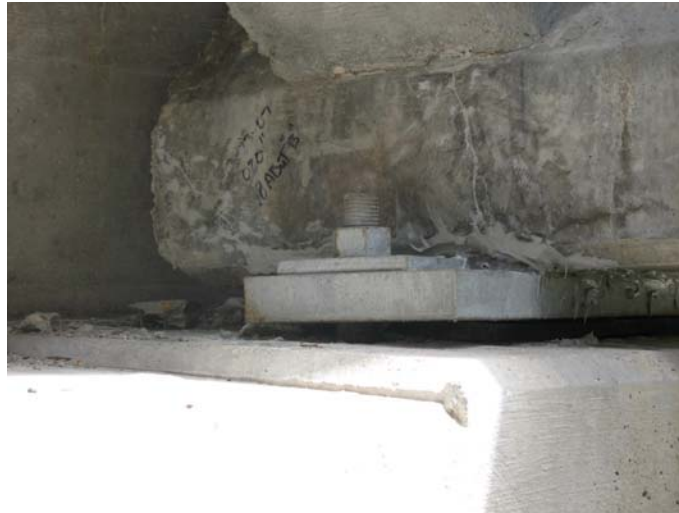
Rotation of Back Wall

Displacement relative
to girder

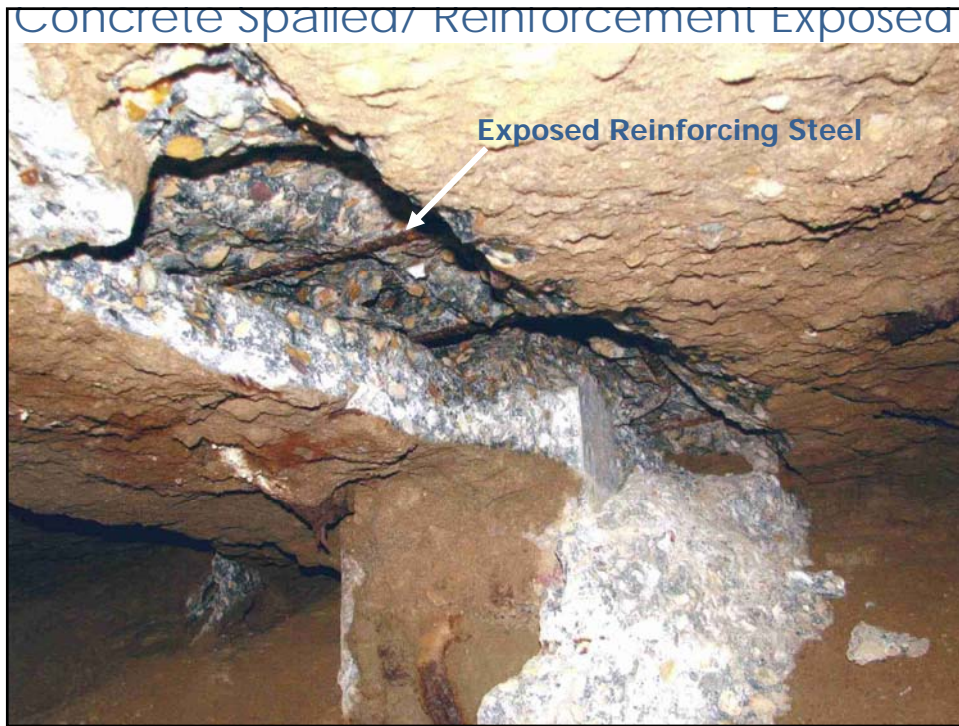
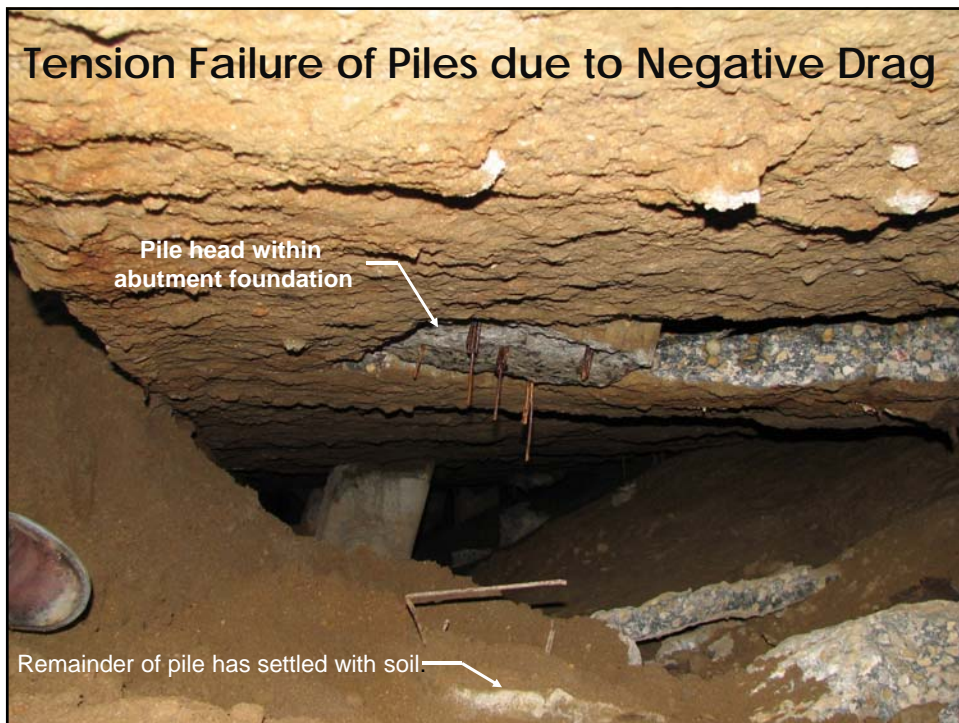
**Vertical and Battered Piles Exposed within
Void Beneath Abutment Foundation**

Calculated as 100 to 120 tons (considering strength gain in clay and drag from overlying sand and embankment fill)

- Working loads 40 to 60 tons
- Combined working loads and negative drag loads exceeded the design allowable capacity of 100 tons
- For piles bearing in clay the capacities were far exceeded

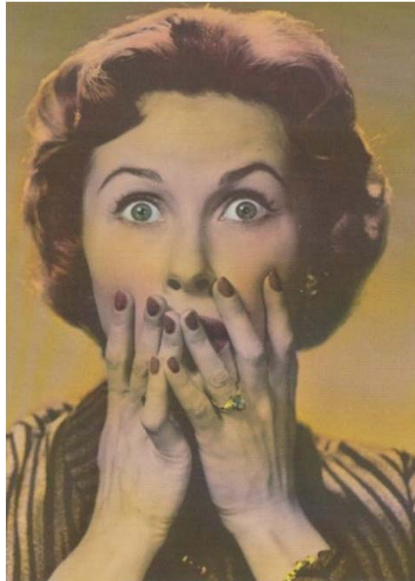
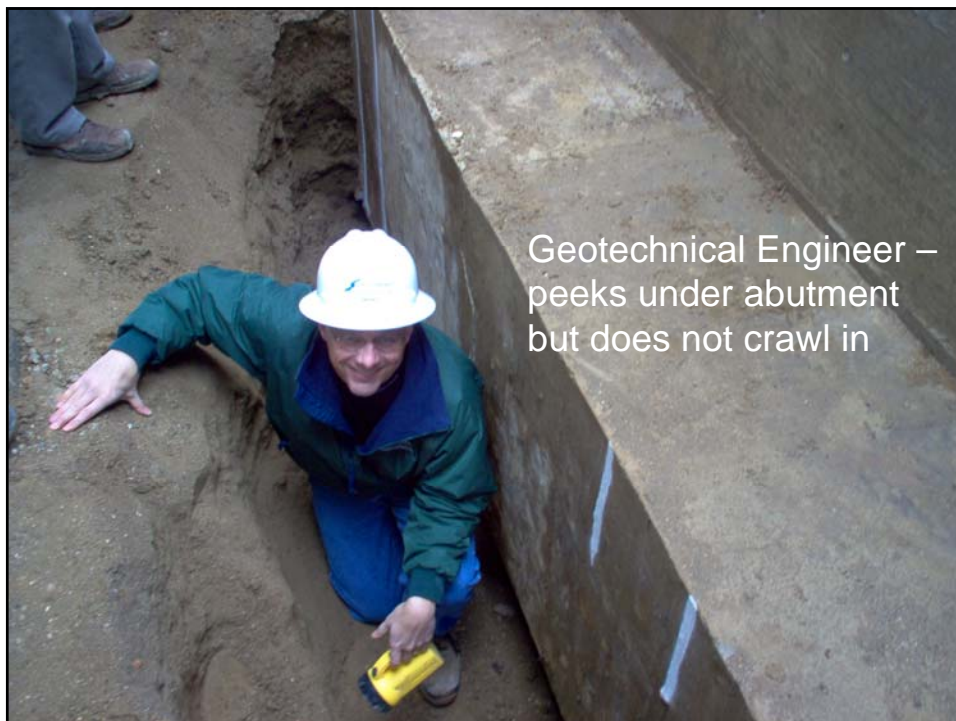
You mean they're.....gone?

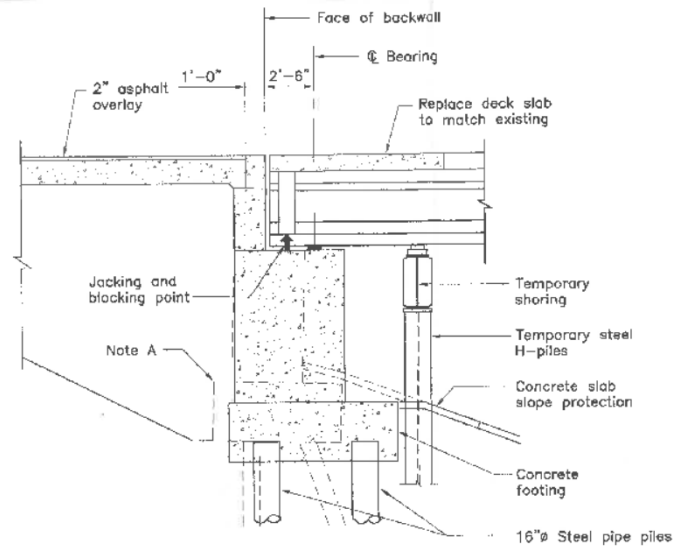
Reconstruct Abutment Using Temporary Pier to Support Bridge Deck

- Use temporary bent to support span while replacing abutment
- Minimize drag load
 - Case upper 50 ft
 - Using pile coatings within clay
- Testing during construction
 - Dynamic testing: initial drive and restrike
 - Static testing:
 - Compression test on full length pile
 - Tension test on cased & coated portion.

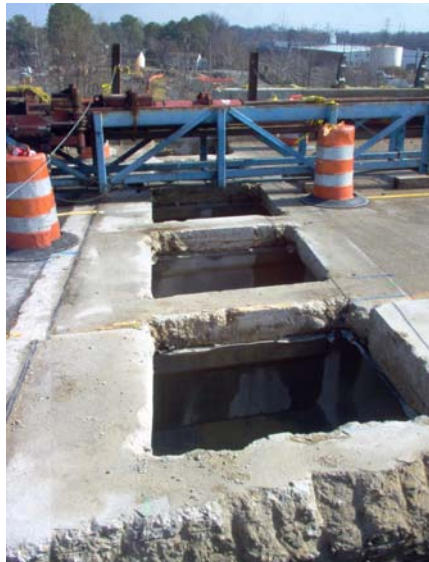
Access Holes Cut Through Bridge Deck

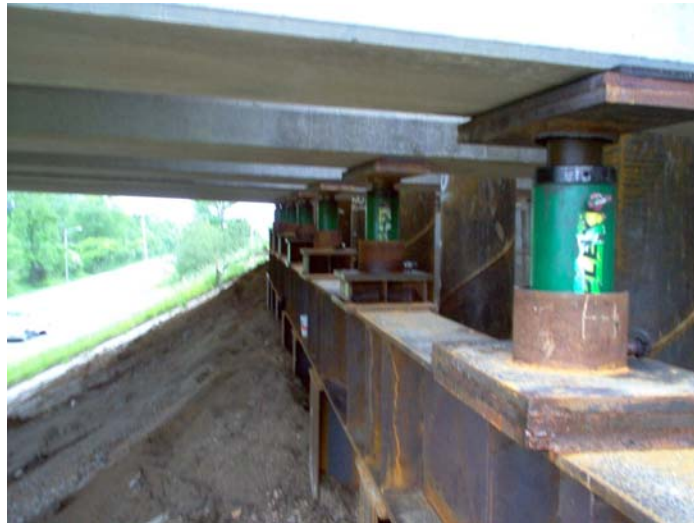
Jacking Up End Span

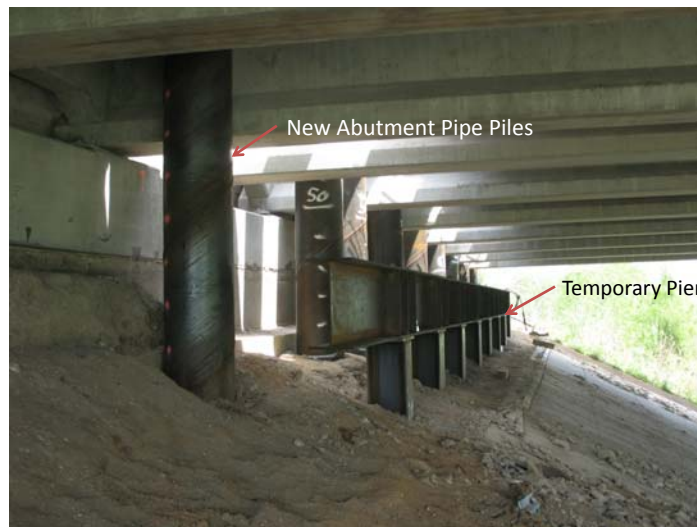
Temporary Shoring

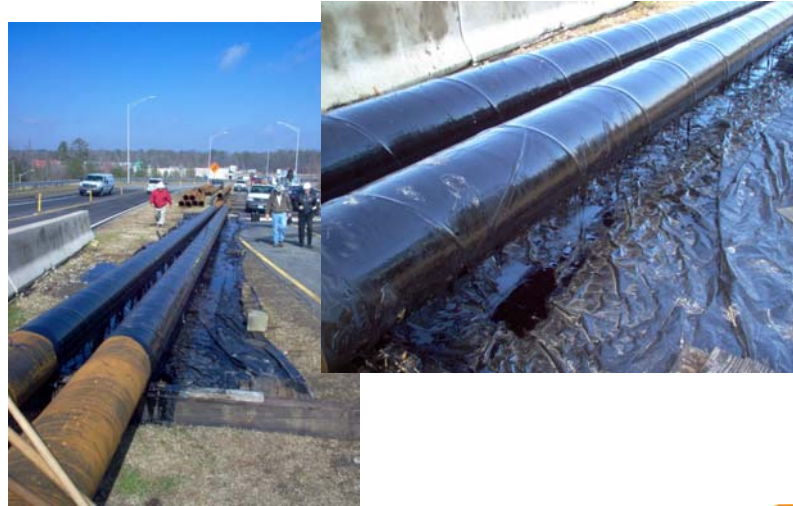
Pile Coatings Applied

- Using pile coatings to reduce pile friction may be dubious, particularly when you're trying to coat a cylinder.
- Don't argue with a contractor while standing above ground on a narrow beam.
- Don't crawl under failing structures (unless you're a bridge engineer).

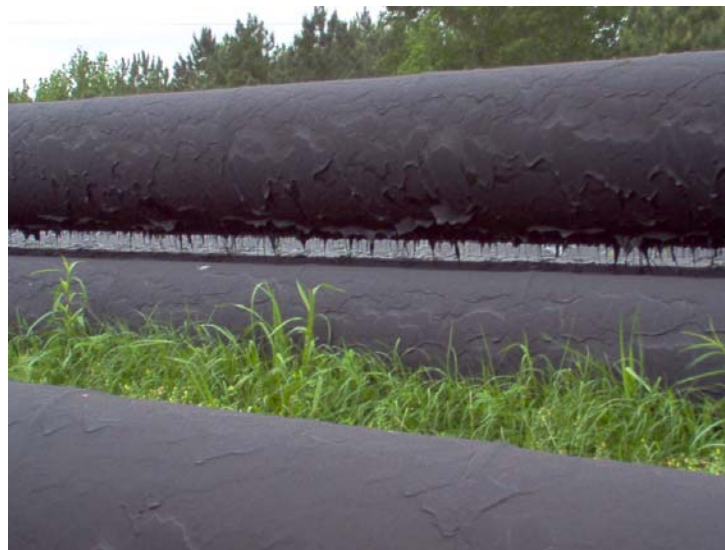
Hardened Coatings on Piles

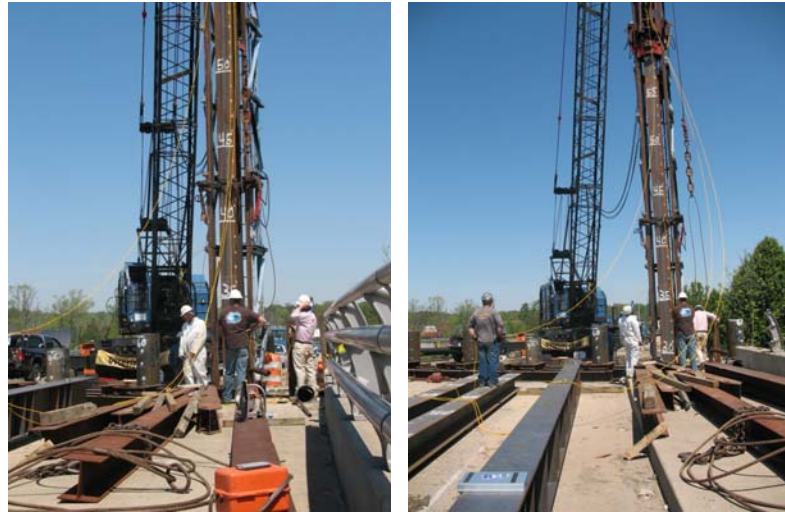
Control Piles being Driven

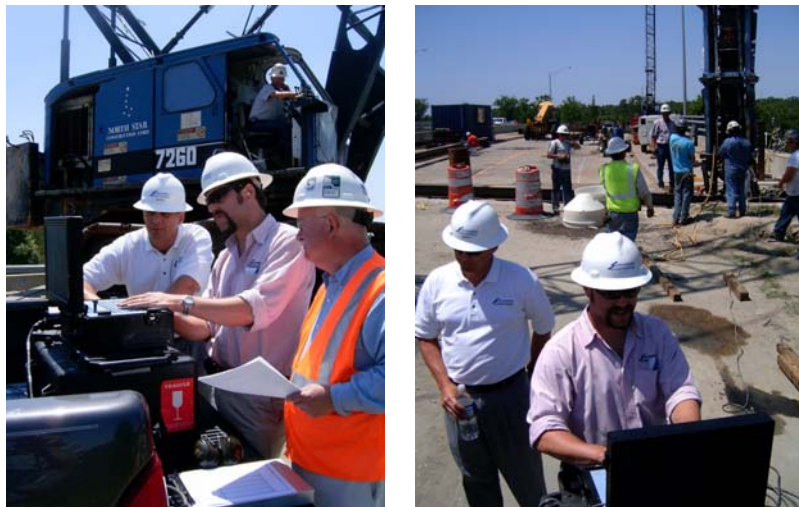
PDA Testing

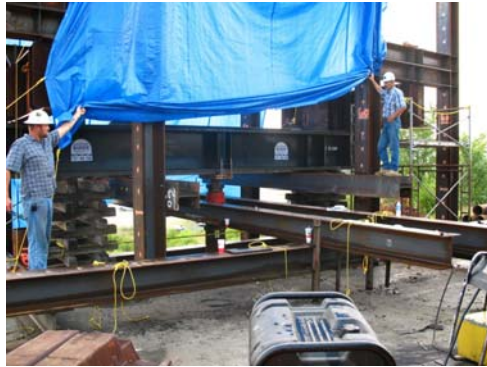
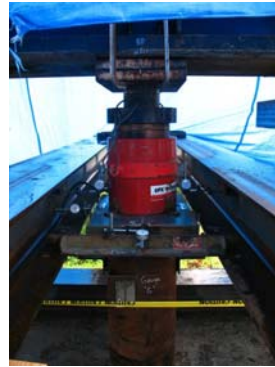
Pile Load Test

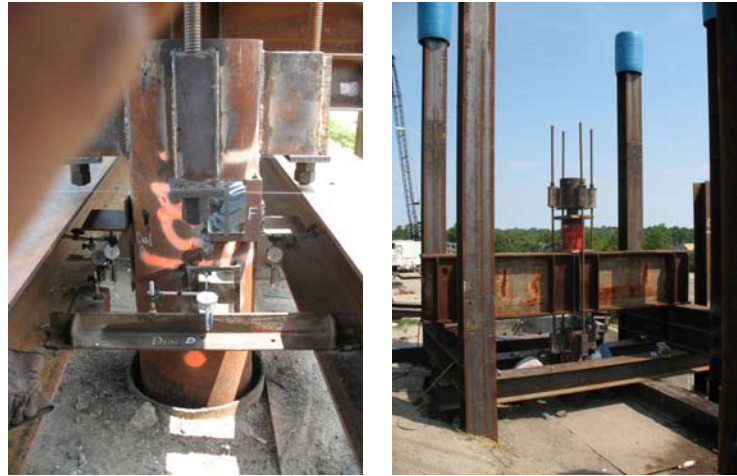
Pullout Test Setup

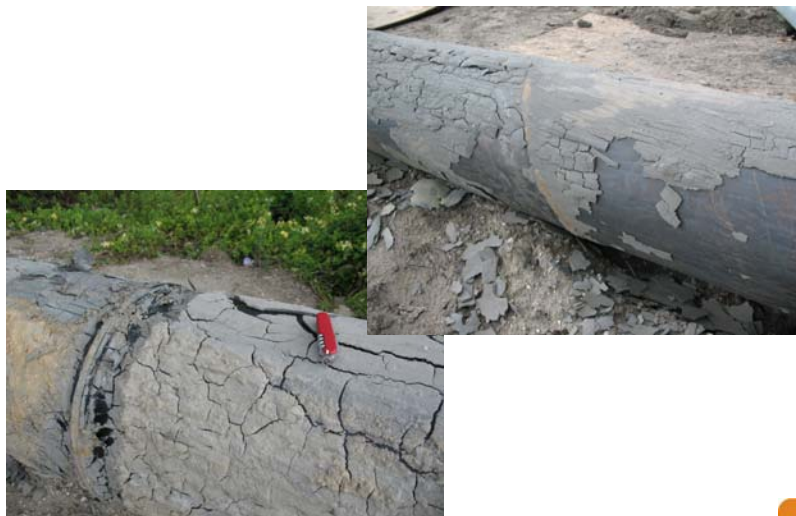
Shear Failure Appears to be Mostly in Clay

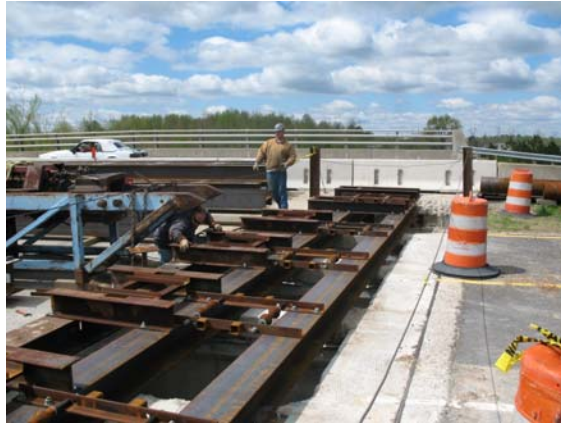
Pile Driving Template

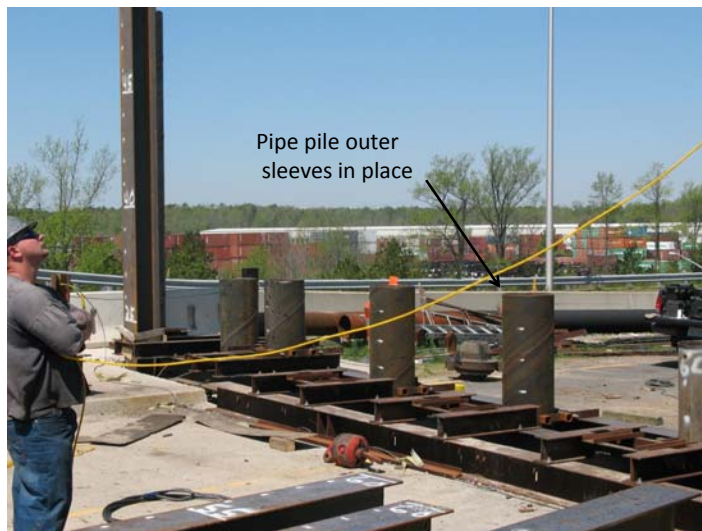
Template With Outer Pipe Sleeves

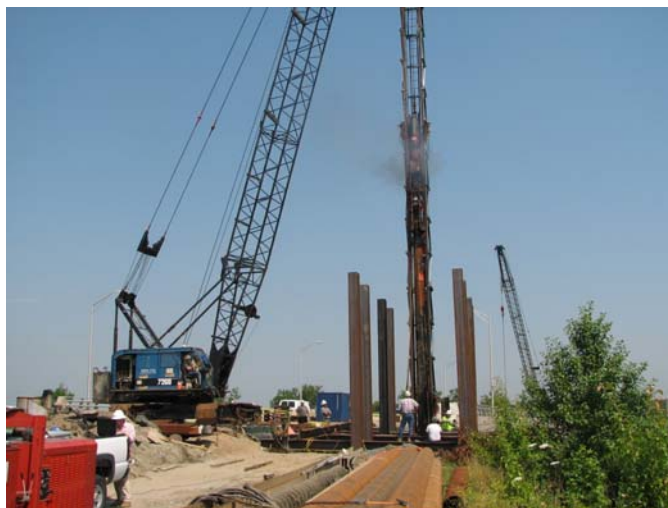
Driving Replacement Pipe Piles
