# BRIDGE INSPECTION REPORT

INSPECTION TYPE: Routine Inspection

COUNTY GASTON BRIDGE NUMBER 350118 INSPECTION CYCLE 2 YRS **15.8**  
 ROUTE SR1327 ACROSS I85 M.P. 0

SUPERSTRUCTURE RC DECK ON PRECAST PRESTRESSED CONCRETE GIRDERS, APPR.SLABS

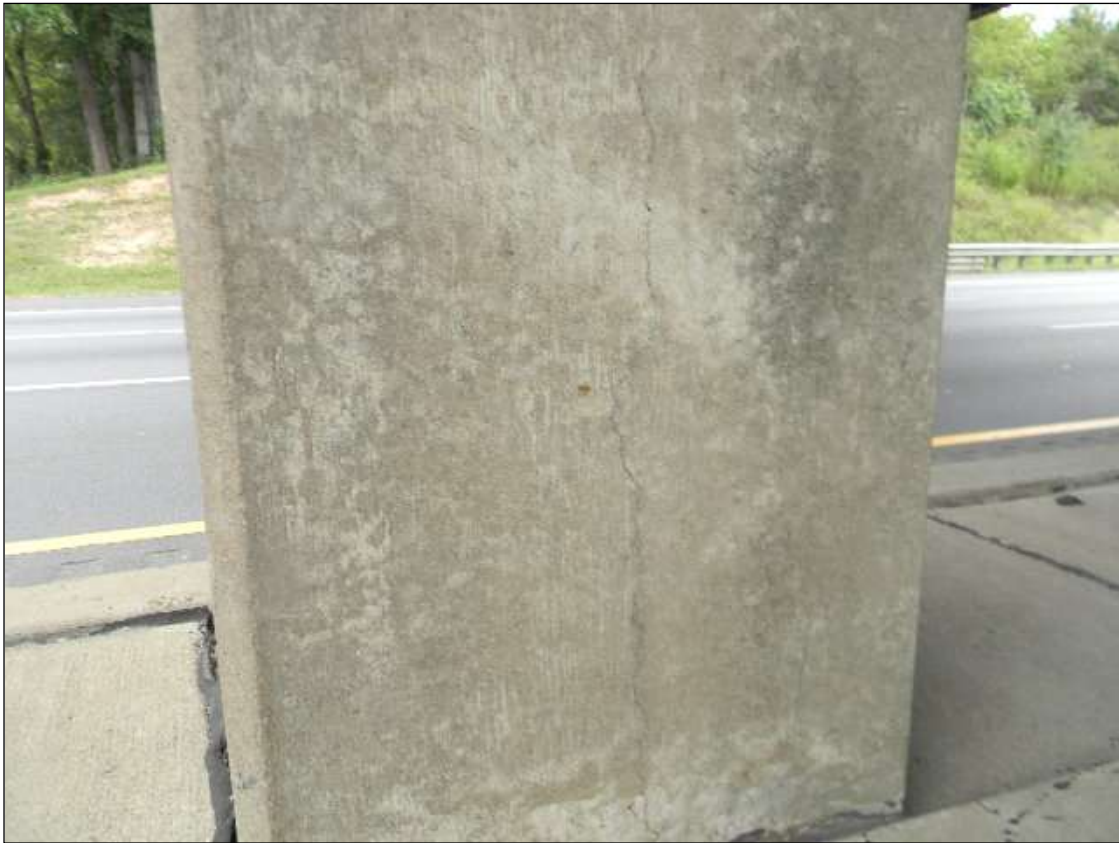
BENT 2, COLUMN 1 EAST FACE HAS A 4' LONG VERTICAL H/L CRACK IN THE CENTER. THERE ARE SEVERAL COLUMN FACES WITH THESE CRACKS.

3348	Maintain Concrete Substructure Components	LF	30	BENT 2, COLUMN 1 EAST FACE HAS A 4' LONG VERTICAL H/L CRACK IN THE CENTER. THERE ARE SEVERAL COLUMN FACES WITH THESE CRACKS.

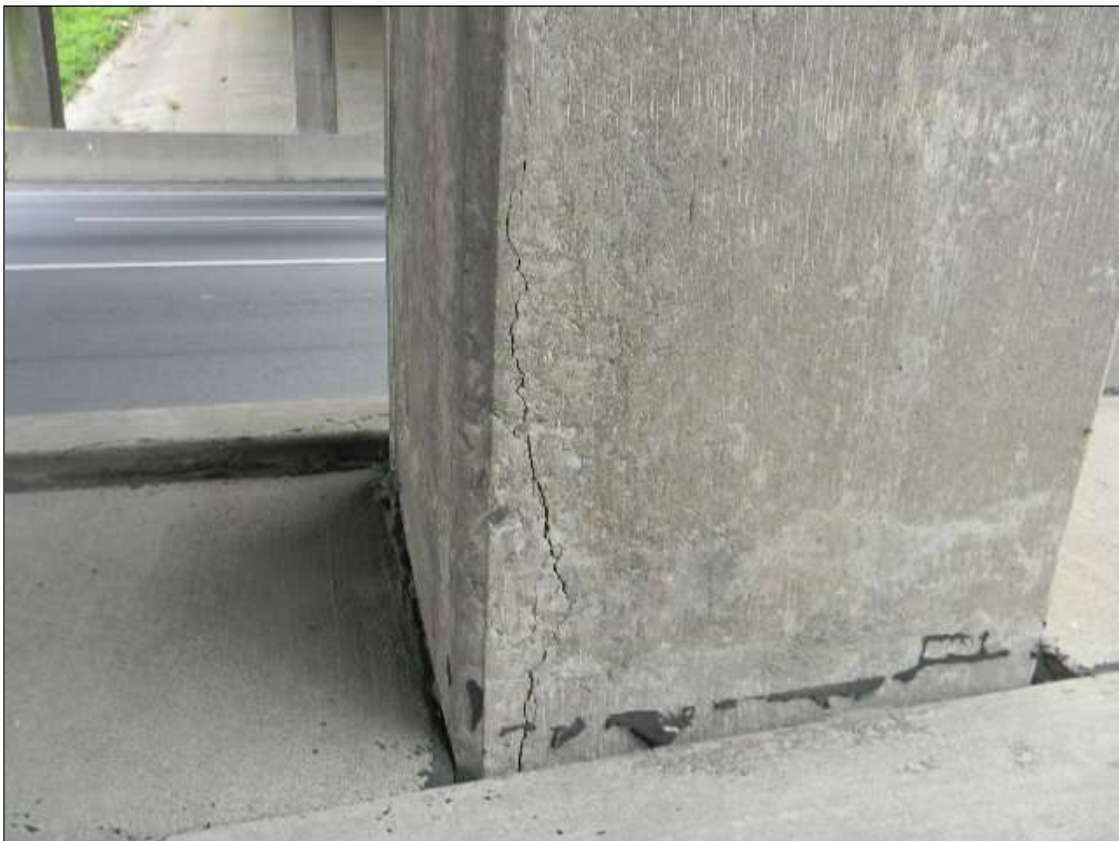
VERTICAL CRACKING WITH IMMINENT CORNER SPALLS ARE PRESENT ON COLUMNS 1 AND 3 AT BENT 2.

MMS Code	Description of Function	Unit	Quantity	Remarks	Est. Cost
2816	Asphalt Surface Repair or Replacement	SY	16	THE APPROACH ROADWAYS ARE CRACKED AND SETTLED 1/2" ALONG THE FILLFACES.	
3310	Maintenance/Repair/Replacement of Standard Bridge Expansion Joints	LF	72	JOINT SEALS AT BENTS 1 & 3 AND ABUTMENT 2 HAVE SETTLED 1/2 INCH AND ARE ALLOWING SAND ACCUMULATION IN THE JOINTS.	
3326	Maintain Concrete Deck	SF	2	SPAN 4 ROADWAY SURFACE HAS A 6 INCH LONG BY 6 INCH WIDE BY 1/2 INCH DEEP SPALL WITH EXPOSED REINFORCEMENT IN THE WESTBOUND LANE. SPAN 1 HAS A SIMILAR SPALL IN THE EASTBOUND LANE.	
3326	Maintain Concrete Deck	SF	24	SPAN 1 DECK ROADWAY SURFACE HAS A 2 FT LONG X 12 FT WIDE AREA PATCHED ALONG BENT 1 JOINT WITH BREAKING UP OF THE PATCH IN THE EASTBOUND LANE.	
3348	Maintain Concrete Substructure Components	LF	1	EAST FACE OF BENT 3 CAP HAS A 1' DIAMETER SPALL UNDER BAY 1.	
3348	Maintain Concrete Substructure Components	LF	10	VERTICAL CRACKING WITH IMMINENT CORNER SPALLS ARE PRESENT ON COLUMNS 1 AND 3 AT BENT 2.

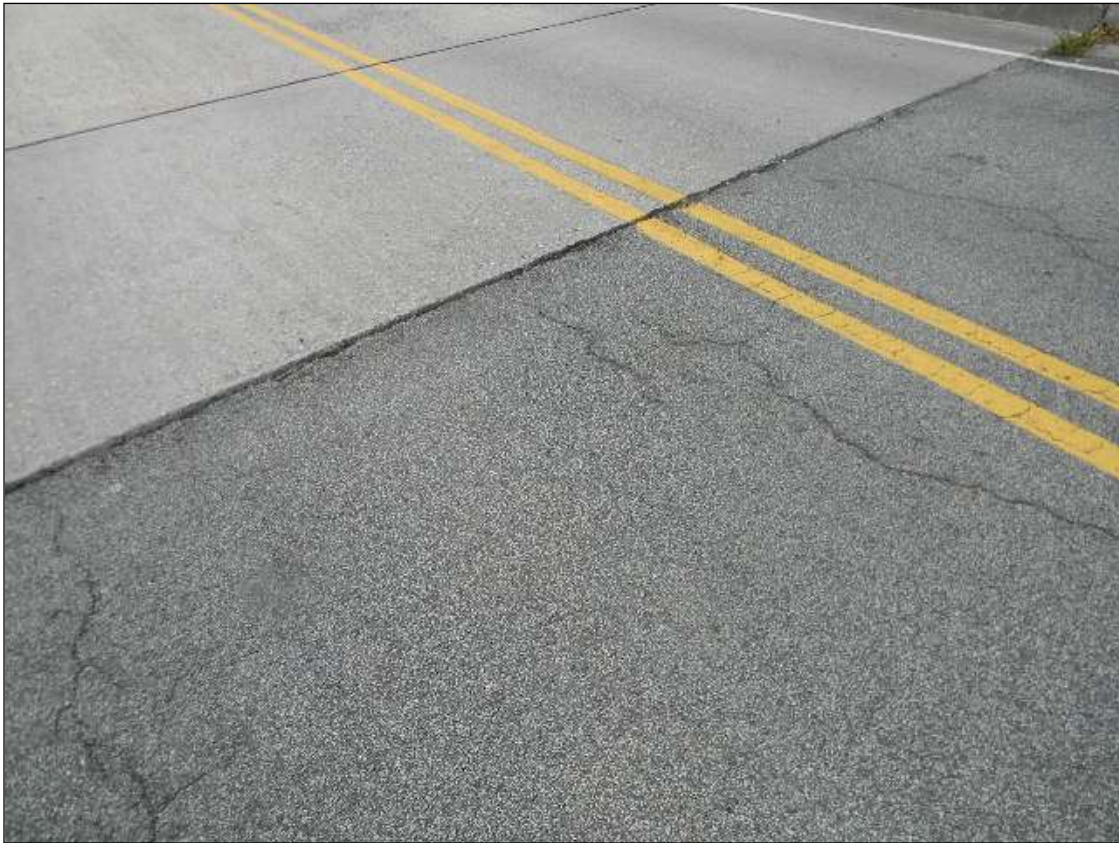
THE APPROACH ROADWAYS ARE CRACKED AND SETTLED 1/2" ALONG THE FILLFACES.

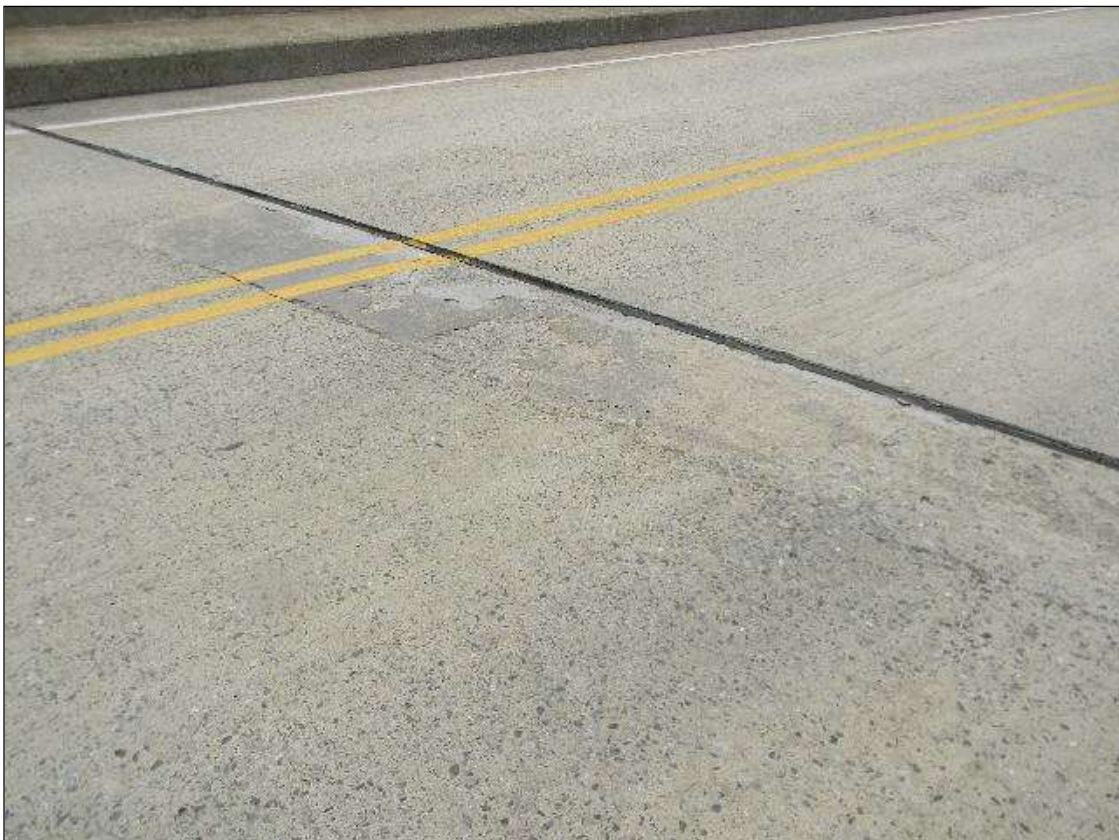
SPAN 1 DECK ROADWAY SURFACE HAS A 2 FT LONG X 12 FT WIDE AREA PATCHED ALONG BENT 1 JOINT WITH BREAKING UP OF THE PATCH IN THE EASTBOUND LANE.

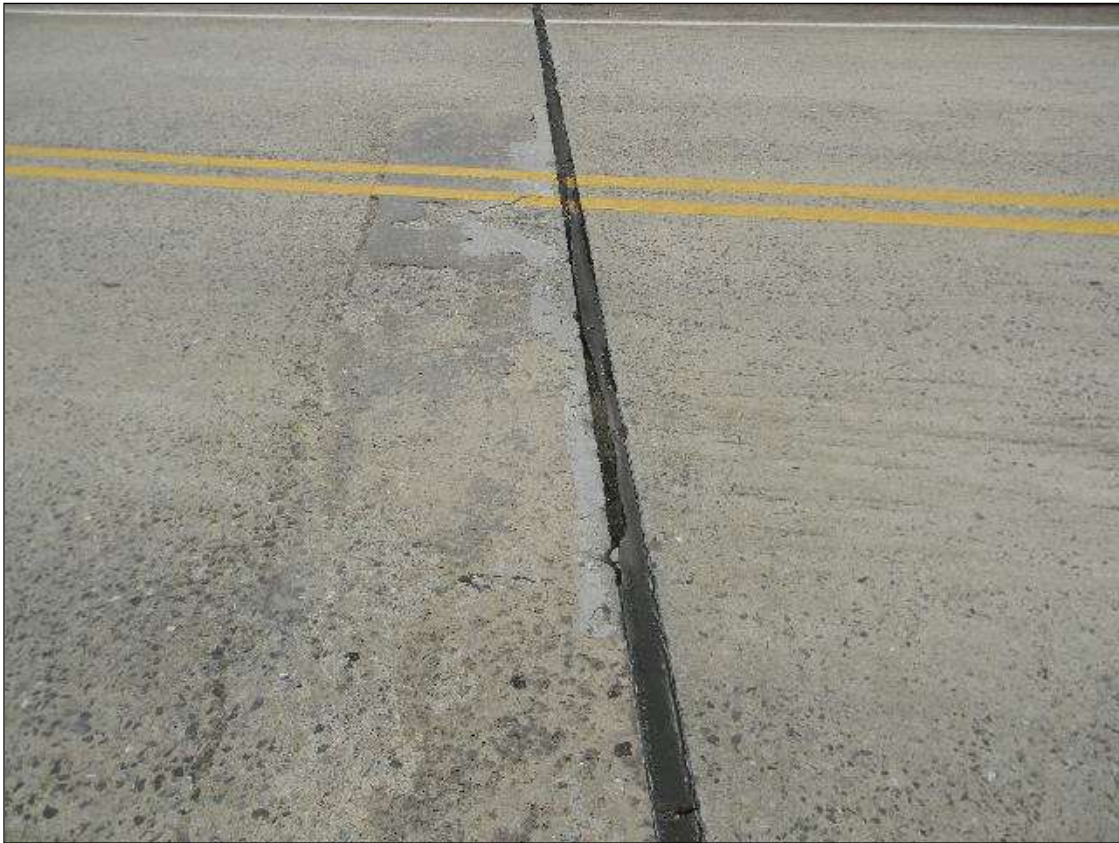
JOINT SEALS AT BENTS 1 & 3 AND ABUTMENT 2 HAVE SETTLED 1/2 INCH AND ARE ALLOWING SAND ACCUMULATION IN THE JOINTS.

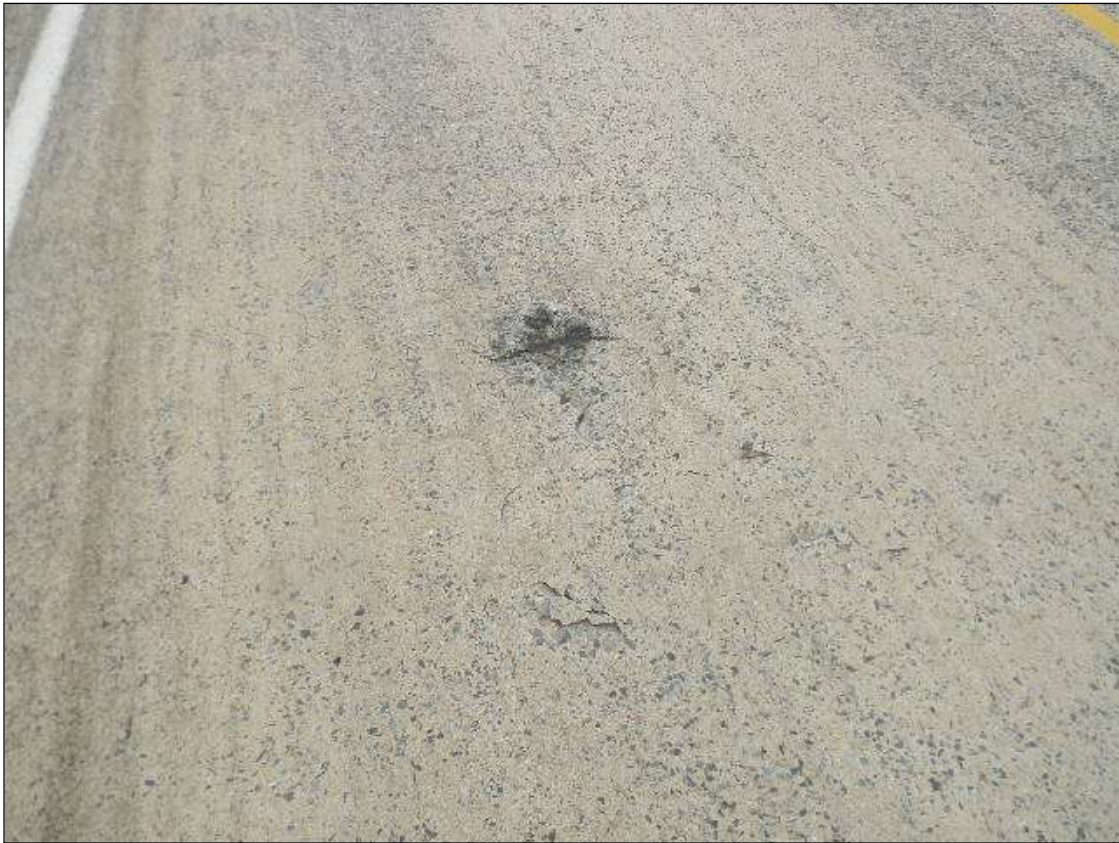
SPAN 4 ROADWAY SURFACE HAS A 6 INCH LONG BY 6 INCH WIDE BY 1/2 INCH DEEP SPALL WITH EXPOSED REINFORCEMENT IN THE WESTBOUND LANE. SPAN 1 HAS A SIMILAR

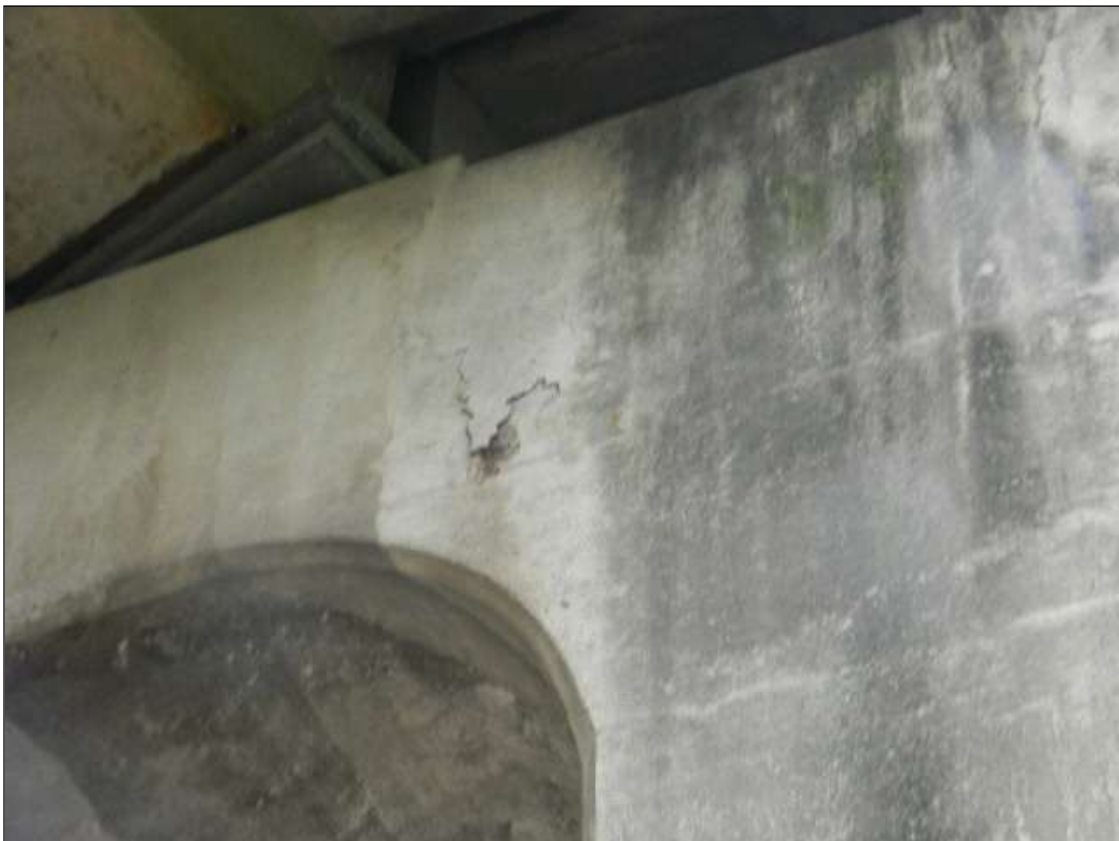
EAST FACE OF BENT 3 CAP HAS A 1' DIAMETER SPALL UNDER BAY 1.

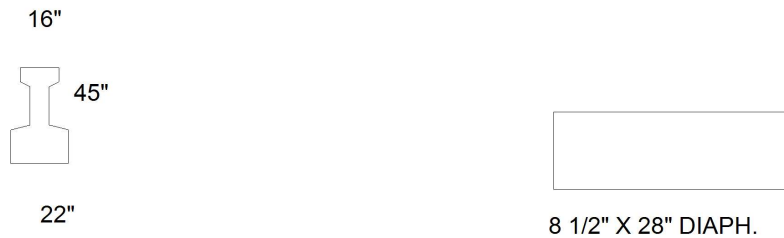
TYPICAL SECTION

Deck Width/Out to Out	40.58ft	Wearing Surface	
Between Rails	38.33ft	Median Width	
Curb Height	.96ft	Median Height	
Top Rail to Deck/Wearing Surface	4.13ft	Left Guardrail Width	1.10ft
Clear Roadway	28.00ft	Right Guardrail Width	1.10ft
Left Bridge Rail	Type 13	Right Bridge Rail	Type 13

Measurements for Span #	1	SPANS 2 TO 4 SIMILAR	
Deck Thickness	.63	Left Overhang	2.67
Top of Rail to Bottom of Beam	7.76	Right Overhang	2.67

Beam No	Beam Type	Spacing	Comments
1	PPC Girder	5.88ft	
2	PPC Girder	5.88ft	
3	PPC Girder	5.88ft	
4	PPC Girder	5.88ft	
5	PPC Girder	5.88ft	
6	PPC Girder	5.88ft	
7	PPC Girder

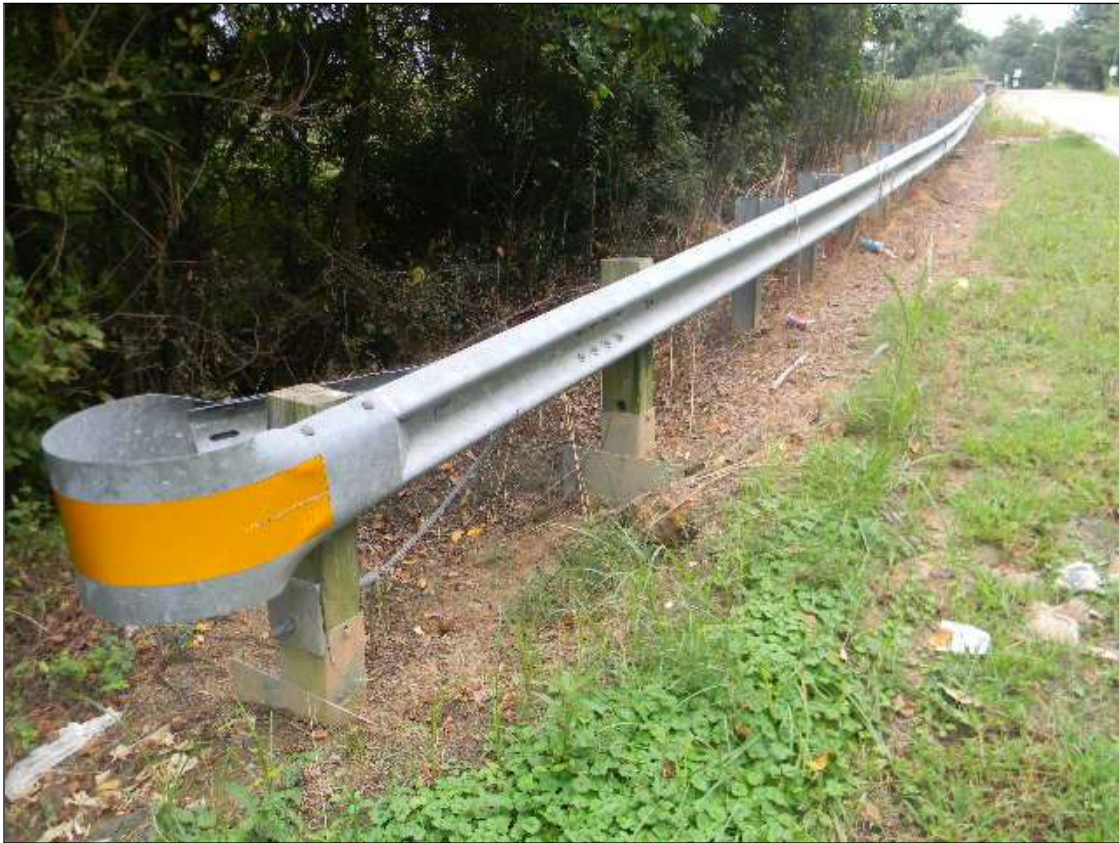
TYPICAL GUARDRAIL END AND POST SPACING. NW END SHOWN.

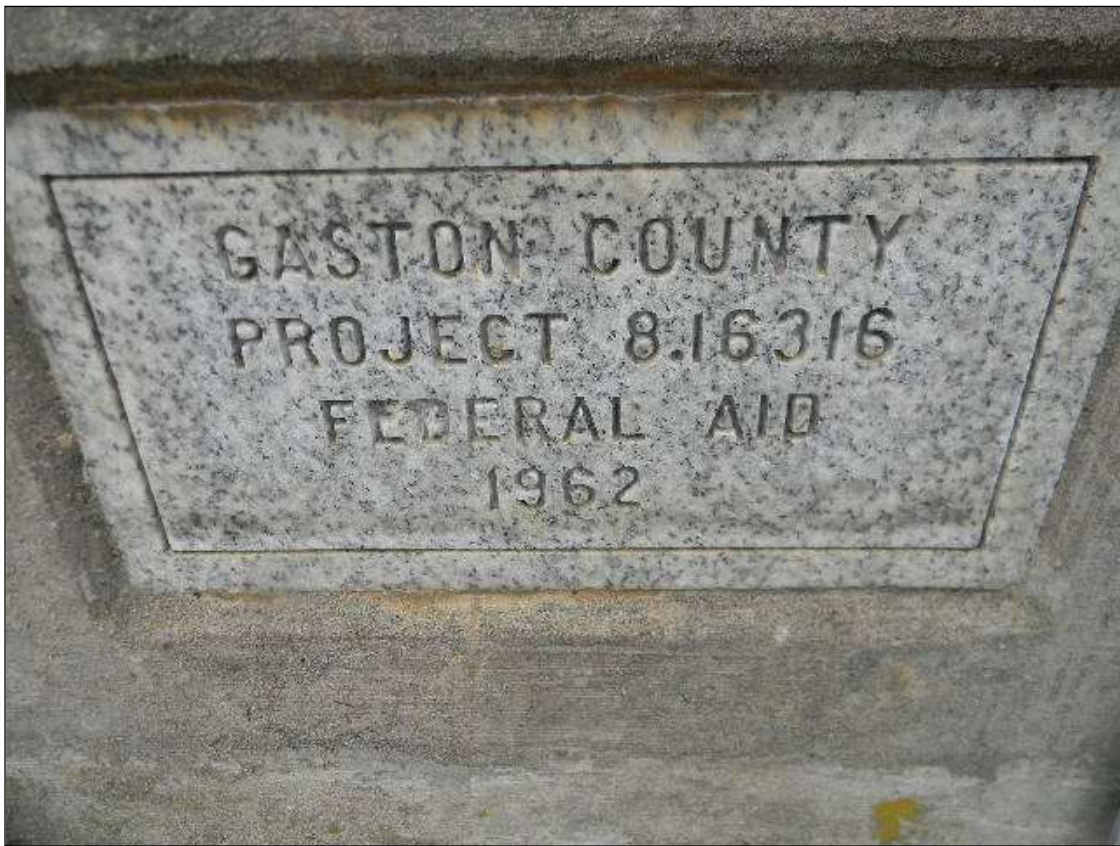
BRIDGE INFO PLATES AT THE SW AND NE CORNERS.

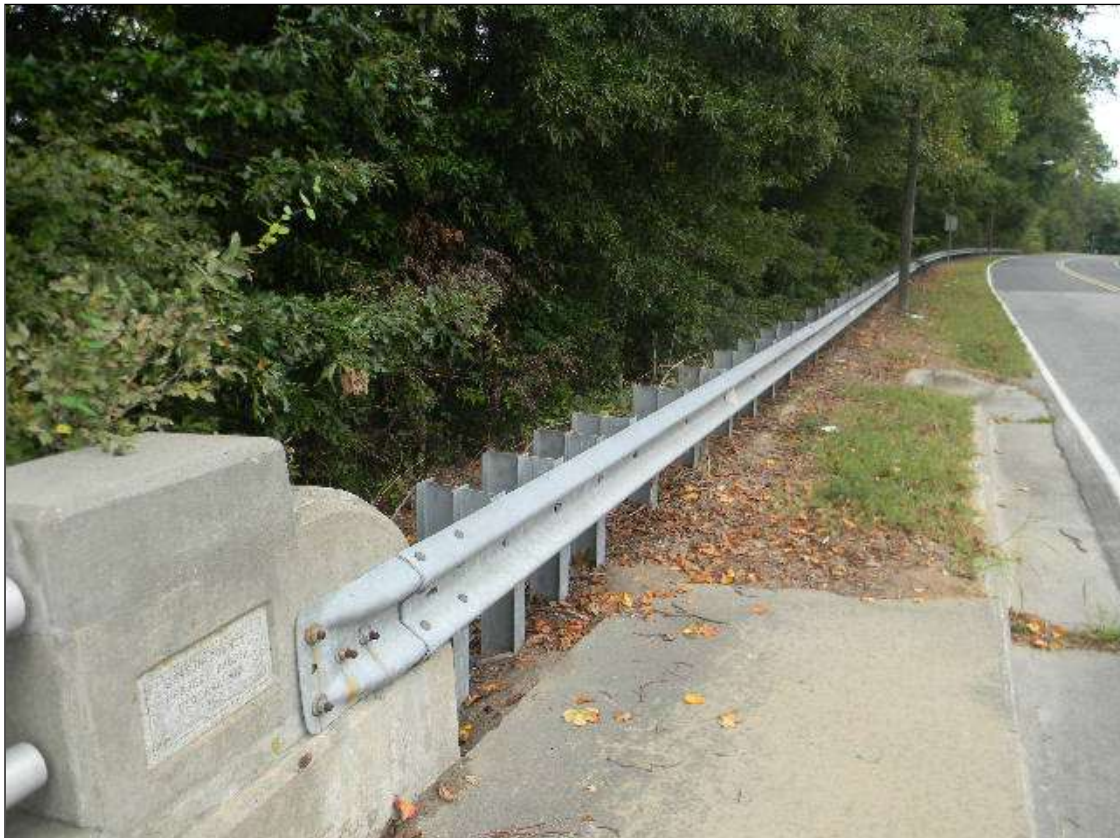
TYPICAL GUARDRAIL CONNECTION AND POST SPACING. SW CORNER SHOWN.
