# BRIDGE INSPECTION REPORT

INSPECTION TYPE: Routine Inspection

COUNTY JOHNSTON BRIDGE NUMBER 500037 INSPECTION CYCLE 2 YRS  
 ROUTE US301&701& ACROSS CSX RR M.P. 0

SUPERSTRUCTURE REINF. CONC. FLOOR ON I-BEAMS

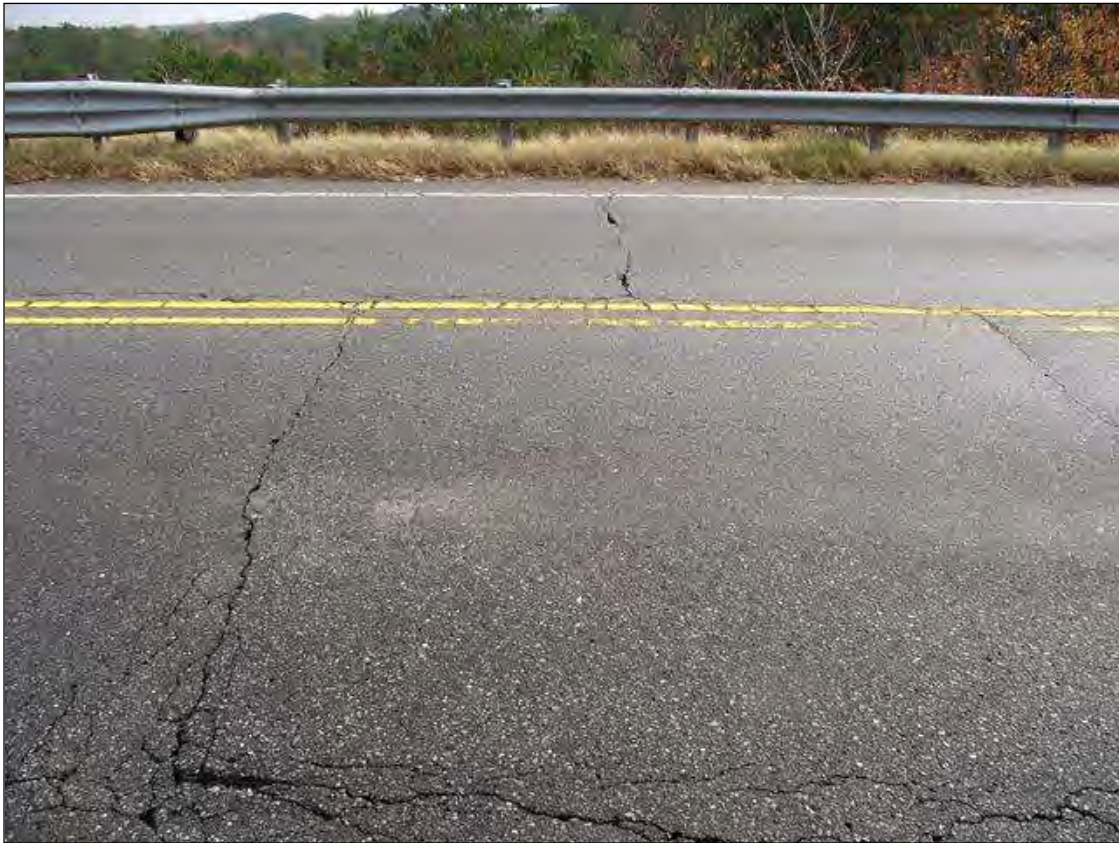
LONGITUDINAL AND TRANSVERSE CRACKS IN APPROACH 1

MMS Code	Description of Function	Unit	Quantity	Remarks	Est. Cost
2816	Asphalt Surface Repair or Replacement	SY	140	CRACKS AND SETTLEMENT IN BOTH APPROACHES.	
3306	Maintain Concrete Superstructure Components	SF	80	DIAPHRAGMS CRACKED AND SPALLED WITH REBAR EXPOSED.

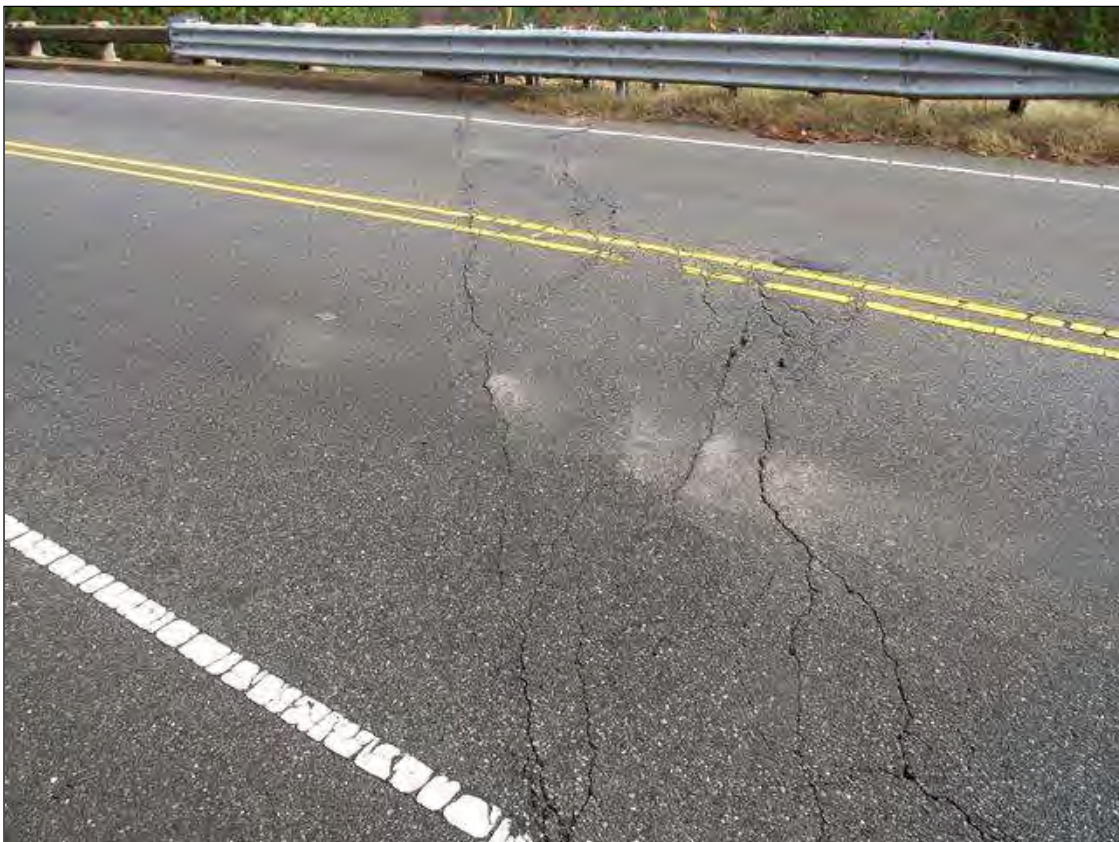
TRANSVERSE CRACK IN WEARING SURFACE OVER END BENT 1

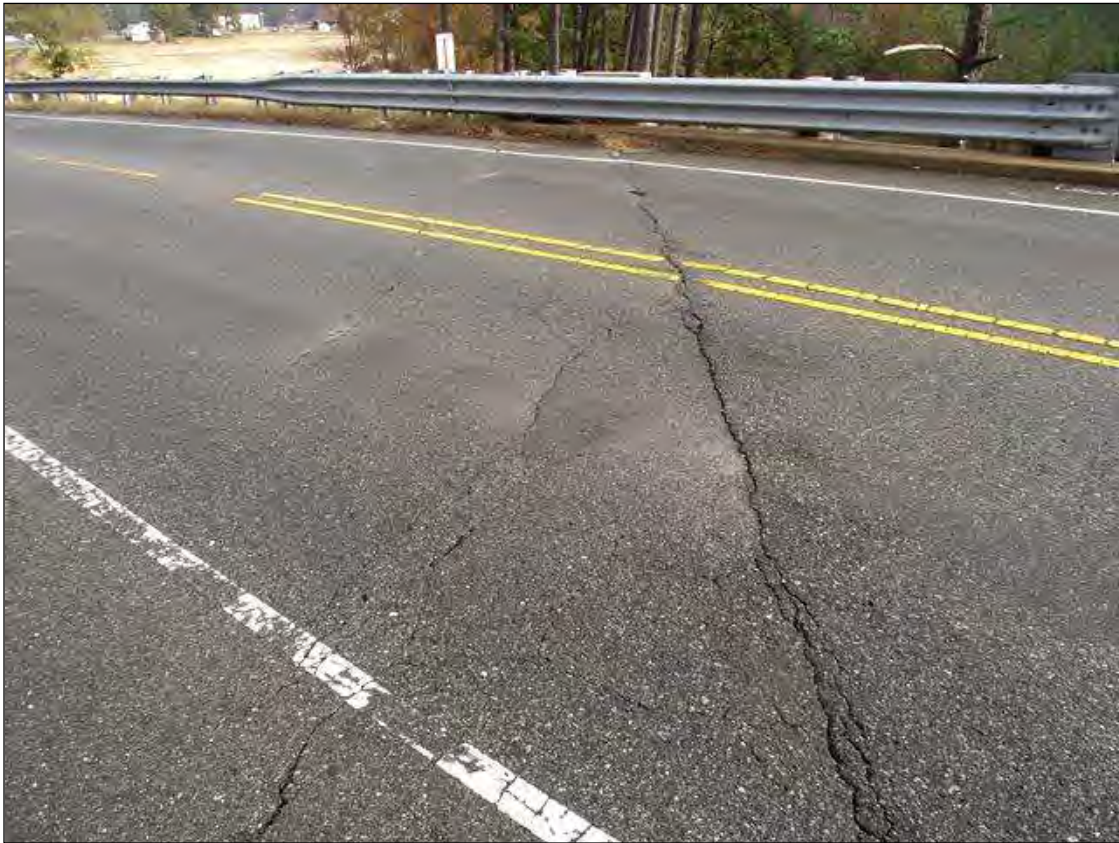
WEARING SURFACE CRACKED OVER END BENT 2 AND APPROACH 2

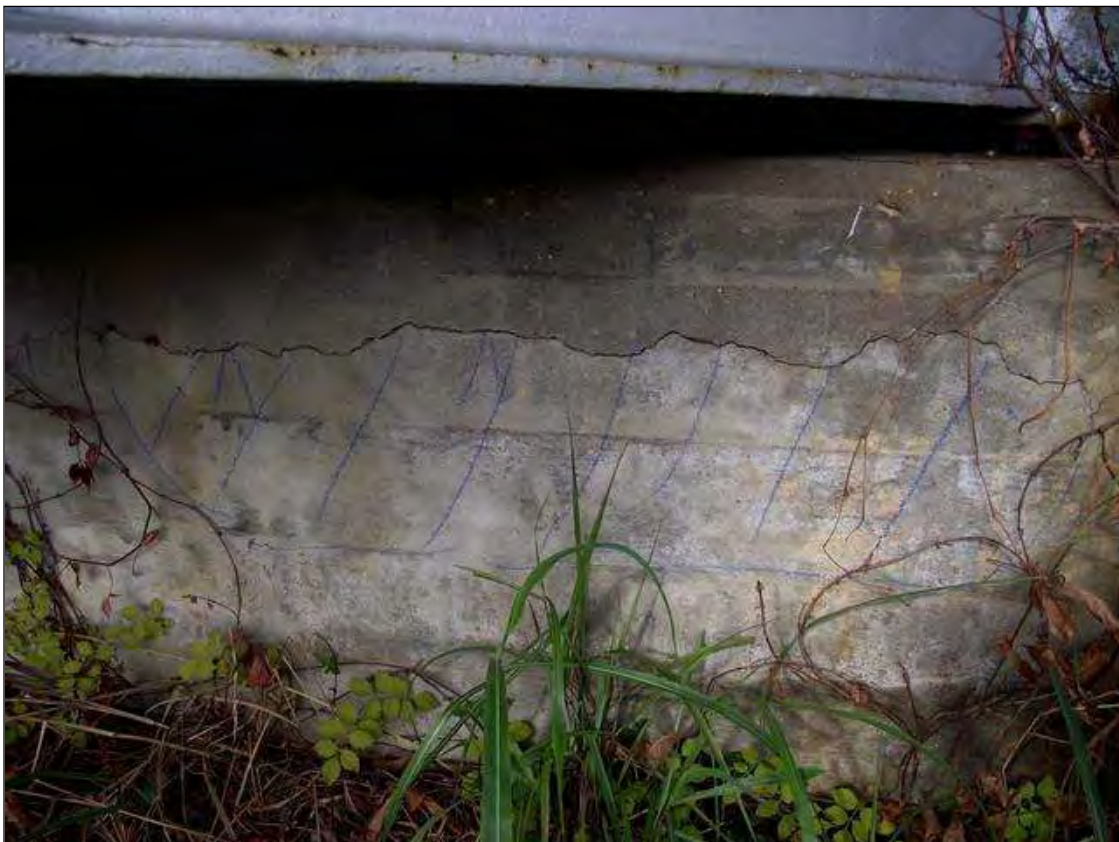
Item No.	Grade		
36a	F	<p>CONCRETE ABUTS, BENTS, CAPS: RANDOM HAIRLINE TRANSVERSE CRACKS ON TOP AND FACE OF END BENT CAPS. END BENT 1 SPALL 6" DIAMETER. X 1" DEEP WITH REBAR EXPOSED ON FACE OF CAP UNDER BAY 4, SIMILAR AT GROUND LINE AT BEAM 2. VERTICAL CRACK AND DELAMINATION 6 INCHES X 18 INCHES ON FACE UNDER BAY 4. BENT 1 LEFT END OF CAP CRACKED SPAN 1 SIDE . 1/16 IN. X 4 FT. LONG LONGITUDINAL CRACK IN BAY 3 SPAN 1 SIDE AT BOTTOM CORNER. 1/32" HORIZONTAL CRACK AND DELAMINATED PATCH ON SPAN 2 SIDE OF CAP AT BEAM 1. 1/32" LONGITUDINAL CRACKS 3' LONG UNDER BEAM 3 AND ON SPAN 1 SIDE OF LEFT SIDE FILLET. 7 INCH X 8 INCH DELAMINATED PATCH ON SPAN 2 SIDE OF CAP AT BEAM 4. BENT 2 1/16" CRACK X 4' LONG HORIZONTAL CRACK ON FACE OF CAP ON SPAN 3 SIDE UNDER BEAM 2 AND 1/16 INCH CRACKS ON BOTTOM CORNER OF CAP AT MIDPOINT, SPAN 2 SIDE. CAP HAS TRANSVERSE CRACK ON BOTTOM AT PEAK OF FILLET AND UP SIDES, BENT 3 SIMILAR. 6 IN. DIAMETER X 1/2 IN. DEEP SPALL WITH REBAR EXPOSED ON SPAN 3 SIDE UNDER BEAM 1. END BENT 2 CAP 1/16 INCH HORIZONTAL CRACK 5 FT LONG AND HAIRLINE MAP CRACKS AT BEAM NO. 5.</p>

AREA OF DELAMINATION IN FACE OF CAP AT END BENT 2 UNDER BEAM 5

3334	Bridge Bearings	EA	<i>X TSE</i>	BEAM 5 SPAN 4 AT BENT 3 LEFT SIDE ANCHOR BOLT HAS SECTION LOSS WITH 1/4 IN. DIAMETER REMAINING.	
3342	Clean and Paint Structural Steel	SF	2400	ENDS OF BEAMS AND BEARINGS ARE RUSTY WITH SECTION LOSS IN SOME BEAMS OVER INTERIOR BENTS.	
3348	Maintain Concrete Substructure Components	LF	100	CRACKS , DELAMINATIONS, AND SPALLS IN CAPS AND COLUMNS.	
3352	Maint Slope Protection	SF	600	EROSION UNDER SPAN 1.

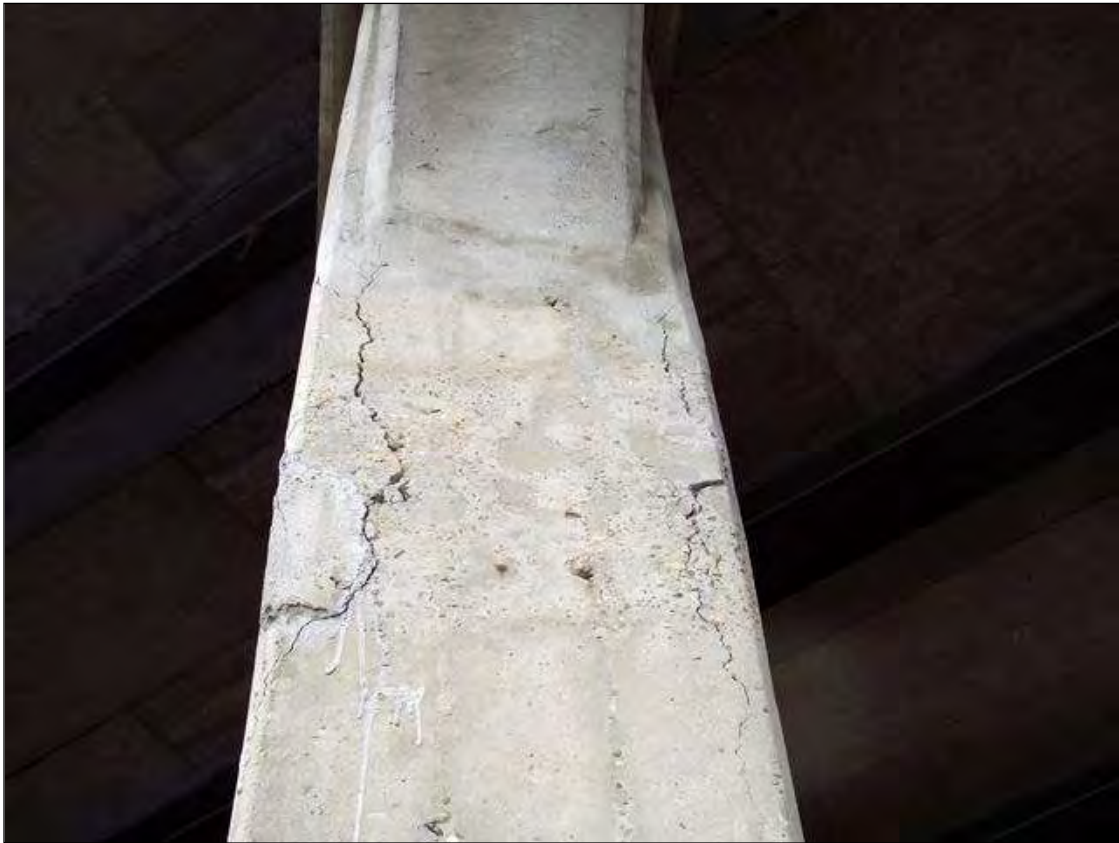
<p>36b</p> <p>F</p> <p>CONCRETE COLUMNS BENT 1 COLUMN 1 1/16 INCH VERTICAL CRACKS ON LEFT CORNER WITH 8 IN WIDE X 4 FT. LONG DELAMINATION IN SPAN 2 SIDE. COLUMN 2 CRACKED AND DELAMINATED ON THE LEFT CORNER, SPAN 1 SIDE AND DELAMINATED ON THE SPAN 2 SIDE. RIGHT CORNER HAS 1/8 IN. WIDE VERTICAL CRACK AT SPAN 2 SIDE WITH DELAMINATION.  BENT 2 1/2" WIDE VERTICAL CRACK IN PEDESTAL WALL BETWEEN COLUMNS.  BENT 3 COLUMN 1 SPALLED 12 IN. X 12 IN. X 1 1/2 IN. DEEP WITH REBAR EXPOSED AT TOP OF SPAN 3 SIDE. HAIRLINE VERTICAL CRACK ON LEFT SIDE SIDE OF COLUMN 1. COLUMN 2 AT BENT 3 CRACKED WITH DELAMINATION ON THE RIGHT SIDE, 2 CRACKS 1/2" WIDE X 4' LONG WITH DELAMINATION. SPAN 4 SIDE CRACKED AND DELAMINATED 8 IN. WIDE X 4 FT. LONG. 1/2" WIDE VERTICAL CRACK IN PEDESTAL WALL BETWEEN COLUMNS.  BENT 4...COLUMN 1 HAS VERTICAL HAIRLINE CRACKS ON SPAN 5 SIDE. 1/2" VERTICAL CRACK 5' LONG WITH DELAMINATION IN LEFT CORNER OF COLUMN 2, SPAN 5 SIDE, AND 3/16 IN. VERTICAL CRACK IN RIGHT CORNER OF SPAN 5 SIDE .</p>

CRACKING AND DELAMINATION IN THE RIGHT SIDE OF COLUMN 2 AT BENT 3 AND SPAN 4 SIDE

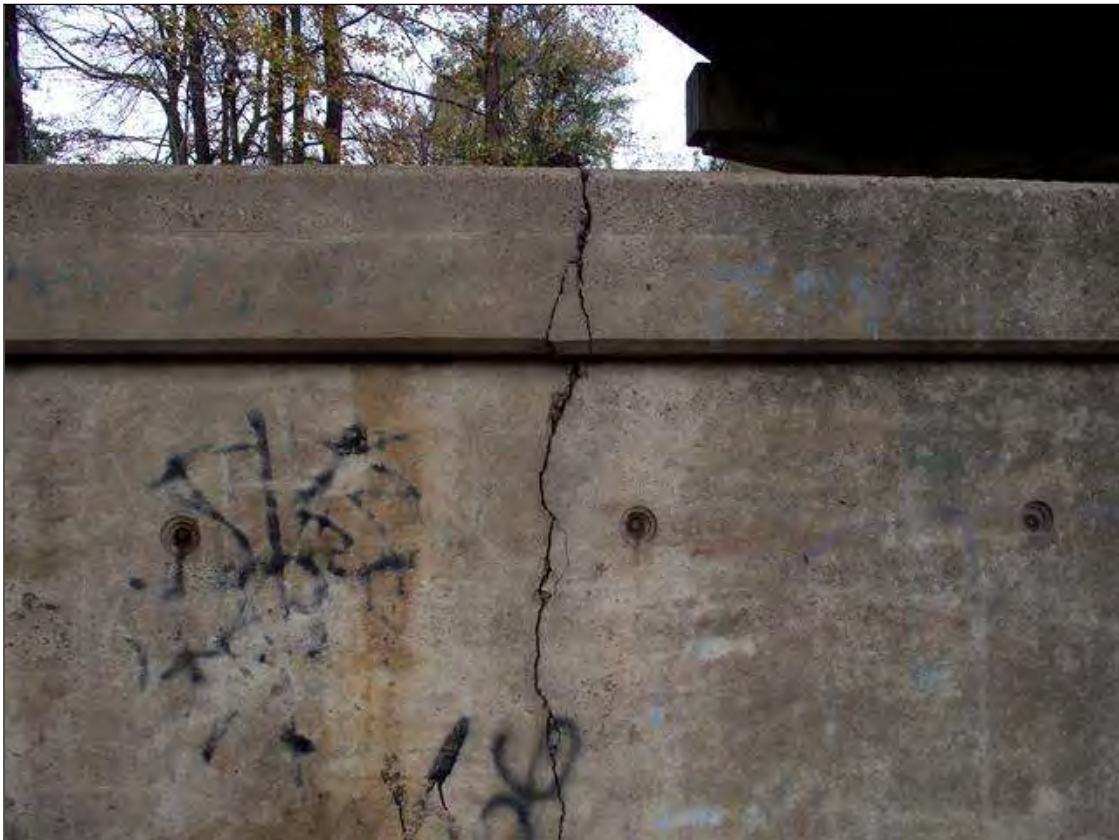
VERTICAL CRACK IN BENT 2 PEDESTAL SPAN 2 SIDE - EXTENDS OVER TOP AND DOWN SPAN 3 SIDE

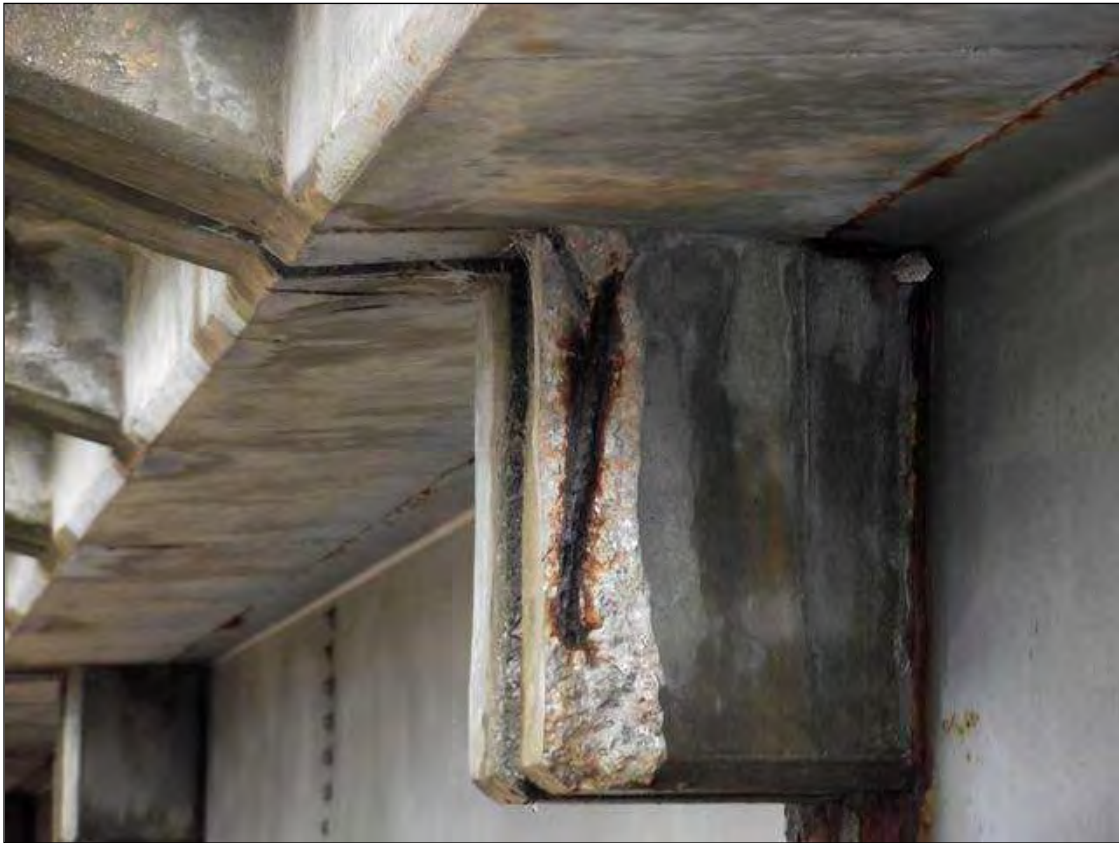
Item No.	Grade		
10A	NO	NO CURVED GIRDERS.	
13	F	END DIAPHRAGMS SPAN 1 LEFT SIDE EXTERIOR DIAPHRAGM AT BENT 1 SPALLED WITH REBAR EXPOSED. DIAPHRAGM CRACKED WITH DELAMINATION AT BOTTOM EDGE IN BAY 1 AND SPALLED IN BAY 2 AT BENT 1. SPAN 2 DIAPHRAGM CRACKED WITH DELAMINATION AT BOTTOM EDGE IN BAY 2 AND 4 AT BENT 1. SPAN 3 DIAPHRAGM CRACKED WITH DELAMINATION AT BOTTOM EDGE IN BAY 4 IN AT BENT 2. SPAN 4 DIAPHRAGM CRACKED WITH DELAMINATION AT BOTTOM EDGE IN BAY 2 AND 4 AT BENT 4. SPAN 5 BAY 1 SPAN 5 DIAPHRAGM AT BENT 4 SPALLED 12 IN. DIAMETER .	
15	P	BEARING ASSEMBLIES BEARING ASSEMBLIES HEAVILY RUSTED AT INTERIOR BENTS. BENT 3 SPAN 4 BEAM 4 AT BENT 3 RIGHT SIDE ANCHOR BOLT HAS SECTION LOSS WITH 1/4 IN. DIAMETER REMAINING. PRIORITY MAINTENANCE ISSUED SPAN 4 BEAM 5 AT BENT 3 LEFT SIDE ANCHOR BOLT HAS SECTION LOSS WITH 1/4 IN. DIAMETER REMAINING. PRIORITY MAINTENANCE ISSUED	
16	P	DRAINAGE SYSTEM ALL OF THE DECK DRAINS ARE CLOGGED.

LEFT EXTERIOR END DIAPHRAGM IN SPAN 1 AT BENT 1 SPALLED WITH SECTION LOSS TO EXPOSED REBAR

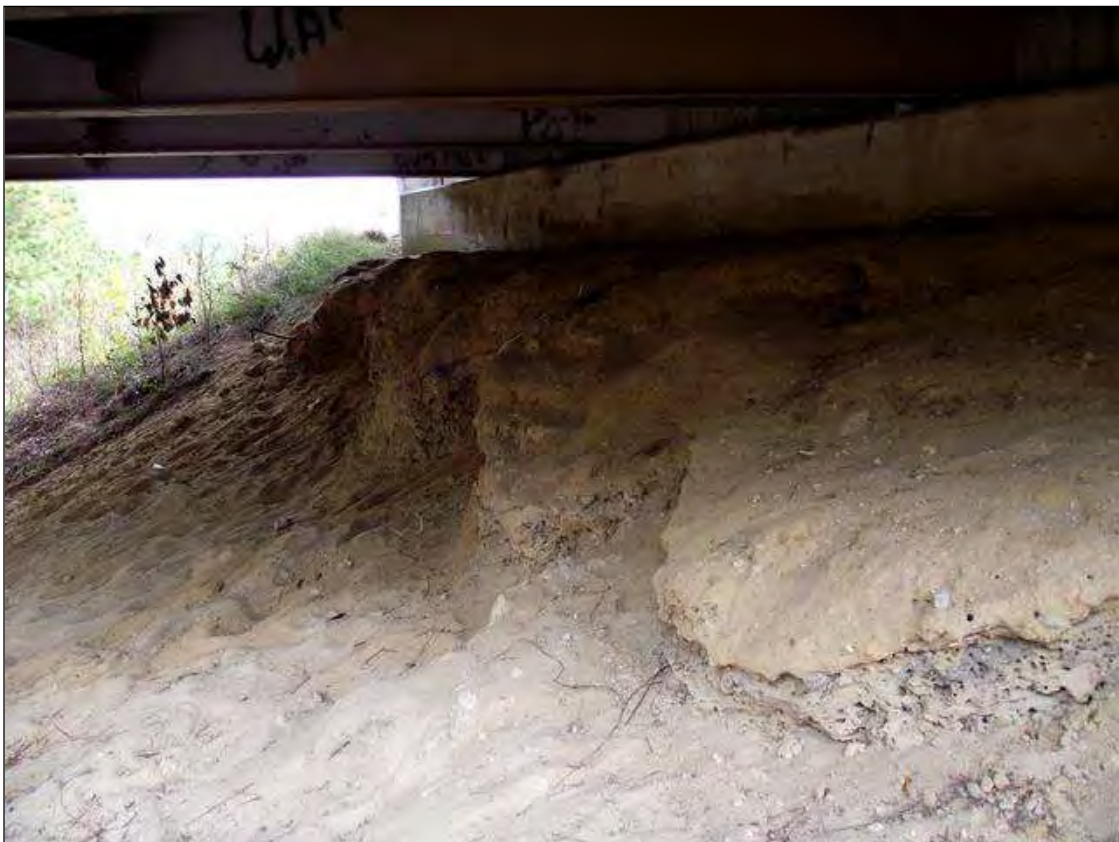
EROSION AT TOP OF SLOPE UNDER SPAN 1

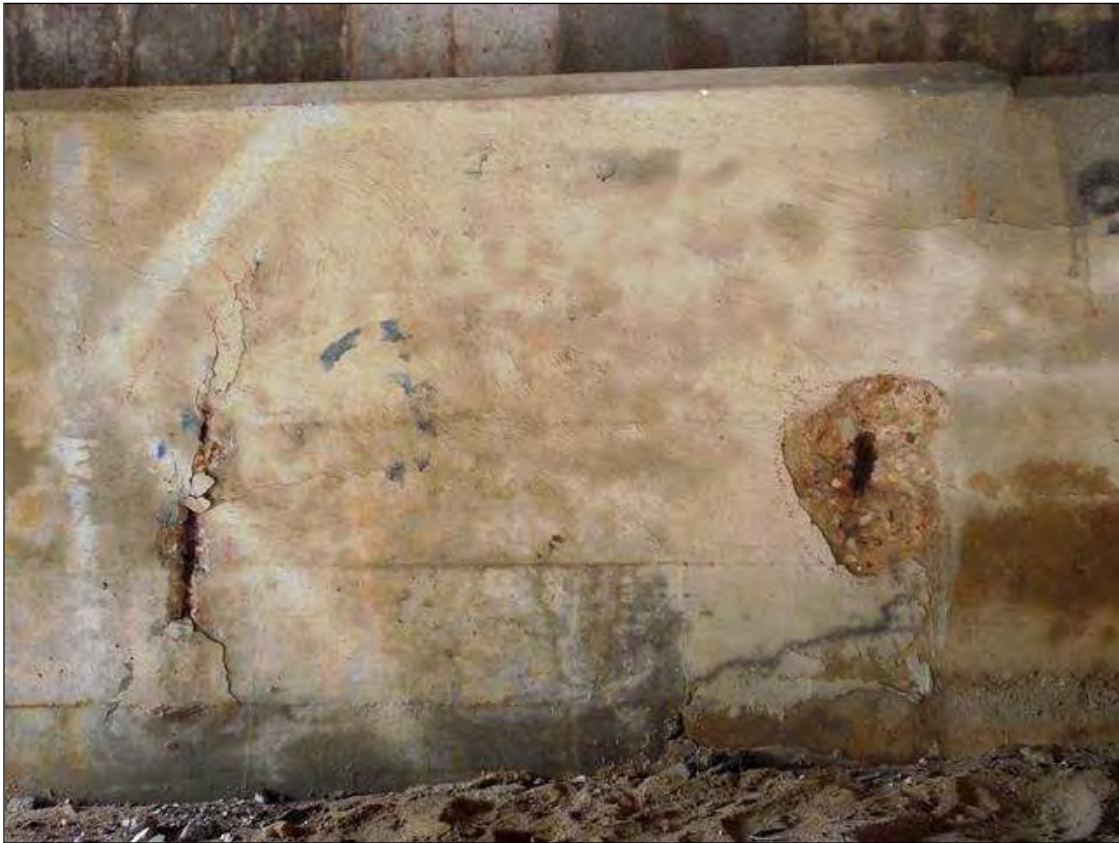
SPALLING WITH EXPOSED REBAR IN FACE OF CAP AT END BENT 1 BAY 4

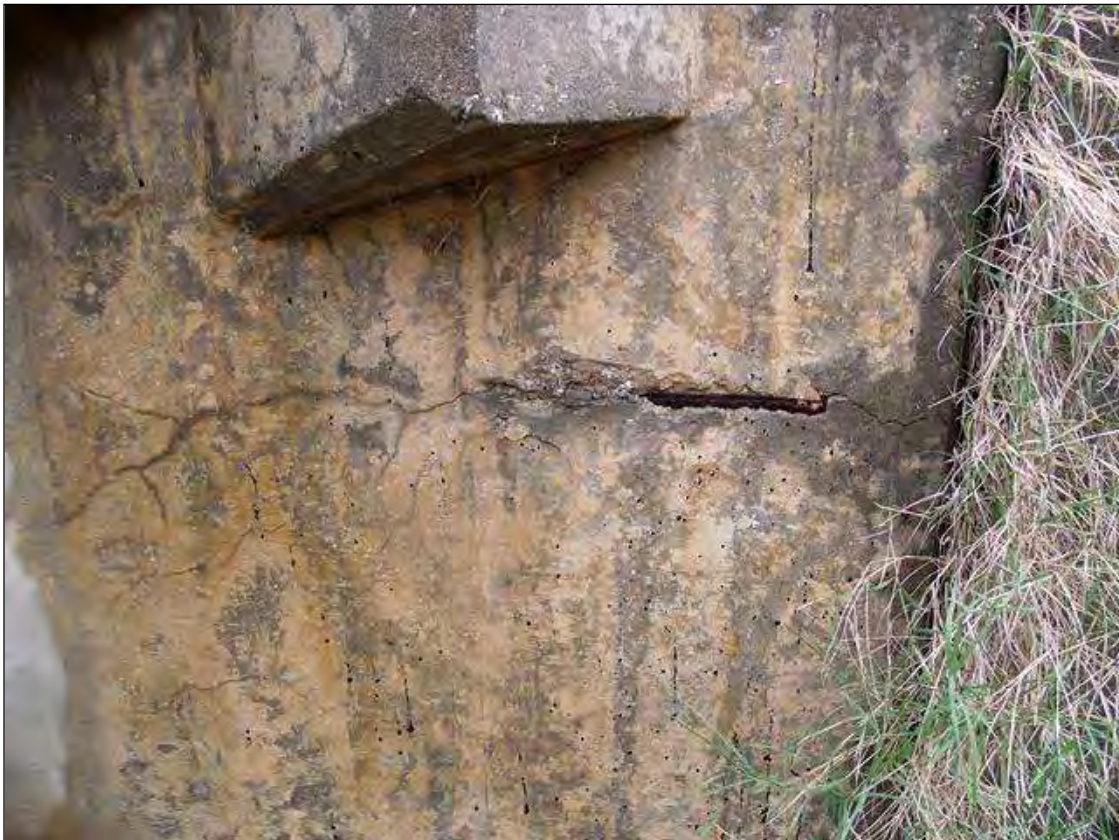
Bridge I&A Form 1(82)H		<b>FIELD INSPECTION REPORT</b> <u>Bridge Inspection &amp; Analysis</u>	
State of North Carolina Dept. of Transportation Division of Highways			
Team Leader <b>WILLIS C MAY</b>			
Assisted By <b>WTW</b>			
Item No.	Grade		
<b>36d</b>	<b>F</b>	<p>CONCRETE RETAINING WALLS  END BENT 1  LEFT SIDE BACKWALL EXTENSION HAS 1/32 INCH HORIZONTAL CRACK WITH REBAR EXPOSED 7 INCHES AND HAIRLINE MAP CRACKING.  BACKWALL CRACKED WITH DELAMINATION AT BEAM 1.  END BENT 2  BACKWALL CRACKED WITH DELAMINATION AT BEAM 1.</p>	
<b>39</b>	<b>F</b>	<p>SLOPE PROTECTION:  UNPROTECTED SLOPE.  3' DEEP EROSION AT END BENT 1.</p>	
<b>50</b>	<b>F</b>	<p>APPROACH ROADWAY:  APPROACH 1  TRANSVERSE AND LONGITUDINAL CRACKS IN APPROACH ASPHALT WITH 1" SETTLEMENT AT END BENT 1.  APPROACH 2  TRANSVERSE CRACKS IN ASPHALT AND 1" SETTLEMENT AT END BENT 2.</p>

SPALLING WITH EXPOSED REBAR IN THE LEFT EXTERIOR BACKWALL AT END BENT 1

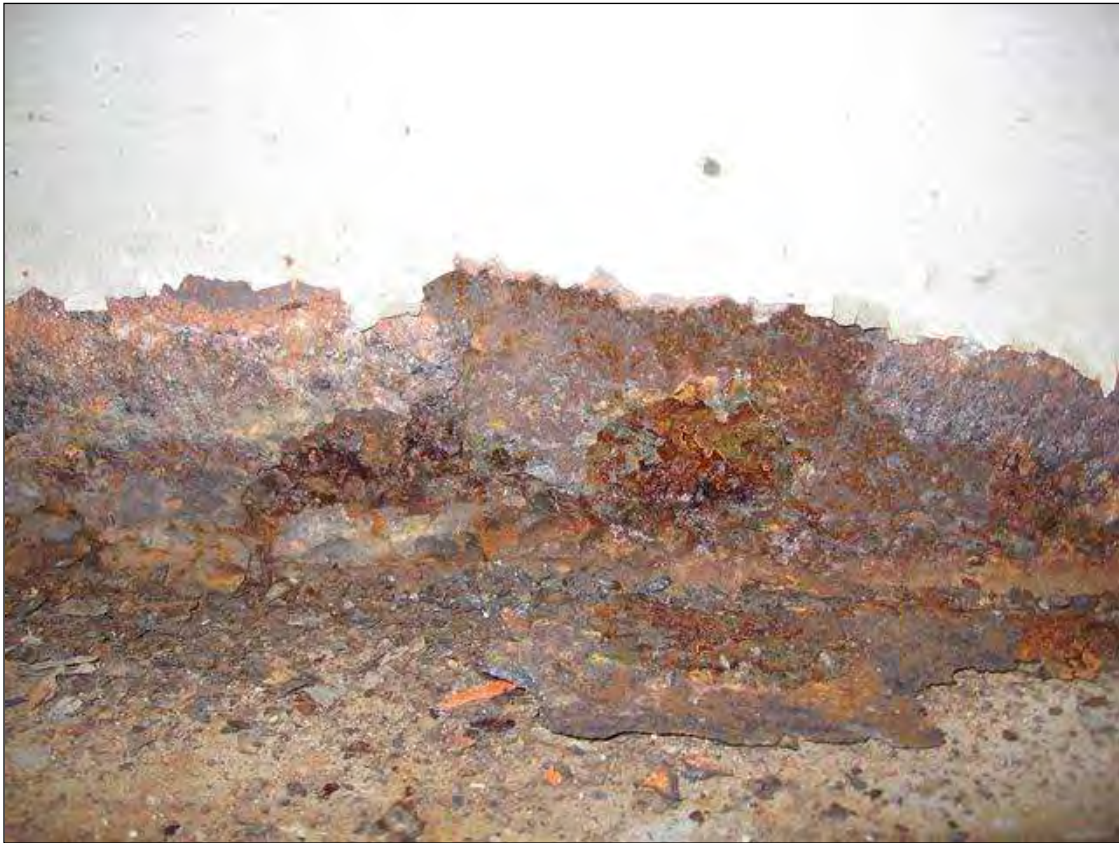
Item No.	Grade		
10	F	<p>LONGITUDINAL BEAMS:            BEAM, WEBS AND FLANGES RUSTY AND SCALED AT BENTS.            FROM 1/16 TO 1/8 IN. SECTION LOSS 1 IN. WIDE IN WEBS AROUND DIAPHRAGMS.            EXTERIOR BEAM BOTTOM FLANGE RUST SCALED AT END BENTS.</p> <p>SPAN 1 AT BENT 1            BEAM 1 SPAN 1 AT BENT 1 HAS SECTION LOSS WITH 7/16 IN. REMAINING IN WEB 3 IN. HIGH X 5 FT. LONG.            BEAM 5 SPAN 1 AT BENT 1 HAS SECTION LOSS WITH 7/16 IN. REMAINING IN WEB 3 IN. HIGH X 4 FT. LONG AND 1/2 IN. REMAINING IN BOTTOM FLANGE 5 FT. LONG.</p> <p>SPAN 2 AT BENT 1            BEAM 1 SPAN 2 BENT 1 HAS SECTION LOSS IN WEB WITH 3/8 IN. REMAINING 4 IN. X 10 IN. UNDER DIAPHRAGM. OTHER BEAMS AT BENT 1 HAVE SURFACE IN BOTTOM FLANGES OUT 2 FT.            BOTTOM FLANGES OF SPAN 2 BEAMS AT BENT 2 HAVE SECTION LOSS WITH 15/32 TO 7/16 IN. REMAINING OUT 1 TO 2 FT.</p> <p>SPAN 3 AT BENT 2            BEAM 1 SPAN 3 BENT 2 HAS SECTION LOSS WITH 1/2 IN. REMAINING IN WEB 6 IN. HIGH X 4 FT. LONG AND 9/16 IN. REMAINING IN BOTTOM FLANGE 4 FT. LONG.            BEAMS 2 THRU 4 AT BENT 2 HAVE RUST SCALE IN BOTTOM FLANGE OUT 2 FT.            BEAM 5 SPAN 3 BENT 2 HAS SECTION LOSS IN WEB WITH 1/2 IN. REMAINING 12 IN. X 12 IN. AND 6 IN. HIGH X 3 FT. LONG, BOTTOM FLANGE HAS SECTION LOSS WITH 3/4 IN. REMAINING 3 FT. LONG.</p> <p>SPAN 3 AT BENT 3            BEAM 1 SPAN 3 BENT 3 HAS SECTION LOSS WITH 7/16 IN. REMAINING IN WEB 12 IN. X 12 IN. AND 6 IN. HIGH X 6 FT. LONG, SECTION LOSS IN BOTTOM FLANGE WITH 1/2 IN. REMAINING 7 FT. LONG.            BEAM 5 SPAN 3 BENT 3 HAS SECTION LOSS WITH 7/16 IN. REMAINING IN WEB 5 IN. HIGH X 3 FT. LONG.            OTHER BEAMS AT BENT 3 HAVE RUST SCALE IN WEBS AND BOTTOM FLANGE OUT 4 FT.</p> <p>SPAN 4 AT BENT 3            BEAM 1 SPAN 4 BENT 3 HAS SECL WITH 7/16 IN. REMAINING 16 IN. X 16 IN. AND 3 IN. HIGH X 4 FT. LONG, SECTION LOSS IN BOTTOM FLANGE WITH 1/2 IN. REMAINING 6 FT. LONG.            INTERIOR BEAMS AT BENT 3 RUSY AND FLAKING FROM ENDS OUT 2' LONG.            BM5 SPAN 4 BENT 3 HAS SECTION LOSS WITH 1/4 IN. REMAINING IN BOTTOM FLANGE 2 IN. LONG. AND 9/16 IN. REMAINING 3 FT. LONG.</p> <p>SPAN 4 AT BENT 4            BEAM 1 SPAN 4 BENT 4 HAS SECTION LOSS WITH 7/16 IN. REMAINING IN WEB 4 IN. HIGH X 3 FT. LONG AND 9/16 IN. REMAINING IN BOTTOM FLANGE 4 FT. LONG.            BEAM 2 SPAN 4 BENT 4 HAS SECTION LOSS WITH 9/16 IN. REMAINING IN BOTTOM FLANGE 2 FT. LONG.</p> <p>SPAN 5 AT BENT 4            BEAM 1 SPAN 5 BENT 4 HAS SECTION LOSS WITH 3/8 IN. REMAINING IN WEB 1 1/2 IN. HIGH X 2 FT. LONG AND 1/2 IN. REMAINING IN BOTTOM FLANGE 3 FT. LONG.            BEAM 2 SPAN 5 BENT 4 HAS SECTION LOSS WITH 3/8 IN. REMAINING IN WEB 2 IN. WIDE AROUND END DIAPHRAGM AND 4 IN. DIAMETER BELOW DIAPHRAGM.            BEAM 5 SPAN 5 BENT 4 HAS SECTION LOSS WITH 3/8 IN. REMAINING IN WEB 4 IN. HIGH X 3 FT. LONG AND 1/2 IN. REMAINING IN BOTTOM FLANGE 4 FT. LONG.</p>

SECTION LOSS IN THE WEB OF BEAM 1 IN SPAN 1 OVER BENT 1

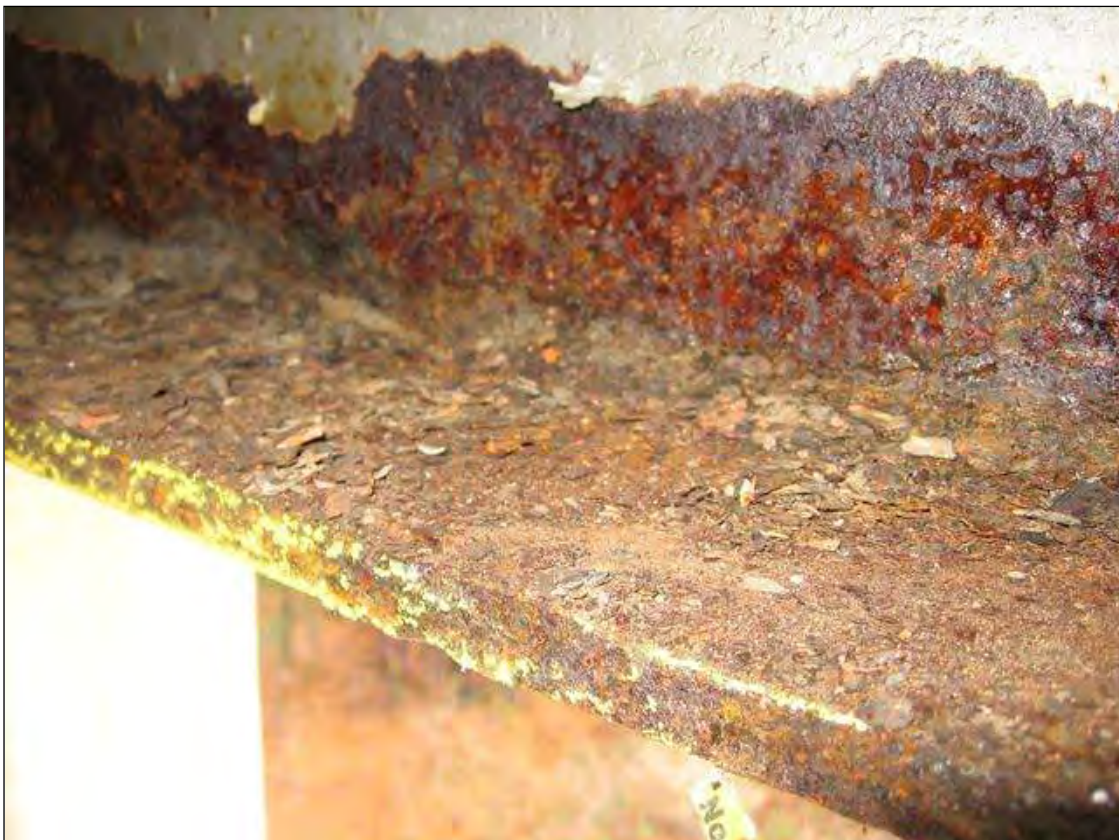
SECTION LOSS IN THE WEB AND BOTTOM FLANGE OF BEAM 5 IN SPAN 1 OVER BENT 1

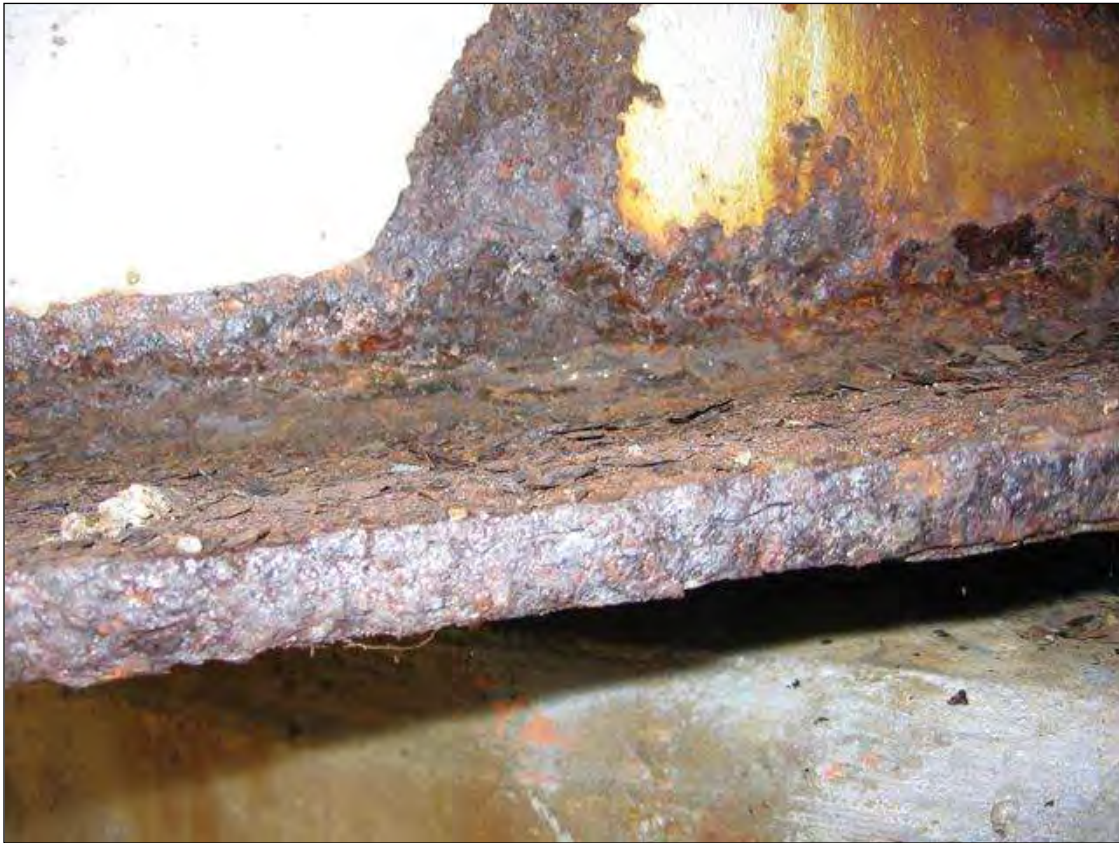
SECTION LOSS IN THE WEB AND BOTTOM FLANGE OF BEAM 5 IN SPAN 5 OVER BENT 4

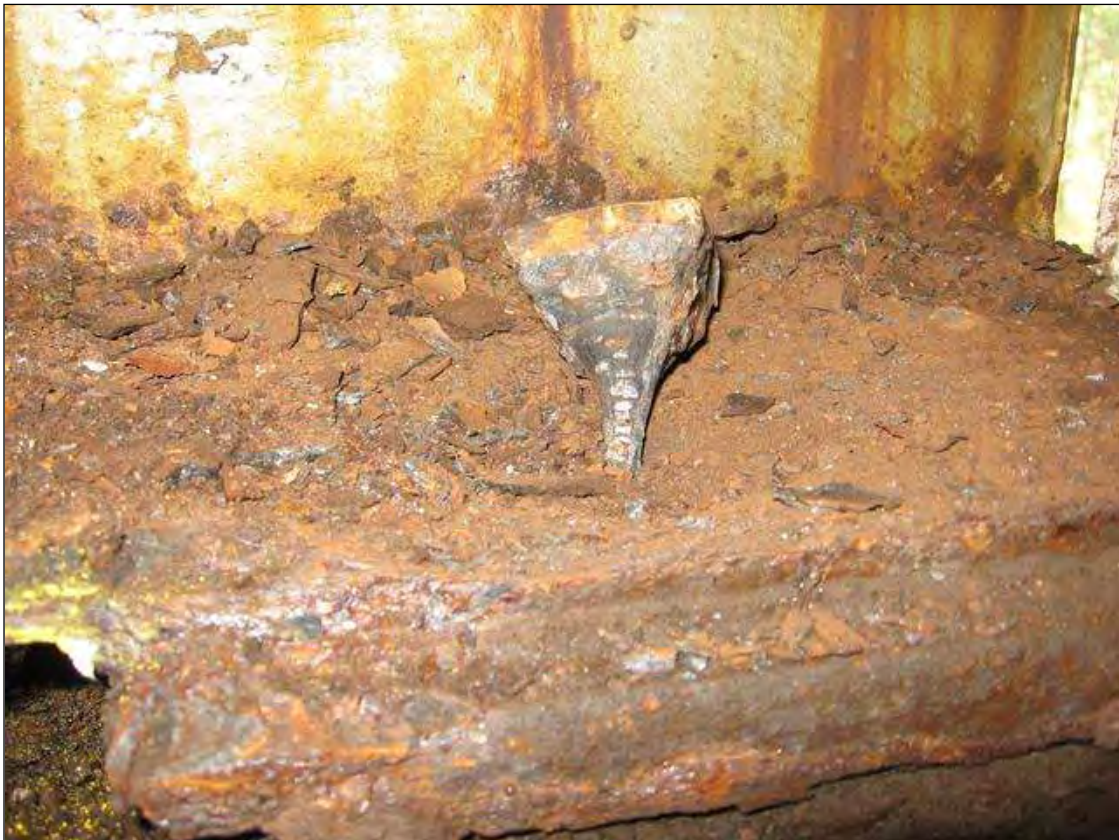
SECTION LOSS IN THE LEFTSIDE ANCHOR BOLT FOR BEAM 5 IN SPAN 4 AT BENT 3 - PRIORITY MAINTENANCE ISSUED

MMS Code	MMS Description	Quantity
3334	Bridge Bearings	1 EA
Location:		
Beams and Girders                      Bent/Span No.    4                      ANCHOR BOLT		
Priority Level		Status
Priority Maintenance		Division Bridge Maintenance Notification Received
Submitted Date:	Submitted By:	Assisted By:
11/21/2011	WILLIS C MAY	WAYNE T WILKINSON
Details		
BEAM 5 SPAN 4 AT BENT 3 LEFT SIDE ANCHOR BOLT HAS SECTION LOSS WITH 1/4 IN. DIAMETER REMAINING.

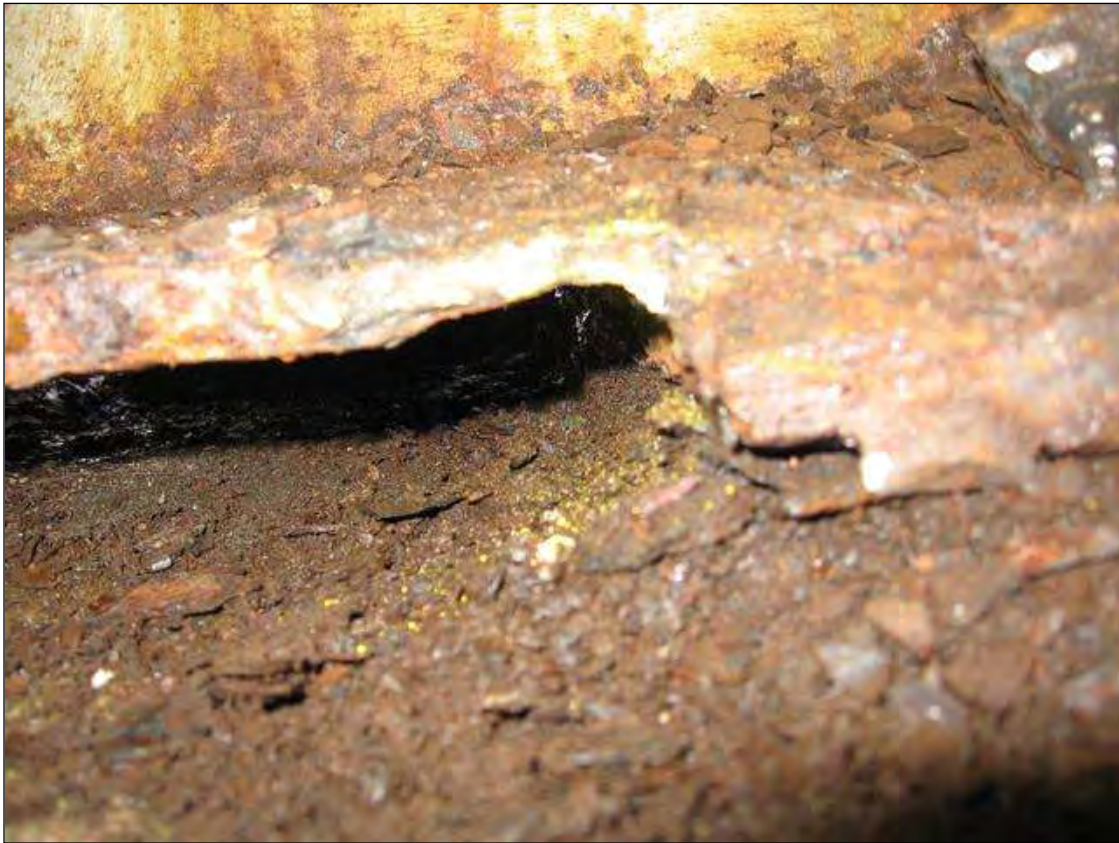
SECTION LOSS IN THE BOTTOM FLANGE OF BEAM 5 IN SPAN 4 OVER BENT 3

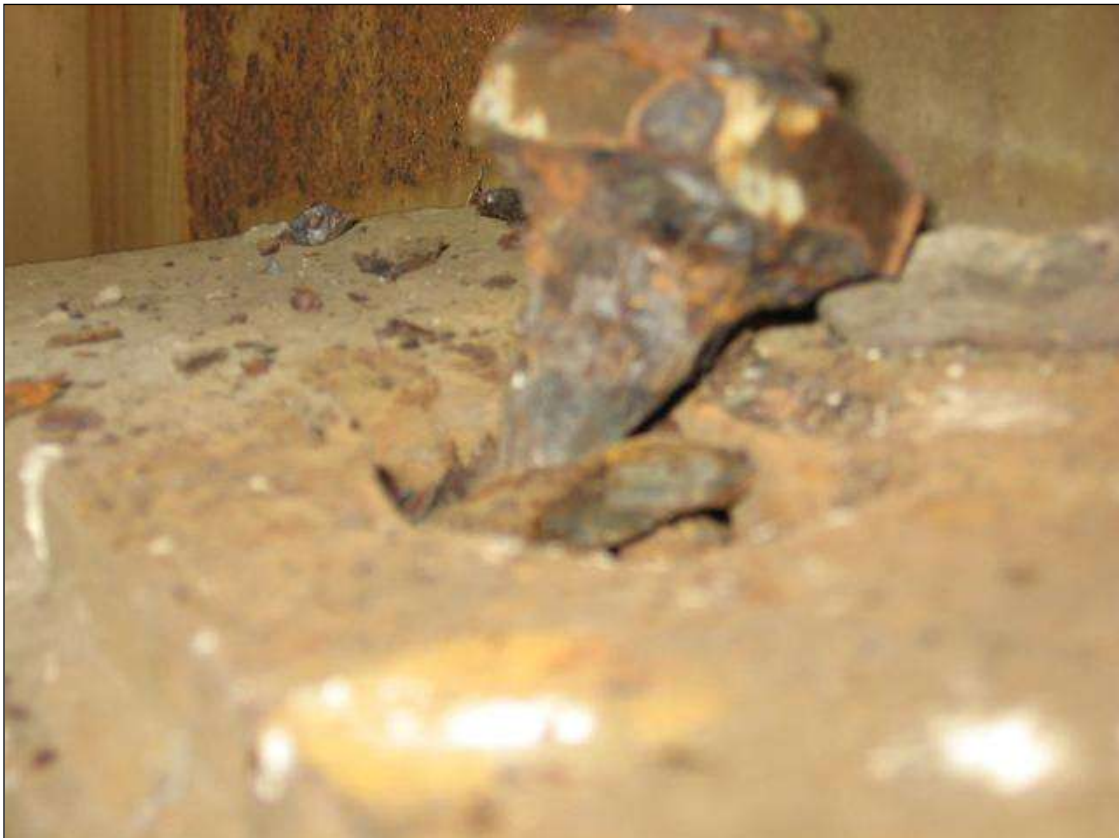
SECTION LOSS IN THE RIGHT SIDE ANCHOR BOLT FOR BEAM 4 IN SPAN 4 OVER BENT 3 - PRIORITY MAINTENANCE ISSUED

3334	Bridge Bearings	EA	<i>X TSE</i> <i>3/6/12</i>	BEAM 4 SPAN 4 AT BENT 3 RIGHT SIDE ANCHOR BOLT HAS SECTION LOSS WITH 1/4 IN. DIAMETER REMAINING.

MMS Code	MMS Description	Quantity
3334	Bridge Bearings	1 EA
Location:		
Beams and Girders                      Bent/Span No.    4                      ANCHOR BOLT		
Priority Level		Status
Priority Maintenance		Division Bridge Maintenance Notification Received
Submitted Date:	Submitted By:	Assisted By:
11/21/2011	WILLIS C MAY	WAYNE T WILKINSON
Details		
BEAM 4 SPAN 4 AT BENT 3 RIGHT SIDE ANCHOR BOLT HAS SECTION LOSS WITH 1/4 IN. DIAMETER REMAINING.

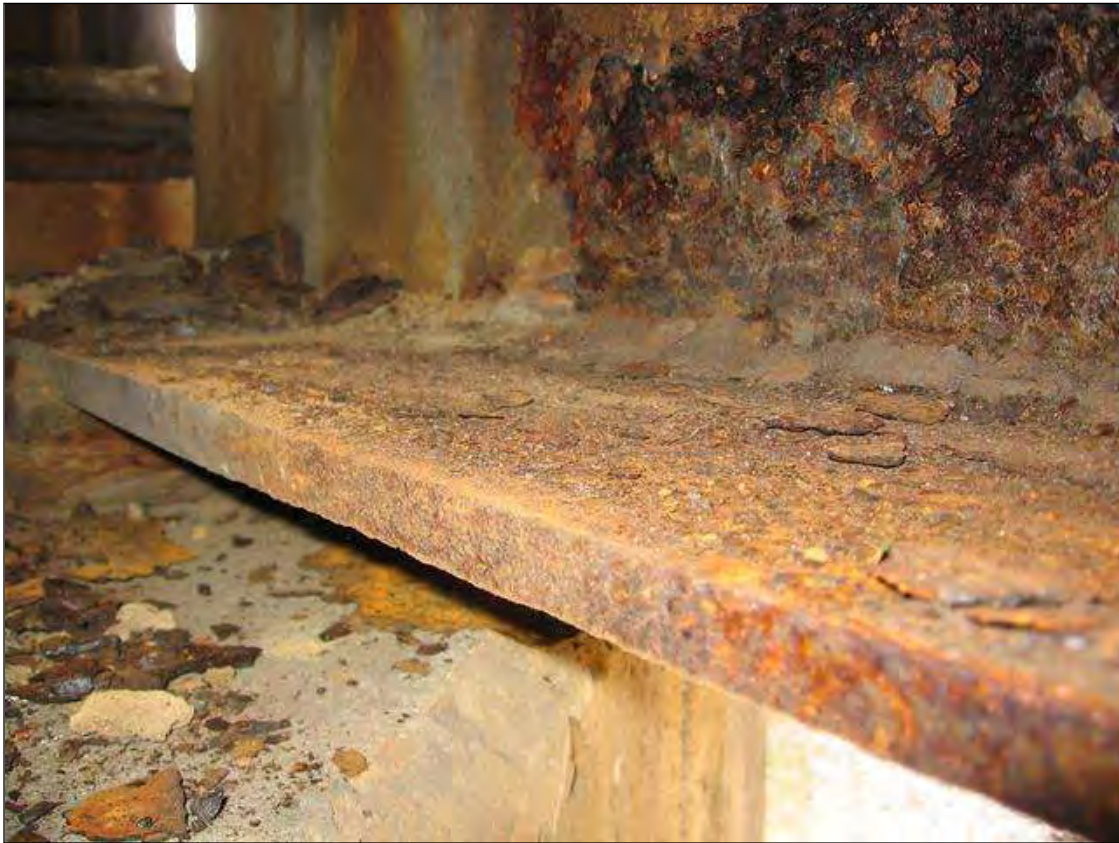
SECTION LOSS IN THE BOTTOM FLANGE OF BEAM 1 IN SPAN 3 OVER BENT 2

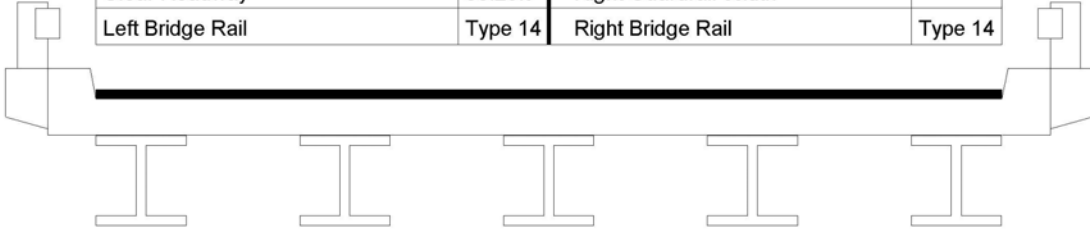
<b>Title</b> TYPICAL SECTION		<b>Description</b> LOOKING NORTH	
<b>Bridge No:</b> 500037	<b>Drawn By:</b> GGW	<b>Date:</b> 04/12/2006	<b>File Name:</b> S0214000200

Deck Width/Out to Out	33.5ft	Wearing Surface	.333ft
Between Rails	33.333ft	Median Width	
Curb Height	.5ft	Median Height	
Top Rail to Deck/Wearing Surface	2.25ft	Left Guardrail Width	
Clear Roadway	30.25ft	Right Guardrail Width	
Left Bridge Rail	Type 14	Right Bridge Rail	Type 14

Measurements for Span #	1		
Deck Thickness	.542	Left Overhang	3.083
Top of Rail to Bottom of Beam	5.25	Right Overhang	3.083

Beam No	Beam Type	Spacing	Comments
1	Steel I Beam	6.833ft	
2	Steel I Beam	6.833ft	
3	Steel I Beam	6.833ft	
4	Steel I Beam	6.833ft	
5	Steel I Beam

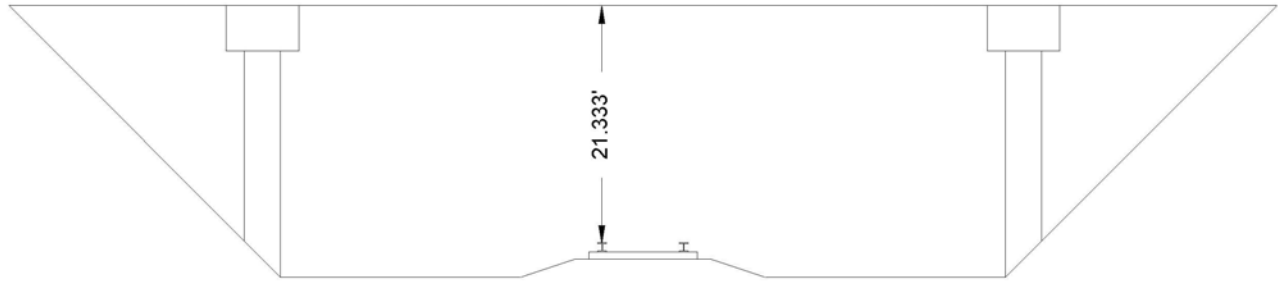
<b>Title</b> RAILROAD CLEARANCE PROFILE		<b>Description</b> LOOKING EAST	
<b>Bridge No:</b> 500037	<b>Drawn By:</b> WTW	<b>Date:</b> 11/28/2007	<b>File Name:</b> S0214000201

Rail to Rail	5ft	1 set(s) of tracks	Looking: EAST
Vertical Clearance	21.333ft	Measured from rail 2 at Beam # 1	
Distance to Left Bent	19.25ft		
Distance to Left Toe of Slope			
Distance to Right Bent	9.333ft		
Distance to Right Toe of Slope

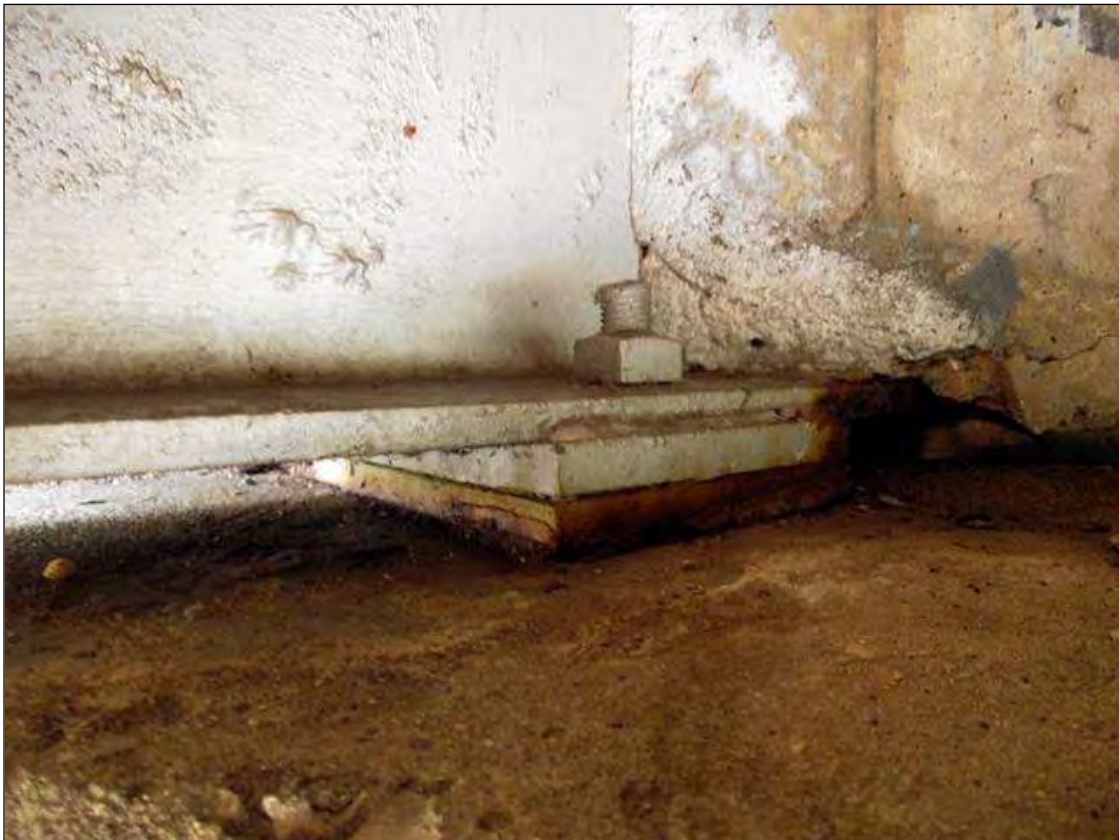
TYPICAL BEARING ASSEMBLY THROUGHOUT STRUCTURE
