Coastal Monitoring Program

NC 12 Transportation Management Plan

TIP Project B-2500

2021 UPDATE REPORT

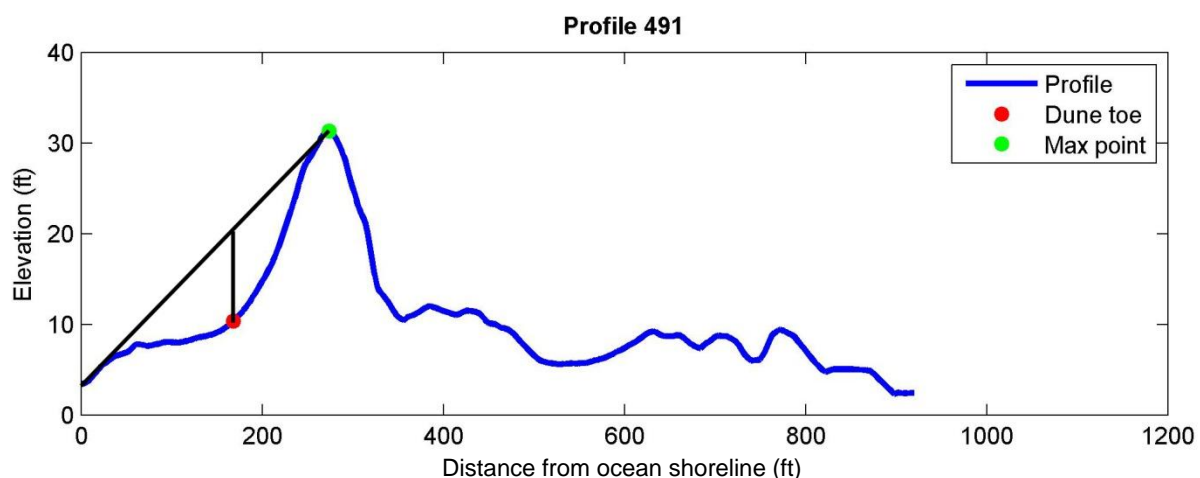
Figure 2. Schematic of dune toe identification methodology. Ocean shoreline is at horizontal position zero.

To identify the dune toe, a partially automated algorithm was used. For initial dune toe identification, a straight line between the maximum profile elevation and the shoreline was drawn, and the maximum difference between this line and the profile elevation was identified as the toe (see Figure 2). However, in some cases the automatically extracted toe was either not suitable, or no significant dune was present on the profile. This led to the development of an inspection method where the user views the profile at each transect, and can either accept or replace the estimated dune toe, or identify a profile as having no visible dune feature. For profiles identified as “no dune,” the dune toe elevation and position were not reported.

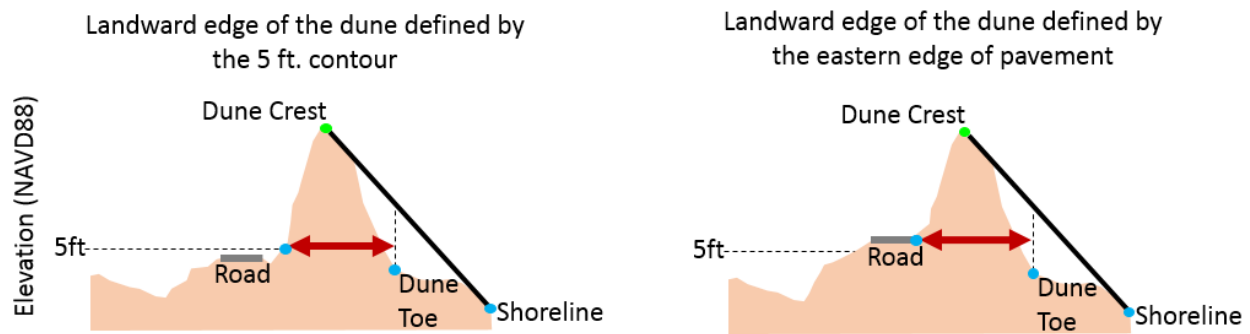
Figure 4. Definition of the horizontal extent of a dune (red arrow) on a cross-shore transect and visualization of the dune toe extraction method.

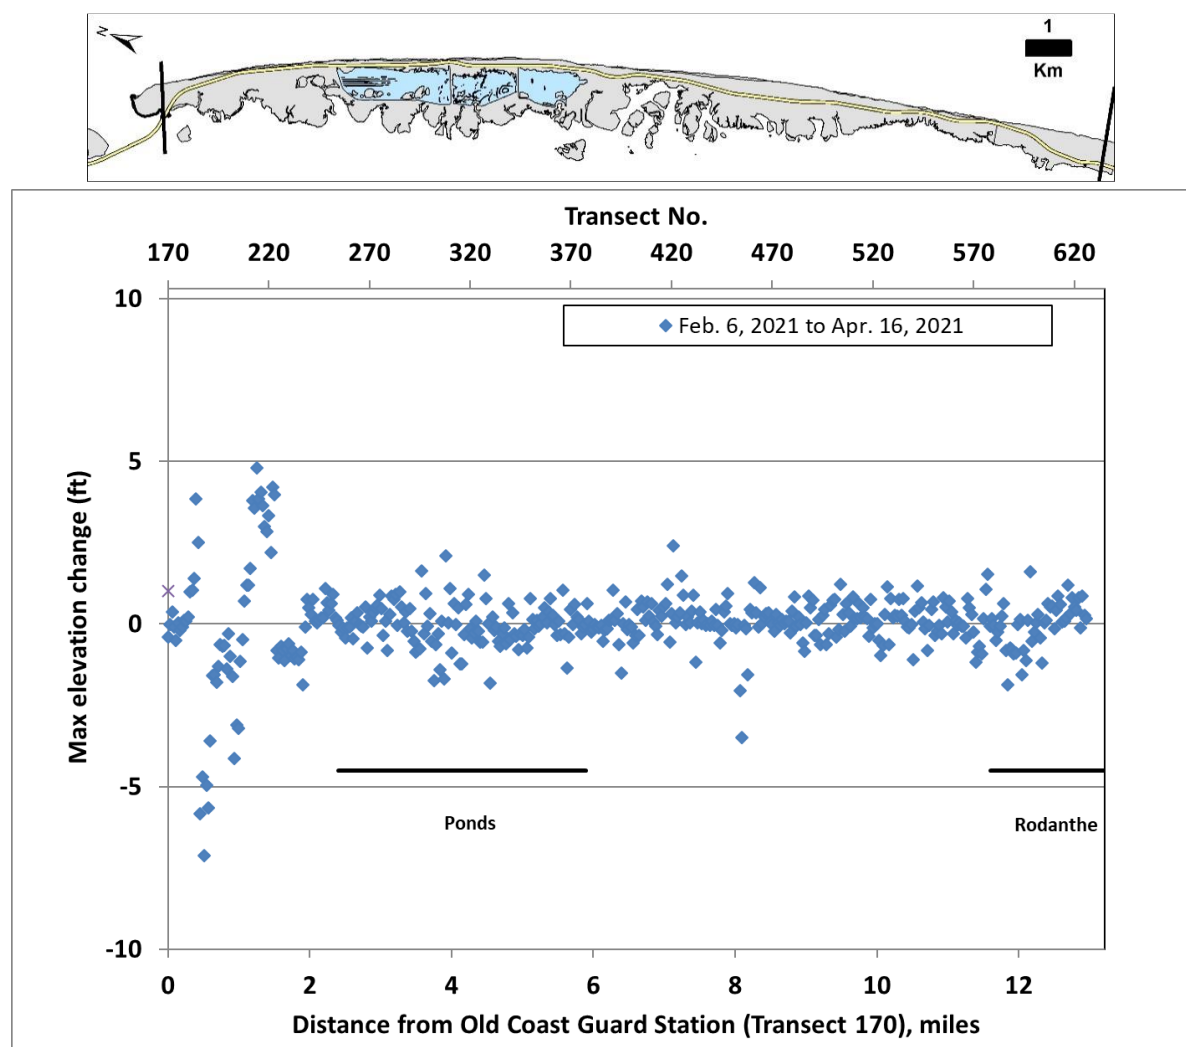
Figure 12. Maximum elevation change from February 6, 2021 to April 16, 2021 at each transect, displayed from north to south along the study area. Note that transects are spaced 150 ft apart.

The maximum elevation between the NC 12 EOP and the ocean shoreline was determined at each transect for the 2021 digital terrain models (February 6, April 16, August 12 and September 30, 2021); for the purpose of this analysis, the maximum elevation is identified as the dune crest. Changes in the maximum elevation from date to date are shown in this section to illustrate the variability. Negative change means the elevation of the later date was lower than that of the earlier date (decrease in maximum elevation); positive change means that the maximum elevation increased between the two dates. Figure 12 illustrates the changes from February 6 to April 12, 2021. The average change in maximum elevation over the entire study area during this time frame was approximately 0.7 ft (computed using the absolute value of the difference). The largest change was an increase of just under 5 ft at Transect 214 near mile 1.25. The largest decrease was just over 7 ft at Transect 188 near mile 0.5. As in past reports, the majority of the elevation changes were in the Canal Zone area.

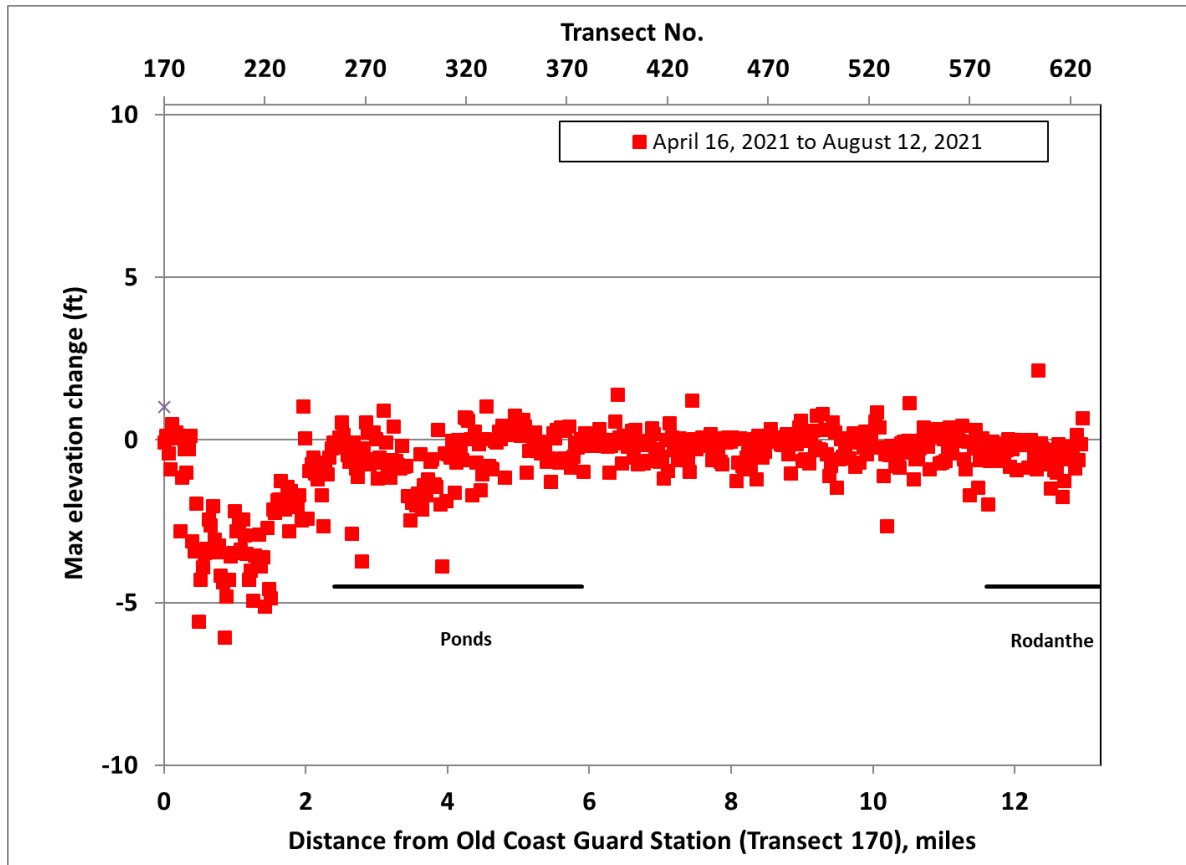
Figure 13. Maximum elevation change from April 16, 2021 to August 12, 2021 at each transect, displayed from north to south along the study area. Note that transects are spaced 150 ft apart.

Changes occurring between April 16 and August 12, 2021 are shown in Figure 13. The average change was 0.85 ft (considering the absolute value of the difference). The largest increase was approximately 2.2 ft near mile 12.3 (Transect 604), and the largest decrease approximately 6 ft near mile 0.85 (Transect 200). It is noted that the region (Canal Zone) that showed high variability in the February-April time period showed an overall decrease during the summer months.

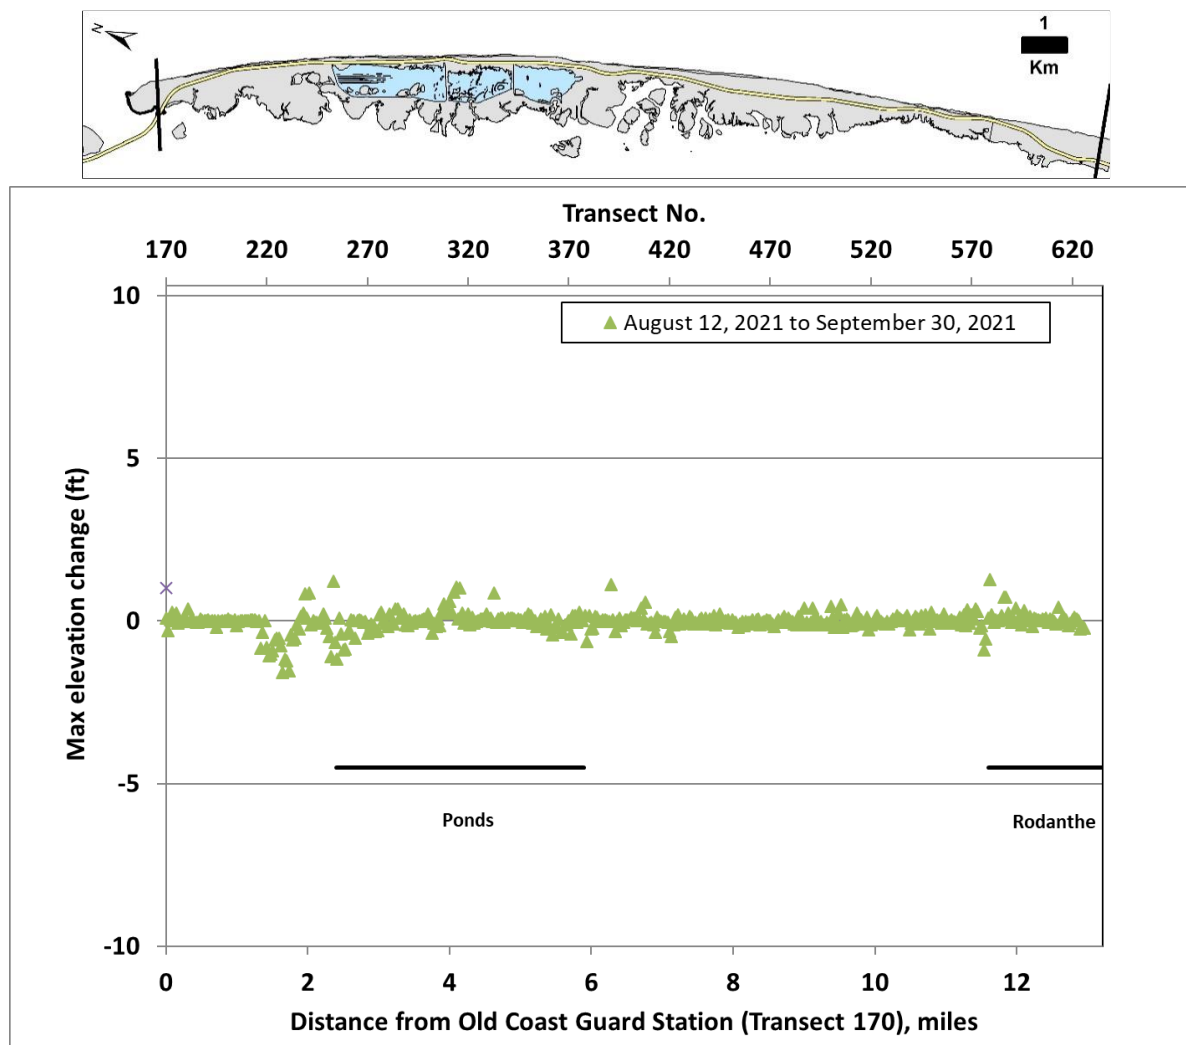
Figure 14. Maximum elevation change from August 21, 2021 to September 30, 2021 at each transect, displayed from north to south along the study area. Note that transects are spaced 150 ft apart.

Changes in maximum elevation from August 12 to September 30, 2021 are shown in Figure 14. This time period had the least observed change during the 2021 study year. Average change during this time period was 0.2 ft. The largest increase was 1.3 ft at Transect 579 (approximately mile 11.6), and the largest decrease was 1.6 ft at approximately mile 1.7 (Transect 228).

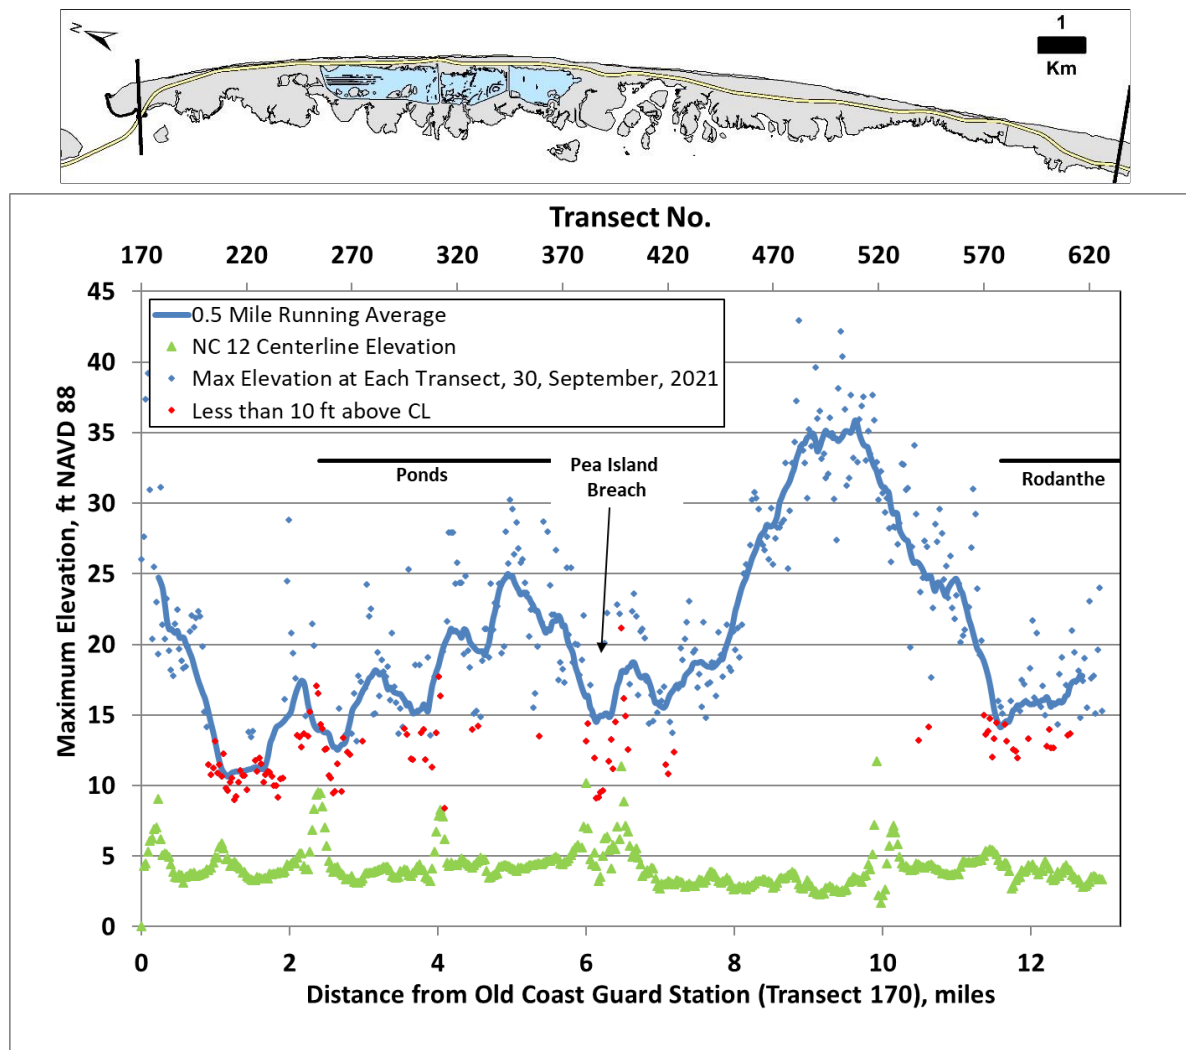
Figure 15. Maximum elevation at each transect, displayed from north to south along the study area for the September 30, 2021 topographic data set. Blue points are > 10 ft above the CL elevation, red points are ≤ 10 ft above the CL elevation. Note that transects are spaced 150 ft apart.

Peak profile elevations (referenced to NAVD 88) ranged from a minimum of approximately 9 ft at Transect 386 adjacent to the Pea Island Breach to a maximum of 43 ft at Transect 482 in a wide dune field about 3 miles north of Rodanthe. As shown in Figure 15, there is a high degree of variability in the maximum elevation at each transect, due to the non-uniform degradation and buildup of the dune system. A 0.5-mile running average is also plotted to illustrate the overall alongshore trend. In the northern six miles of the study area, the average elevation of the dunes ranges from approximately 15 to 25 ft. Just south of the ponds the dunes were removed by the Pea Island Breach in 2011 and are gradually recovering. From miles 7 to 10, most dunes were greater than 20 ft in elevation; moving south from this area toward Rodanthe, the dune field is substantially degraded. In many parts of this stretch a narrow artificial dune was previously constructed over sandbags; these dunes were augmented by a beach nourishment project in August-September 2014, although the area has since returned to pre-project or further eroded conditions. As described in the methodology section, the maximum elevation was compared to the elevation of the road at each transect. The trends are similar to those described in previous reports.

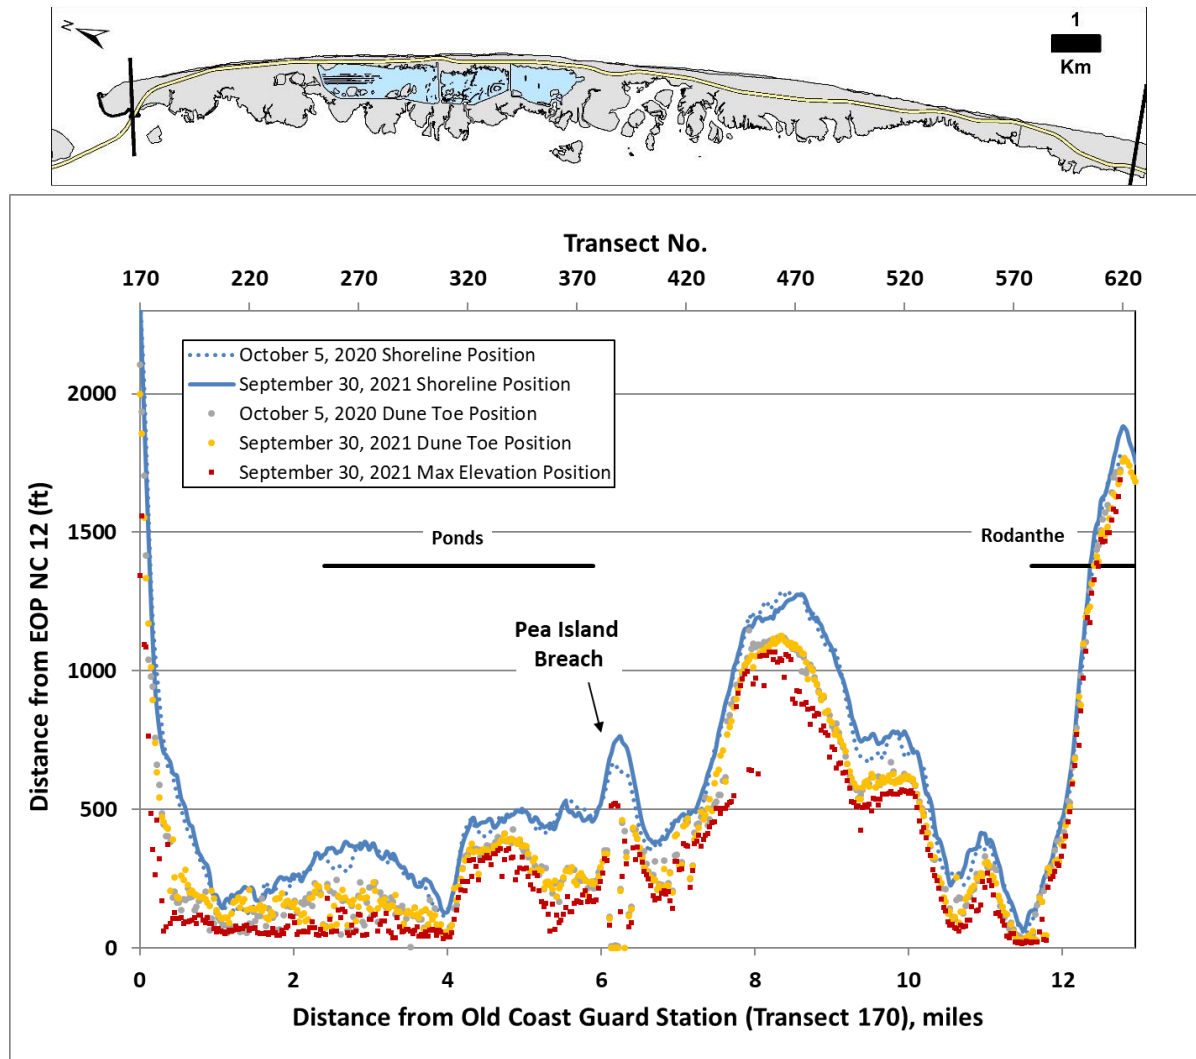
Figure 16. Dune toe, shoreline, and maximum elevation positions as of September 30, 2021, measured as distance from the NC 12 edge of pavement, compared with dune toe and shoreline positions as of October 5, 2020.

Dune toe position and elevation for the September 30, 2021 topographic data were evaluated. Figure 16 shows the horizontal dune toe position relative to the NC 12 edge of pavement as well as the shoreline and maximum dune elevation position. The position of the shoreline and maximum elevation as of October 5, 2020 are presented as well, for reference. The position of the dune toe is similar to that in 2020, as were the general patterns across the study area. Dunes along miles 1 through 4 and south of mile 11 have been reconstructed multiple times. It is noted that NCDOT is restricted in where and how high the dunes could be constructed due to the location of the current NC 12 highway easement within the PINWR. NCDOT was required to stay within its existing easement unless otherwise authorized. This is why the dunes in these areas are so close to the roadway.

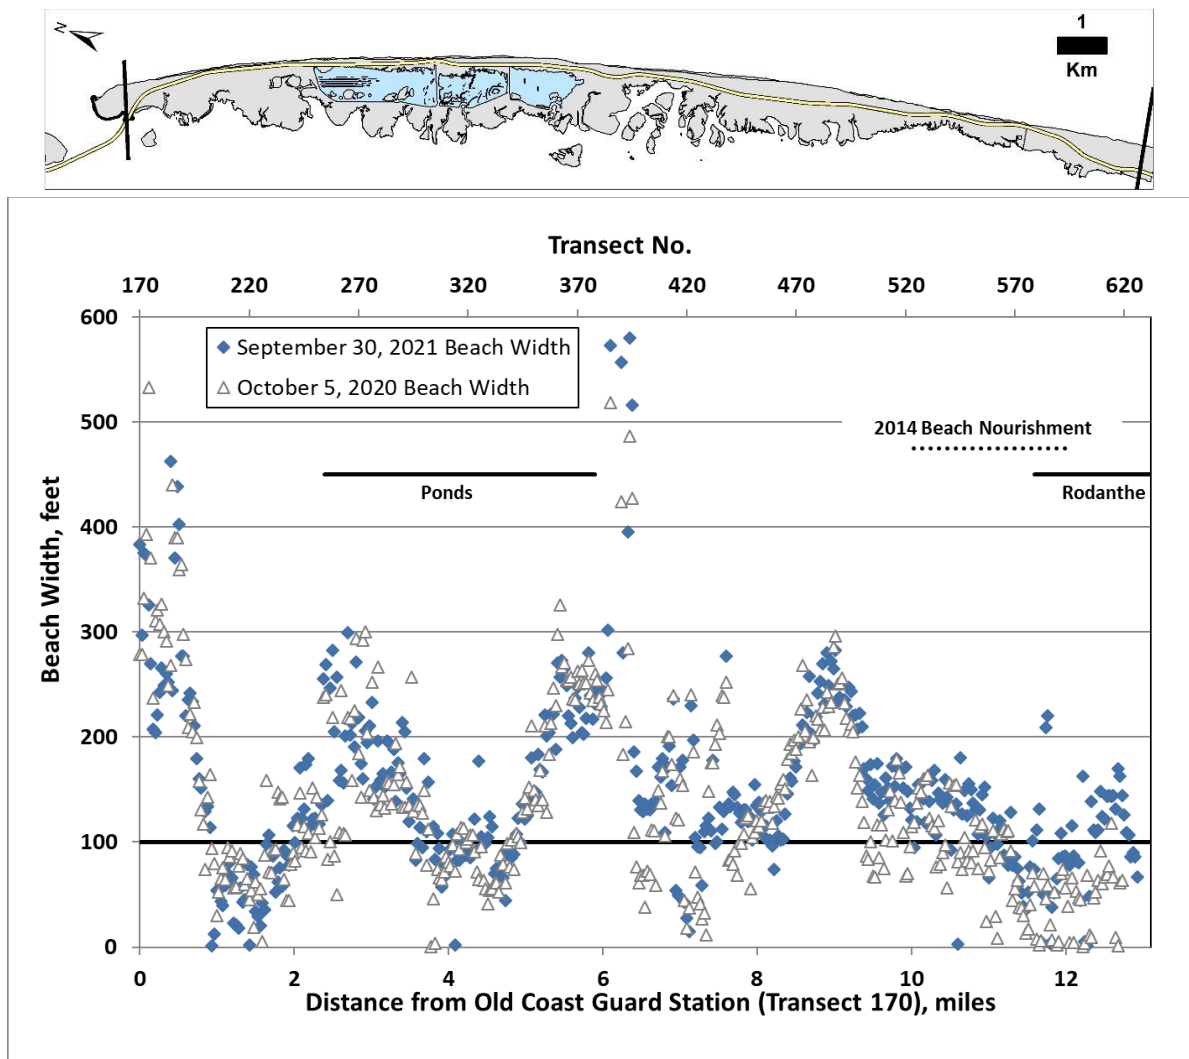
Figure 18. Beach width as of September 30, 2021 (blue), compared with beach width on October 5, 2020 (gray).

Beach width, determined as the distance between the dune toe and ocean shoreline, as of September 30, 2021 is shown in Figure 18, with the beach width as of October 5, 2020 for comparison purposes. As discussed in the methodology section, a beach width of less than 100 ft is considered to increase vulnerability of the dune field to wave impact. In areas where dunes are already degraded, narrow beaches increase the likelihood of further dune erosion and/or overwash. In 2021, 121 transects had beach widths less than 100 ft; in 2020, this number was 181. The average beach width across the study area as of September 2021 was 150 ft, whereas in October 2020 it was 142 ft, and in October 2019 it was 130 ft. The pattern of beach widths as of September 30, 2021 was similar to that from the 2020 report. At this point in time, seven years after placement, the beach width in the area of the Rodanthe beach nourishment project is narrower than pre-project conditions. This was expected as the project was designed to mitigate erosion for three years (see the 2014 Report for further details on the project).

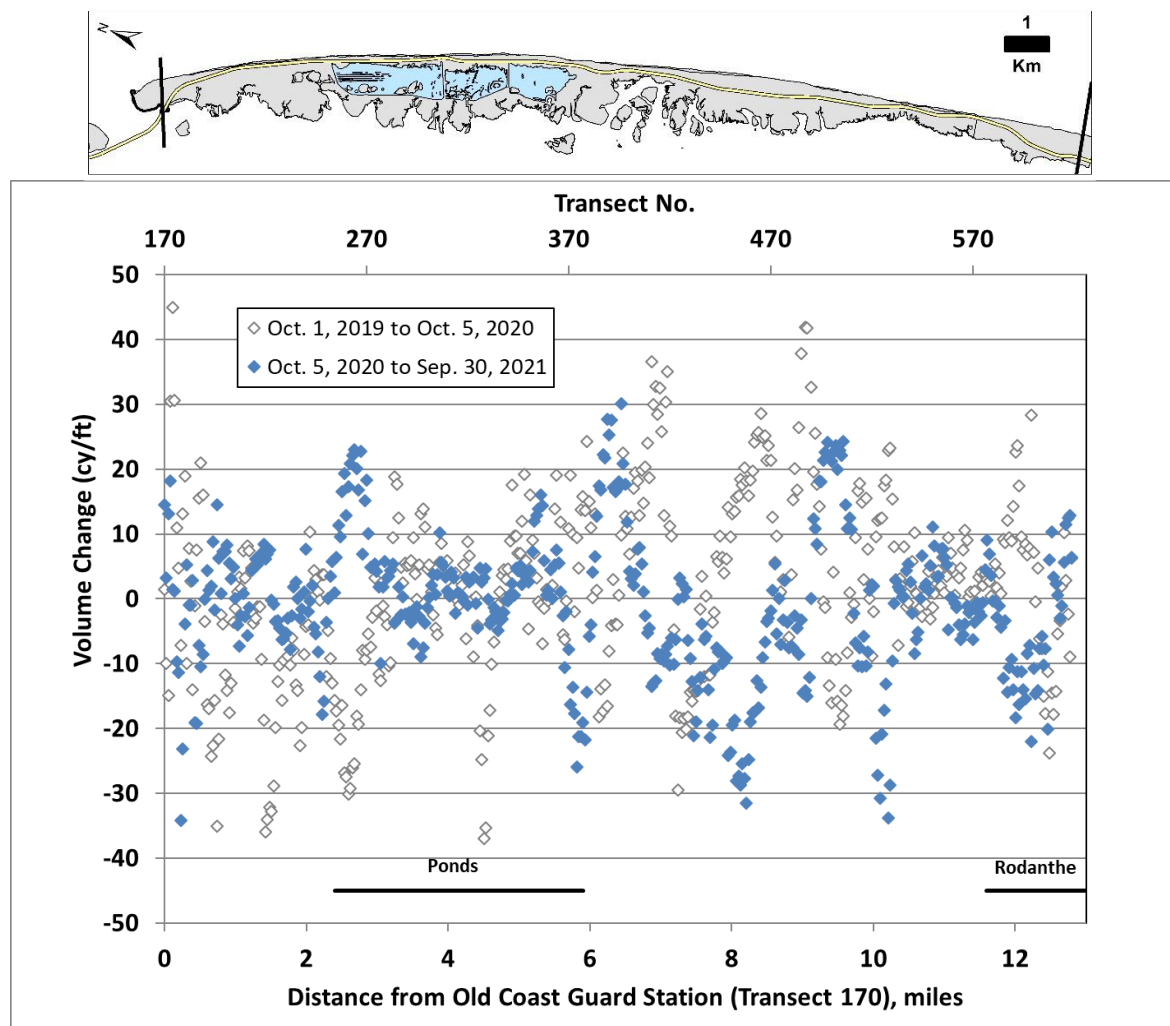
Figure 19. Changes in volume from October 2020 to September 2021, measured from the NC 12 EOP to the shoreline above the MHW elevation (displayed from north to south along the study area). Changes from October 2019 to October 2020 are also shown for reference.

The changes in beach volumes above MHW from October 5, 2020 to September 30, 2021 are presented in Figure 19. The volume per unit distance alongshore from the NC 12 EOP to the MHW elevation was computed at each transect. The numbers reflect both dune size and the distance from the road to the shoreline. Also included on the figure is the comparison between October 1, 2019 to October 5, 2020. When the two change rates are compared, it is noted that in several places a loss from 2019 to 2020 is mirrored by a gain from 2020 to 2021 or vice versa. The beach volume data inherently reflect variability due to storm impacts and recovery. It is noted that as detailed in the 2019 Report, Appendix B, there was a change in the edge of pavement reference line for the volume computations in 2019; some of the volume changes from 2018 to 2019 were attributed to this reference change. From transects 376 to 404, the EOP shifted west, causing an average increase of 3.2 cy/ft in that area, and from transects 513 to 526, the EOP shifted east, causing an average decrease of 4.6 cy/ft at those transects.

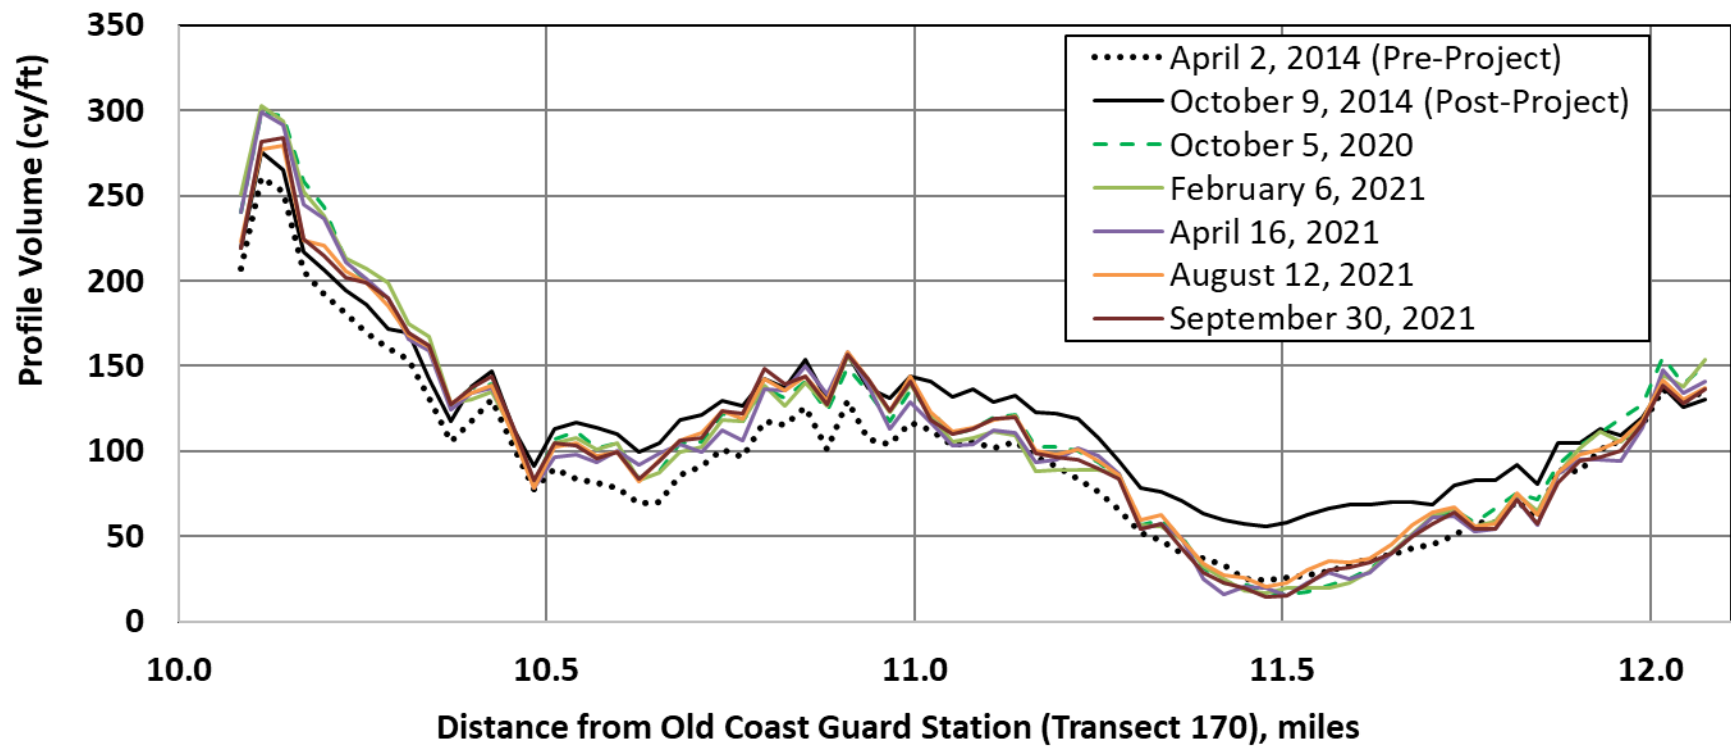
Figure 20. Profile volume from edge of pavement to shoreline, above the MHW elevation, by transect in region of the beach nourishment project.

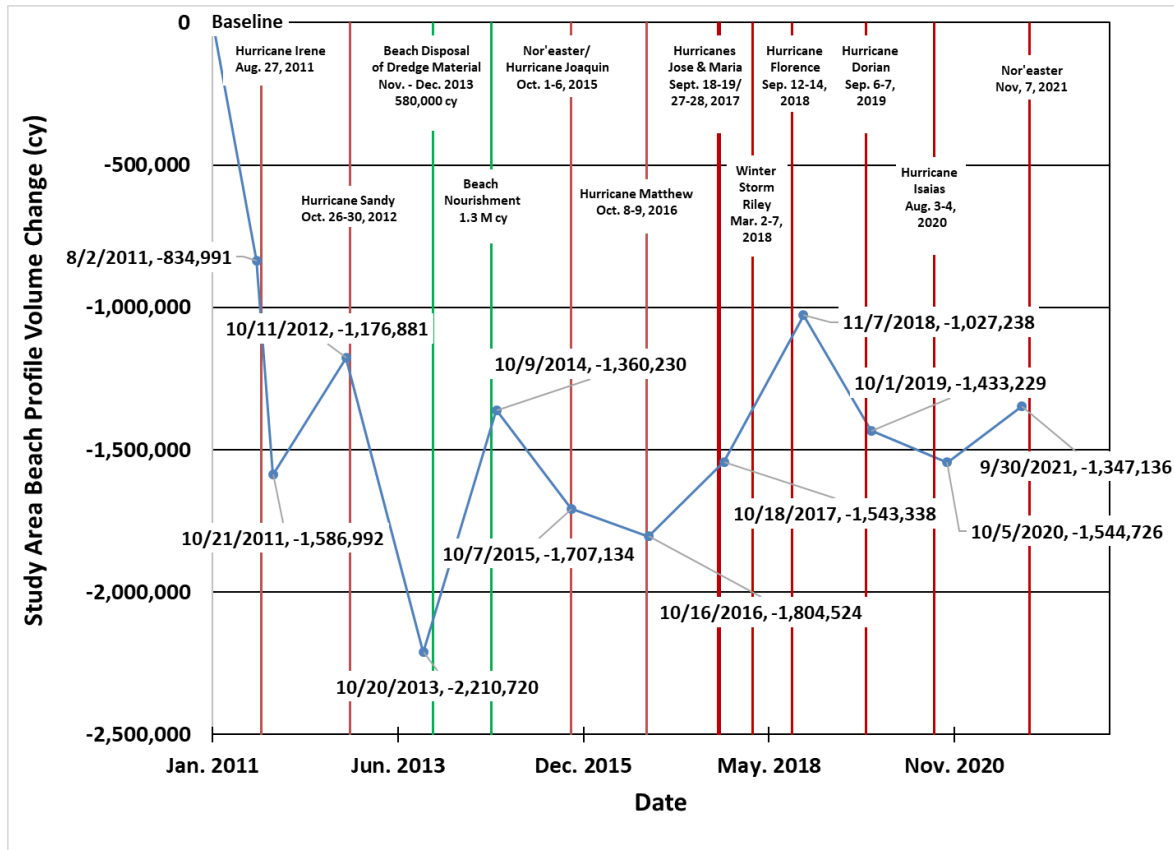
Figure 21. Total beach volume change (EOP to shoreline) across the study area, with respect to baseline conditions.

To compare volumetric conditions across the entire study area since the inception of the coastal monitoring program, a comparison of total sub-aerial volume change between the edge of pavement and the shoreline is shown in Figure 21. Dates of sand placement (2013 dredge material disposal near Oregon Inlet and the 2014 beach nourishment project) and significant storms are also indicated. The total volume was calculated by multiplying each of the profile volumes by 150 ft (the distance between the profiles) and summing the total across transects 170 to 626. Significant events affecting the volumes are highlighted by vertical red lines (Hurricane Irene, Hurricane Sandy, the October 2015 “Joaquín-easter” event, Hurricane Matthew in October 2016, Hurricanes Jose and Maria in September 2017, Winter Storm Riley and Hurricane Florence in 2018, Hurricane Dorian in 2019, Hurricane Isaias in 2020, and a severe nor’easter in November 2021. As of September 30, 2021, there was an estimated approximately 1.3 million cubic yards less volume between the road and the shoreline than there was under baseline conditions (January 2011).

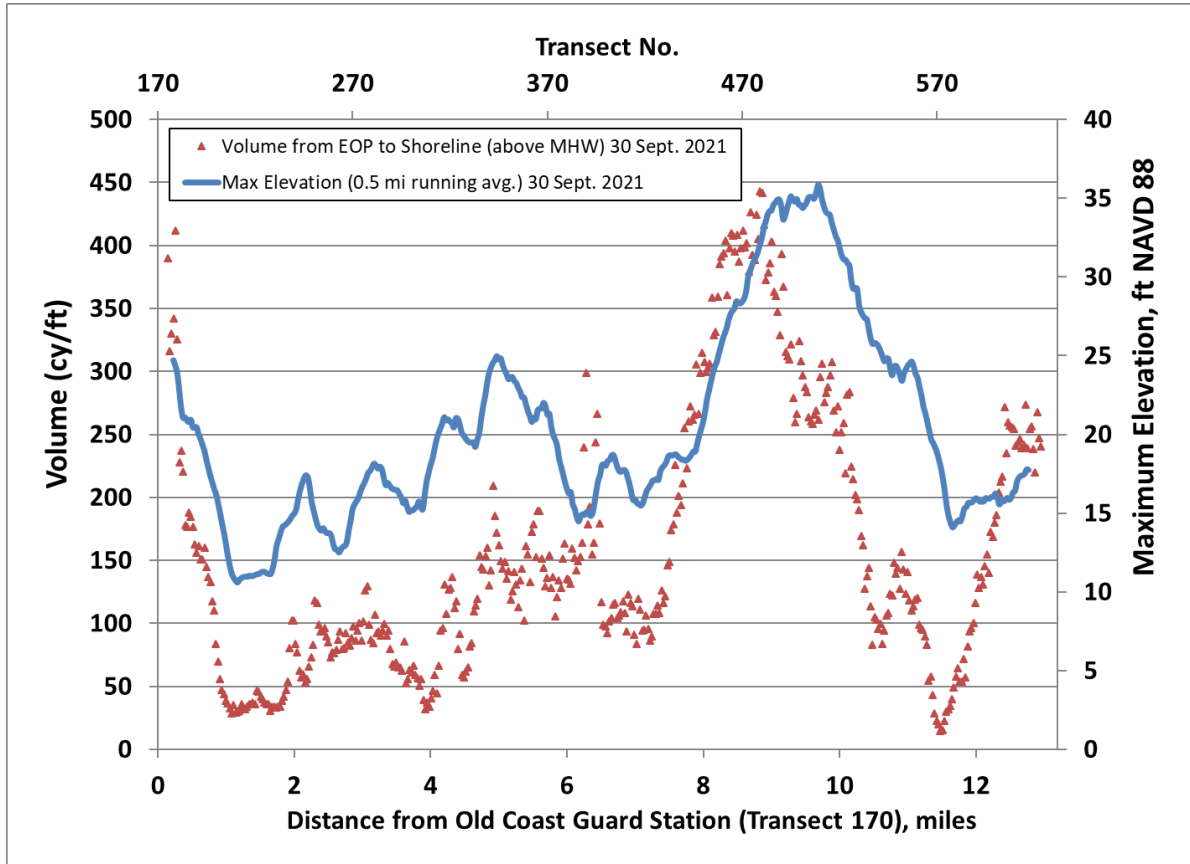
Figure 22. Computed volume as of September 30, 2021, from the NC 12 edge of pavement (EOP) to the shoreline above the MHW elevation displayed from north to south along the study area. The volume follows a trend similar to the running average of the maximum dune crest height, also shown.

To assess conditions as of the last available topographic data of 2021, the computed volumes for September 30, 2021 are presented in Figure 22 with the running average of dune height included for comparison. The minimum measured value was approximately 15 cy/ft at Transect 574 at mile 11.5 north of Rodanthe. The average volume from the edge of pavement to the shoreline in September 2021 was approximately 166.5 cy/ft (in 2020 it was 166.2 cy/ft). Low values along the Canal Zone and freshwater ponds sections reflect the smaller dunes as well as the proximity of the road to the shoreline. From miles 7 to 10 the larger volumes correspond with higher dunes and the position of NC 12, which is set back further from the shoreline. In general, the spatial variation in profile volumes are similar to those observed in previous reports.

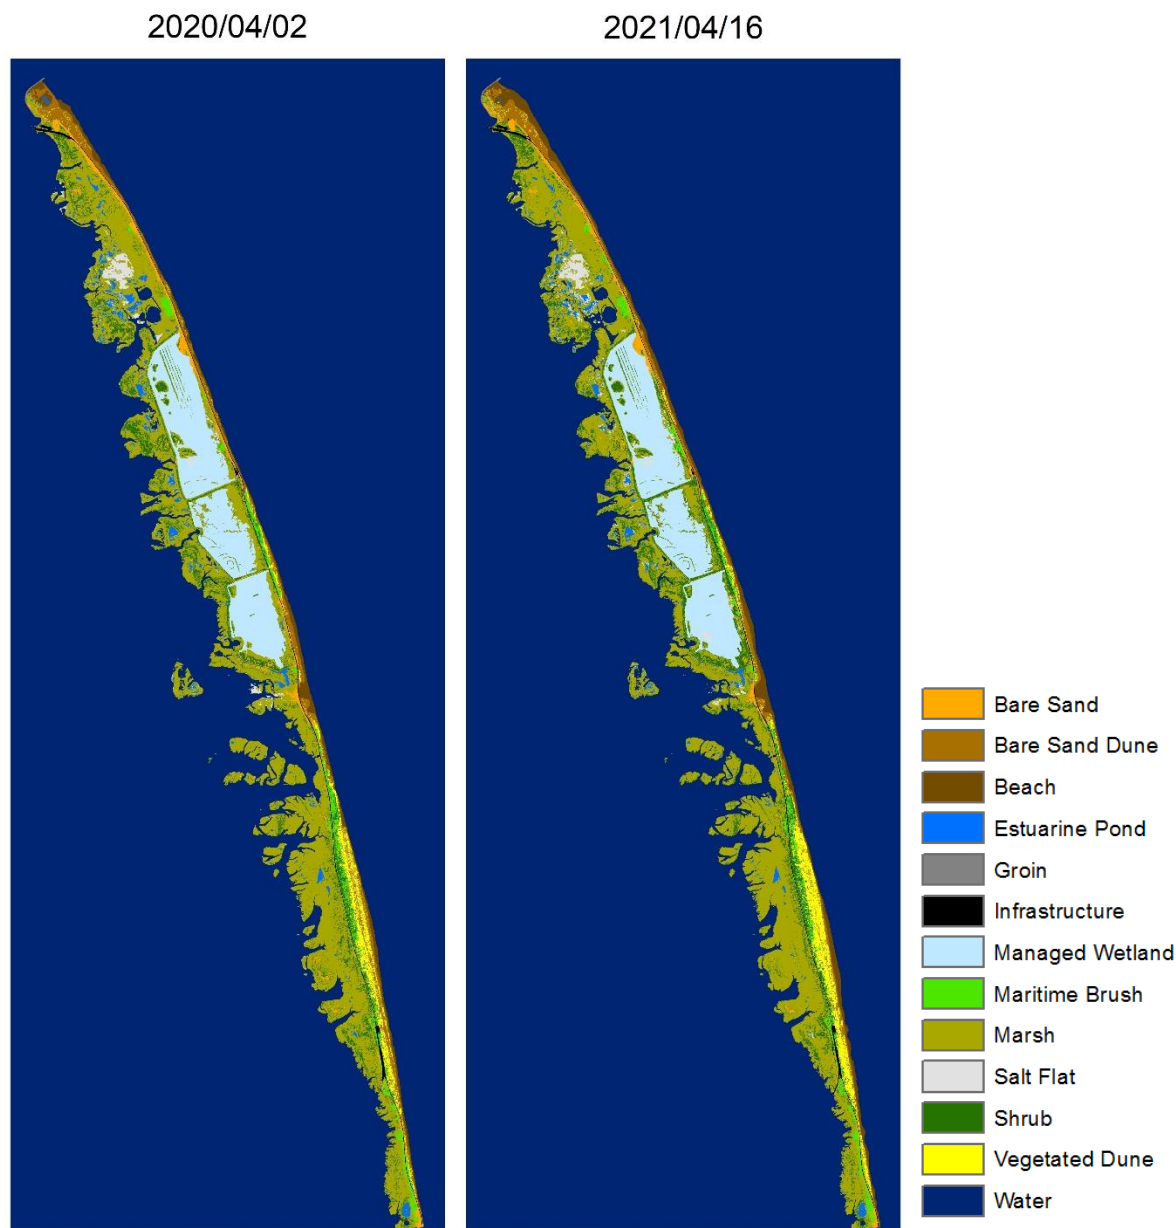
Figure 24. Habitat maps for 2020 and 2021

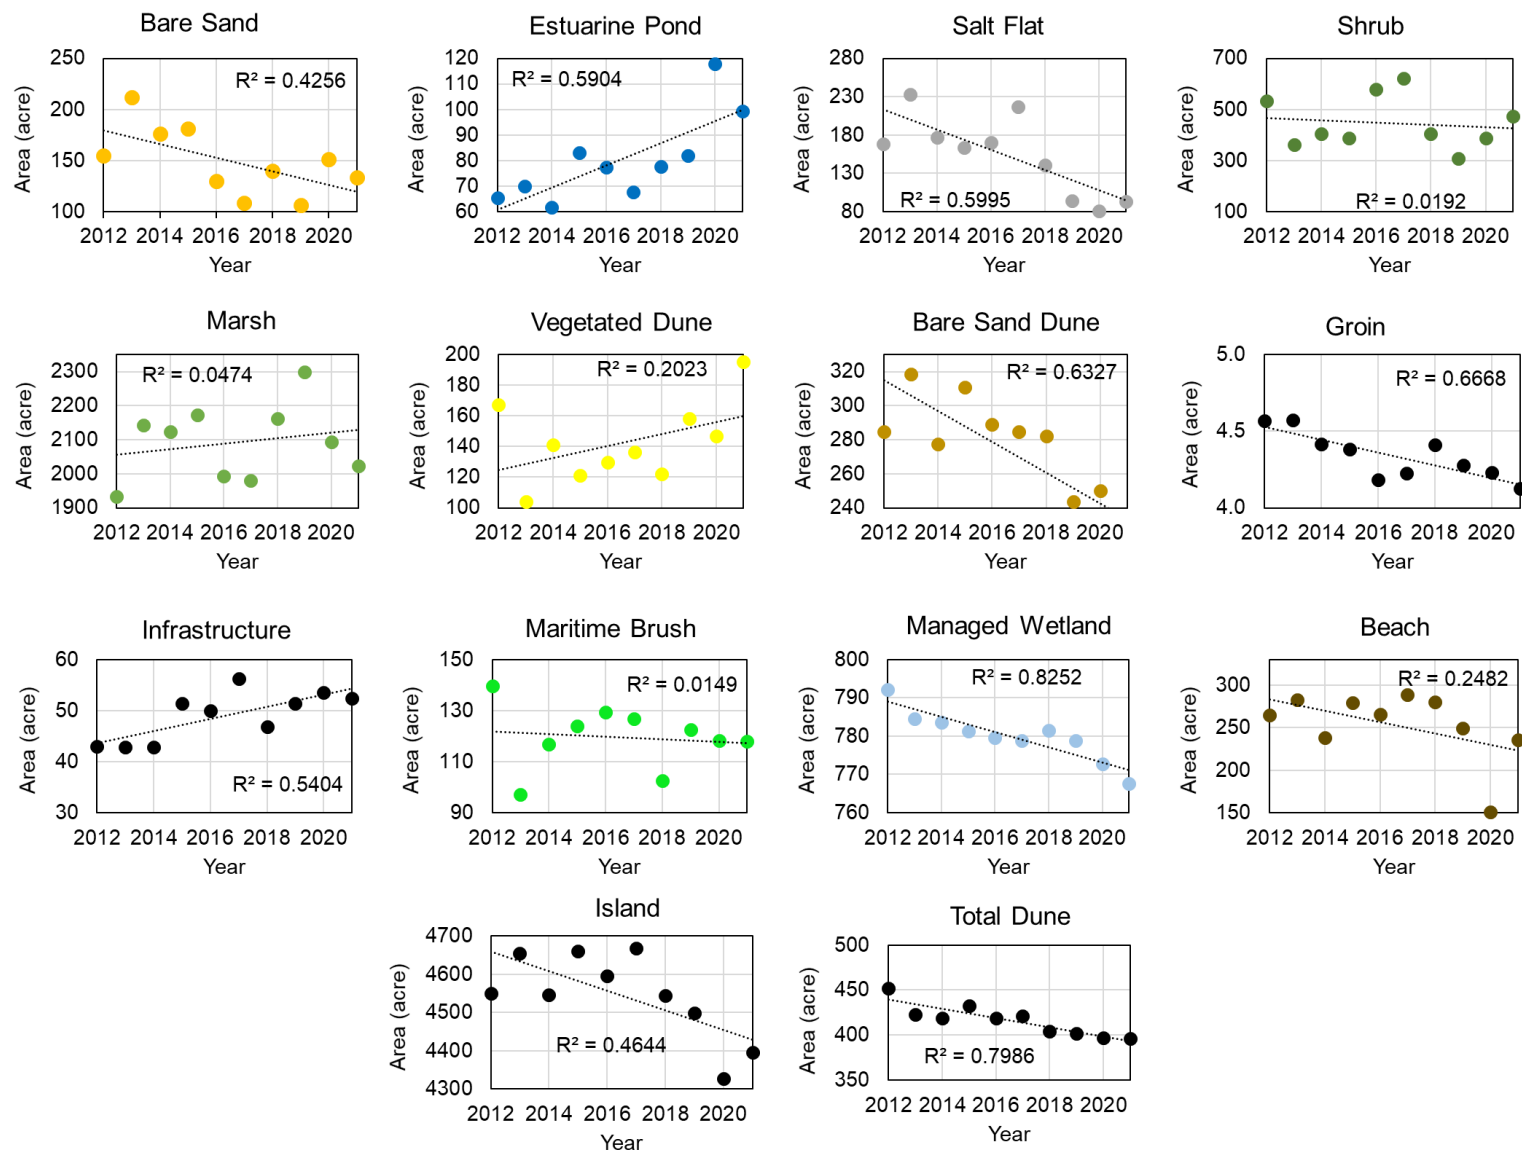
Figure 25. Linear trends for each habitat class.

- Dune: Bare sand dune has a decreasing trend. Vegetated dune has a stable linear trend but fluctuations are observed. As expected, both classes show a strong sensitivity to ocean-side storms.

- Beach: Highly variable and dependent on storm activity and water levels. 2020 data shows a large decrease in beach area primarily due to the observed elevated water levels in April 2020. April 2021 water levels were more normal conditions showing a rebound in beach area.

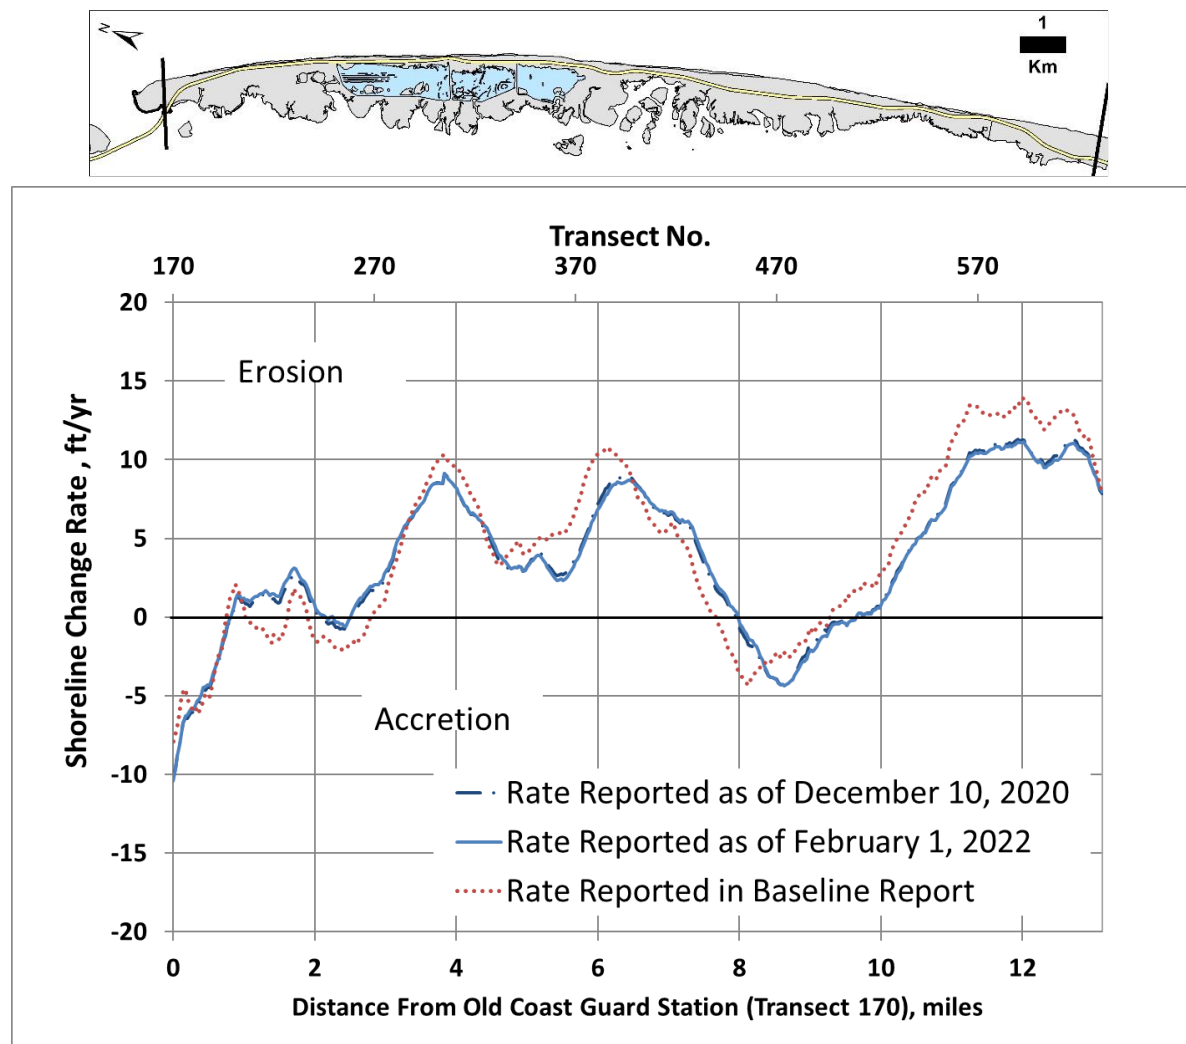
Figure 27. Updated erosion rates through February 1, 2022, compared with 2020 update conditions (as of December 10, 2020) and baseline report conditions.

With the recent shoreline position data from 2021 through February 2022 (this date was used because there was no December 2021 flight) added, the linear regression long-term shoreline change rates for the study area changed very little from the 2020 update conditions, as shown in Figure 27. Note that in this figure, “positive” shoreline change rates indicate erosion. In order to see more clearly the trends since the Baseline Report (conditions as of January 2011), Figure 28 shows each of the erosion rates reported yearly since December 2011. While the rates have not changed significantly year to year, it is apparent that there are some trends in the changes. In the first mile, while accretion has been present, the rates of accretion have been decreasing. In the Canal Zone, rates of accretion have been transitioning to rates of erosion (generally less than 2 ft/year). Over the remainder of the study area, trends have remained similar since the Baseline Report, with an average slight decrease in the rates of erosion in most areas. An accretionary area near Transect 470 has shifted slightly to the south over the past three to four years.

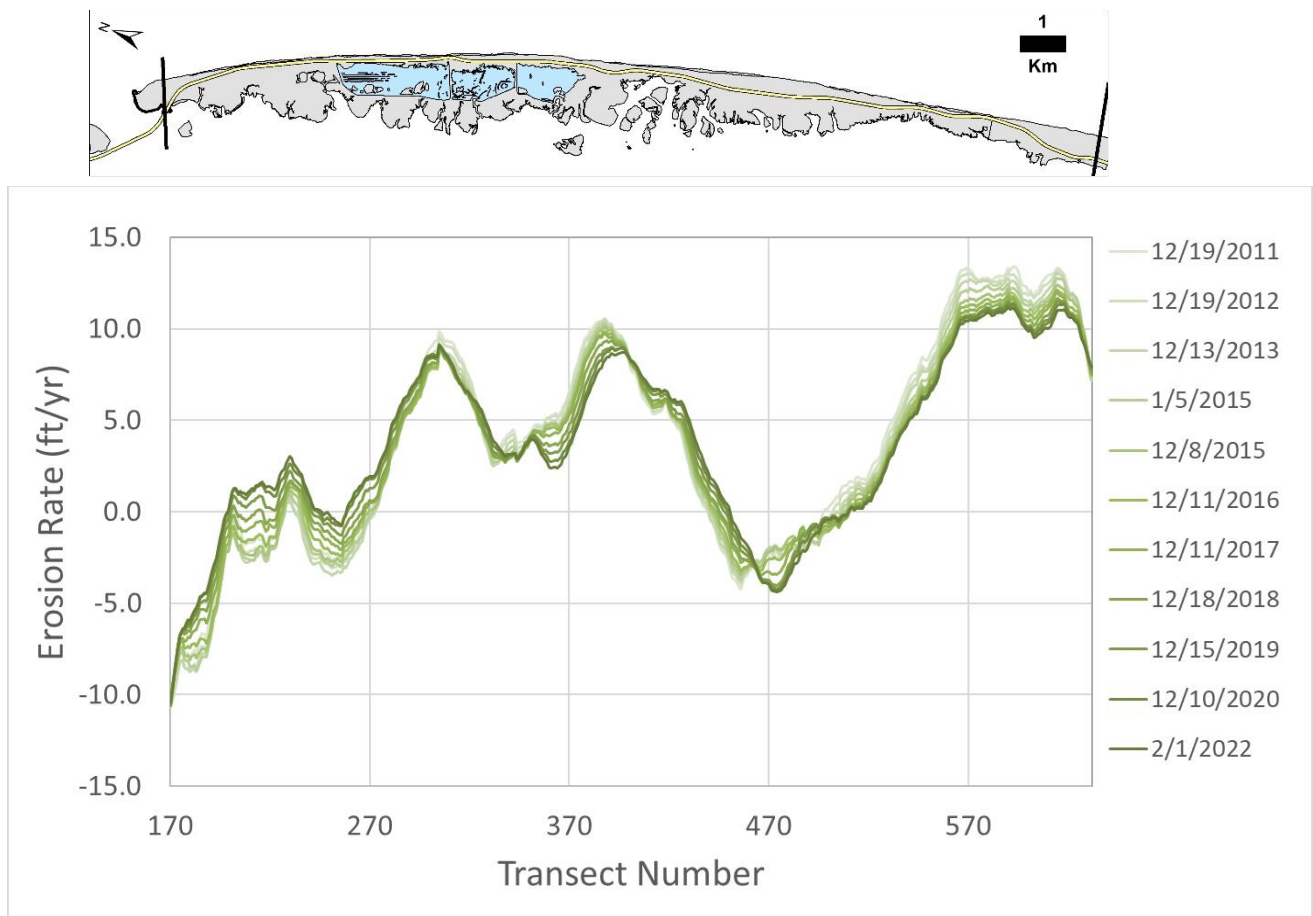
Figure 28. Erosion rate changes from December 2011 to February 2022.
