Coastal Monitoring Program

NC 12 Transportation Management Plan

TIP Project B-2500

2021 UPDATE REPORT

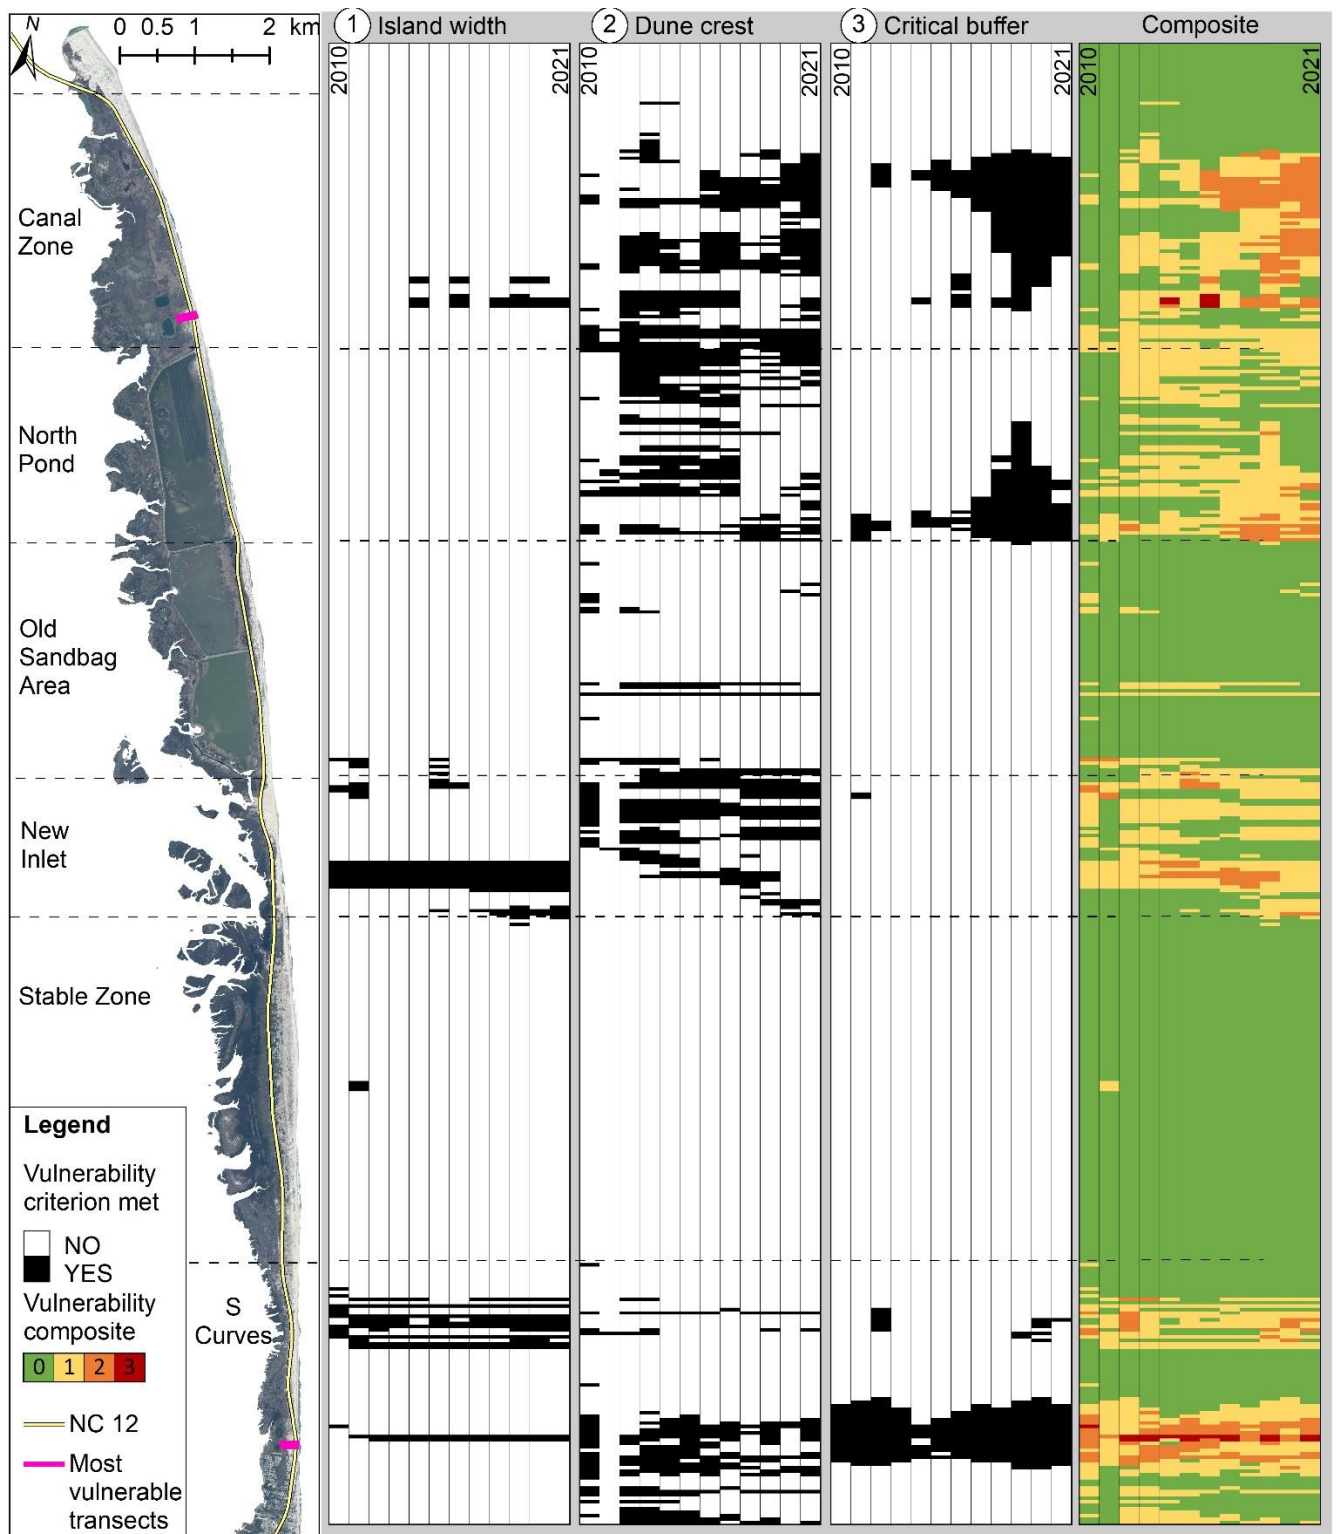
Figure 60. Comparison of vulnerability from the baseline report to the 2021 report. Vulnerabilities reported at the end of each study year.

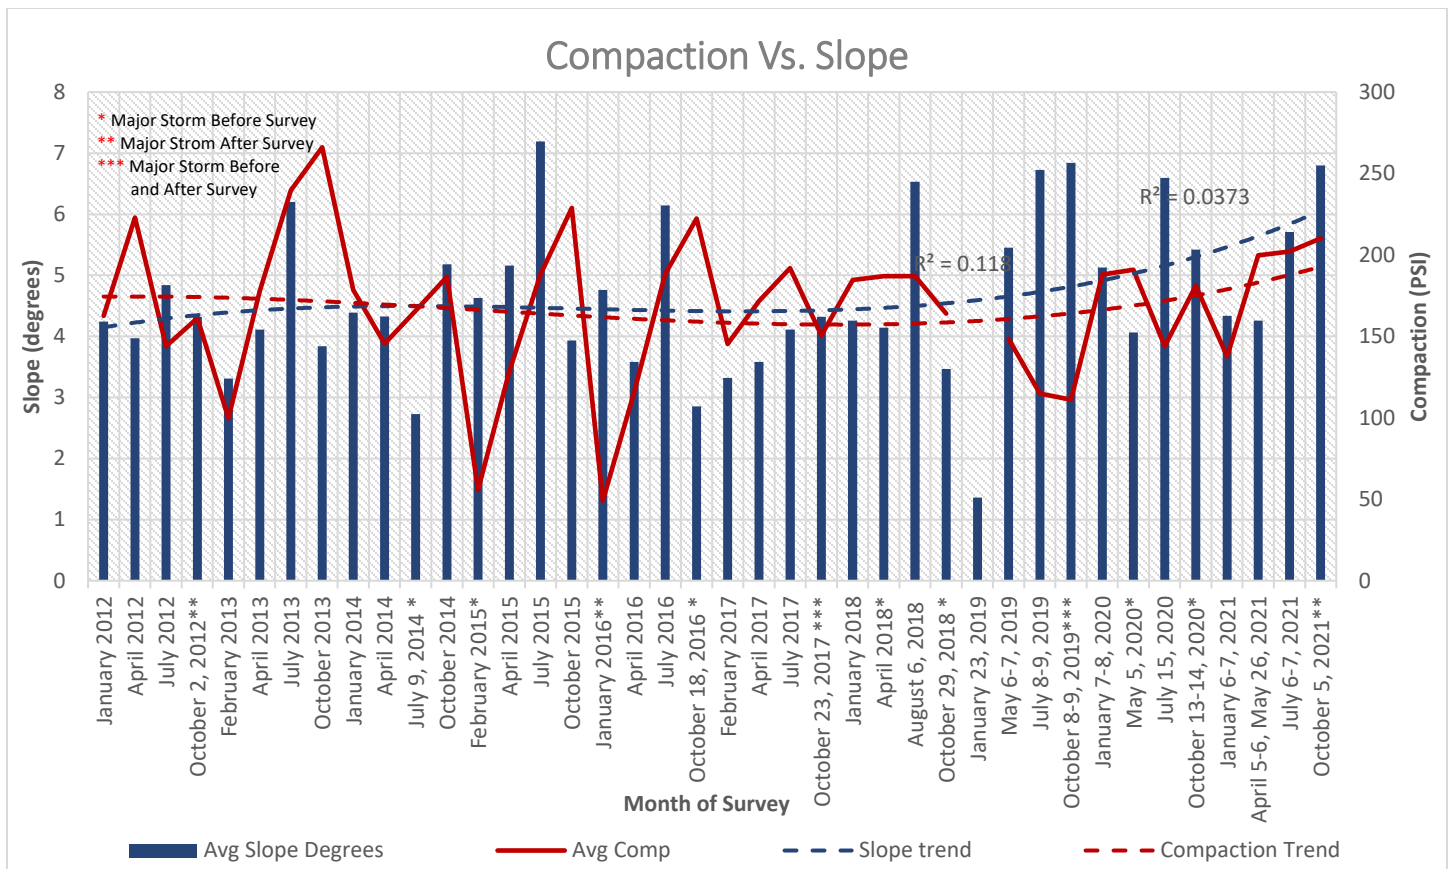
Fig.14 – The comparison between compaction and slope. Note: January 2019 compaction data not available.

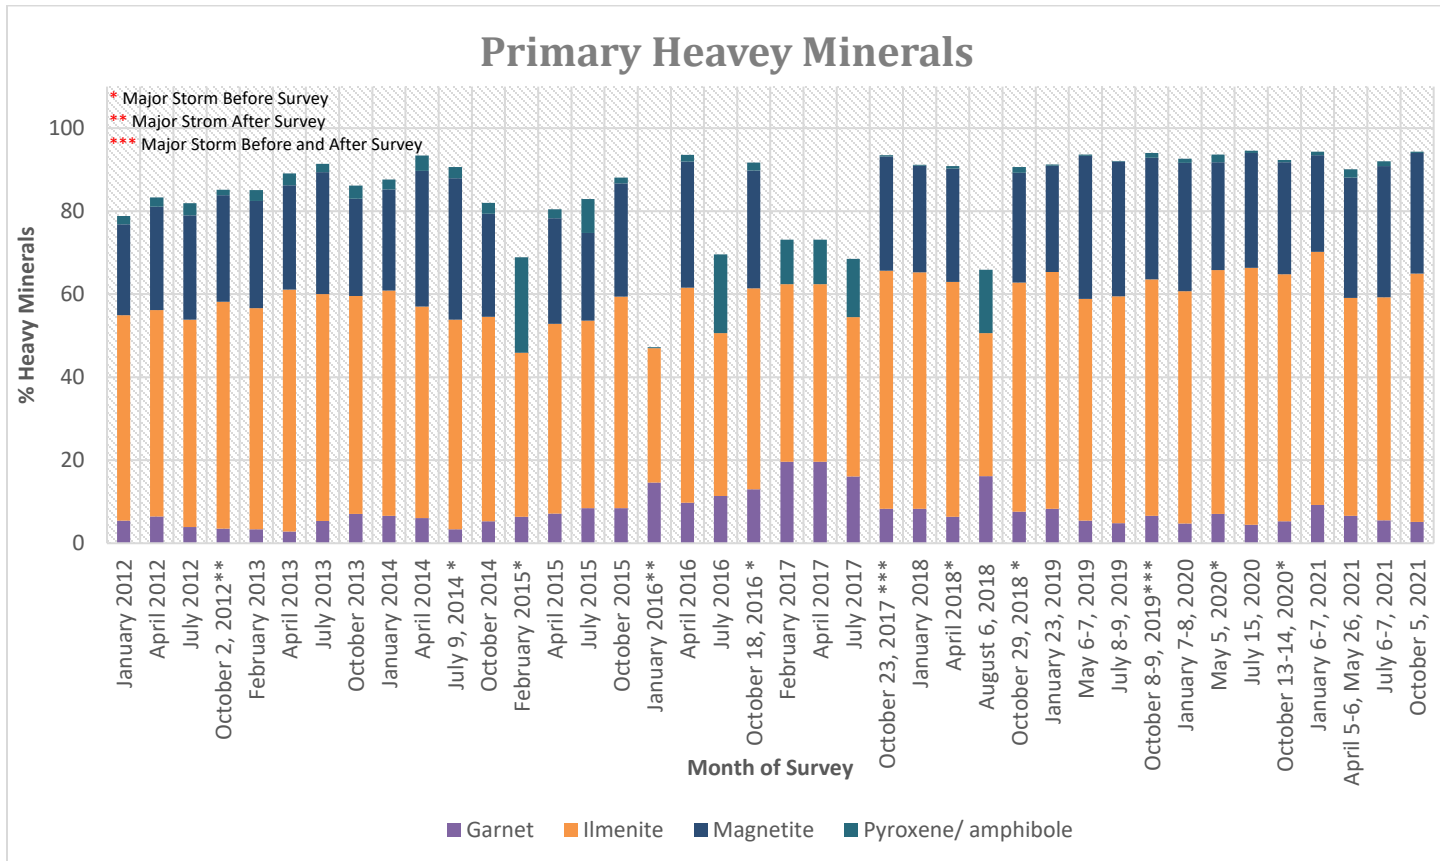
Fig.17 – The percent of primary heavy minerals observed in each survey.

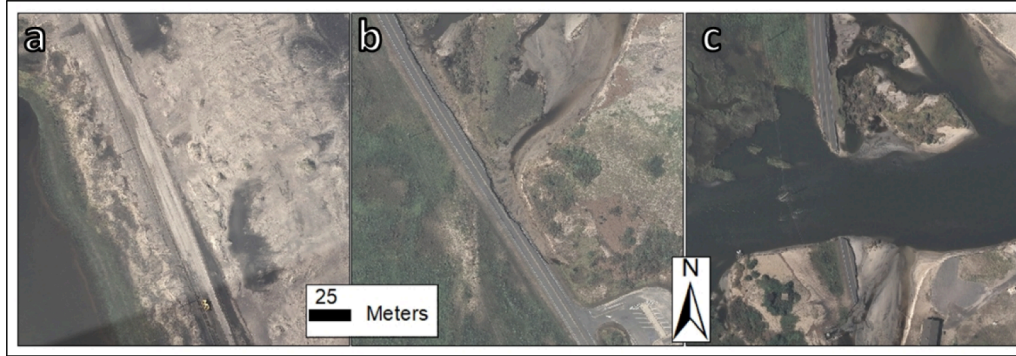
Fig. 3. Storm impacts to the highway after Hurricane Irene in August 2011: (a) overwash sand covered road; (b) ocean-side erosion damaged pavement; (c) island breach damaged pavement.

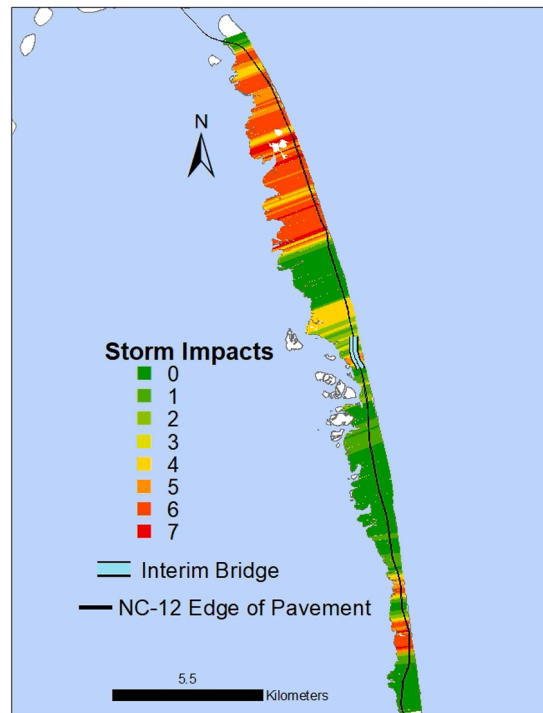
Fig. 8. Distribution of highway impacts along the study area.

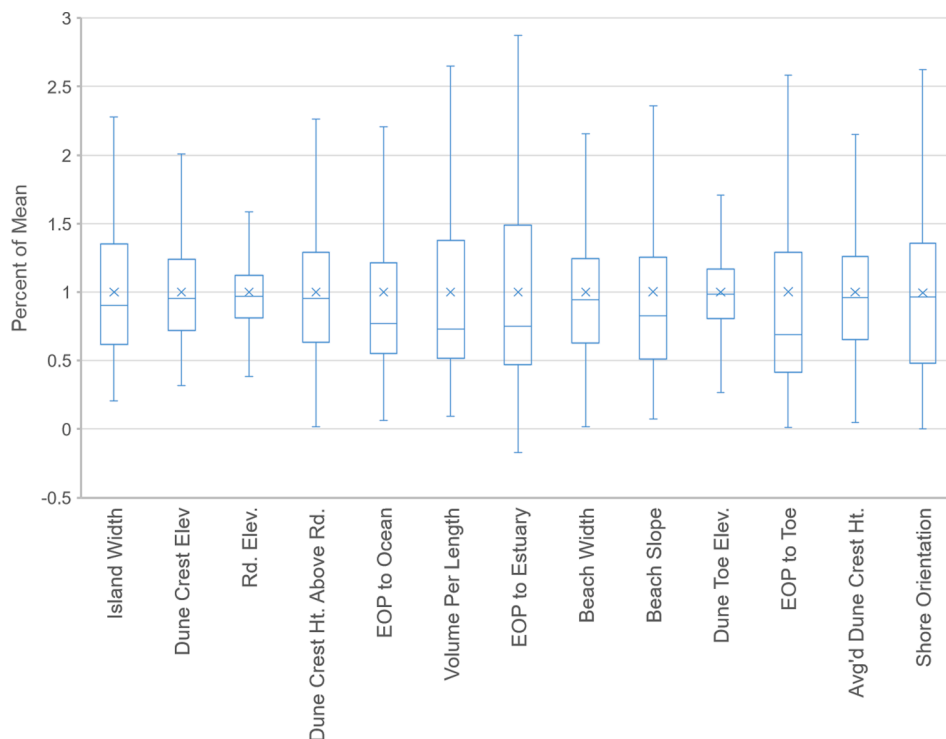
Fig. 10. Box-and-whisker plot of each indicator's values normalized by their average, which summarizes the spread of values around each indicator's mean. The top and bottom whiskers correspond to the maxima and minima. The tops and bottoms of the boxes correspond to the upper and lower quartiles of the data. The × represents the mean, 1 in all cases because the data have been normalized by the mean. The line within each box represents the median.
