TRAFFIC SEPARATION STUDY
FOR THE
TOWN OF MOORESVILLE

August 2018

HDR, Inc.

Prepared for the
North Carolina Department of Transportation

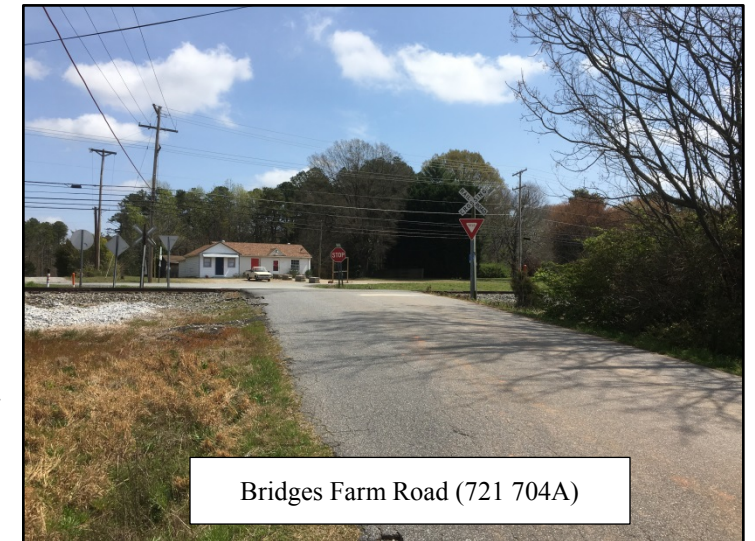
Bridges Farm Road (721 704A)

- Bridges Farm Road (SR 1106) (721 704A) – This is a paved, two-lane, slightly skewed crossing that provides access to a dead end residential area of approximately 200 homes. The railroad is in a tangent section, and the sight distances are adequate. The warning devices at the crossing include crossbuck signs.
- Private road (721 703T) – This is a paved, one-lane, humped crossing with adequate sight distances on a gravel road leading to farm land and a single residence. The warning devices at the crossing include a stop sign on both sides of the railroad.
- Private road (721 702L) – This is a paved, one-lane, severely humped crossing with adequate sight distances on a gravel road leading to vacant wooded land. The warning devices at the crossing include a stop sign on both sides of the railroad.

The installation of flashing lights and gates at a construction cost of approximately \$300,000 is the mid-term recommendation for the Bridges Farm Road crossing.

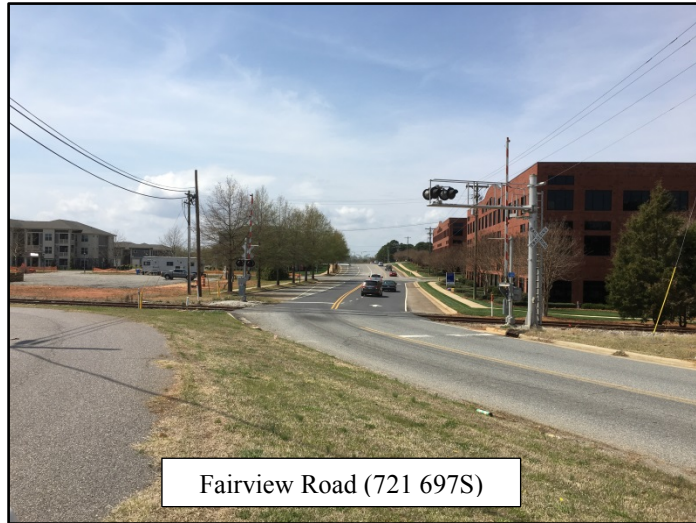
Fairview Road (721 697S)

- Fairview Road (SR 1246) (721 697S) – This is a paved, two-lane crossing with limited sight distances due to a horizontal curve to the south and trees and vegetation to the north. Fairview Road is approximately 65 feet wide (four to five lanes) and perpendicular to the crossing on the west side. It is 32 feet wide. **Brawley Avenue (721 685X)** (two lanes) beginning at the crossing and immediately curves to the north heading towards NC 115. Lake Norman Regional Medical Center lies approximately 0.2 mile west of the crossing. The warning devices at the crossing include crossbuck signs, flashing lights, and gates.

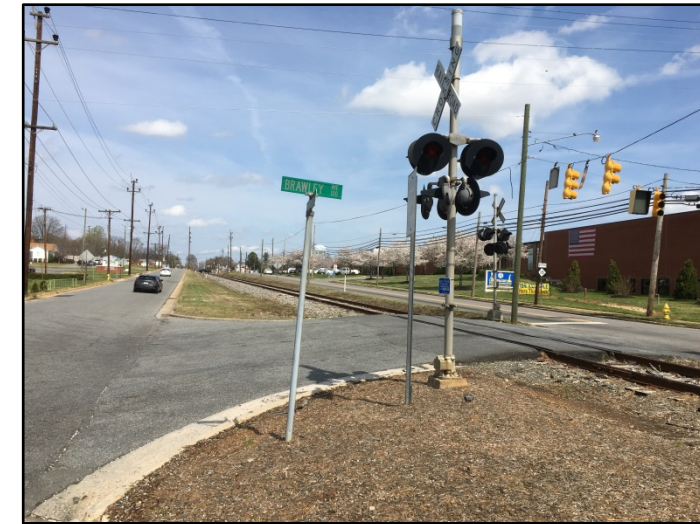
- Brawley Avenue (721 685X) – This is a paved, two-lane, humped crossing with adequate sight distances. The crossing geometry is similar to Norman Drive/Doster Avenue in that it is very close to NC 115, leaving little room to allow a car to wait on the east side to turn without being on the tracks. Brawley Avenue ends at South Broad Street immediately to the west of the crossing. The parking driveway for a municipal baseball field is across South Broad Street from the crossing. There is frequent pedestrian activity at this crossing. The warning devices at the crossing include crossbuck signs and flashing lights. There is not enough clearance for gates.

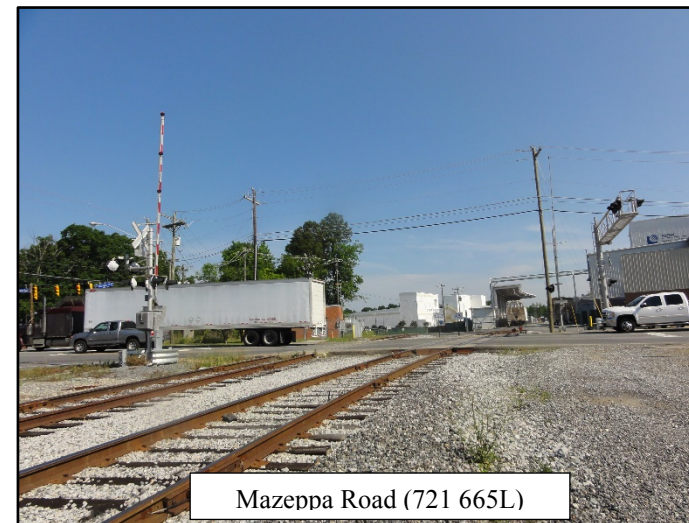
- Mazeppa Road (SR 2395) (721 665L) – This is a paved, three-lane, two-track crossing with concrete surfaces and adequate sight distances. The NGK Ceramics plant is located in the northeast quadrant of the crossing. Trains making deliveries to the plant frequently block the Mazeppa Road crossing. Mazeppa Road experiences a high volume of traffic and serves numerous industrial/manufacturing facilities east of the crossing. Mazeppa Road turns into the recently constructed Connector Road west of NC 115, crosses over US 21 and will eventually connect to I-77 at a future interchange. The warning devices at the crossing include crossbuck signs, flashing lights, and gates.

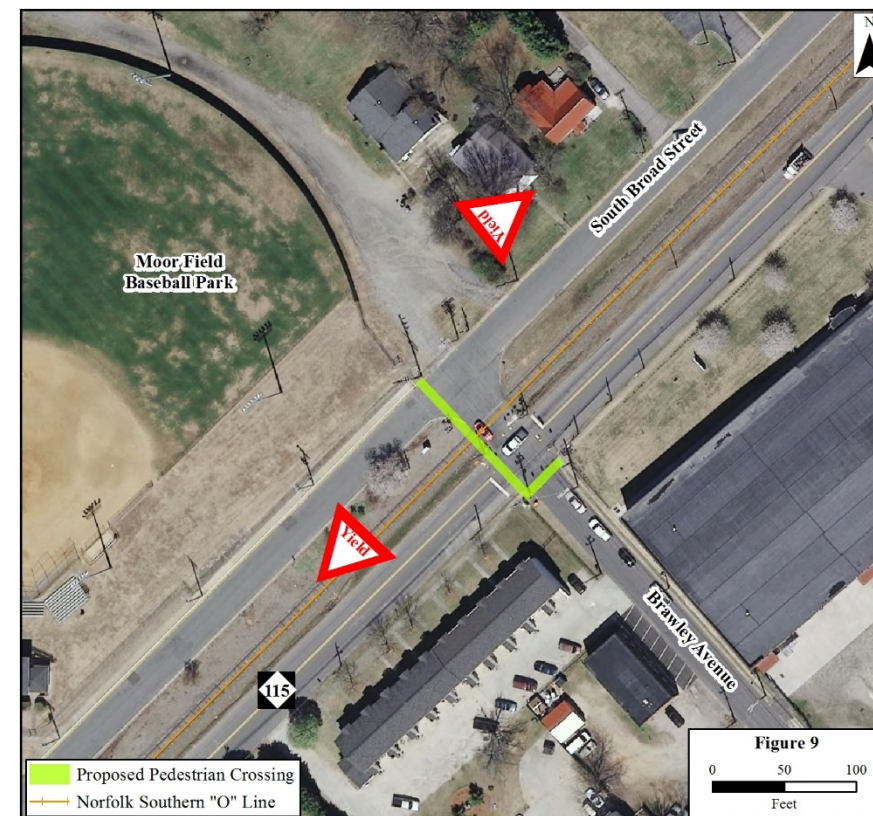
The Brawley Avenue crossing is a paved, two-lane, humped crossing with a poor crossing surface and adequate sight distances that carries 3,400 vpd. The crossing geometry is similar to Norman Drive/Doster Avenue in that it is very close to NC 115, leaving little room to allow a car to wait on the east side to turn without being on the tracks. Brawley Avenue ends at South Broad Street immediately to the west of the crossing. The parking driveway for Moor Field Baseball Park is across South Broad Street from the crossing. There is frequent pedestrian activity but no crosswalks at this crossing. According to a local official, people often park on the east side of NC 115 and walk across the railroad to the baseball field. The warning devices at the crossing include crossbuck signs and flashing lights. There is not enough clearance for gates. Local police, fire and EMS officials indicate this crossing presents difficulties for tractor trailers due to the severity of the hump and the narrow crossing width. Currently, Brawley Avenue traffic must yield to South Broad Street traffic at the crossing – sometimes causing vehicles to stop on the tracks while waiting to turn.

The near-term recommendation for the Brawley Avenue crossing is to improve the crossing surface at an estimated construction cost of \$3,000 and change the signage so South Broad Street traffic yields to Brawley Avenue traffic. Traffic patterns at the crossing will change with the closing of the two crossings on both sides of the Brawley Avenue crossing (Norman Drive/Doster Avenue and Mills Avenue) and the future opening of the nearby Timber Road Extension. A traffic analysis should be conducted that considers future traffic patterns as a result of the closures and new at-grade crossing.

A mid-term recommendation for the Brawley Avenue crossing is to widen it to accommodate tractor trailer turning movements and a pedestrian crosswalk at an estimated construction cost of \$156,000. Crosswalks should be provided across Brawley Avenue east of NC 115 and across NC 115 and South Broad Street on the south side of the crossing (see Figure 9). The flashing lights should be upgraded in conjunction with widening the crossing.

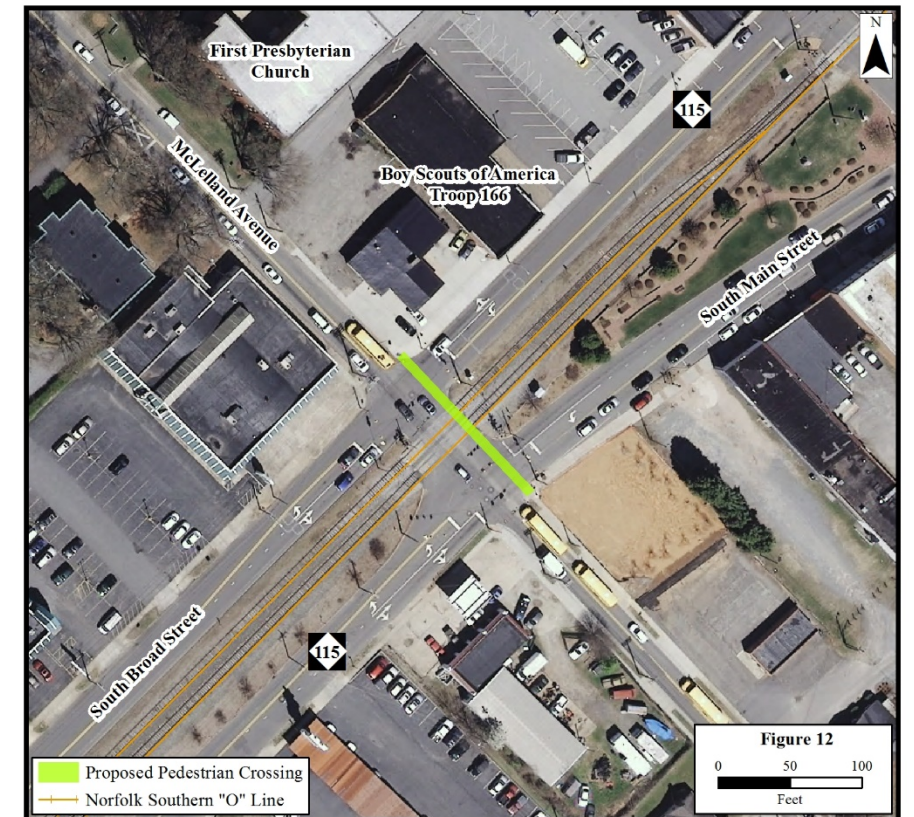
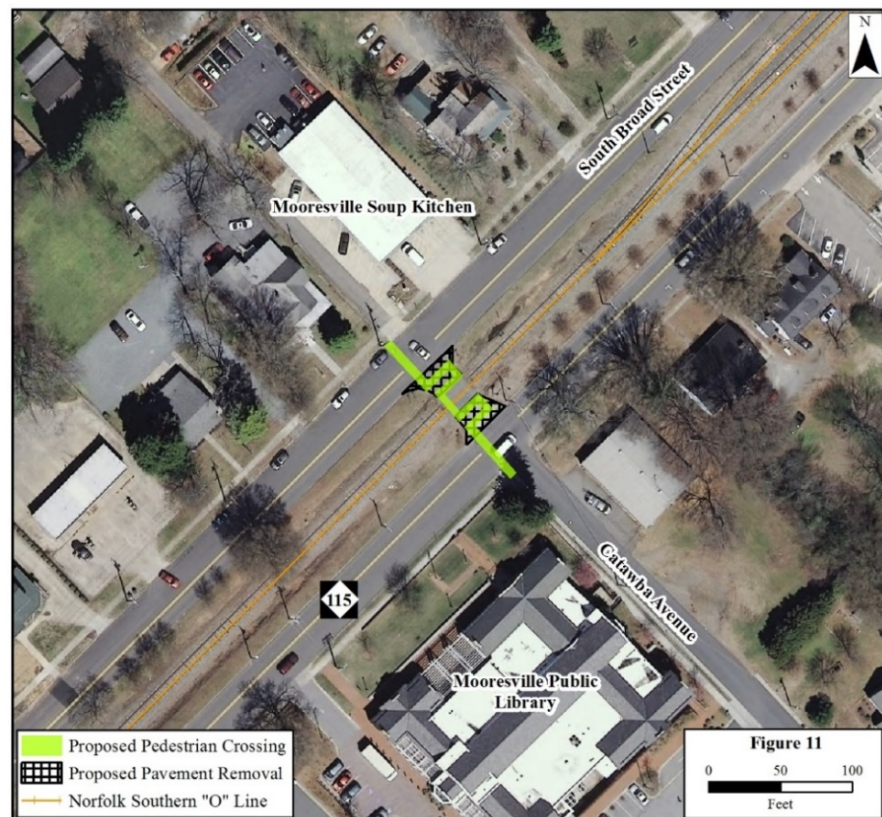
The McLelland Avenue crossing is a wide, paved, two-lane, humped crossing with a good concrete surface and adequate sight distance to the south and limited to the north due to a horizontal curve in the railroad. Approximately 5,200 vpd use the crossing. It is in close proximity to NC 115 and South Broad Street, similar to the crossings discussed above. NC 115 is on the east side of the tracks south of the McLelland Avenue crossing and crosses to the west side north of the crossing. There are existing sidewalks on both sides of McLelland Avenue east of NC 115/South Main Street and west of NC 115/South Broad Street. Sidewalks are also present along the east side of NC 115/South Main Street and the west side of NC 115/South Broad Street. There are no pedestrian crosswalks in the vicinity of the McLelland Avenue railroad crossing. The warning devices at the crossing include crossbuck signs, flashing lights, and gates.

The near-term recommendation for the McLelland Avenue crossing calls for a pedestrian crosswalk across NC 115 and South Main Street on the north side of the crossing at an estimated construction cost of \$1,000 (see Figure 12). Upgrading the flashing lights and gates at a construction cost of \$300,000 is the mid-term recommendation.
