NC Department of Transportation  
**RAIL DIVISION**

# WILMINGTON

## TRAFFIC SEPARATION STUDY

FEBRUARY 2017

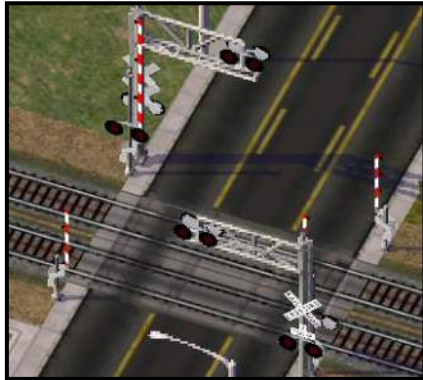
This crossing treatment requires an additional gate on each approach, completely "sealing" the crossing. Several measures are employed to prevent vehicles from becoming "trapped" inside the gates, including careful timing of the gates to allow traffic to clear; providing 16 feet of clearance between track center and gates; leaving adequate space between gate tips for a vehicle to "squeeze" out; and use of breakaway arms. In tests at the

Example of 4 Quadrant Gate

Sugar Creek Road crossing in Charlotte, four-quadrant gates alone reduced violations by 86%; in combination with median barriers, the reduction in violations rose to 98%.
