# Spot Safety Project Evaluation

Spot Safety Project # 02-02-264

**Spot Safety Project Evaluation of the Addition of Left-Turn Lanes on US 13 - 258  
US 13 – 258 at NC 123 and SR 1301 (Vandiford-Thomas Road)  
Greene County**

Documents Prepared By:  
Stantec Consulting Services Inc.  
for  
Safety Evaluation Group  
Traffic Safety Systems Management Section  
Transportation Mobility and Safety Division  
North Carolina Department of Transportation

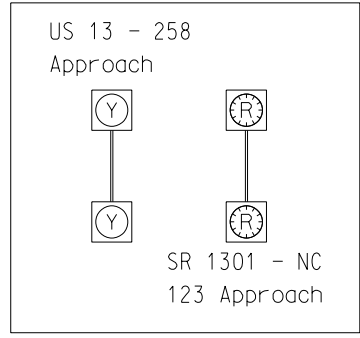
SS# 02-02-264  
 Greene County  
 Before Period  
 6/1/02 - 10/31/07

Target Crashes

Referencing the *Collision Diagrams*, there were three (3) target crashes in the before period. There were no target crashes in the after. The target severity index decreased from 5.9 to 0, as there were no target crashes in the after period.

All three (3) of the target crashes in the before period were rear end crashes. These crashes occurred on the southbound leg of the intersection. There were no target crashes on the northbound leg of US 13 – 258 in the before period.

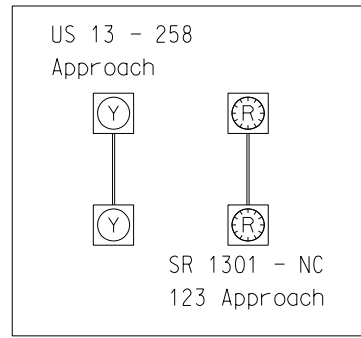
SS# 02-02-264  
 Greene County  
 After Period  
 3/1/08 - 7/31/13

NOTE Crash 3:  
 Vehicle Traveled Off the Roadway  
 to Avoid a Collision with a Vehicle  
 that Pulled from the Intersection

From the additional information chart above, the number of angle crashes remained the same from the before period to the after period. Additionally, left turn, different roadway crashes were reduced from two (2) to one (1) from the before period to the after. Two (2) of angle crashes and the one (1) left turn, different roadway crashes from the after period, all included a southbound through vehicle on US 13 – 258.
