Spot Safety Project Evaluation

Spot Safety Project # 07-02-216

Spot Safety Project Evaluation of the Installation of Pedestrian Signal Heads and Upgrade of Vehicular Signal Heads NC 86 SB Couplet (Pittsboro Street) at Cameron Avenue Orange County

Documents Prepared By:
Stantec Consulting Ltd.
for
Safety Evaluation Group
Traffic Safety Systems Management Section
Transportation Mobility and Safety Division
North Carolina Department of Transportation

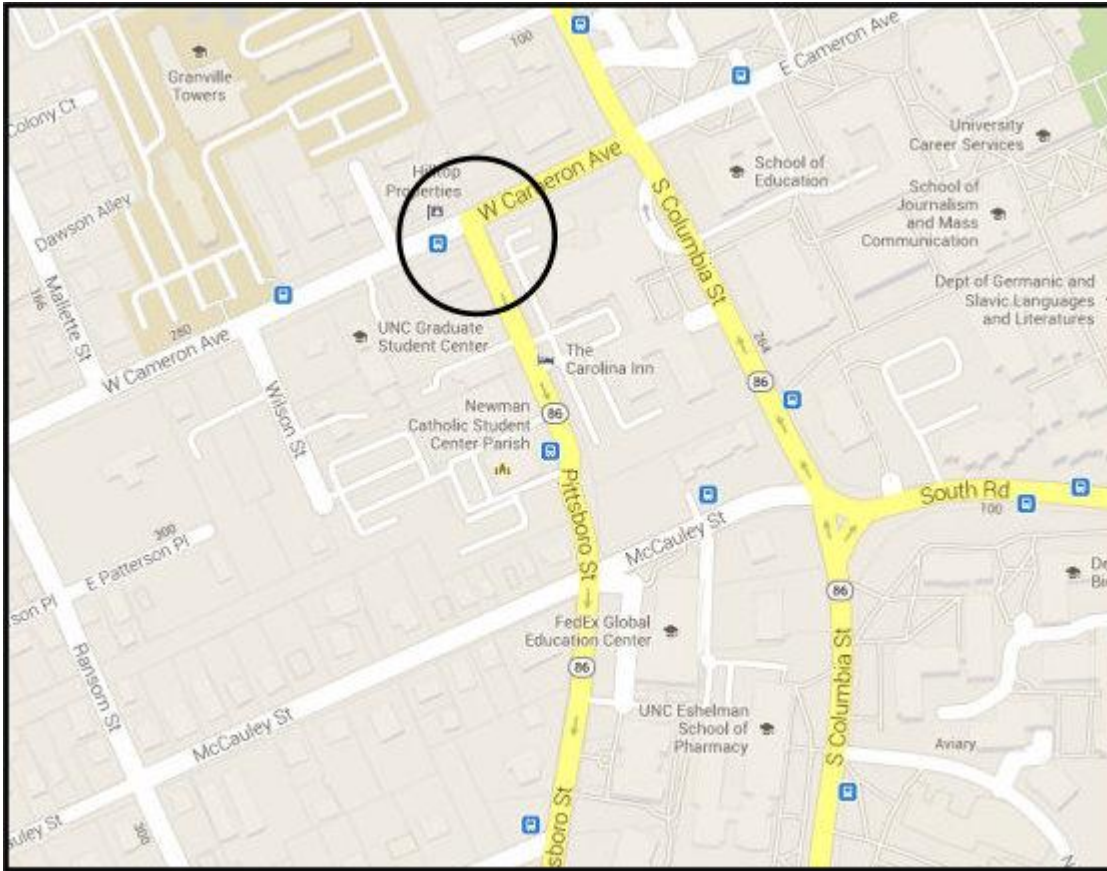
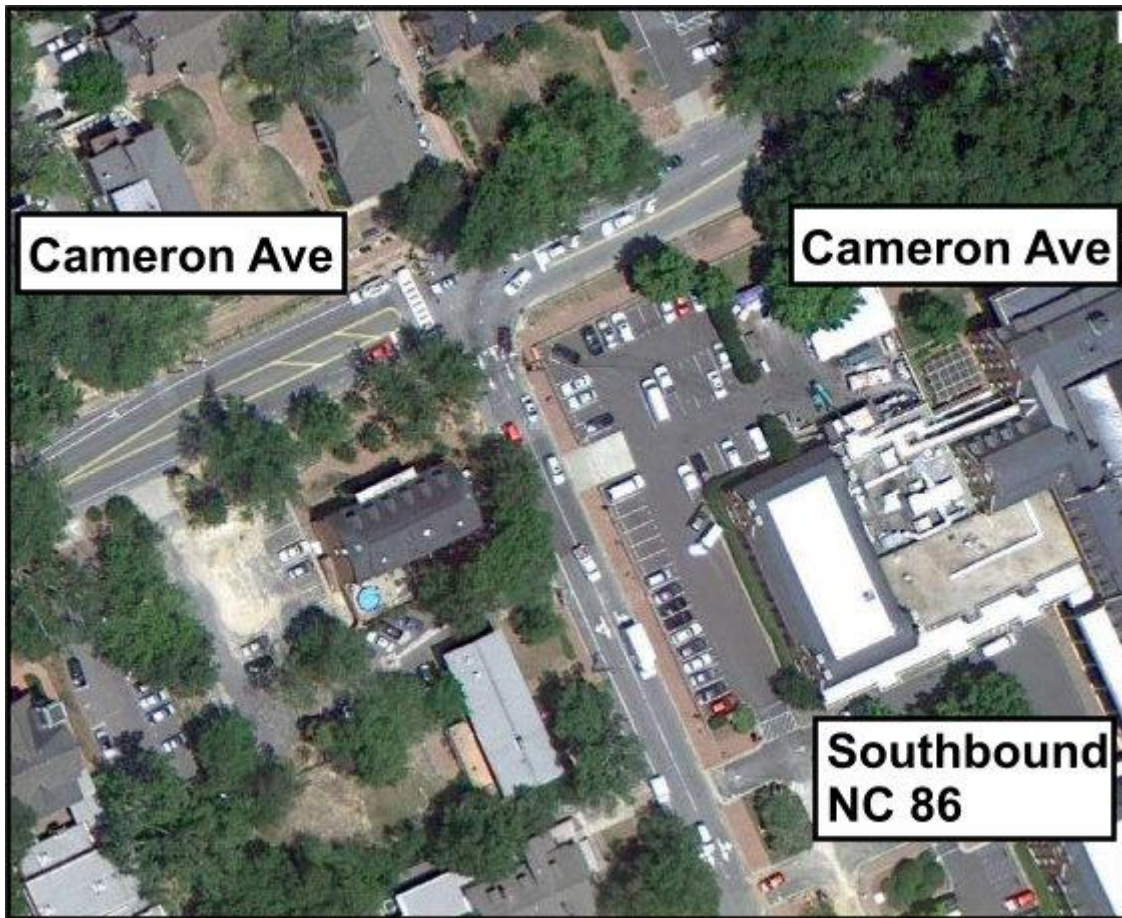
Aerial Provided from Google Maps

Evaluation of Spot Safety Project Number 07-02-216 located at the Intersection of NC 86 SB Couplet (Pittsboro Street) at Cameron Avenue in Orange County, Town of Chapel Hill.

The spot safety project improvement countermeasure chosen for the subject location was the installation of pedestrian signal heads across the east side of Cameron Avenue, and an upgrade of vehicular signal heads to 12”.

NC 86 SB Couplet (Pittsboro Street) is a 2-lane, one way road with bike lanes. Cameron Avenue is a two-lane road, with bike lanes, that widens for a left and right turn lanes at the intersection. The speed limit on NC 86 SB Couplet (Pittsboro Street) and Cameron Avenue is 25 mph. The subject location is signal-controlled.

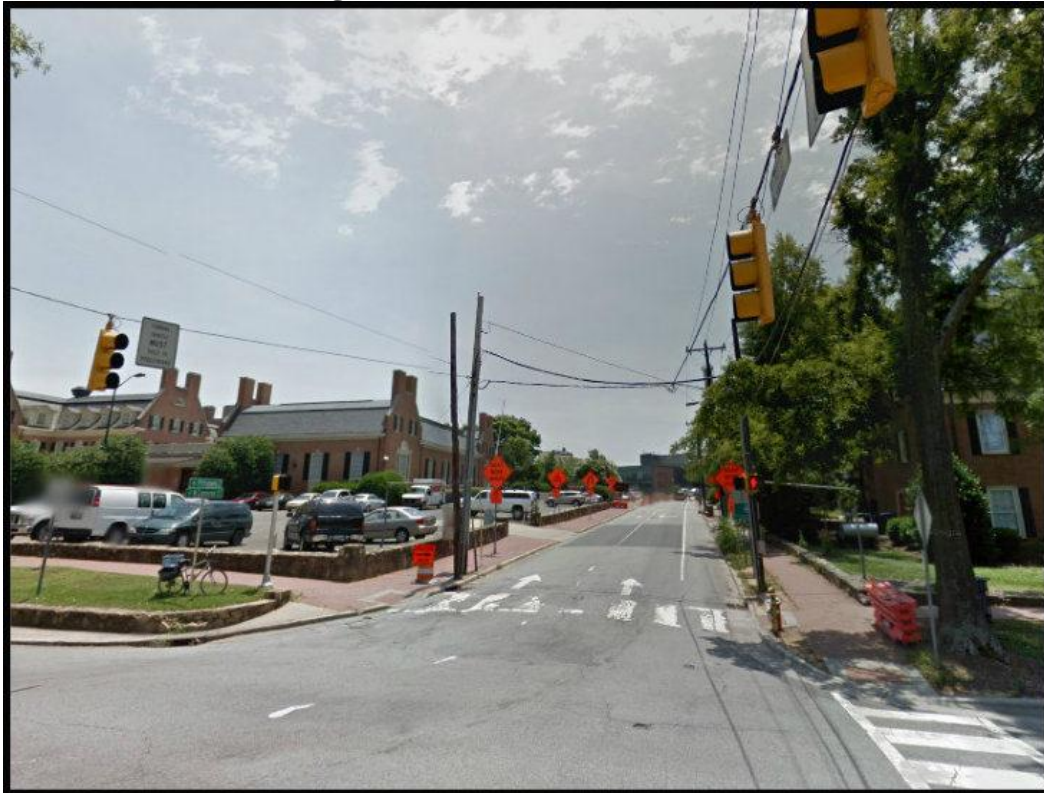
Google Maps (May 2012) – Looking South from NC 86 (Pittsboro Street) Approach

Please see the attached *Treatment Site Photos*. Photos are provided from Google Street View for all three approaches to the treatment intersection. As the Safety Evaluation Group completes additional spot safety reviews for this type of countermeasure, we will be able to provide objective and definite information regarding actual crash reduction factors for this type of intersection.

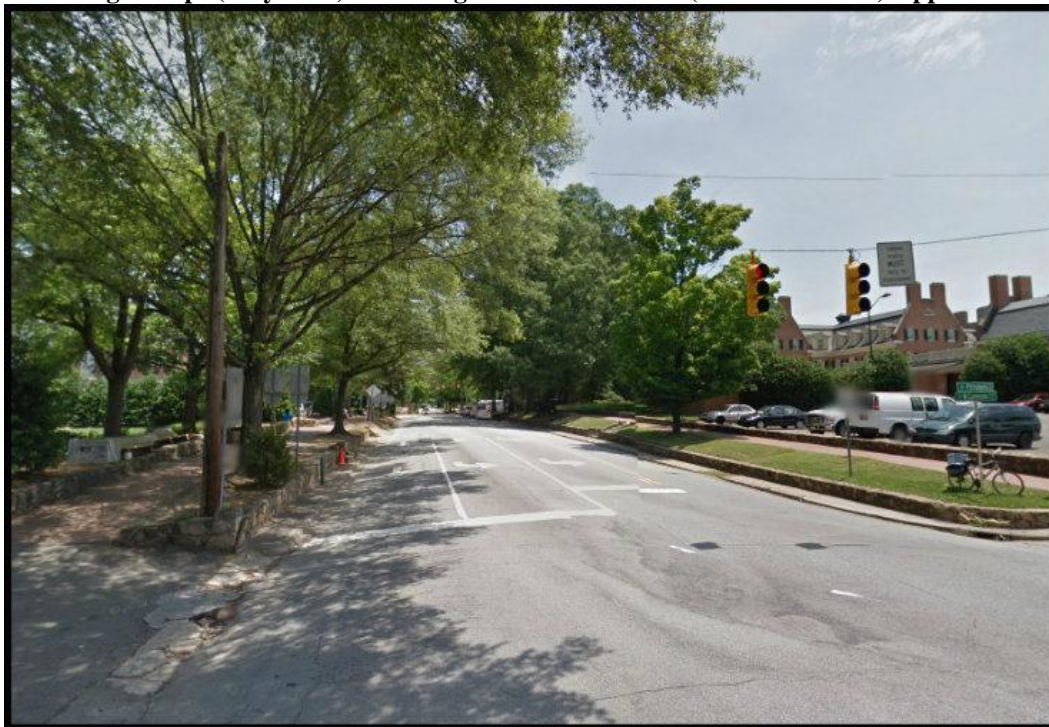
Google Maps (May 2012) – Looking East from Cameron Avenue Approach

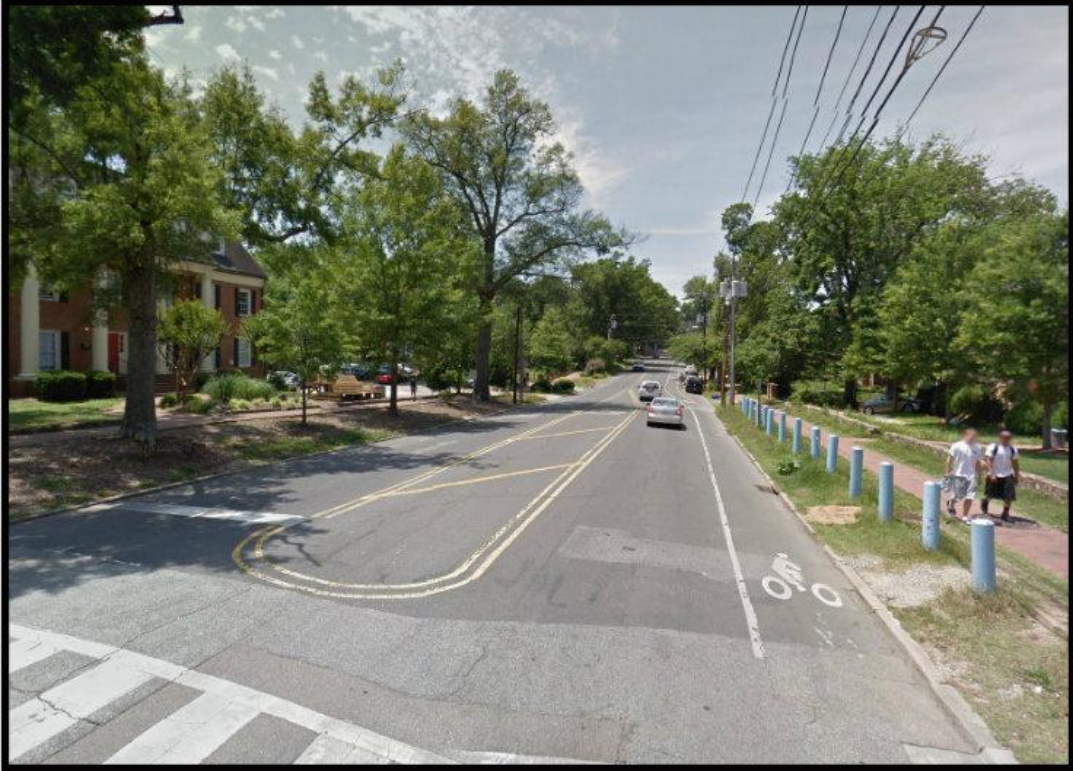
Google Maps (May 2012) – Looking West Cameron Avenue Approach

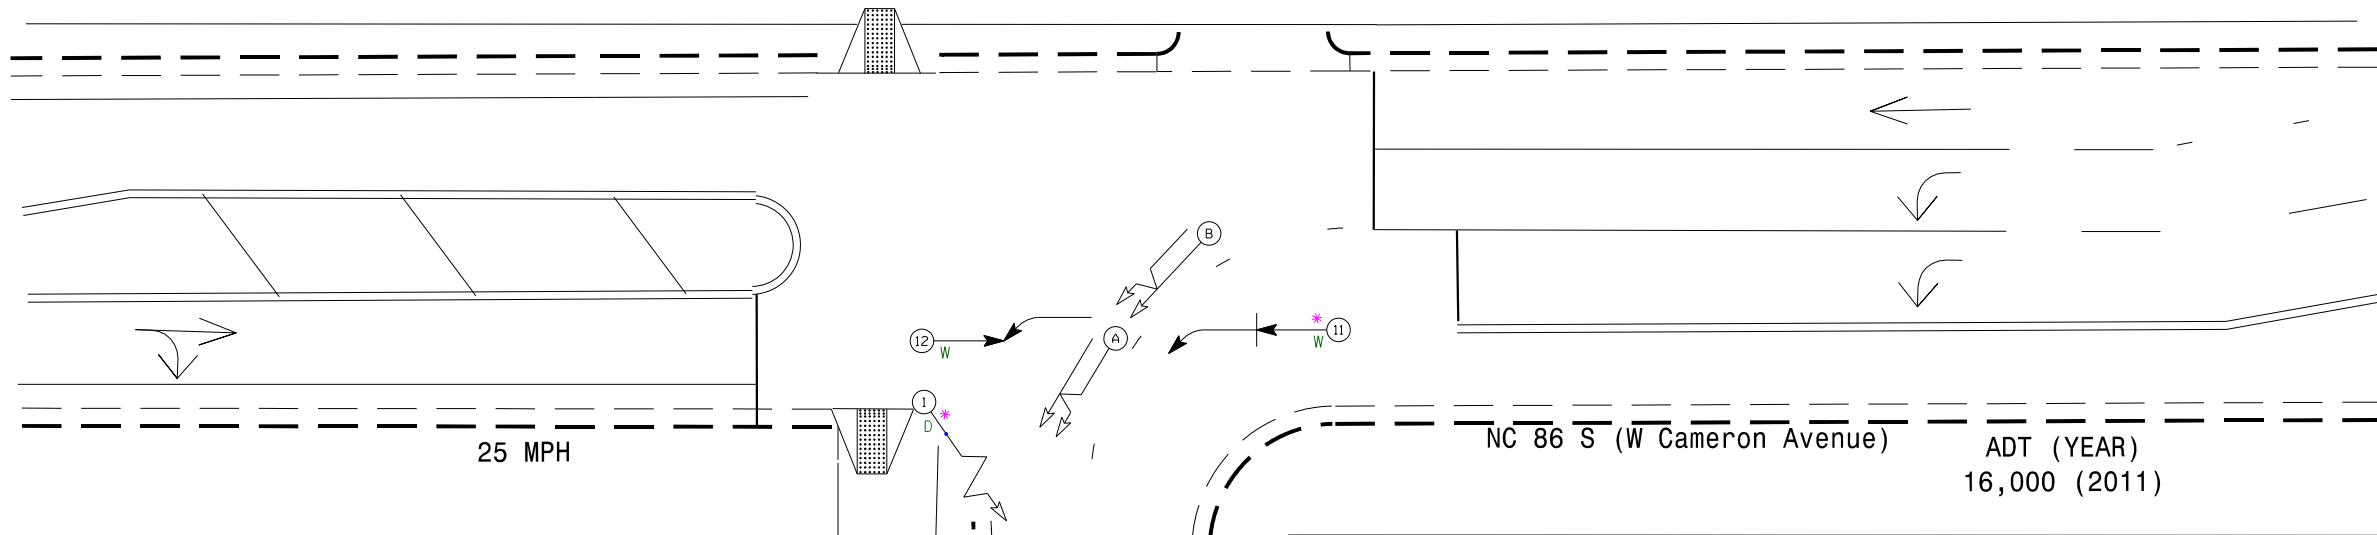
SS# 07-02-216
 Orange County
 After Period
 2/1/09 - 6/30/13

ADT (YEAR)
 7,500 (2011)

ADT (YEAR)
 16,000 (2011)

ADT (YEAR)
 10,000 (2011)
 NC 86 S (Pittsboro Street)

Referencing the *Collision Diagrams*, there were no target crashes in the before or after period. The target crash severity index was zero (0) in both instances.

From the additional information chart above, the number of sideswipe crashes in the intersection are shown reducing from seventeen (17) to fifteen (15) from the before period to the after period. In the before period, thirteen (13) of the sideswipe crashes in the intersection cite the driver in the inside lane as at fault. In the intersection for the after period, nine (9) sideswipes place fault on the inside driver and four (4) place fault on both drivers.
