Spot Safety Project Evaluation

Spot Safety Project # 10-01-202

**Spot Safety Project Evaluation of the Intersection Realignment and Traffic Signal Installation
NC 27 (Mount Holly Road) at SR 1666 (Mount Holly-Huntersville Road)
Mecklenburg County**

Hatch Mott MacDonald For:

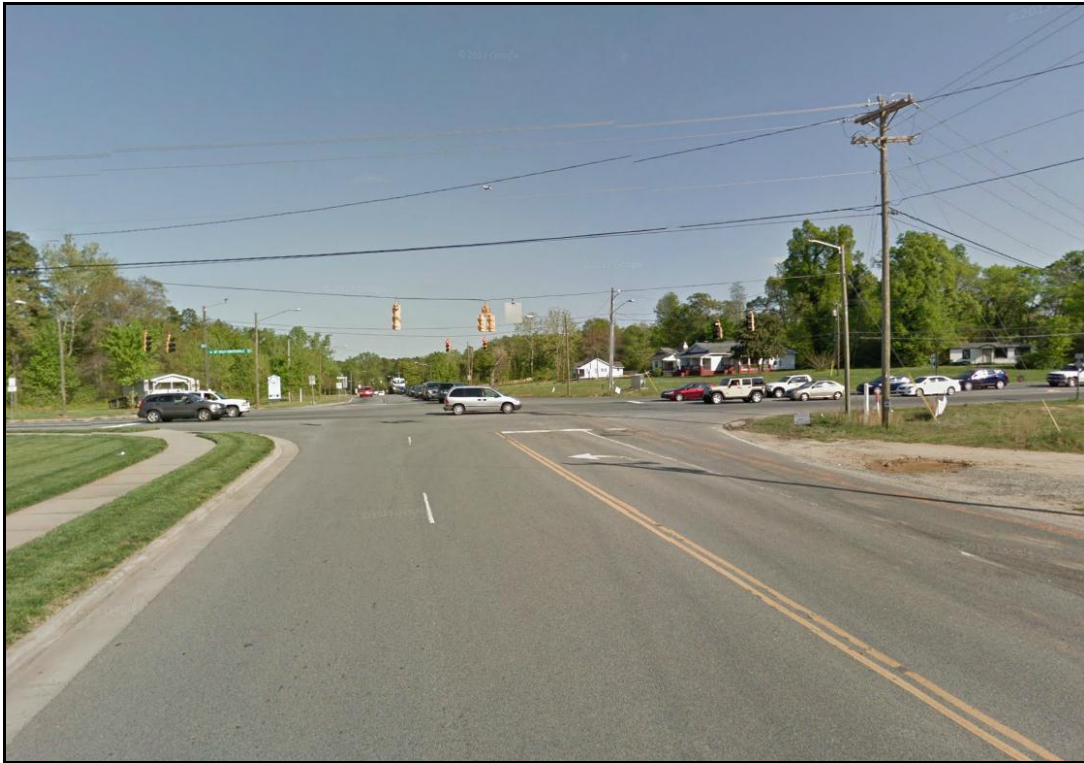
Google Maps (April 2013) – Looking East on Mount Holly Road Approach

Please see the attached *Treatment Site Photos*. Photos are provided from Google Street View for all four approaches to the treatment intersection. As the Safety Evaluation Group completes additional spot safety reviews for this type of countermeasure, we will be able to provide objective and definite information regarding actual crash reduction factors for this type of intersection.

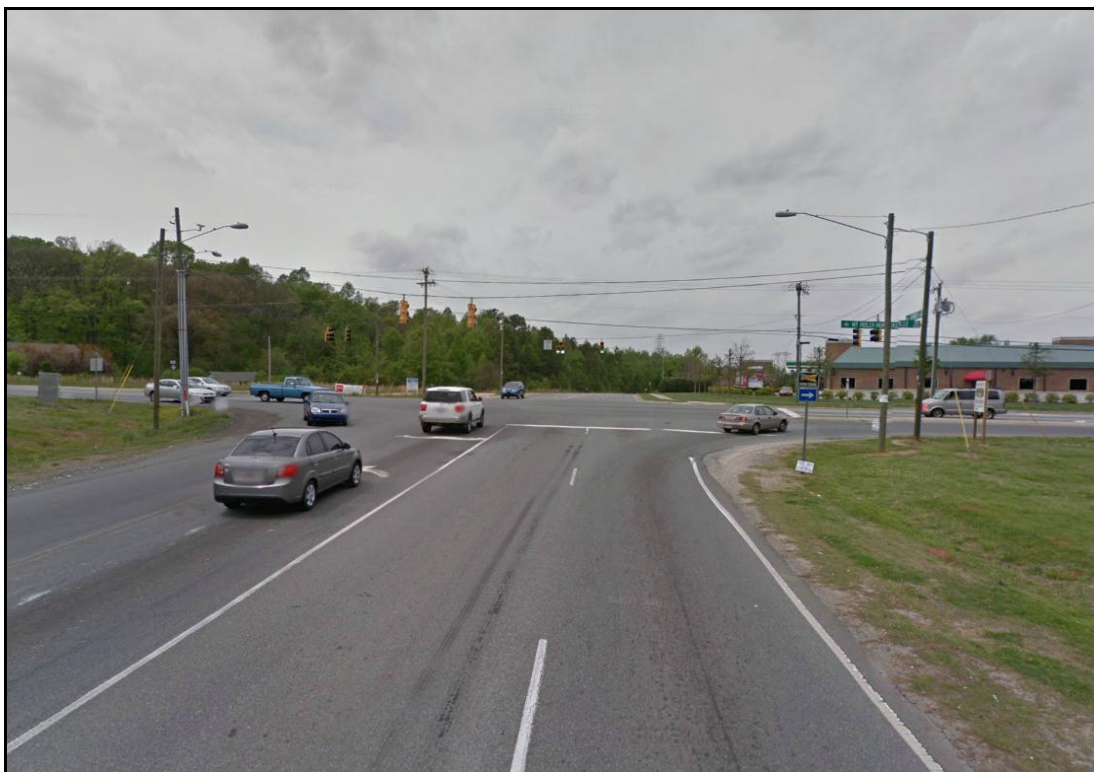
Google Maps (April 2013) – Looking West on NC 27 Approach

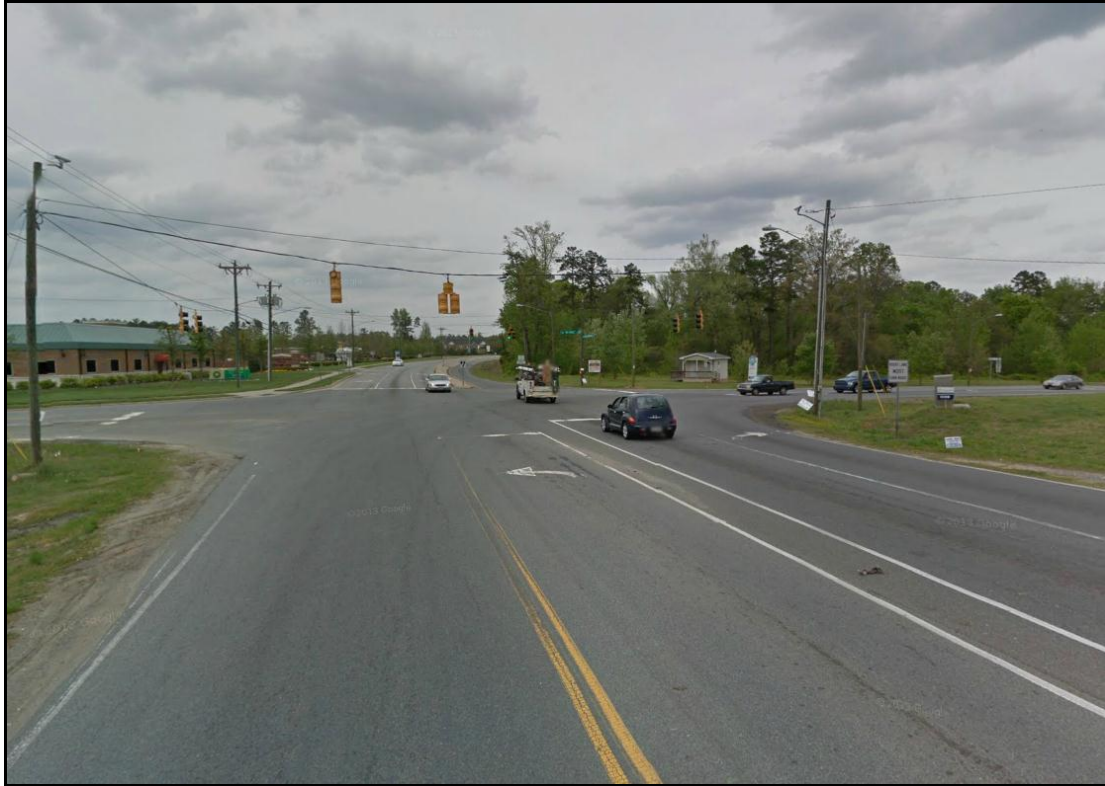
Google Maps (April 2013) – Looking North on NC 27 Approach

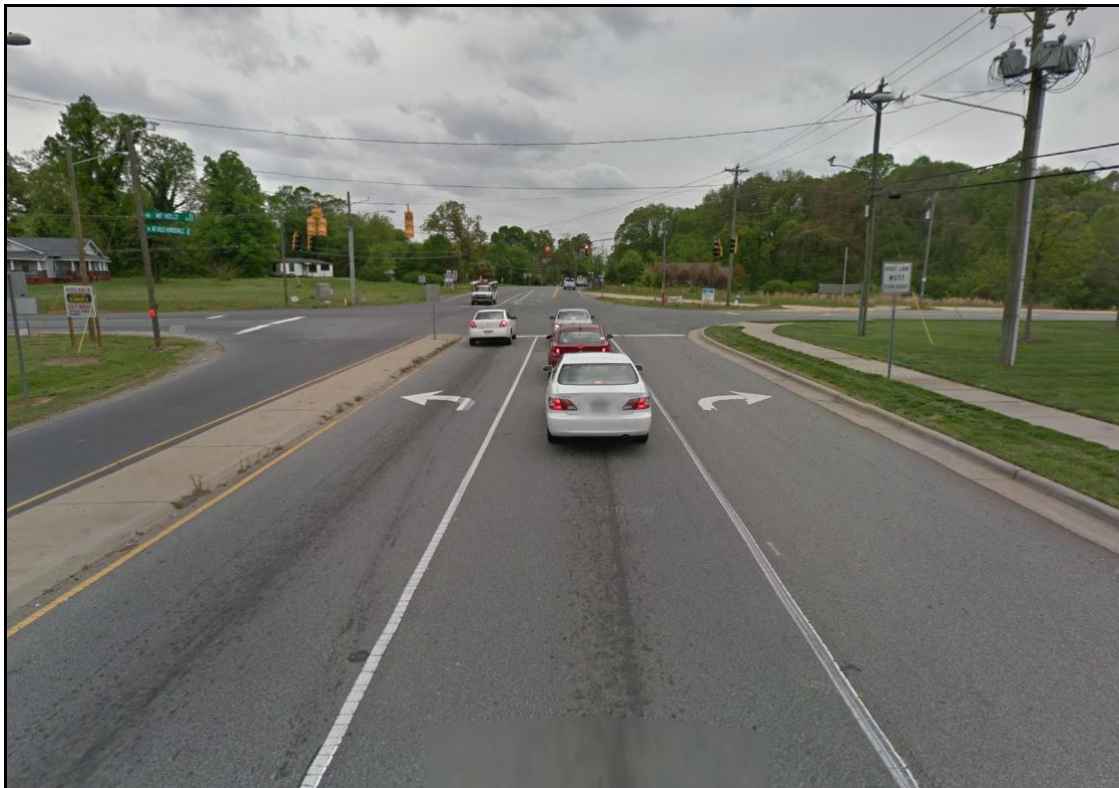
Google Maps (April 2013) – Looking South on SR 1666 Approach

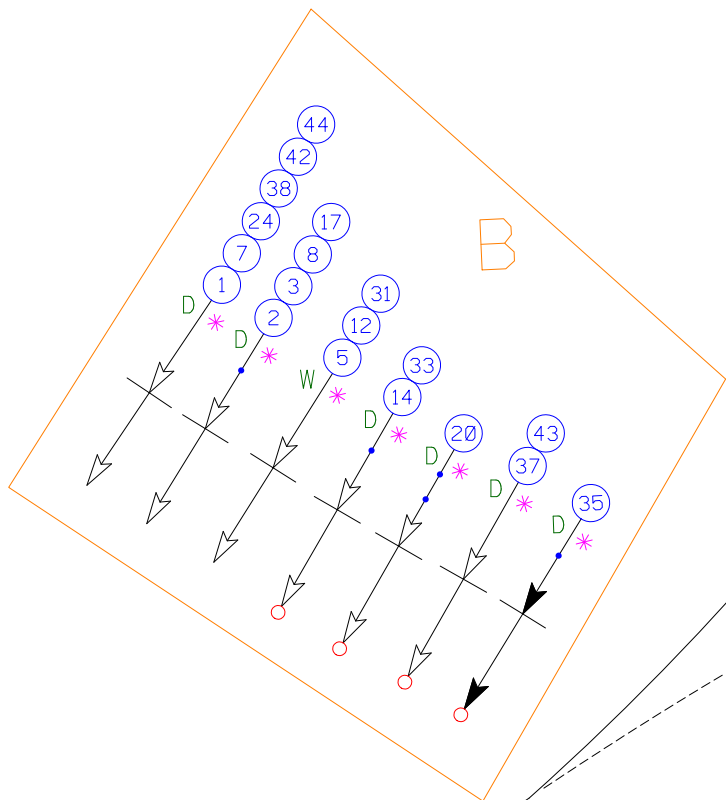
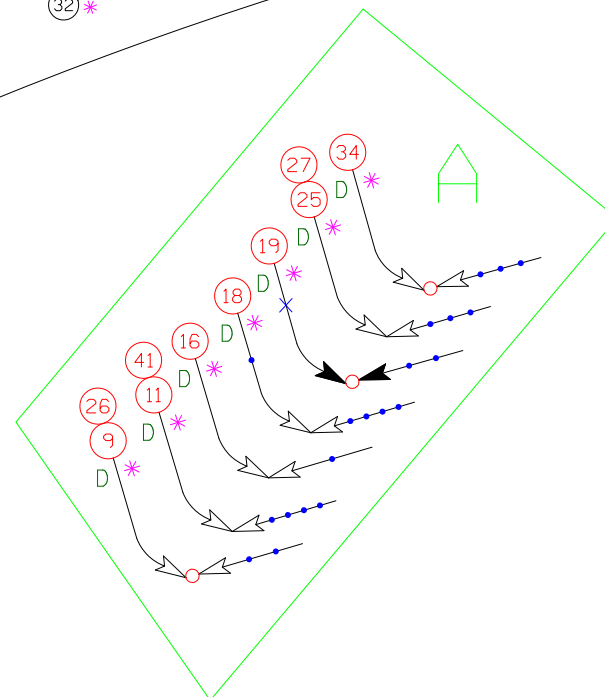
SS# 10-02-202
 Mecklenburg County
 BEFORE Period
 6/1/01 - 5/31/04

Mt. Holly-Huntersville Road
 (SR 1666)
 45 mph

Mt. Holly Road (NC 27)
 45 mph

Target 1 -
 Frontal Impact Crashes

Target 2 -
 Southbound SR 1666
 Rear End Crashes

Referencing the *Collision Diagrams* and the above tables, the Total Crashes per year decreased from the Before period to the After period; however, the Total Severity Index increased slightly from 4.20 in the Before period to 4.51 in the After period.

Target 1 crashes per year decreased from 7.00 cpy in the Before period to 3.03 cpy in the After period. The Severity Index increased from 4.88 to 5.66 for these crashes, respectively. The Target 2 crashes also showed a decrease, with 6.33 cpy in the Before period and 0.90 in the After period. The Severity Index for Target 2 crashes also decreased from 3.34 in the Before period to 2.85 in the After period.
