Spot Safety Project Evaluation

Spot Safety Project # 10-02-209

**Spot Safety Project Evaluation of the
Road Realignment and
Signal Installation
SR 2805 (Harrisburg Road) and
SR 2822 (Robinson Church Road)
Mecklenburg County**

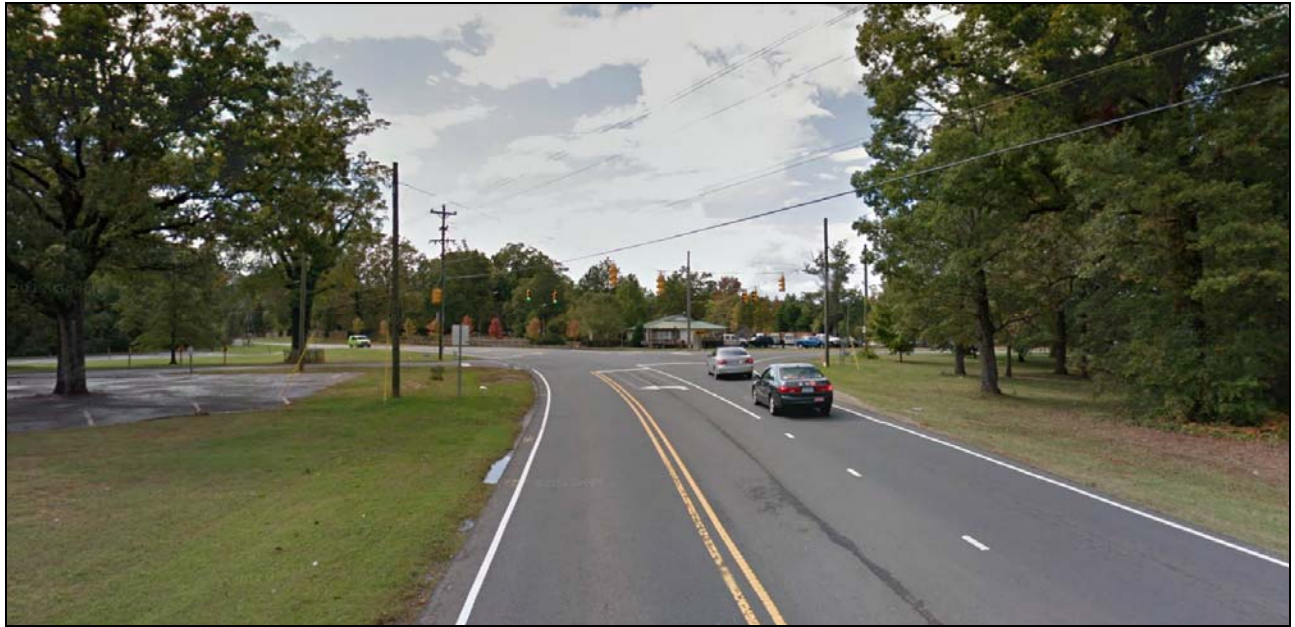
Google Maps (October 2011) – Looking Southwest on SR 2805

Please see the attached *Treatment Site Photos*. Photos are provided from Google Street View for all four approaches to the treatment intersection. As the Safety Evaluation Group facilitates additional spot safety review for these types of countermeasures, it is the goal to be able to provide objective and definite information regarding actual crash reduction factors for these types of treatments.

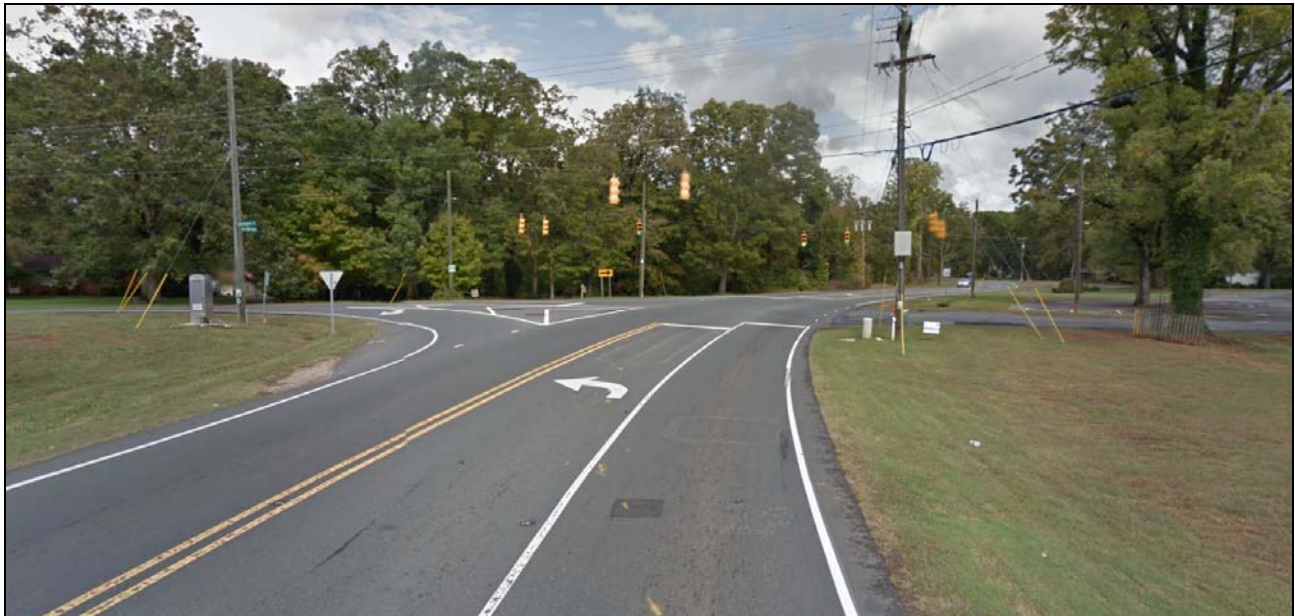
Google Maps (October 2011) – Looking Northeast on SR 2805

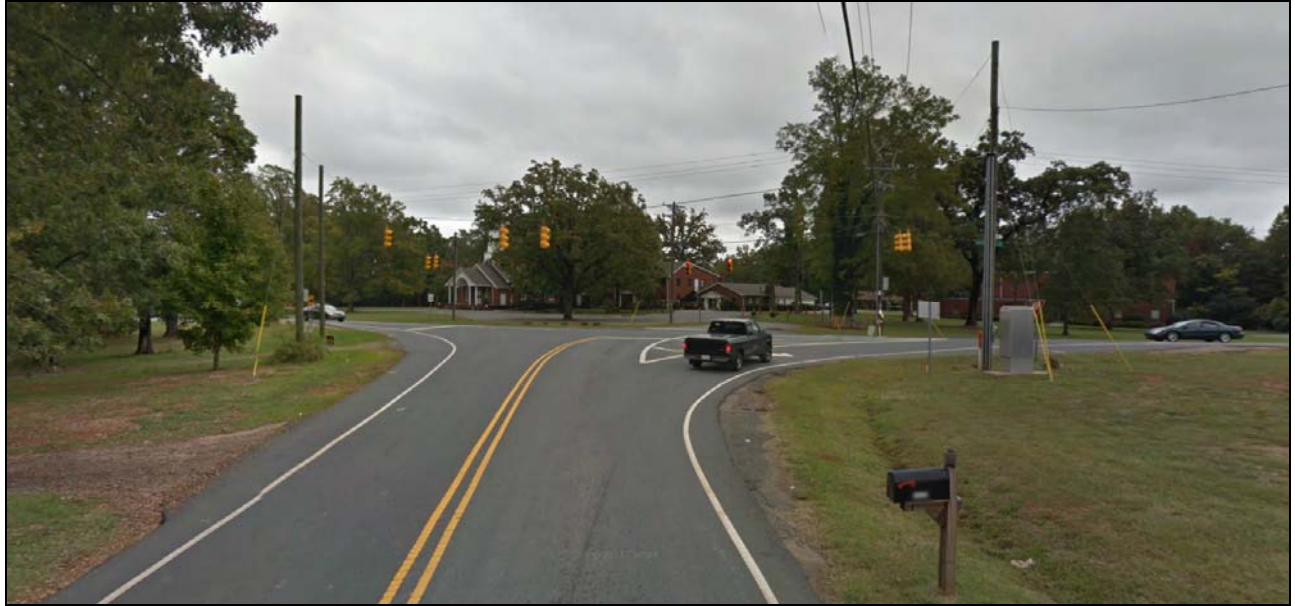
Google Maps (October 2011) – Looking Southeast on SR 2822

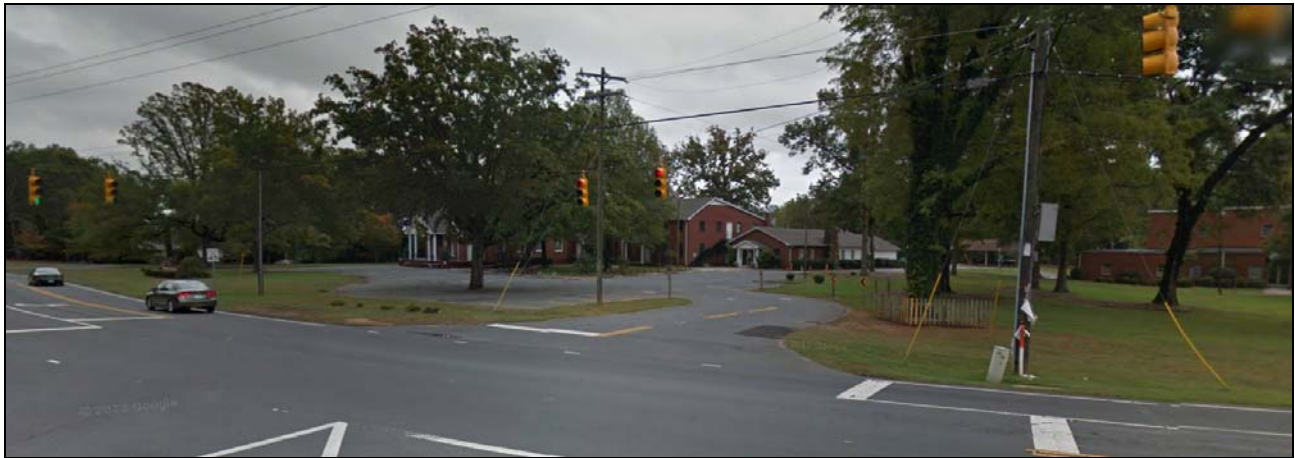
Google Maps (October 2011) – Looking at realigned church driveway

The spot safety project improvement countermeasure chosen for the subject location was the installation of an actuated traffic signal, the straightening of the curve on SR 2805 (Harrisburg Road) at the intersection, and the realignment of the Robinson Presbyterian Church driveway.

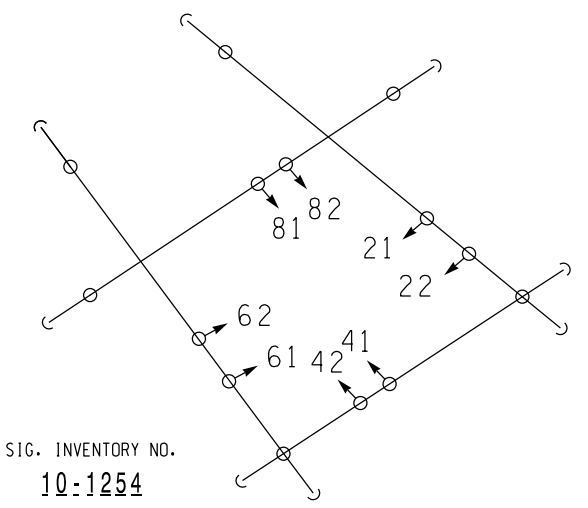
SIGNAL FACE I.D.

Denotes L.E.D.

12"

21, 22
41, 42
61, 62
81, 82
