# Spot Safety Project Evaluation

Spot Safety Project # 01-07-200

**Spot Safety Project Evaluation of the Flashing Signal Revision  
(Revise Flashers and Revise/Add Warning Signs: Vehicle Entering,  
Watch for Approaching Vehicle, and Stop Ahead)  
US 158 (Shortcut Road) at SR 1147 (Indiantown Road)  
Currituck County**

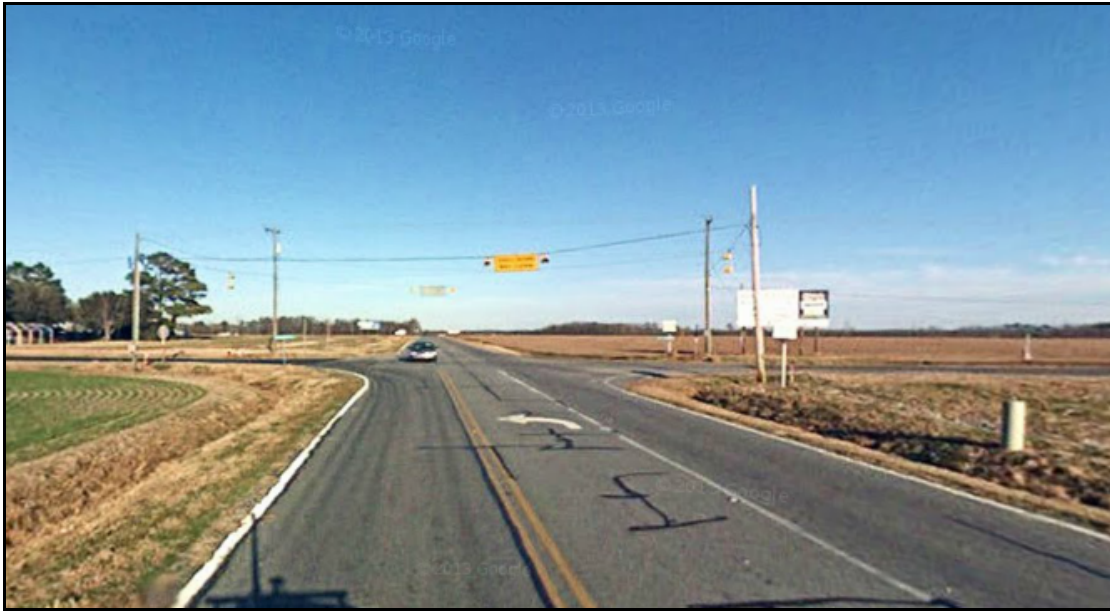
**Google Maps (January 2008) – Looking East on US 158 Approach**

Please see the attached *Treatment Site Photos*. Photos are provided from Google Street View for all four approaches to the study intersection. As the Safety Evaluation Group facilitates additional spot safety reviews for these types of countermeasures, it is the goal to be able to provide objective and definite information regarding actual crash reduction factors for these types of treatments.

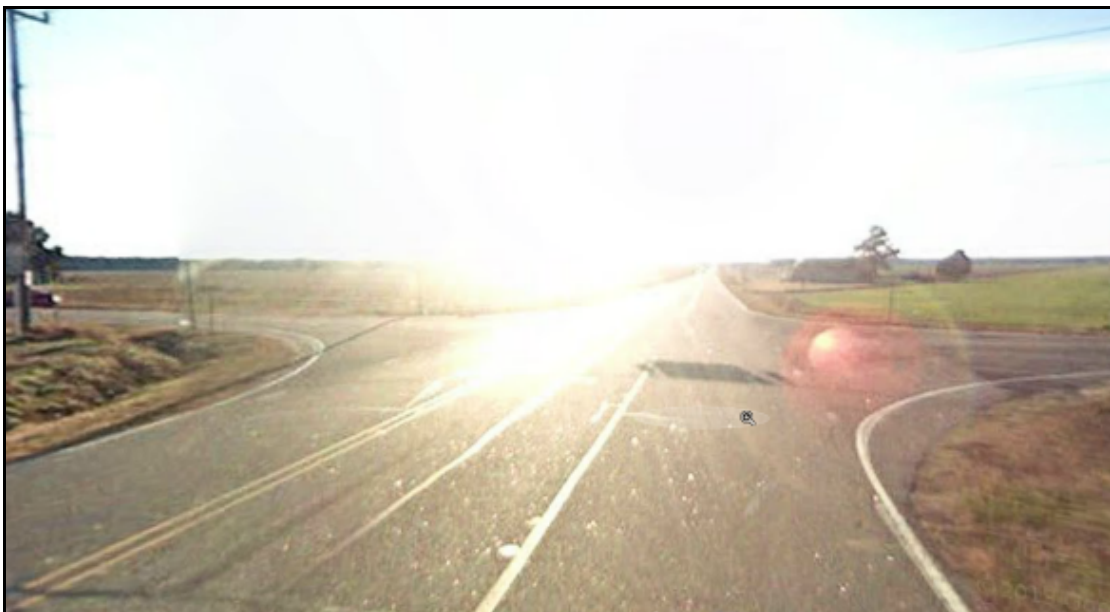
**Google Maps (January 2008) – Looking West on US 158 Approach**

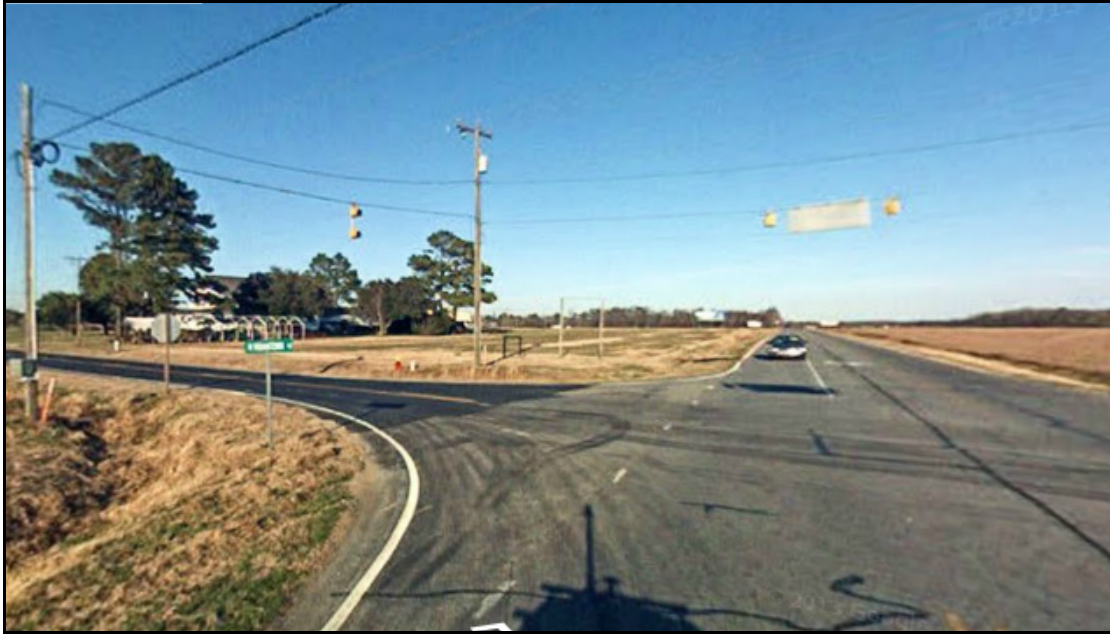
**Google Maps (January 2008) – Looking at the northern leg of SR 1147 from US 158**

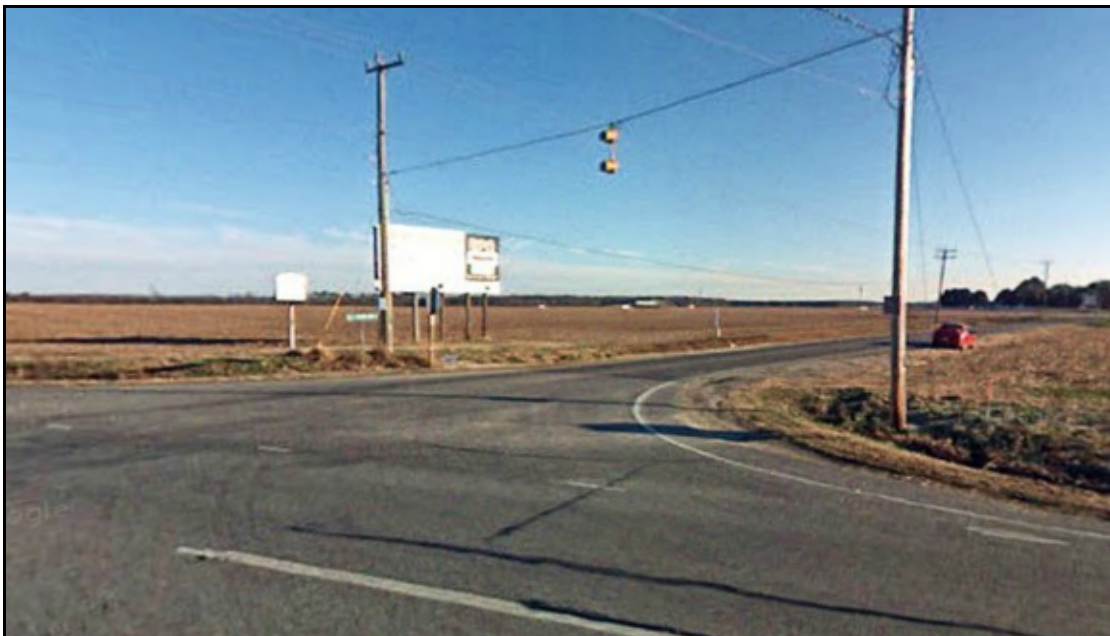
**Google Maps (January 2008) – Looking at the southern leg of SR 1147 from US 158**

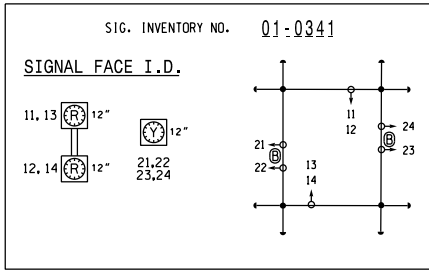
SS# 01-07-200  
 Currituck County  
 BEFORE Period  
 1/1/03 - 2/29/2008

SR 1147  
 (INDIANTOWN ROAD)  
 55 MPH

US 158  
 55 MPH

ADT (Year)  
 6700 (2005)

ADT (Year) 7400 (2005)      US 158 55 MPH

ADT (Year)  
 1200 (2005)

Referencing the *Collision Diagrams* and the above tables, the Target Crashes (Frontal Impact Crashes between vehicles entering from SR 1147 and vehicles traveling on US 158) were reduced from twenty (20) in the before period to eight (8) in the after period. The severity index for these target crash types decreased from 8.49 in the before period to 7.48 in the after period. The study shows a 52.9 percent decrease in Angle crashes and a 100 percent decrease in Left Turn, Different Roadway crashes for the intersection. Right Turn, Same Roadway crashes increased from zero (0) to two (2) crashes from the before period to the after period, but these two crashes do not appear to be related to the applied countermeasure.

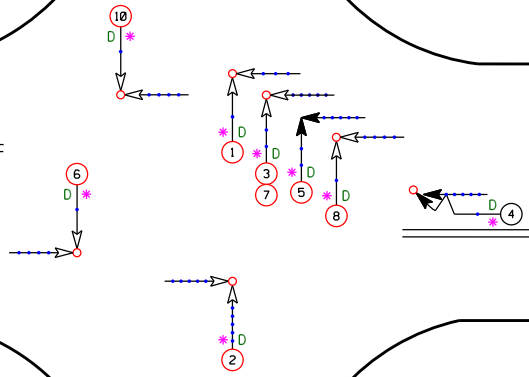
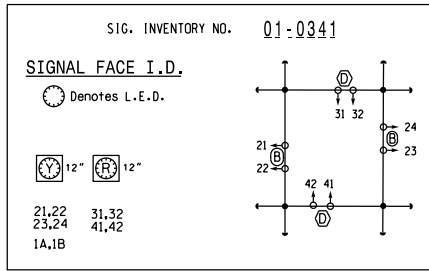
# SS# 01-07-200

### AFTER Period

#### 5/1/08 - 6/30/13

ADT (Year)  
1100 (2010)

ADT (Year)  
5500 (2010)

ADT (Year)  
6100 (2010)

ADT (Year)  
1450 (2010 est.)

Frontal Impact  
Target Crashes
