Spot Safety Project Evaluation

Spot Safety Project # 03-05-206

**Spot Safety Project Evaluation of the Addition of a Left-Turn Lane
SR 1911 (Brooks-Quinn Rd) at Rose Hill-Magnolia Elementary School
Duplin County**

Documents Prepared By:
Stantec Consulting Ltd.
for
Safety Evaluation Group
Traffic Safety Systems Management Section
Transportation Mobility and Safety Division
North Carolina Department of Transportation

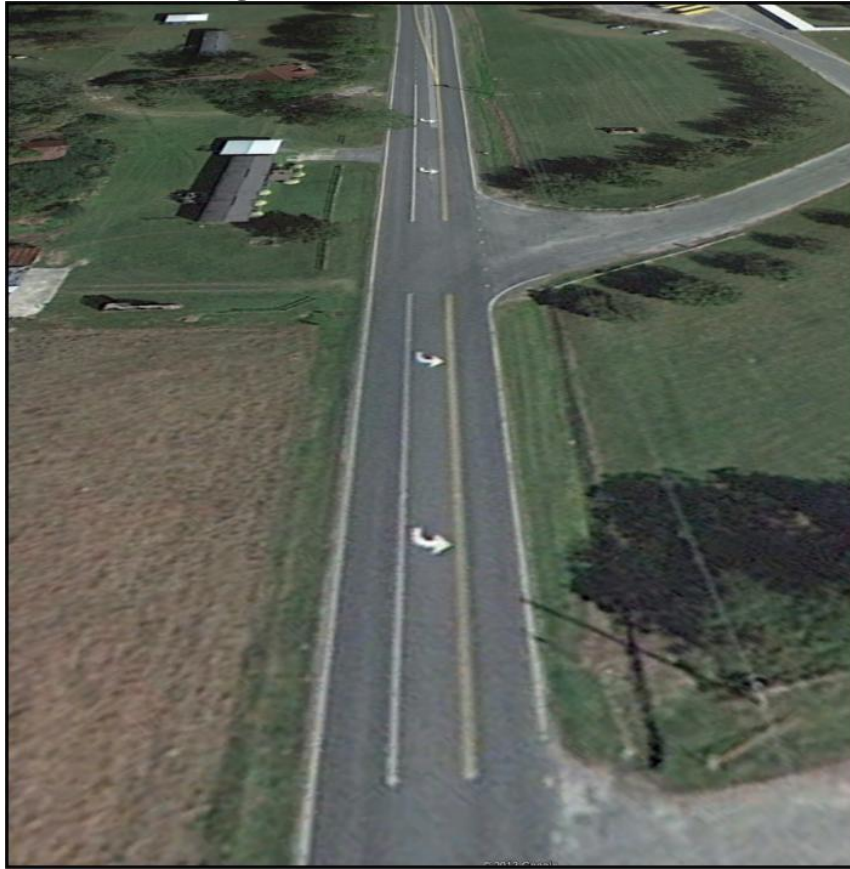
Google Maps (October 2012) – Looking North on SR 1911 (Brooks-Quinn Road) Approach

Please see the attached *Treatment Site Photos*. Photos are provided from Google Street View for all three approaches to the treatment intersection. As the Safety Evaluation Group completes additional spot safety reviews for this type of countermeasure, we will be able to provide objective and definite information regarding actual crash reduction factors for this type of intersection.

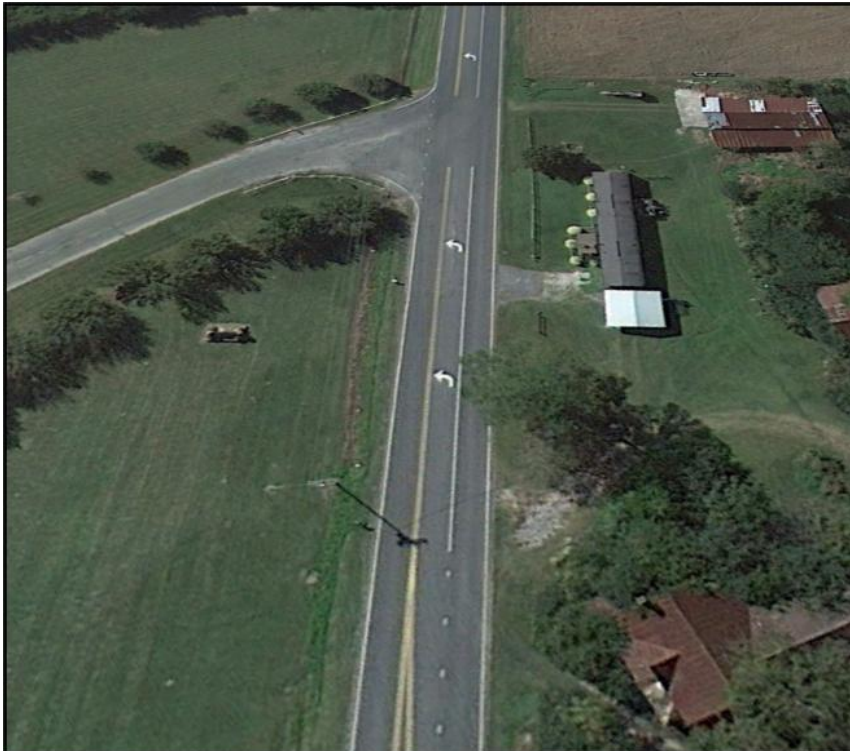
Google Maps (October 2012) – Looking South from SR 1911 (Brooks-Quinn Road) Approach

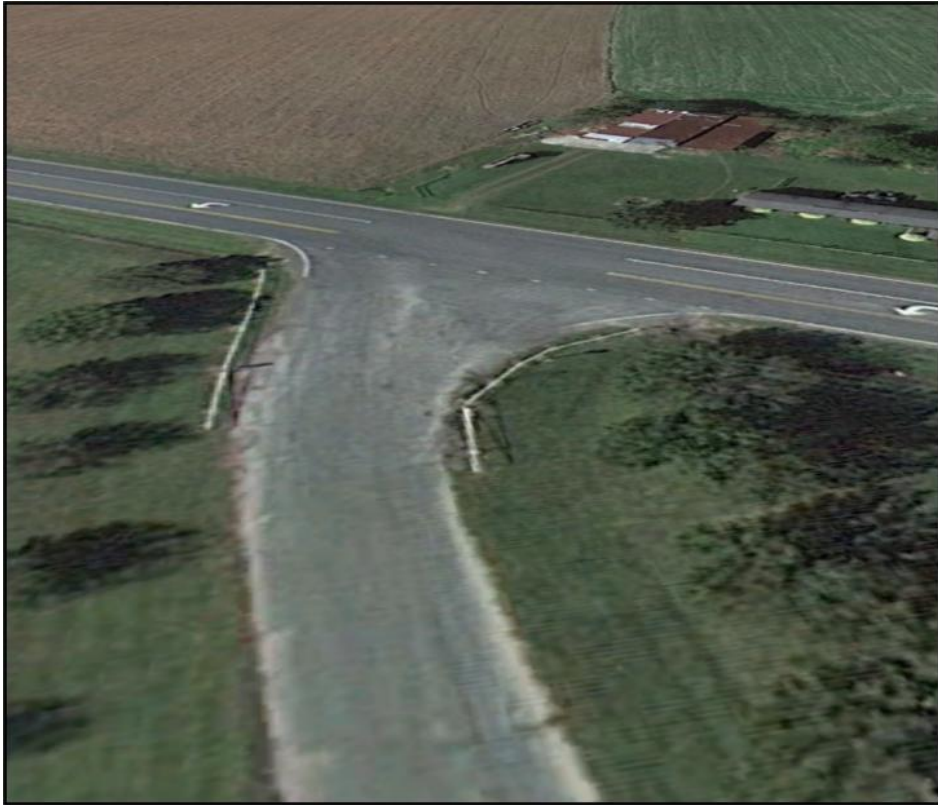
Google Maps (October 2012) – Looking West from Rose Hill-Magnolia Elementary School Approach
