Spot Safety Project Evaluation

Spot Safety Project # 03-07-213

Spot Safety Project Evaluation of Signal Changes (Install Advance Signal Ahead Warning Signs with Actuated Flashers and Long Vehicle Detection Systems)

US 17 (Ocean Highway) at US 17 Business (Main Street)/Frontage Road Brunswick County

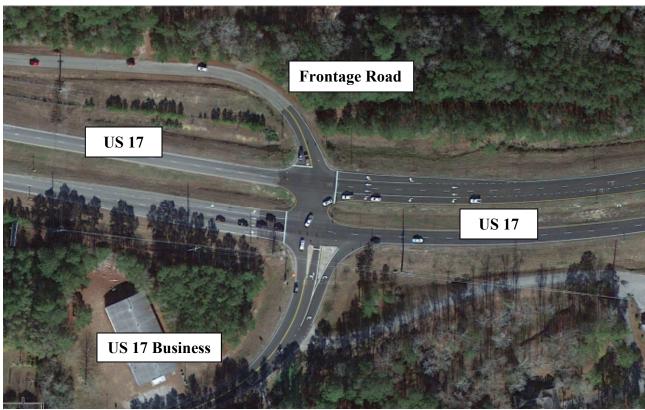
Aerial Provided from Google Maps

The treatment data consisted of all crashes within 150 feet of the intersection of US 17 (Ocean Highway) at US 17 Business (Main Street)/Frontage Road for all approaches. *Please see attached location map and aerial map for further details.*

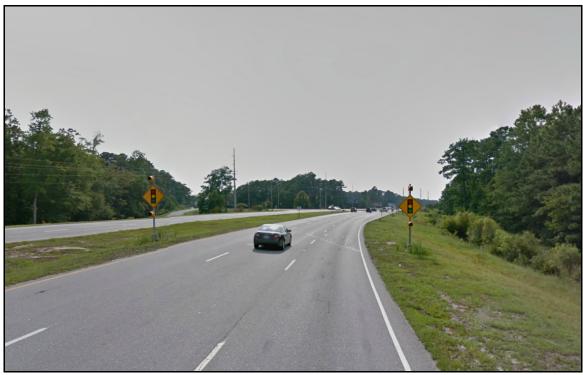
Google Maps (August 2011) - Signal Ahead Signs and Flashers on US 17 Westbound Approach

The spot safety project improvement countermeasure chosen for the subject location was the installation of Advance Signal Ahead (W3-3) warning signs with actuated flashers and long vehicle detection systems on both US 17 approaches.

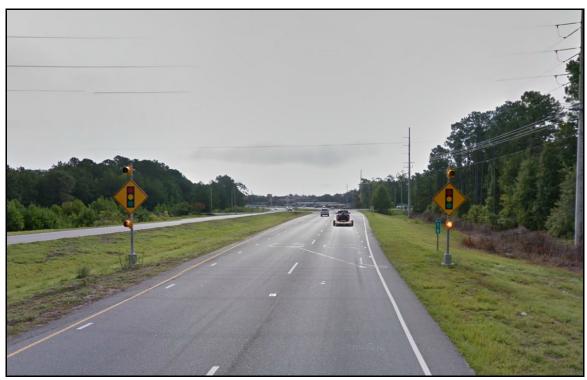
Google Maps (August 2011) – Signal Ahead Signs and Flashers on US 17 Eastbound Approach

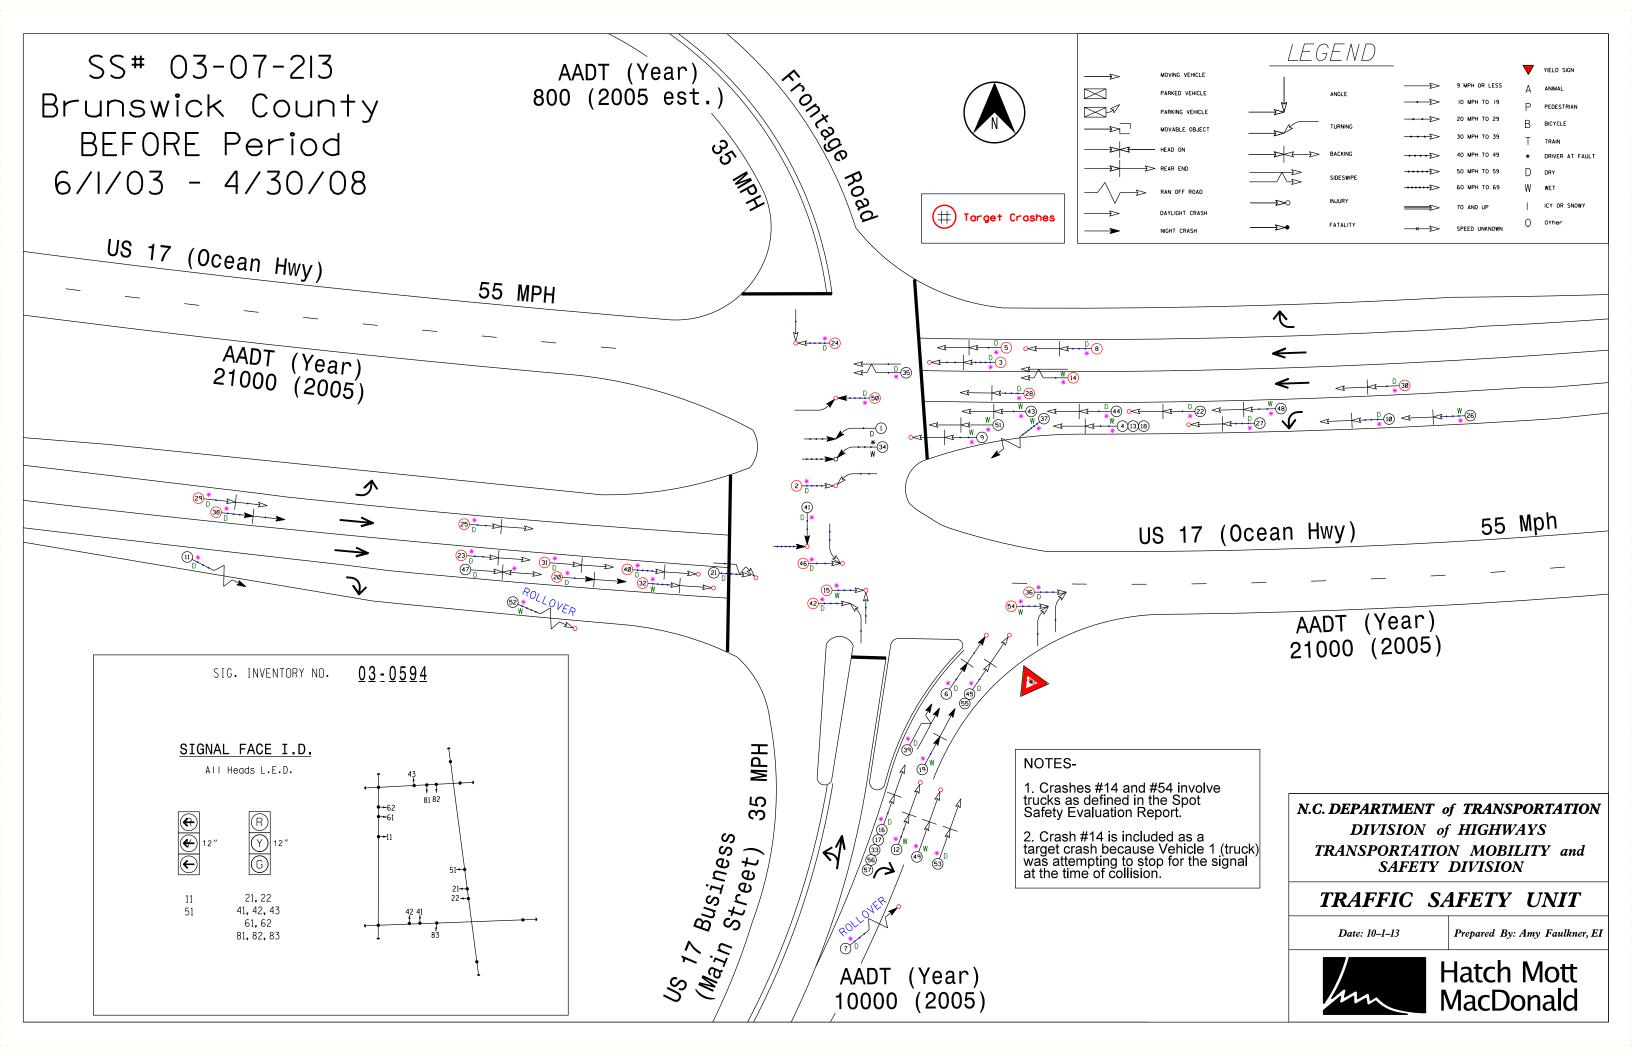
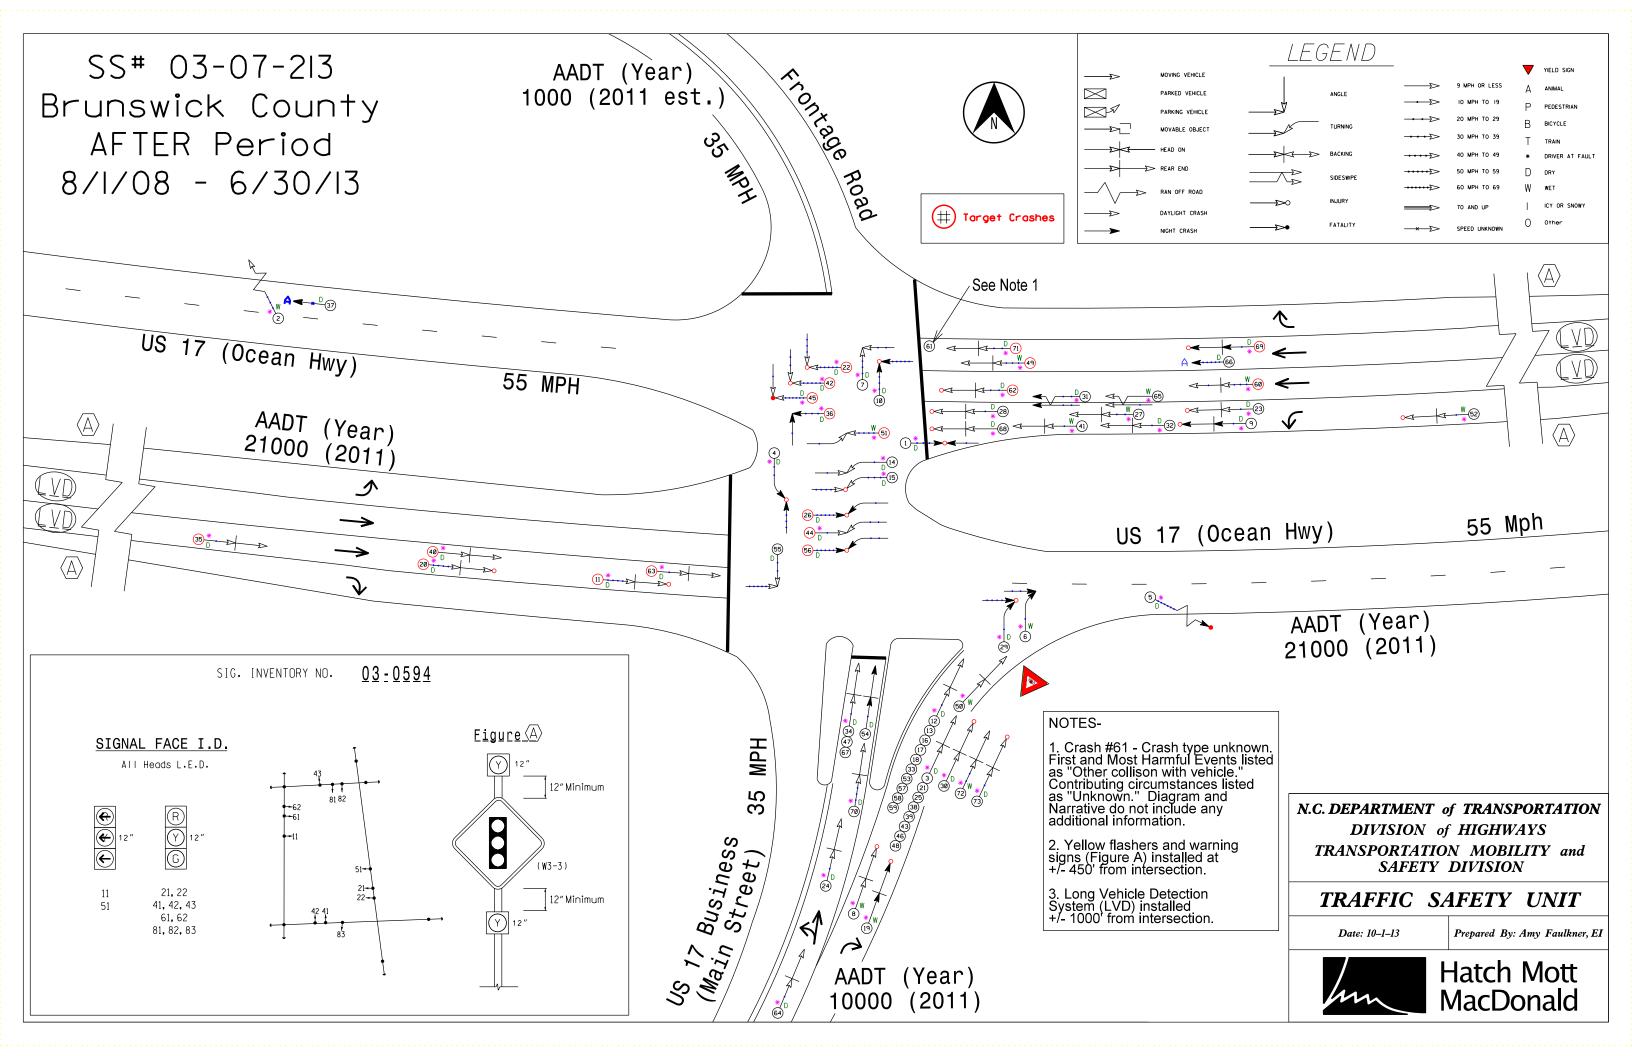
Referencing the *Collision Diagrams* and the above tables, the Target Crashes were reduced from twenty-two (22) in the before period to eighteen (18) in the after period. The severity index for these target crash types increased from 6.80 in the before period to 8.50 in the after period.

As also shown in the *Collision Diagrams*, Rear-End Crashes in the westbound US 17 Left Turn Lane experienced a 33.3 percent reduction from the before period to the after period. On the northbound US 17 Business (Main Street) approach, Rear-End crashes experienced an increase of 158.3 percent from twelve (12) in the before period to thirty-one (31) in the after period.

The evaluation shows that the number of Red Light Run Frontal Impact crashes stayed the same from the before period to the after period. Westbound US 17 Rear-End Crashes decreased by 16.7 percent while Eastbound Rear-End crashes experienced a greater decrease of 37.5 percent. The Target Crashes Involving Heavy Trucks decreased from two (2) in the before period to zero (0) in the after period which may indicate a benefit from the installation of the Long Vehicle Detection Systems.
