Spot Safety Project Evaluation

Spot Safety Project # 03-07-223

**Spot Safety Project Evaluation of Signal Modification
(Install Four-Section Flashing Yellow Arrow Signal Heads)
US 76 (Oleander Drive) at Greenville Loop Road/Greenville Avenue
New Hanover County**

Safety Evaluation Group
Traffic Safety Systems Management Section
Transportation Mobility and Safety Division
North Carolina Department of Transportation

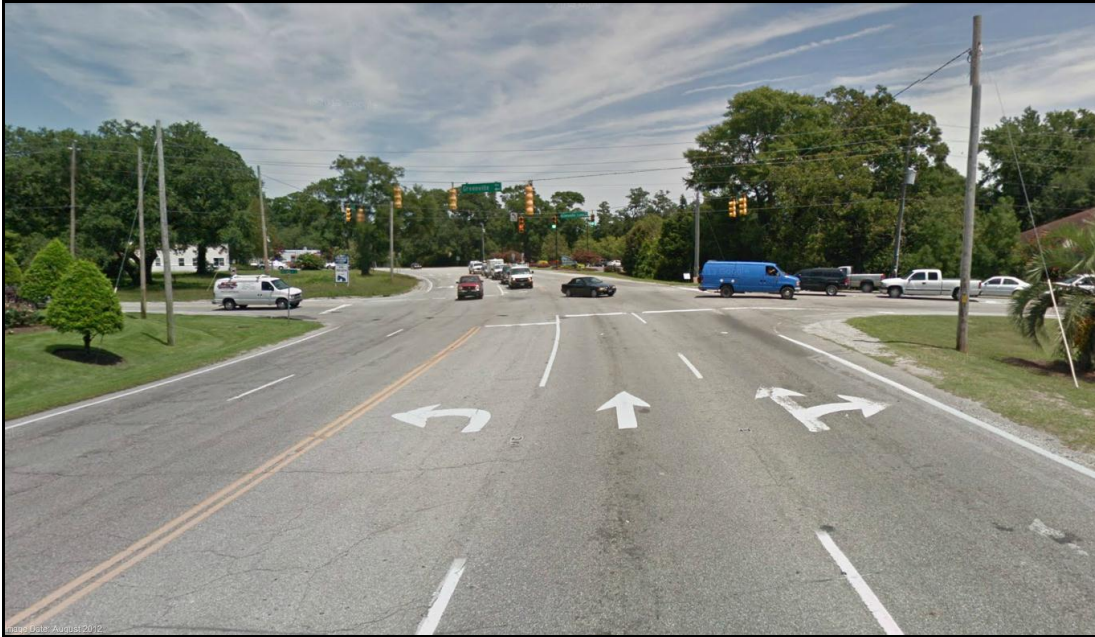
Google Maps (August 2012) – Looking East on US 76 Approach

Please see the attached *Treatment Site Photos*. Photos are provided from Google Street View for all four approaches to the treatment intersection. As the Safety Evaluation Group facilitates additional spot safety review for these types of countermeasures, it is the goal to be able to provide objective and definite information regarding actual crash reduction factors for these types of treatments.

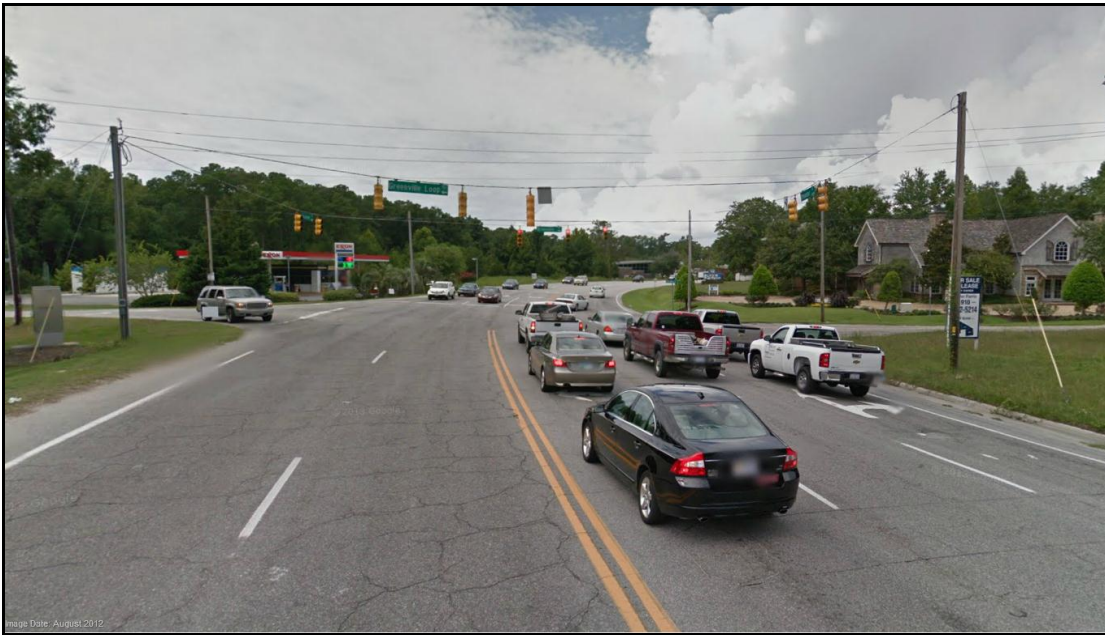
Google Maps (August 2012) – Looking West on US 76 Approach

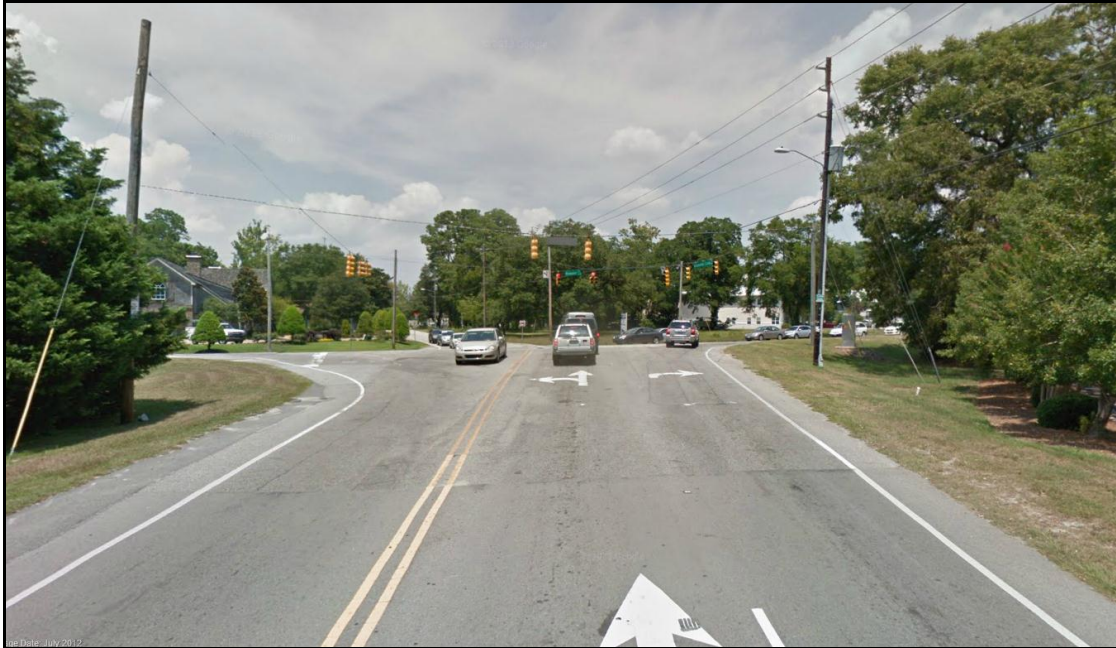
Google Maps (July 2012) – Looking North on Greenville Loop Road Approach

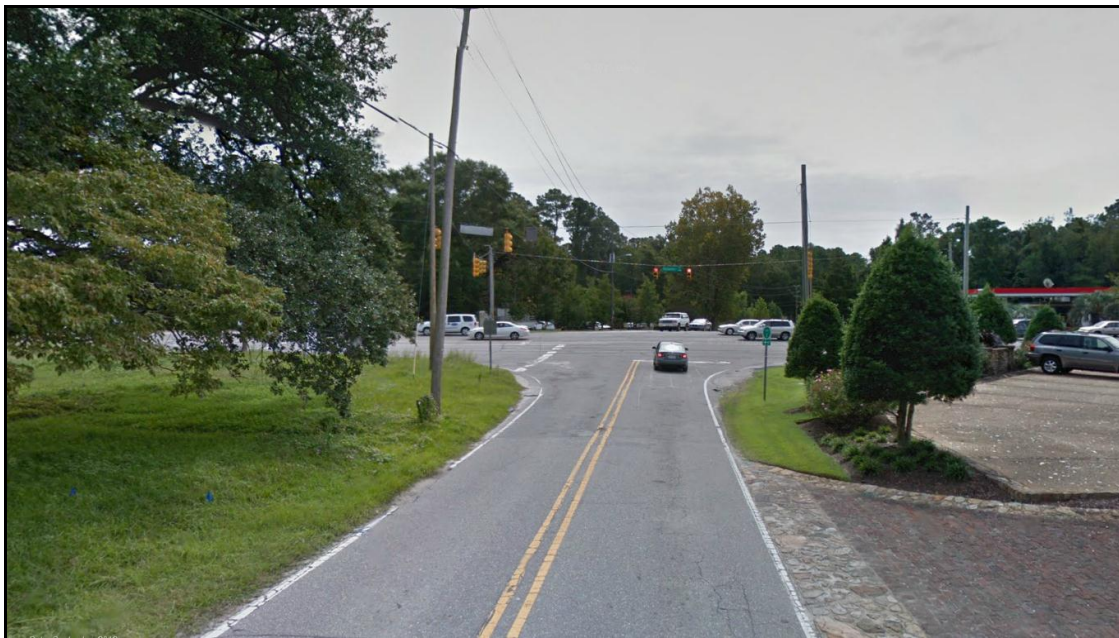
Google Maps (September 2012) – Looking South on Greenville Avenue Approach

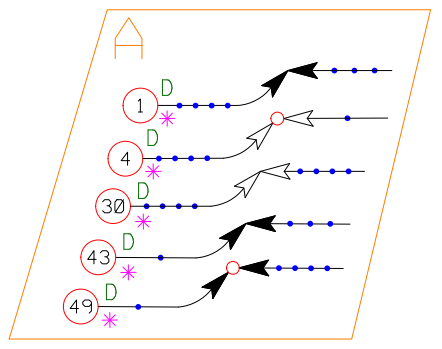
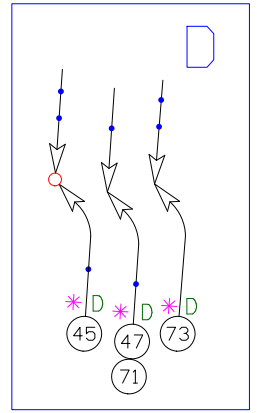
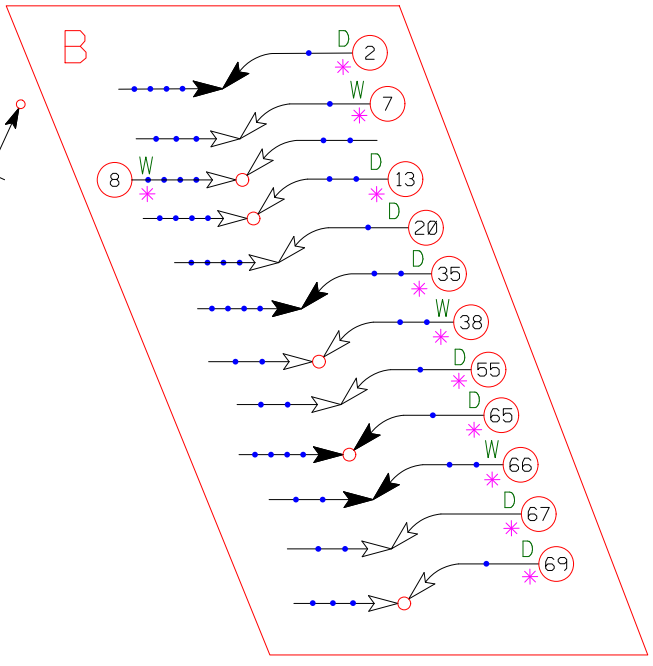
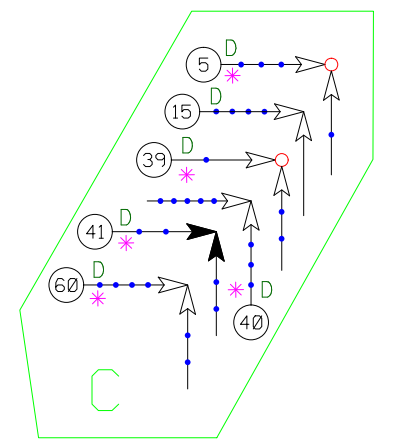
SS# 03-07-223
 New Hanover County
 BEFORE Period
 2/1/04 - 8/31/08

Target Crashes -
 Left Turn Same
 FYA Approaches

SIG ID 03-0052 (Actuated Isolated)
 Note: Signal Heads 11 & 51 assumed

Referencing the *Collision Diagrams*, the target crashes (LTSR crashes which occurred on approaches where flashing yellow arrow signal heads were installed) experienced a 47.1 percent reduction. Although the target crashes were reduced, the severity of these crash types increased by 213.8 percent. From the *Additional Information* table above, the eastbound US 76 approach experienced no change in the number of target crashes. However, the westbound US 76 approach experienced a 66.7 percent reduction in left turn same roadway collisions.

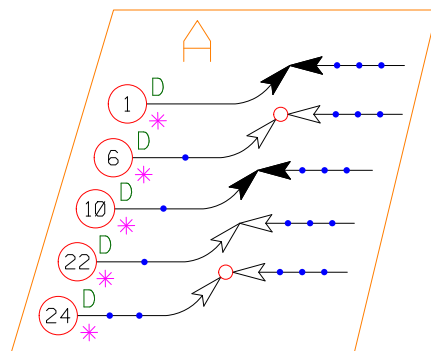
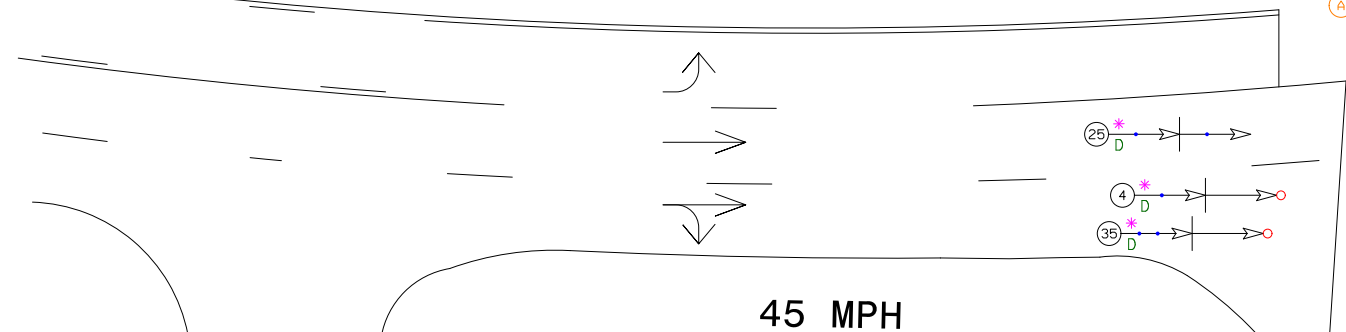
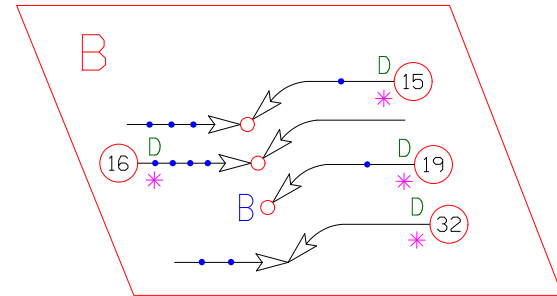
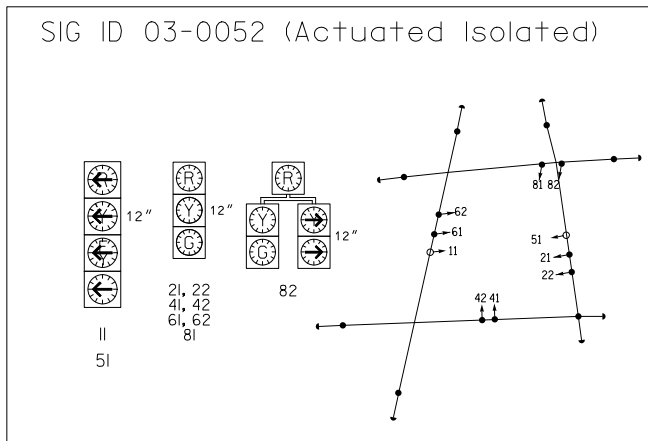
SS# 03-07-223
 New Hanover County
 AFTER Period
 12/1/08 - 6/30/13

Target Crashes -
 Left Turn Same
 FYA Approaches
