Spot Safety Project # 05-05-208

Spot Safety Project Evaluation of the Signal Installation at the Intersection of US 501 (North Roxboro Road) and SR 1601 (Moores Mill Road)/ SR 1468 (Quail Roost Farm Road) Durham County

Spot Safety Project Evaluation Documentation

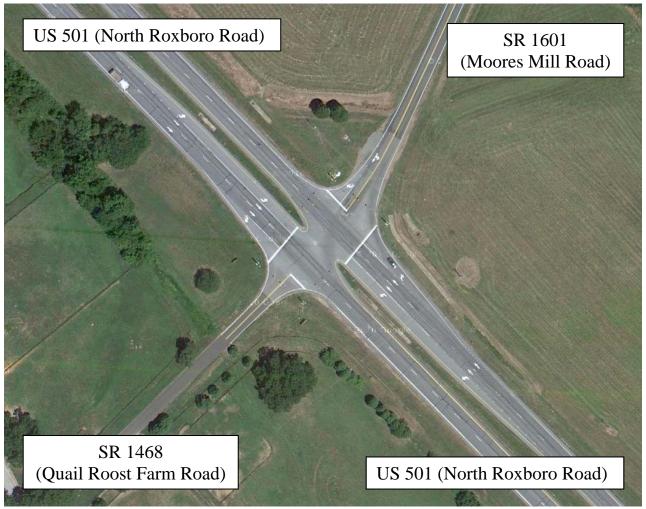
Aerial Provided from Google Maps

The treatment data consists of all crashes within 150 feet of the subject intersection. *Please see the above location map and aerial photo for further details.*

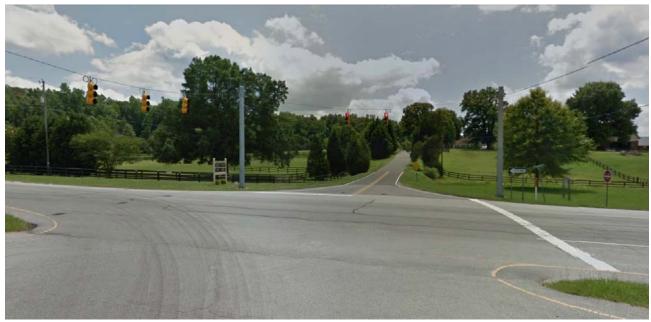
Google Maps (June 2012) – Looking Southwest at SR 1468

Please see the attached *Treatment Site Photos*. Photos are provided from Google Street View for all four approaches to the treatment intersection. As the Safety Evaluation Group facilitates additional spot safety review for these types of countermeasures, it is the goal to be able to provide objective and definite information regarding actual crash reduction factors for these types of treatments.

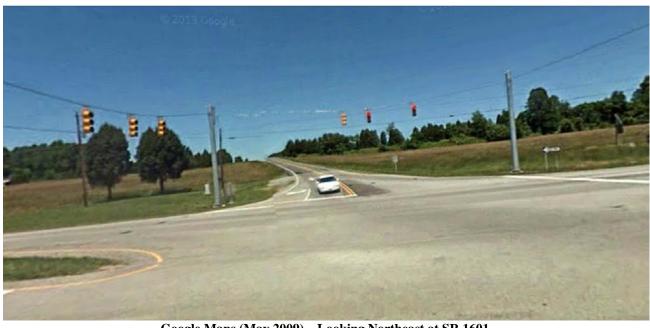
Google Maps (May 2009) – Looking Northeast at SR 1601

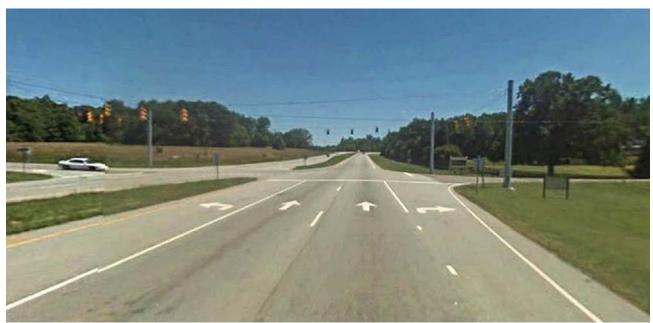
Google Maps (May 2009) – Looking Southeast on US 501

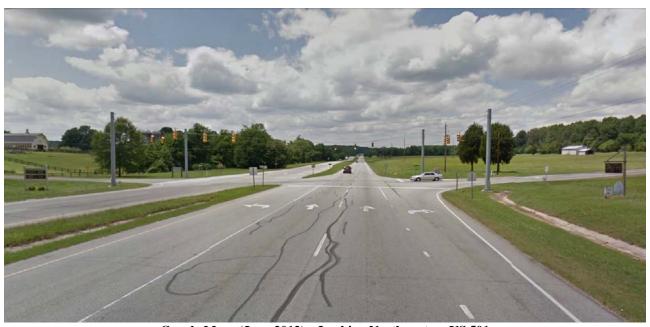
Google Maps (June 2012) – Looking Northwest on US 501

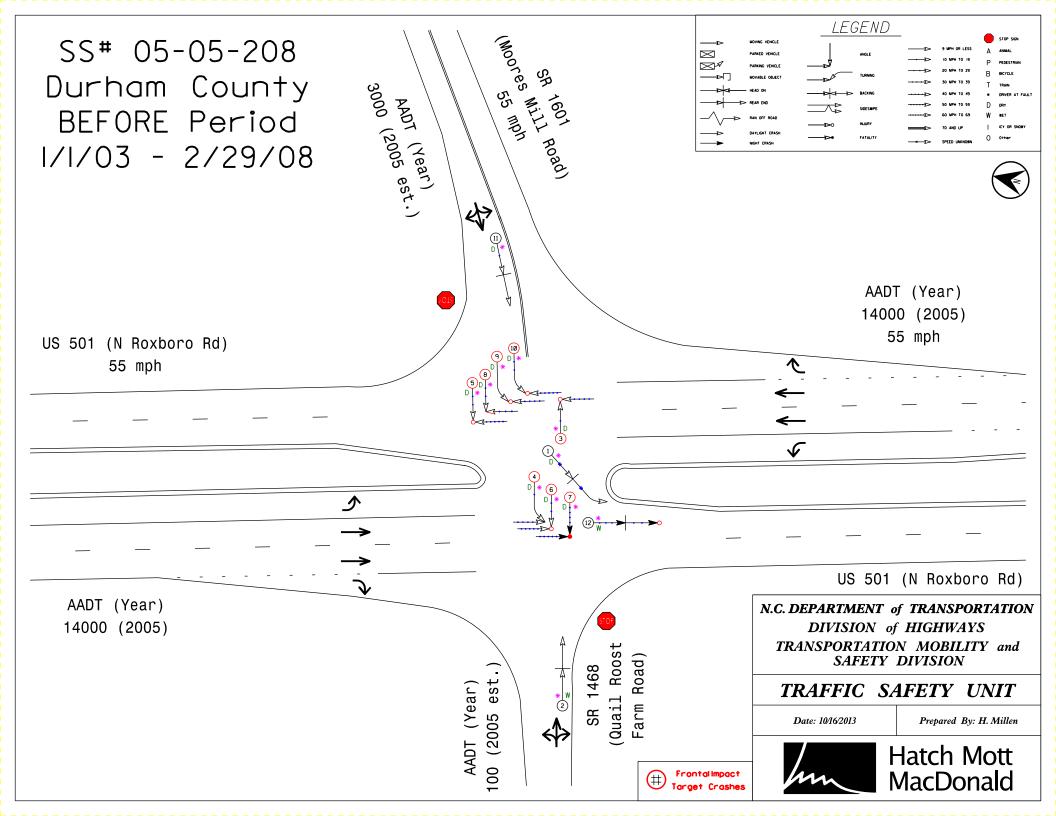
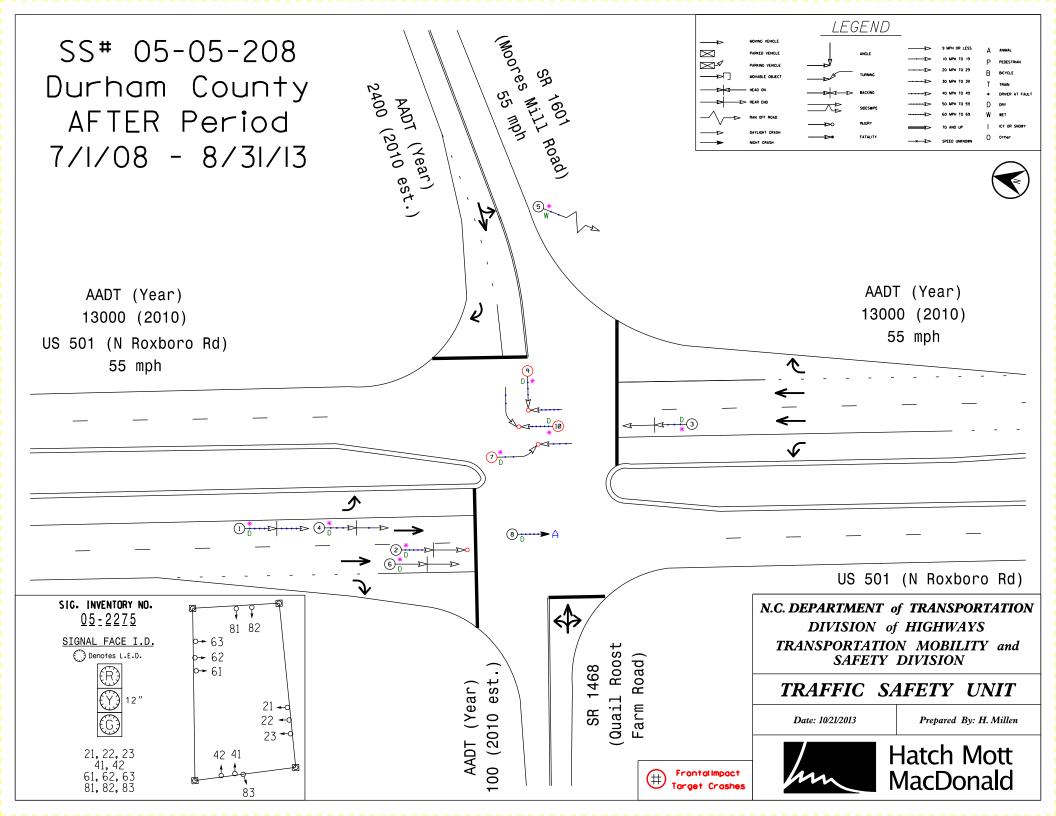
Referencing the *Collision Diagrams*, the target crashes (frontal impact crashes) were reduced from eight crashes in the before period to three in the after period, which equates to a 62.5 percent reduction. Also shown in the *Additional Information* table above, rear end type crashes experienced a 25 percent increase.
