Spot Safety Project Evaluation

Spot Safety Project # 05-07-230

Spot Safety Project Evaluation of the Restriping of SR 1315 (Buck Jones Road) for Left Turn Lanes SR 1315 (Buck Jones Road) at Farm Gate Road Wake County

Documents Prepared By:
Stantec Consulting Services, Inc.
for
Safety Evaluation Group
Traffic Safety Systems Management Section
Transportation Mobility and Safety Division
North Carolina Department of Transportation

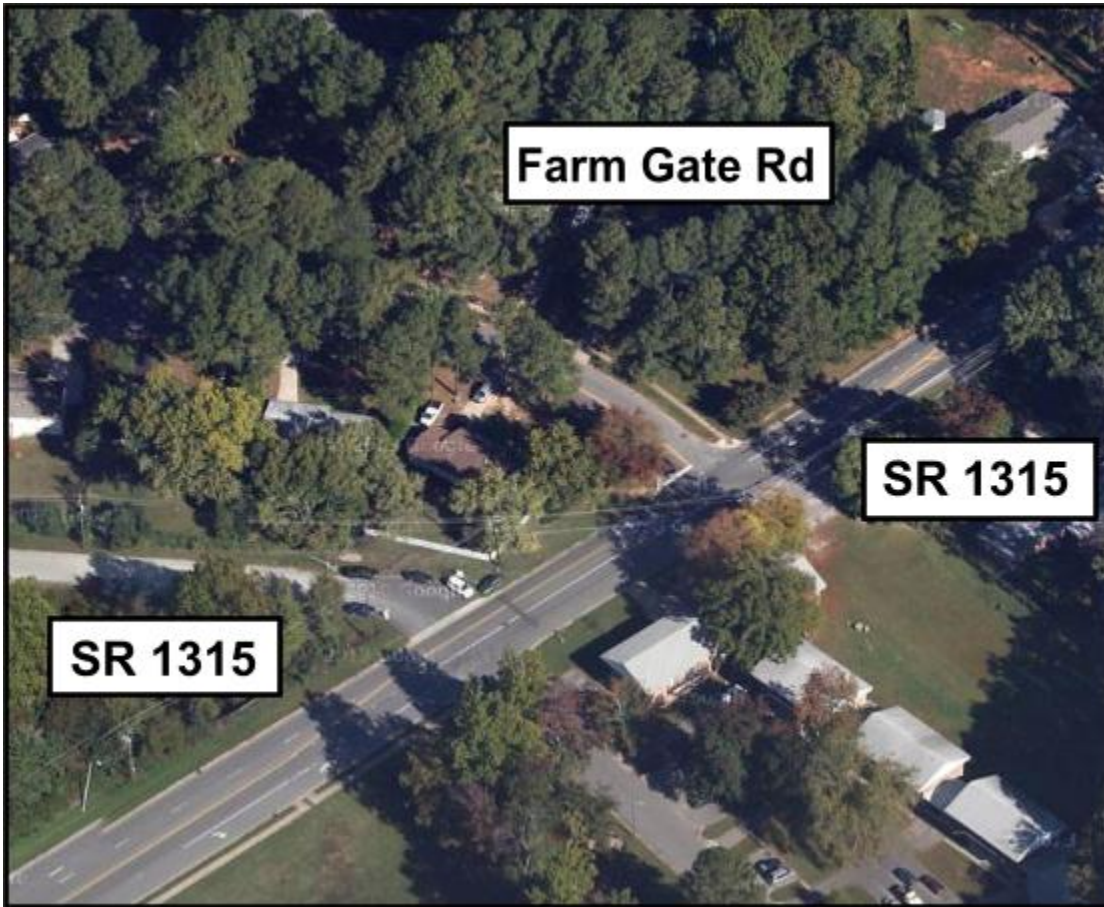
Aerial Provided from Google Maps

Evaluation of Spot Safety Project Number 05-07-230 located at intersection of SR 1315 (Buck Jones Road) at Farm Gate Road in Wake County.

This intersection is stop-controlled.

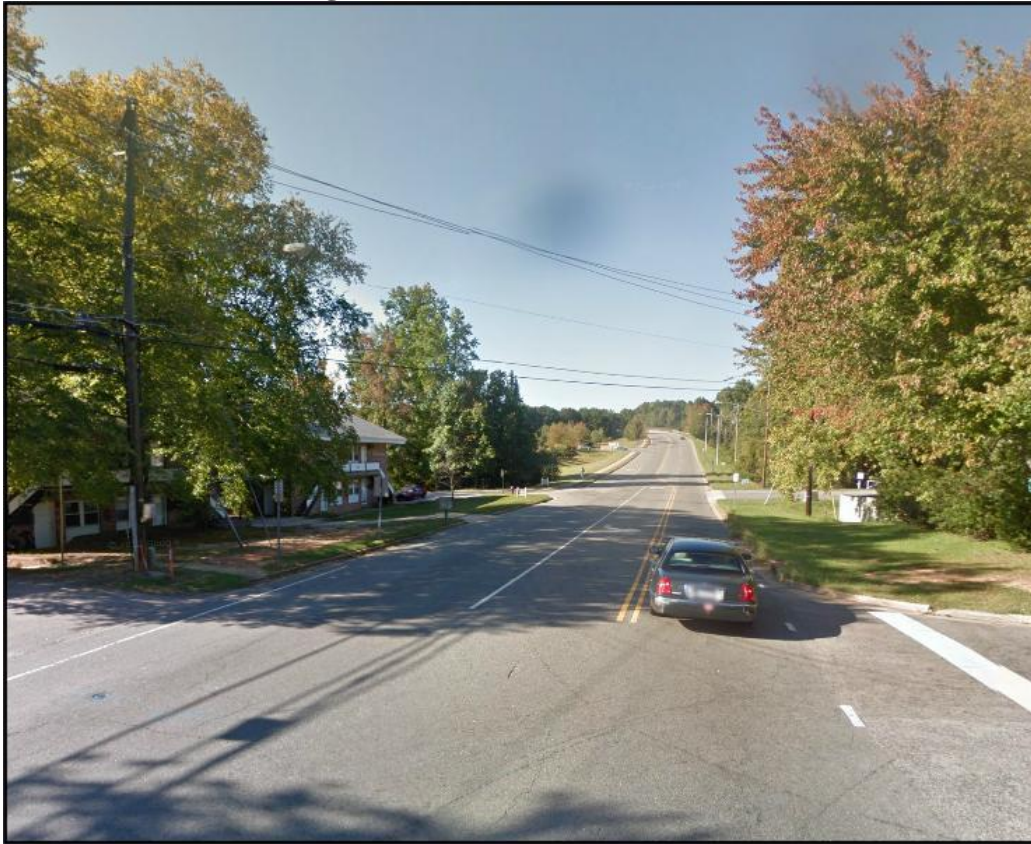
Google Maps (October 2011) – Looking South from SR 1315 Approach

Please see the attached *Treatment Site Photos*. Photos are provided from Google Street View for all three approaches to the treatment intersection. As the Safety Evaluation Group completes additional spot safety reviews for this type of countermeasure, we will be able to provide objective and definite information regarding actual crash reduction factors for this type of intersection.

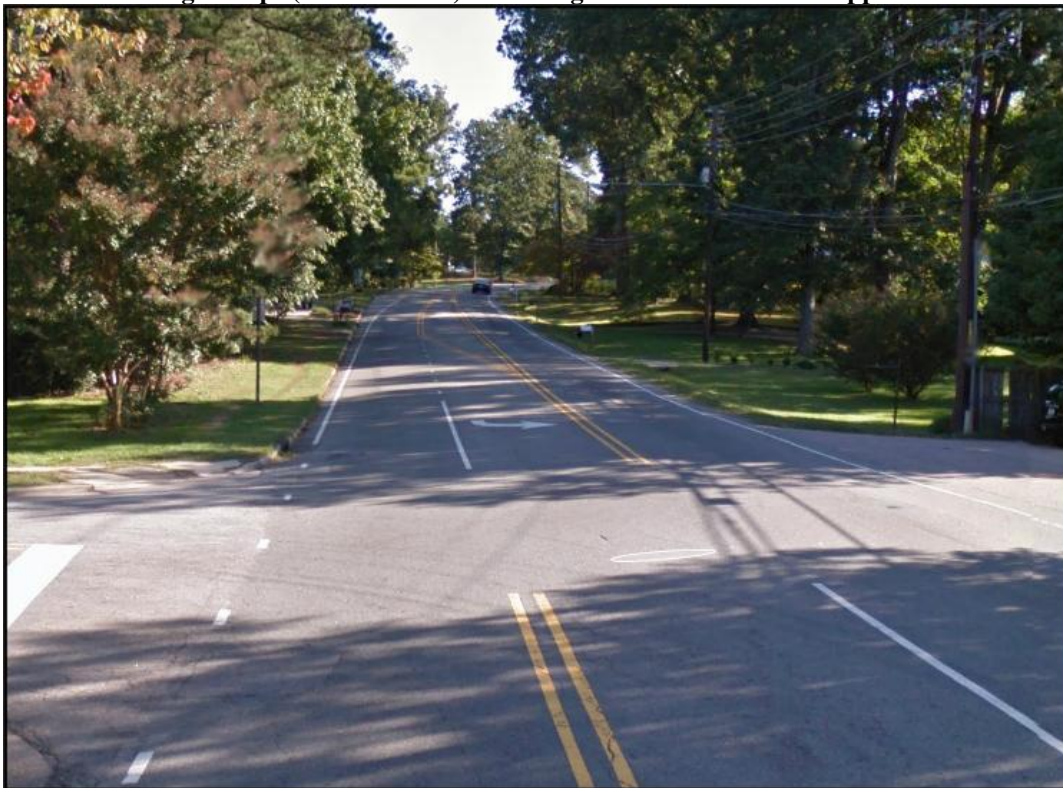
Google Maps (October 2011) – Looking North from SR 1315 Approach

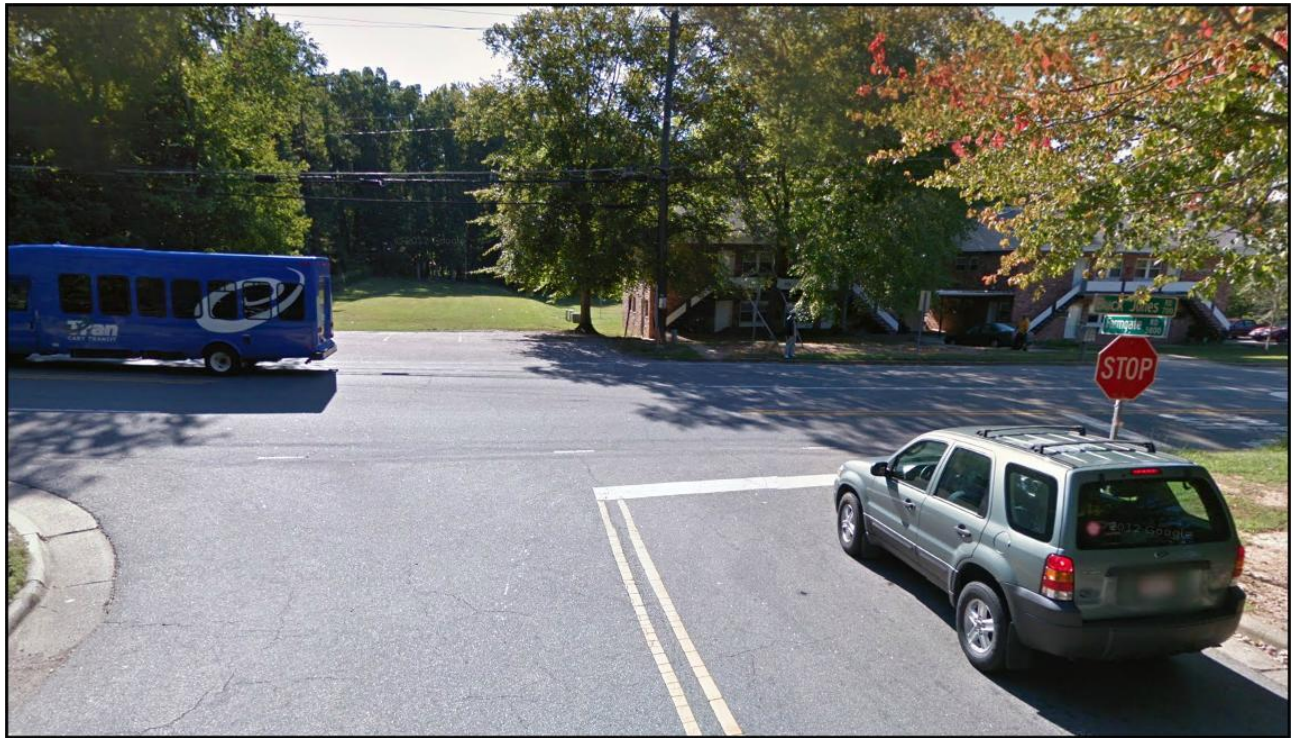
Google Maps (October 2011) – Looking East from Farm Gate Rd Approach
