Spot Safety Project Evaluation

Spot Safety Project # 12-05-205

**Spot Safety Project Evaluation of the Addition of a Westbound Protected/Permitted Left-Turn Phase
SR 1100 (Brawley School Rd.) at SR 1109 (Williamson Rd.)
Iredell County**

Documents Prepared By:
Stantec Consulting Services, Inc.
for
Safety Evaluation Group
Traffic Safety Systems Management Section
Transportation Mobility and Safety Division
North Carolina Department of Transportation

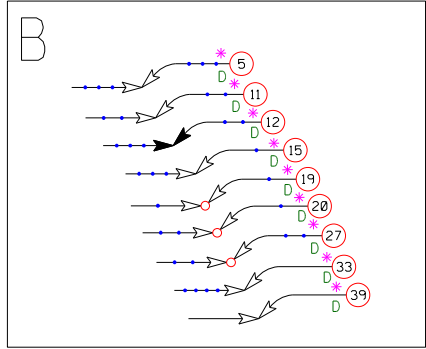
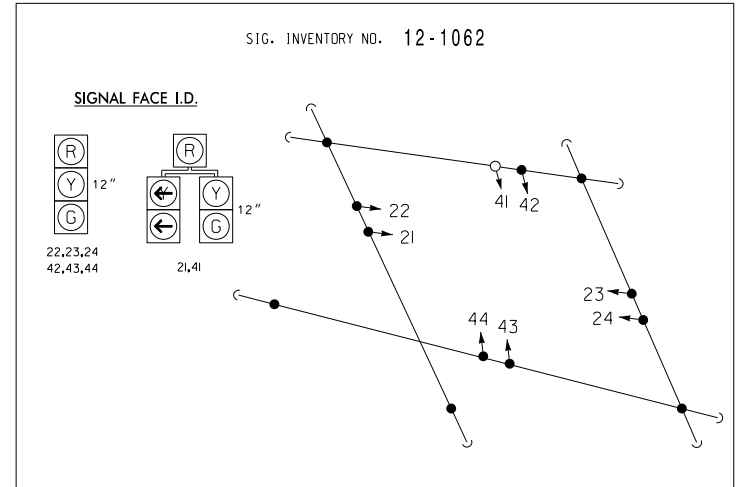
SS# 12-05-205
 Iredell County
 Before Period
 11/1/2005 - 6/30/2008

Target Crashes

Referencing the *Collision Diagrams*, the target crashes experienced an 88.9 percent decrease in westbound left-turn same roadway collisions. The target crash severity index saw an increase of 142.1 percent. However, there was only one target crash in the after period. Class B injury crashes increased by 100.0 percent, while Class C injury crashes decreased by 66.7 percent.

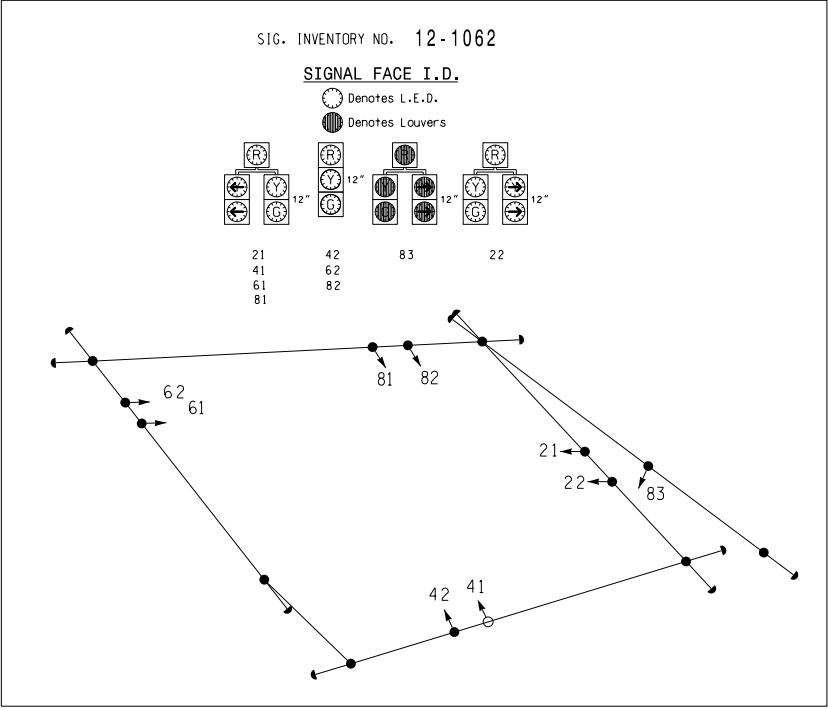
SS# 12-05-205
 Iredell County
 After Period (I)
 10/1/2008 - 5/31/2011

Target Crashes
