Spot Safety Project # 14-07-204

Spot Safety Project Evaluation of the Signal Installation NC 9 at NC 108 Polk County

Documents Prepared By: Stantec Consulting Ltd. for Safety Evaluation Group Traffic Safety Systems Management Section Transportation Mobility and Safety Division North Carolina Department of Transportation

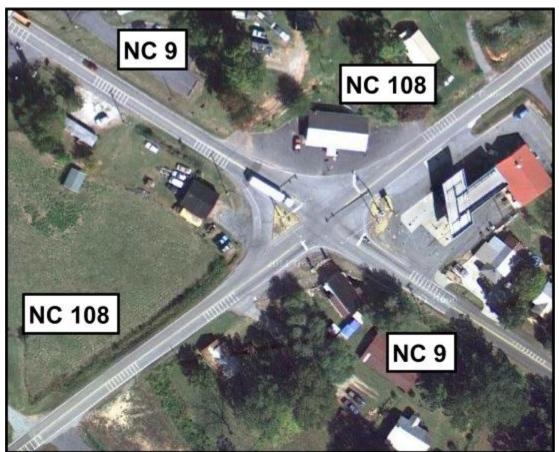
Aerial Provided from Google Maps

The treatment data consisted of all crashes within 150 feet of the subject intersection for the NC 9 and NC 108 approaches. *Please see attached location map and aerial map for further details.*

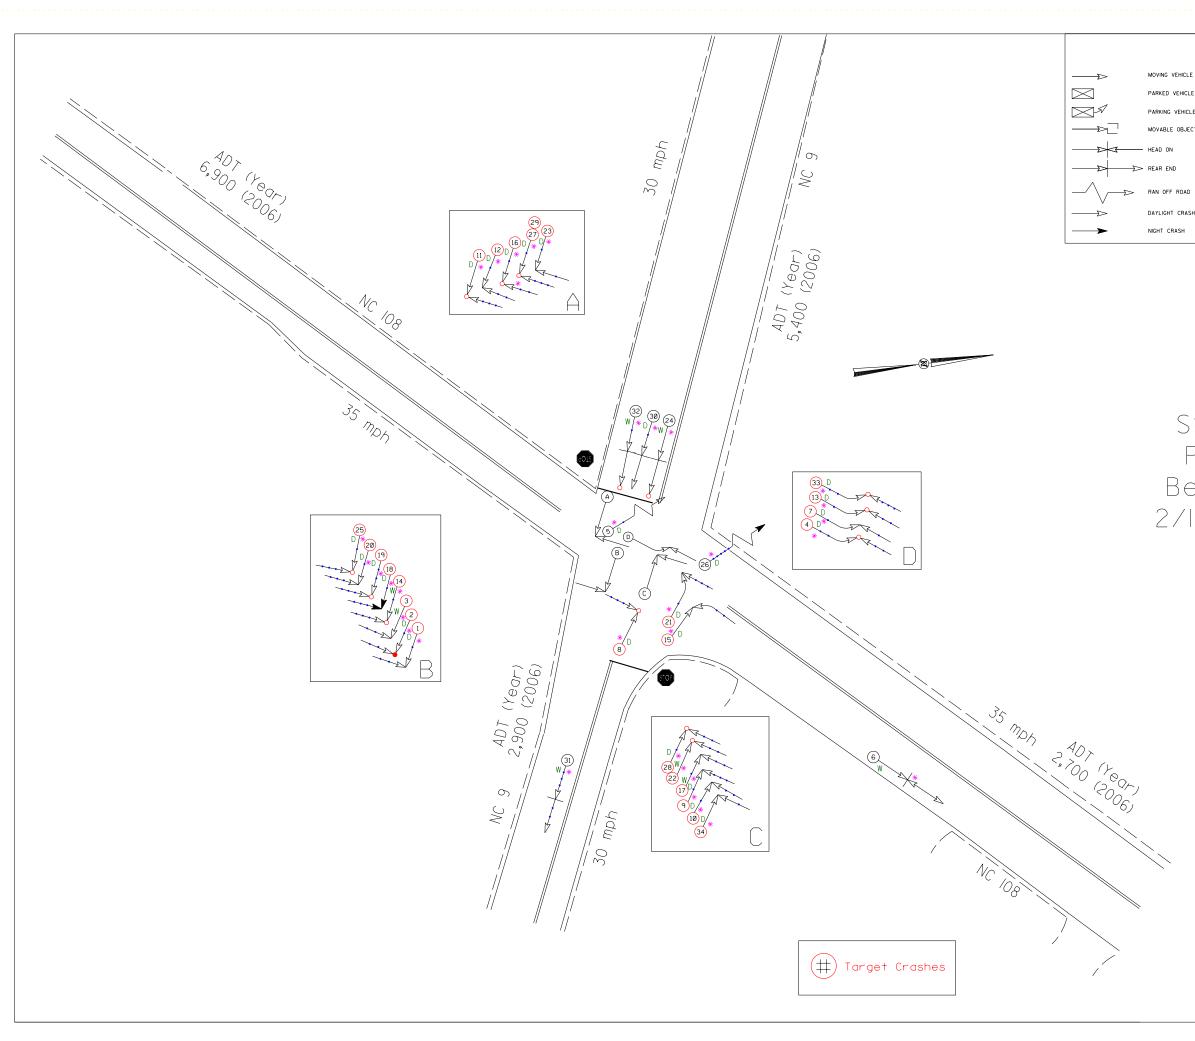
SS# 14-07-204 Polk County Before Period 2/1/04 - 7/31/08

Referencing the *Collision Diagrams*, the target crashes decreased from twenty-seven (27) to seven (7) from the before to the after period. In the before period, the target crashes were 79.4% all crashes that occurred. The target crashes in the after period were 77.7% of all crashes in the study.

From the additional information chart above, the angle crashes reduced from twenty-one (21) to two (2) in the after period. Of the left turn, same roadway crashes on NC 9 three (3) occurred in the after period, and increase from zero (0) in the before period. The left turn, same roadway crashes on NC 108 decreased from four (4) to two (2) through the evaluation time frame.

The target severity index did decrease by 68.6 percent. There were two (2) K and A level crashes in the before period, and zero (0) after. Additionally, the B and C level crashes decreased from twelve (12) to two (2) from the before period to the after period for target crashes.

Along NC 108, the rear end crashes decreased from four (4) to zero (0) throughout the evaluation period. However, the rear-end crashes on NC 9 increased from zero (0) to one (1).
