Spot Safety Project Evaluation

Spot Safety Project # 14-03-215

Spot Safety Project Evaluation of Signal Installation NC 280 (Boylston Highway) at SR 1690 (Broadpointe Drive) Henderson County

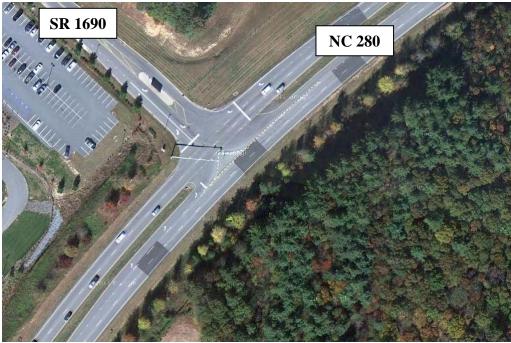
Aerial Provided from Google Maps

Evaluation of Spot Safety Project Number 14-03-215 located at the Intersection of NC 280 (Boylston Highway) at SR 1690 (Broadpointe Drive) in Henderson County.

The Sig ID is 14-1208 for this new installation of a 3-Phase fully actuated traffic signal.

The spot safety project improvement countermeasure chosen for the subject location was a new installation of a 3-phase actuated signal with protected-permitted left-turns (with flashing yellow arrow) on NC 280 (Boylston Highway). Also, flexible traffic delineators were installed at this location to channel the left-turns into and out of SR 1690 (Broadpointe Drive).

The subject intersection is a three-leg intersection, which was stop-controlled on the SR 1690 (Broadpointe Drive) approach before the countermeasure was put in place. Today, SR 1690 (Broadpointe Drive) is a two-lane facility north of NC 280 (Boylston Highway) and serves as access to an industrial park. NC 280 (Boylston Highway) is a four-lane divided facility through the study area. The speed limit on SR 1690 (Broadpointe Drive) is 25 mph and on NC 280 (Boylston Highway) the speed limit is 55 mph.

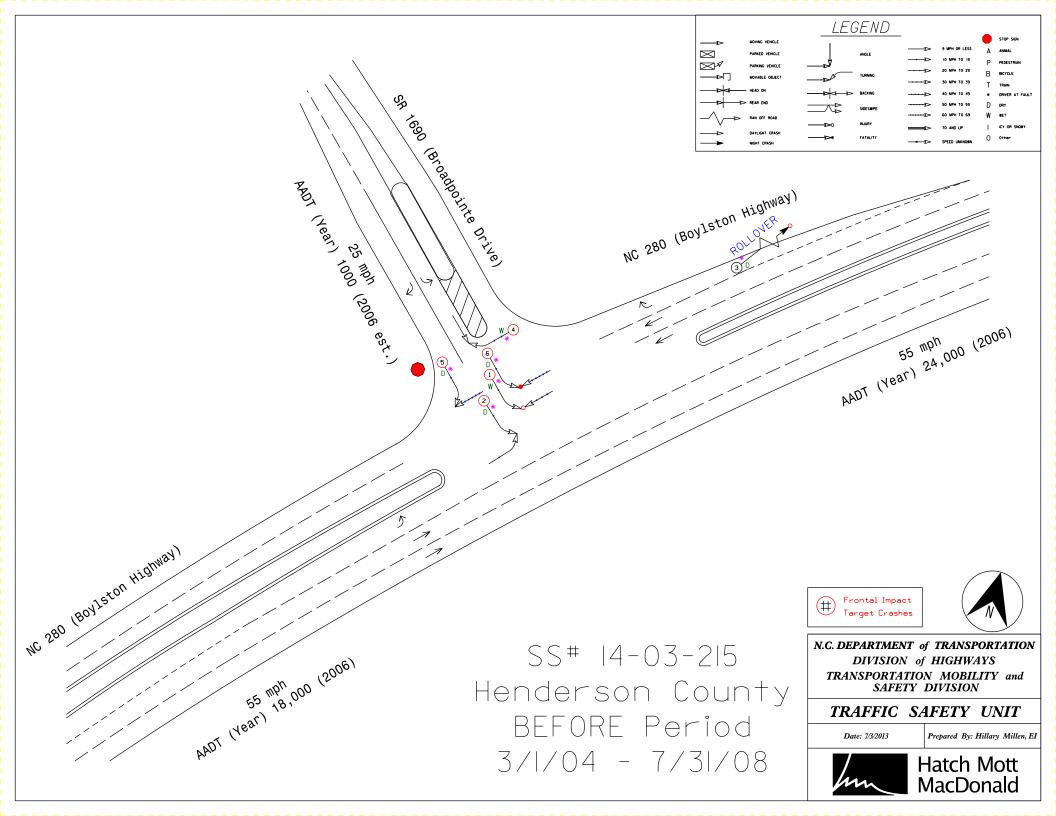
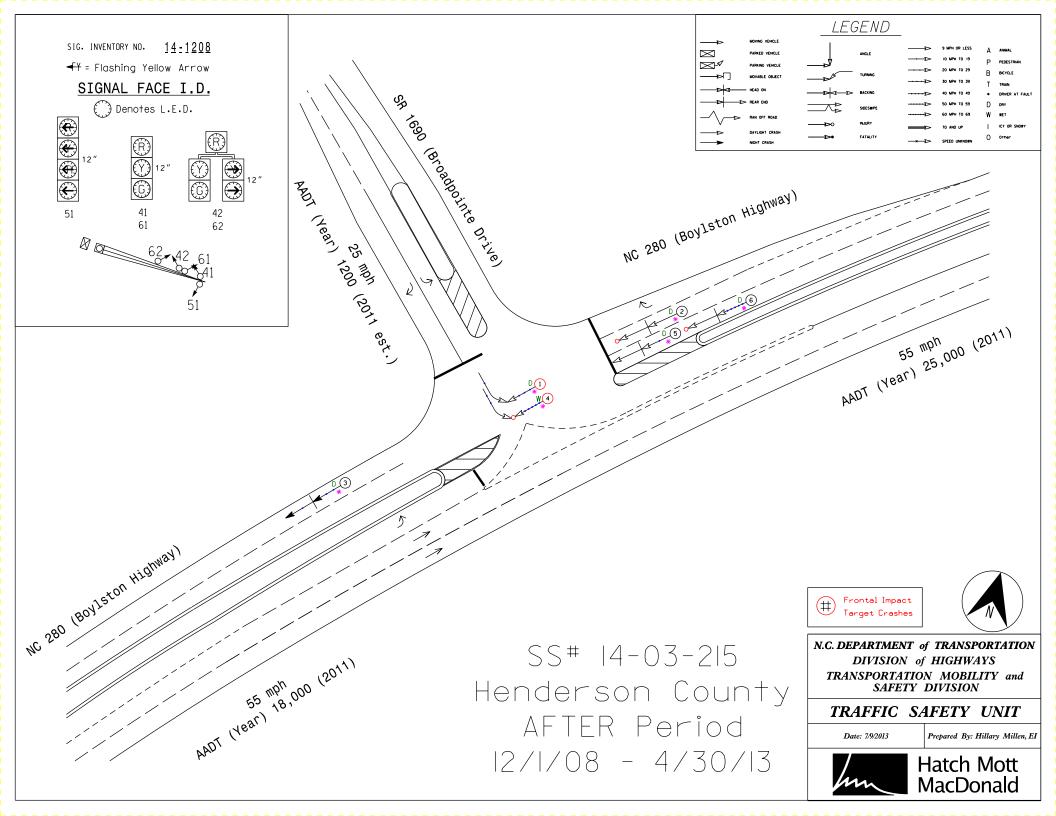
Referencing the *Collision Diagrams*, the target crashes (frontal impact crashes) experienced a 60 percent reduction from five (5) to only two (2) crashes in the After Period. It does appear that there has been an increase in rear end type crashes from zero (0) rear end crashes in the Before Period to four (4) rear end crashes in the After Period. Although one of the rear end crashes in the After Period does not appear to be related to the signal as they had already proceeded through the intersection.
