**An Evaluation of Using Portable
Changeable Message Signs (PCMS)
To Regulate Speed Limit in the I-95 Workzone
Project # I-4913, Northampton County**

Safety Evaluation Group
Traffic Safety Systems Management Section
Traffic Engineering and Safety Systems Branch
North Carolina Department of Transportation

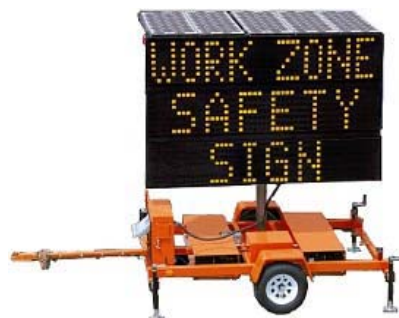
Figure 1: PCMS

From the MUTCD stated standards, the NCDOT Workzone Group is able to set a temporary speed limit in a workzone during a selected period of time using only a Portable Changeable Message Sign as shown in Figure 1 below.

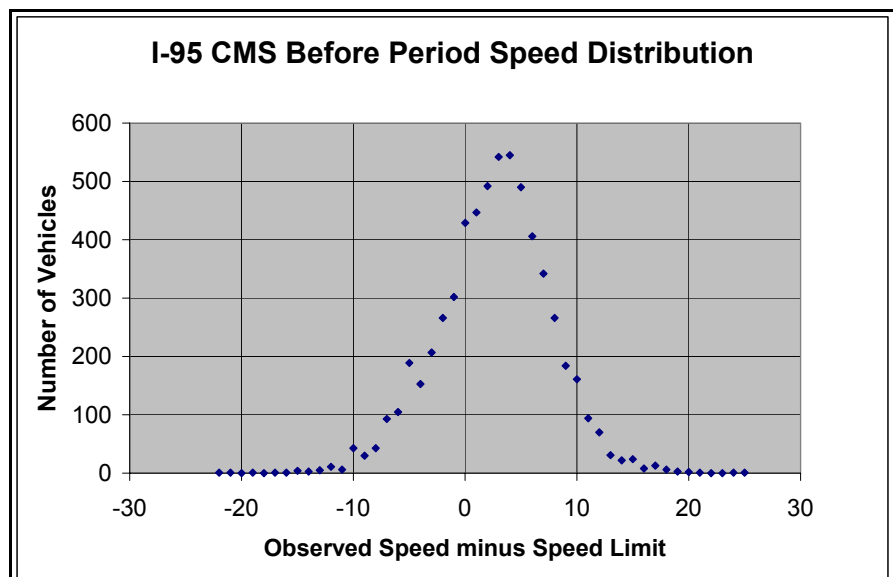
Figure 3: BEFORE Data

The Before Data (figure 3) represents speeds collected prior to the resurfacing project. The posted speed limit at this data location is 70 MPH. From the pace speed analysis we examine over 70 percent of the vehicles between the speeds of 69 and 78 mph. Commonly accepted engineering practices conclude that safety is enhanced when the 10-mph pace includes a large percentage (more than 70 percent) of all the free-flowing vehicles at a location. The before-after analysis actually shows a reduction in the 10-mph pace by one unit while maintaining the 70 percentage of vehicles.

Figures 3 through 5 below show the results of the speed data collected for our analysis. The data is shown with combined northbound and southbound data because the difference between directions was determined to be small and insignificant. More detailed speed data can be found in the Appendix of this report including breakdown by direction.

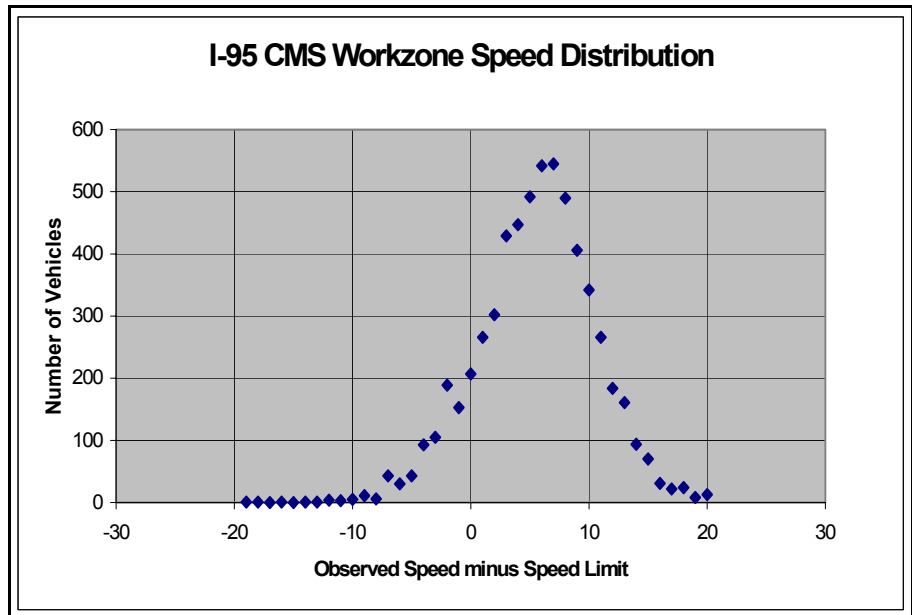
Figure 4: DURING Data

The During Data (figure 4) shows speeds collected in the workzone while the PCMS was being used to set the 55-mph speed limit. We observed a pace speed range of 50 to 59 which places the posted speed directly in the middle. These figures show that over the observation period that the average speeds of motorists traveling in the workzone were in compliance to the temporary speed limit.

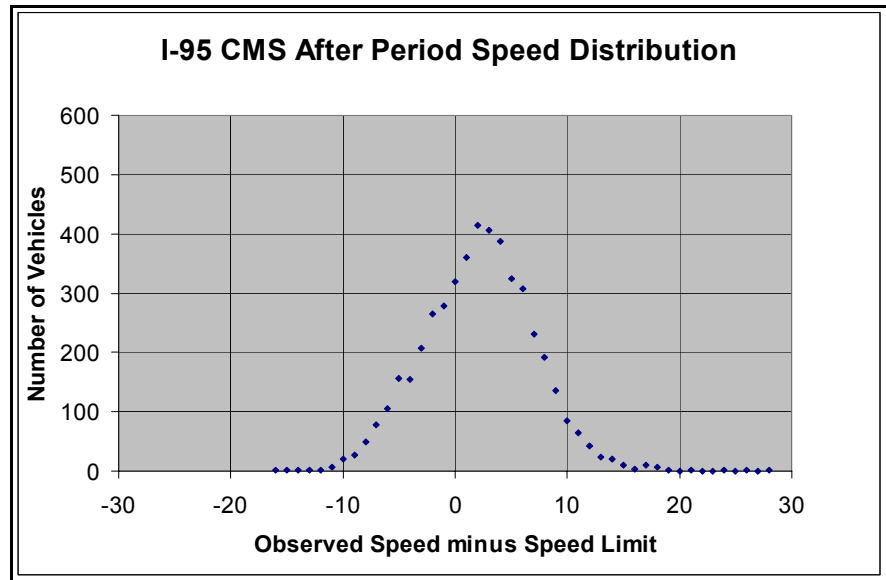
Figure 5: AFTER Data

As it can be seen in the tables above, there was little change in the average and 85th percentile speeds between the before and after data collection periods. The numbers however are statistically significant at the 95% confidence interval but the actual difference is small and not practically significant. The large sample sizes allow for small changes to be detected and declared significant in the statistical tests but the change of one unit in the PACE Speed from the before to the after periods is not enough to affect driver behavior.

The before to after analysis is compared to see if roadway conditions truly affected vehicle speeds. The after period data collection represented a smoother roadway surface and less resistance to the vehicle itself. As previously stated, the average and 85th percentile speeds were not practically different.

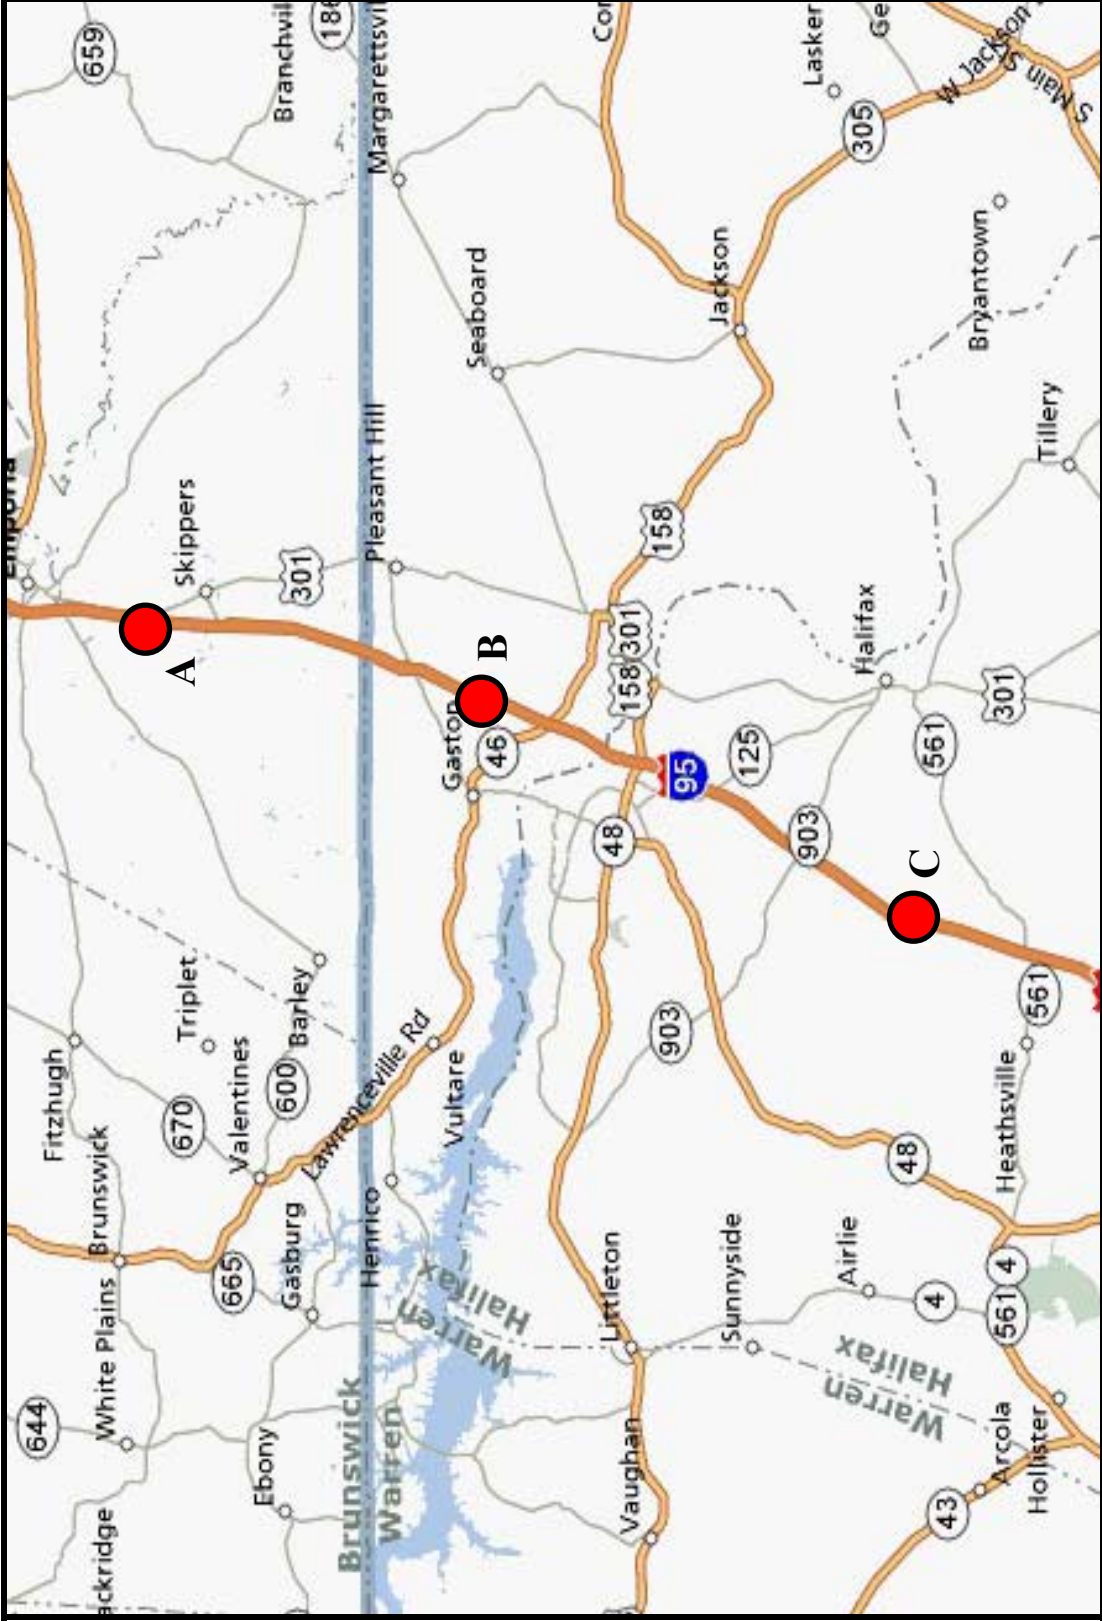
- A. Upstream Location – Greensville County, Virginia: VA 639 (Rock Bridge Rd)
- B. Study Location – Northampton County, North Carolina: SR 1202 (Blythe Rd)
- C. Downstream Location – Halifax County, North Carolina: SR 1001 (Justice Branch Rd)

The Downstream Data Collection Site was located at SR 1001 (Justice Branch Road) in Halifax County, closest Exit is number 160 off I-95. This location is approximately 5 miles south of Roanoke Rapids. SR 1001 is a bridged roadway over the interstate with no access ramps. Northbound and southbound vehicle speeds were collected from the rear on the corresponding side of the bridge. The bridge is located on a skew so that we were able to hide from view of approaching motorists. A map showing the three data collection sites is located in the Appendix.

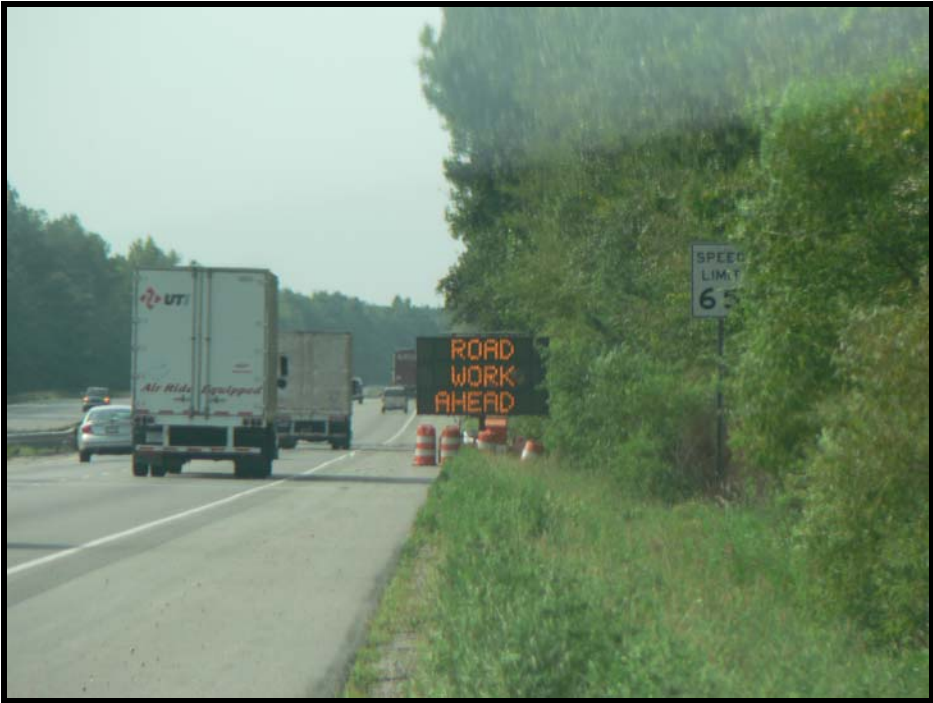
CMS Sign (near Exit 4 in Virginia)

Each PCMS was spaced between one and two miles apart. For example, a southbound lane closure starting at the border had Sign 1 located at Virginia Exit 4, Sign 2 at mile marker 2 in Virginia, Sign 3 at mile marker 1 in Virginia, and Sign 4 at the edge of the workzone (which designated the reduced speed limit of 55 miles per hour). Photos of this scenario can be found in the Appendix.

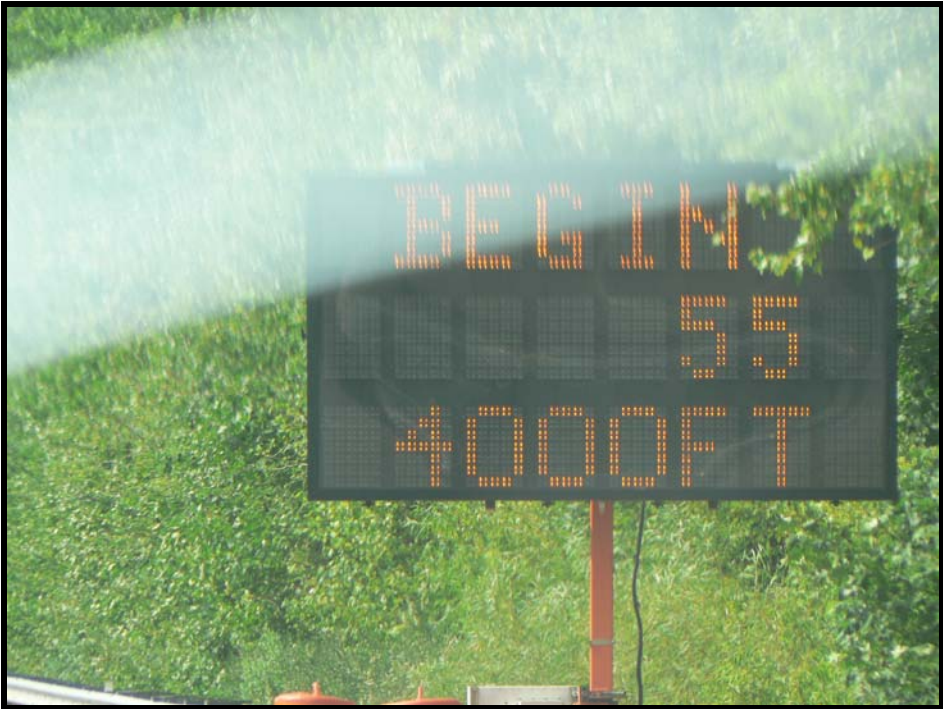
CMS indicating Speed Reduction Ahead

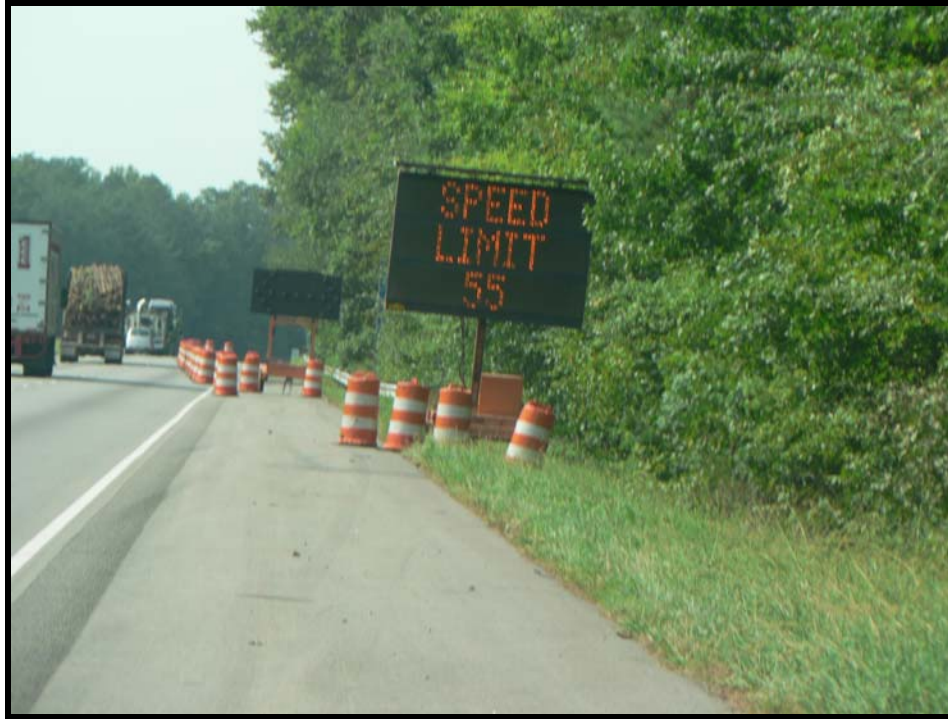
Speed Reduction CMS at beginning of Workzone

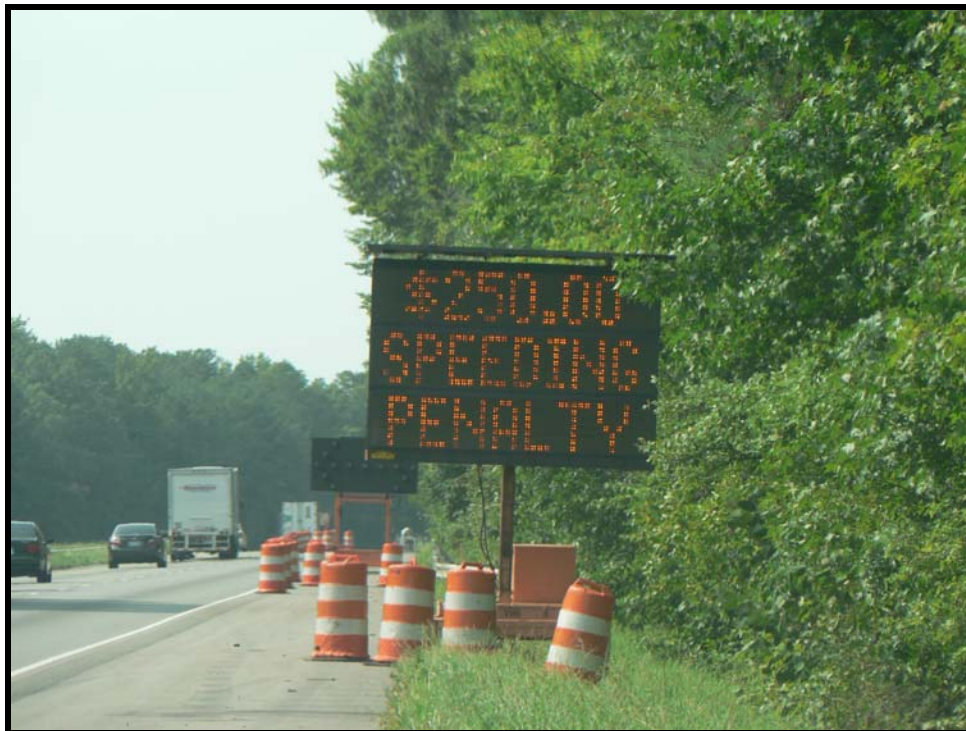
Second Message on Entrance CMS

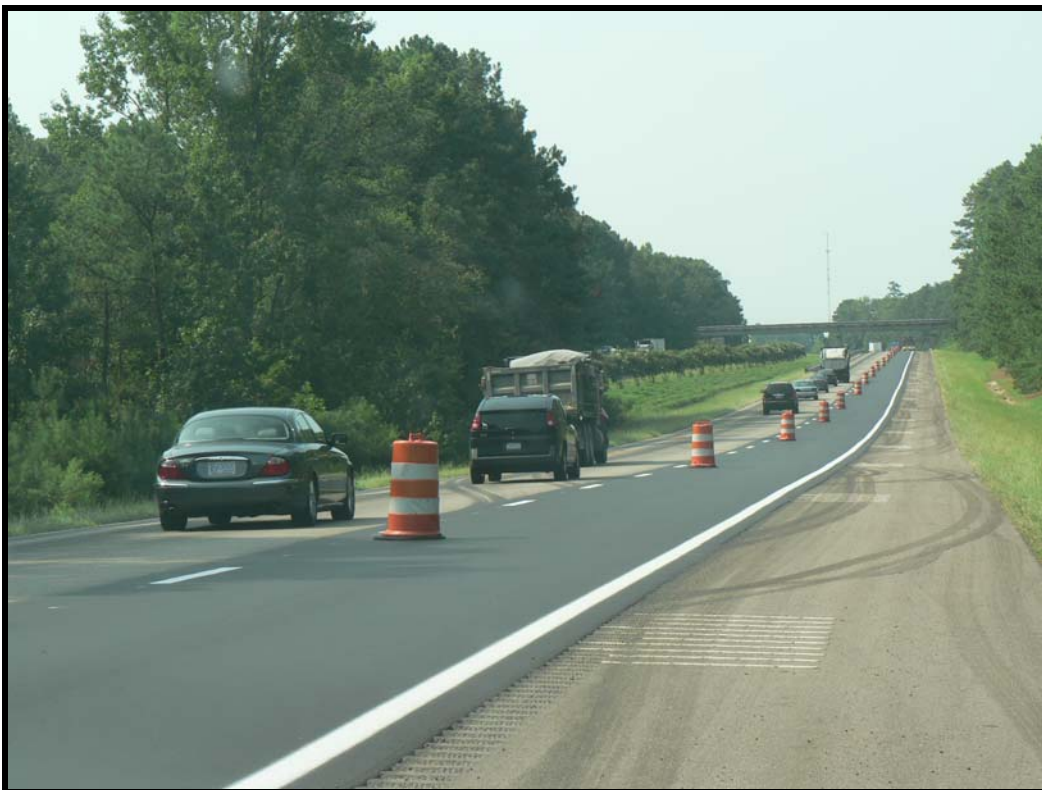
Dump Truck led platoons – assisted in regulating speeds

The company doing the resurfacing work in contract with the NCDOT was Barnhill Construction. Their operation of this resurfacing work was very efficient with the correct number of crewmen and an abundance of vehicles, especially asphalt dump trucks. Observations made in the During Data stage included Barnhill dump trucks traveling through the workzone to refill or get in line within the lane closure to dump asphalt. These dump truck drivers helped to regulate speeds within the workzone by traveling the posted 55-mph speed and queuing traffic behind them.

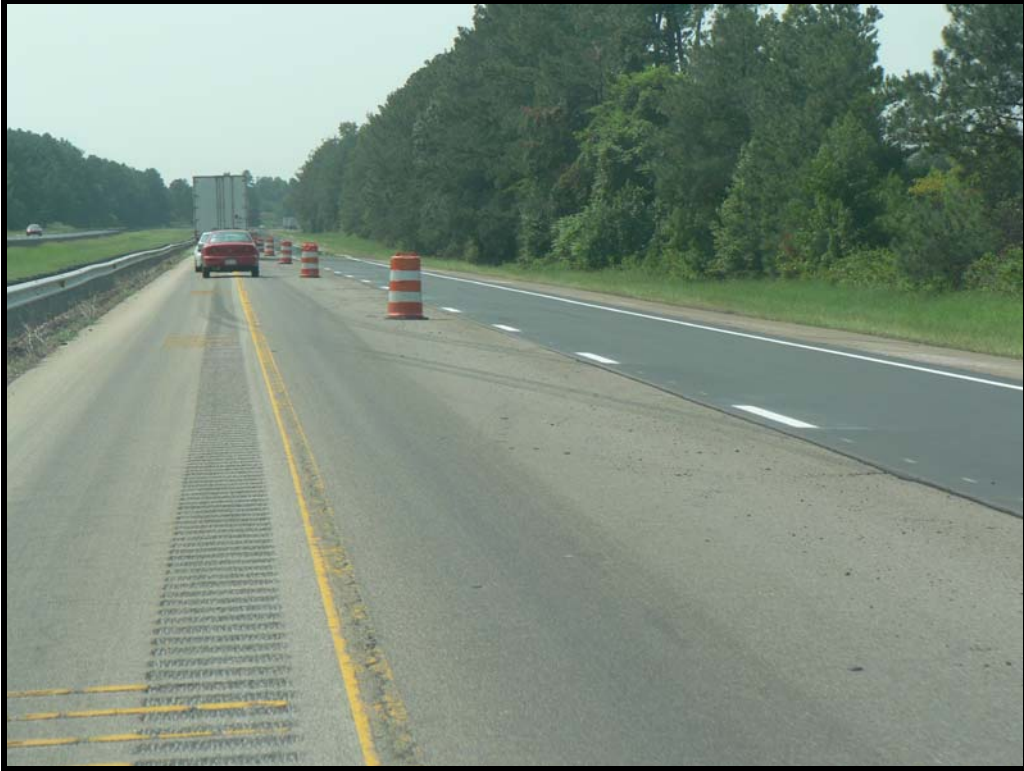
Squeezing of Traffic, Riding on Rubble Strips near WZ Workers

Traffic Barrels were used to designate the lane closure for workzone worker protection. These traffic control devices were placed either on the center-striped line or into the travel lane as a method to “squeeze” traffic for speed reduction. This often forced vehicles, especially tractor-trailers, to use the paved shoulder as part of their driving lane. In order to access the paved shoulder, vehicles had to cross the milled continuous rumble strip. Also, approximately every 30 feet, the same vehicles were striking an outdated thermoplastic intermittent rumble strip forcing them to regulate their traveling speed. Photos are provided showing the “squeezing” of vehicles.
