Project Log # 200506184

**Evaluation of the Conversion from Two-Way Stop Sign Control to Four-Way Stop Sign Control at the Intersection of SR 1006 (Clinton Road) and SR 1835 (Rockhill Road)  
Cumberland County**

Safety Evaluation Group  
Traffic Safety Systems Management Section  
Traffic Engineering and Safety Systems Branch  
North Carolina Department of Transportation

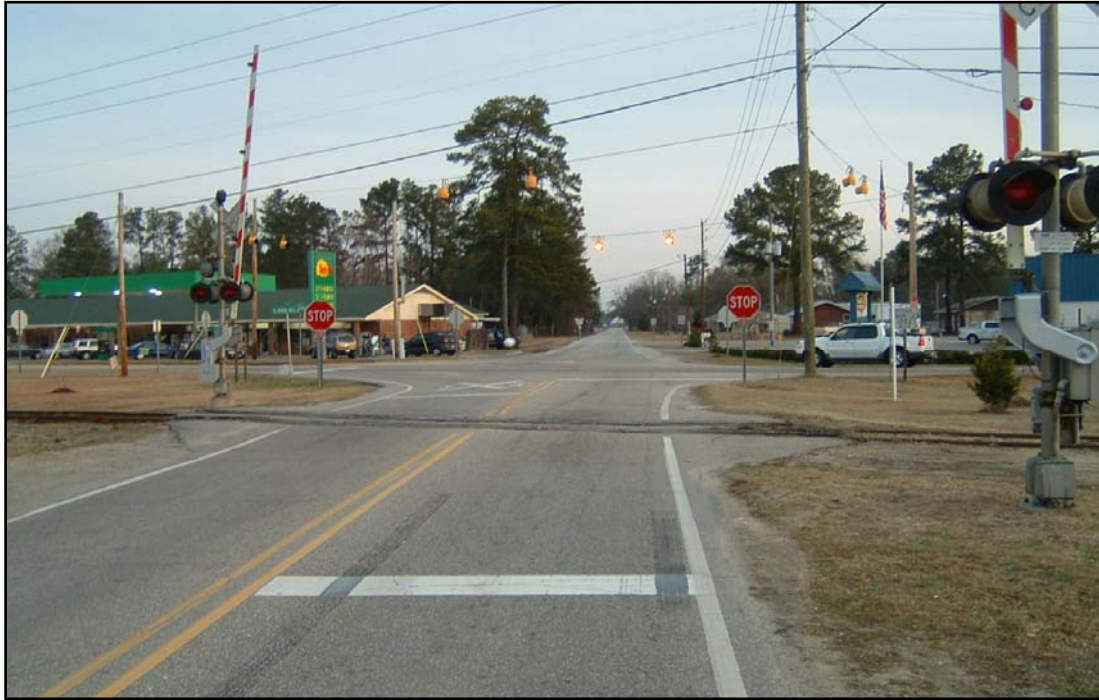
Looking North on SR 1835 (Rockhill Rd)

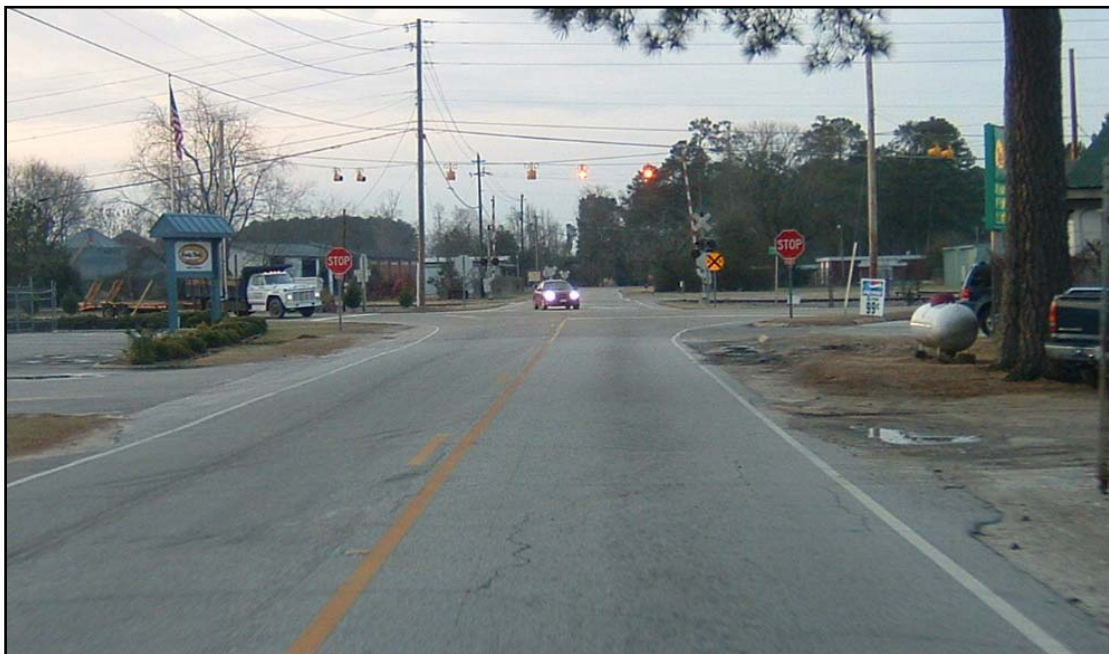
Looking South on SR 1835 (Rockhill Rd)

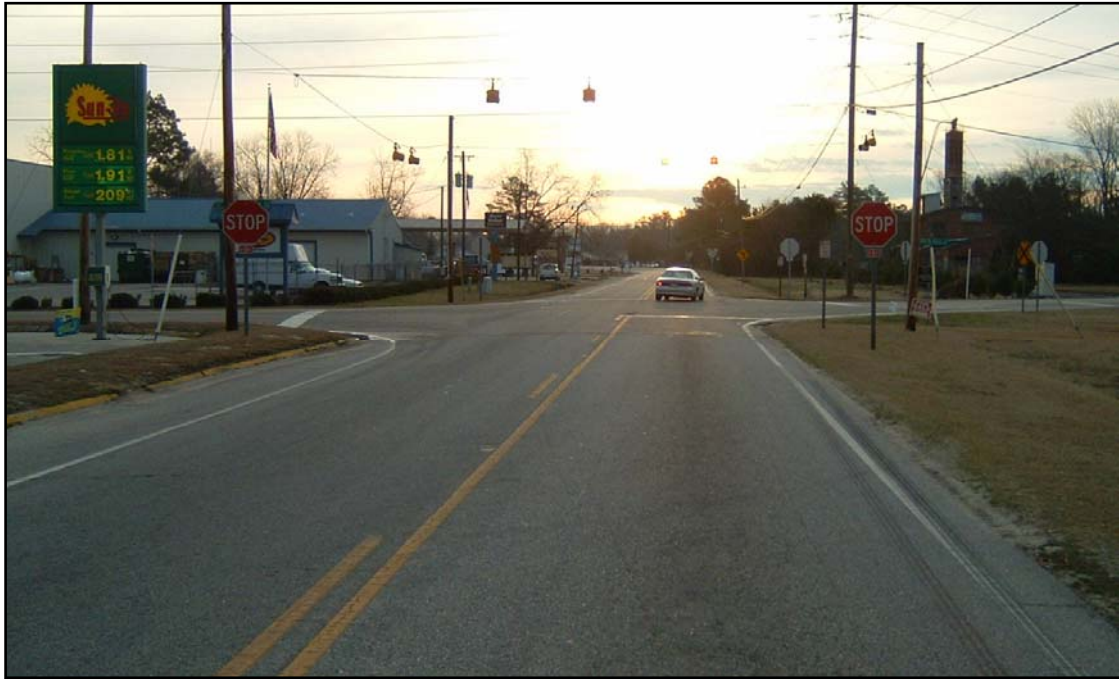
Looking East on SR 1006 (Clinton Rd)

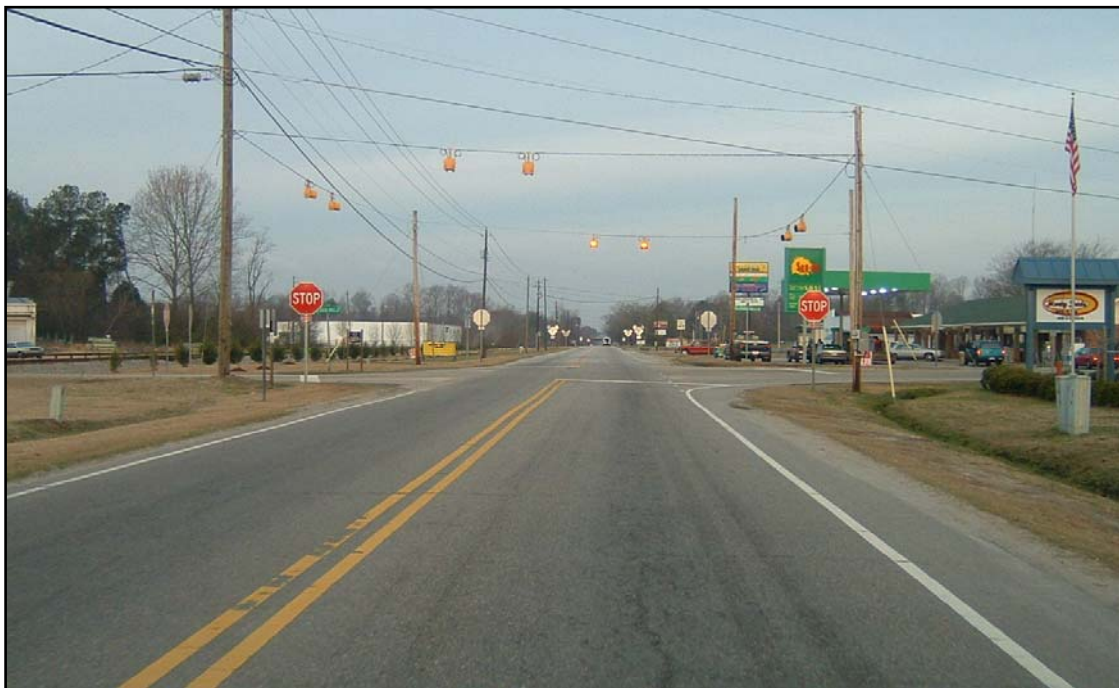
Looking West on SR 1006 (Clinton Rd)

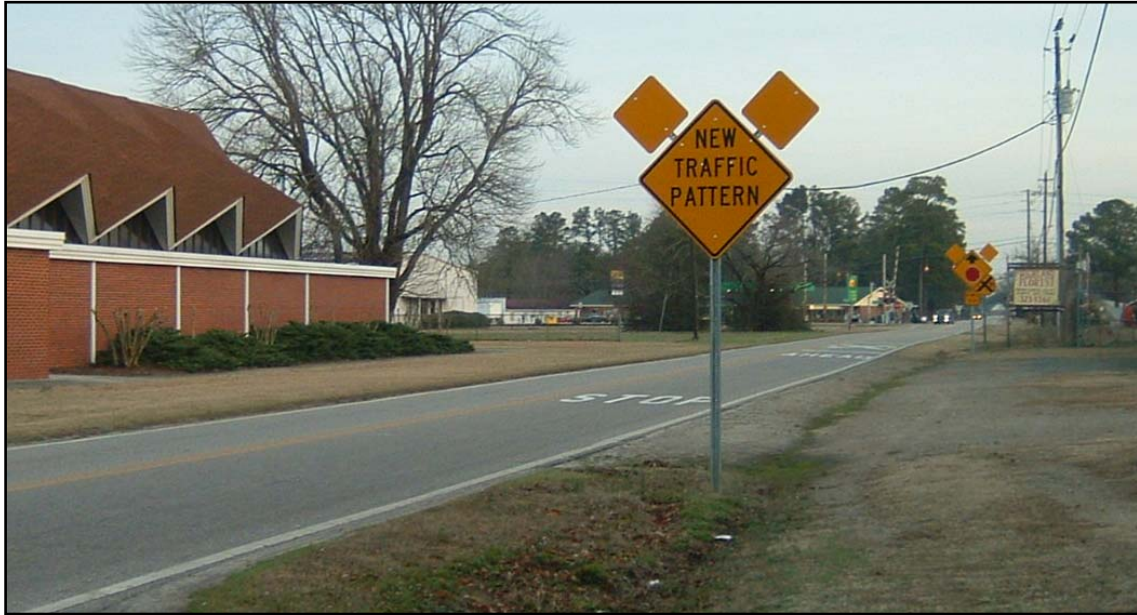
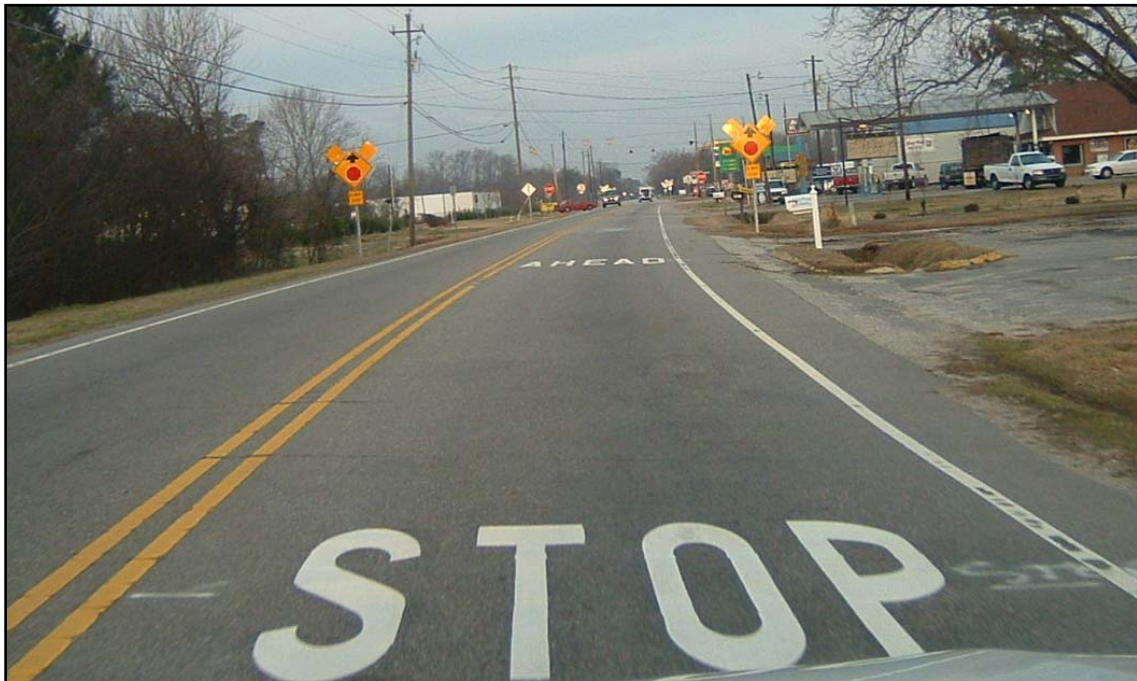
Looking North on SR 1835-Rockhill Rd (Above) and West on SR 1006-Clinton Rd (Below).  
“Stop Ahead” warning signs and pavement markings were placed on all approaches after the traffic control was converted to a four-way stop in order to warn motorists of the new traffic pattern.
