Spot Safety Project Evaluation

Spot Safety Project # 01-03-210

Spot Safety Project Evaluation of the Guardrail Installation on Both Approaches to Bridge #8 on US 158 over Cole Creek Gates County

Safety Evaluation Group
Traffic Safety Systems Management Section
Transportation Mobility and Safety Division
North Carolina Department of Transportation

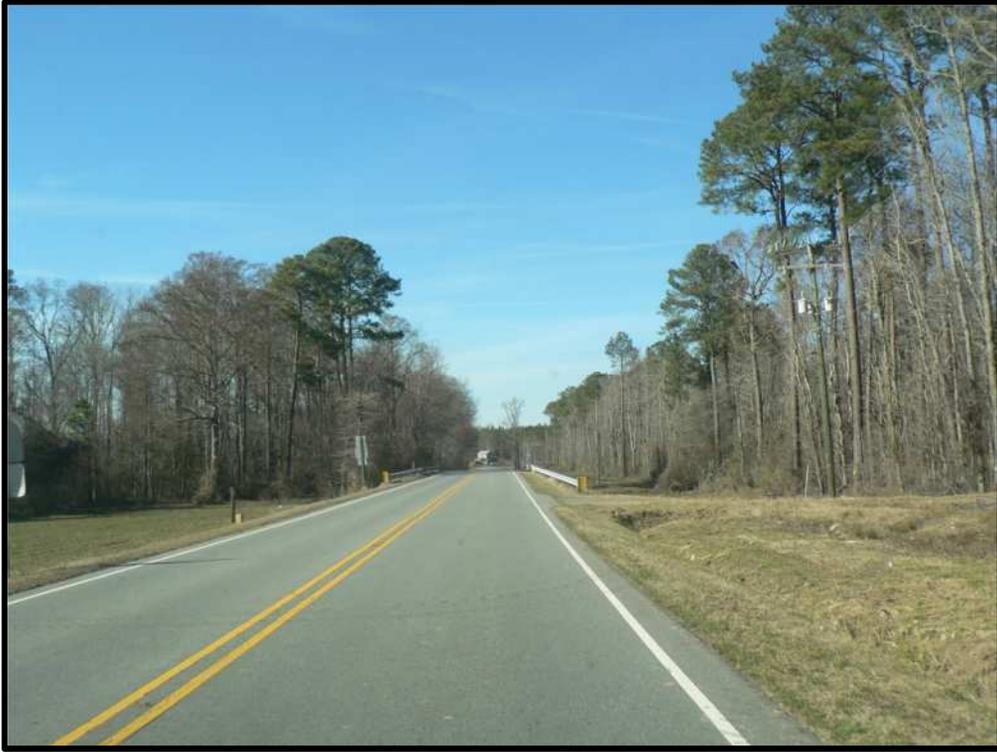
Traveling west on US 158

The spot safety project improvement countermeasure chosen for the subject location was to install guardrail on both approaches to the bridge.

Treatment Site Photos Taken February 13, 2012
