Spot Safety Project Evaluation

Spot Safety Project # 02-99-208

**Spot Safety Project Evaluation of the Right Turn Lane Installation
At the Intersection of US-264 (Pactolus Highway) and SR 1409 (Wharton Station Rd)
Beaufort County, City of Washington**

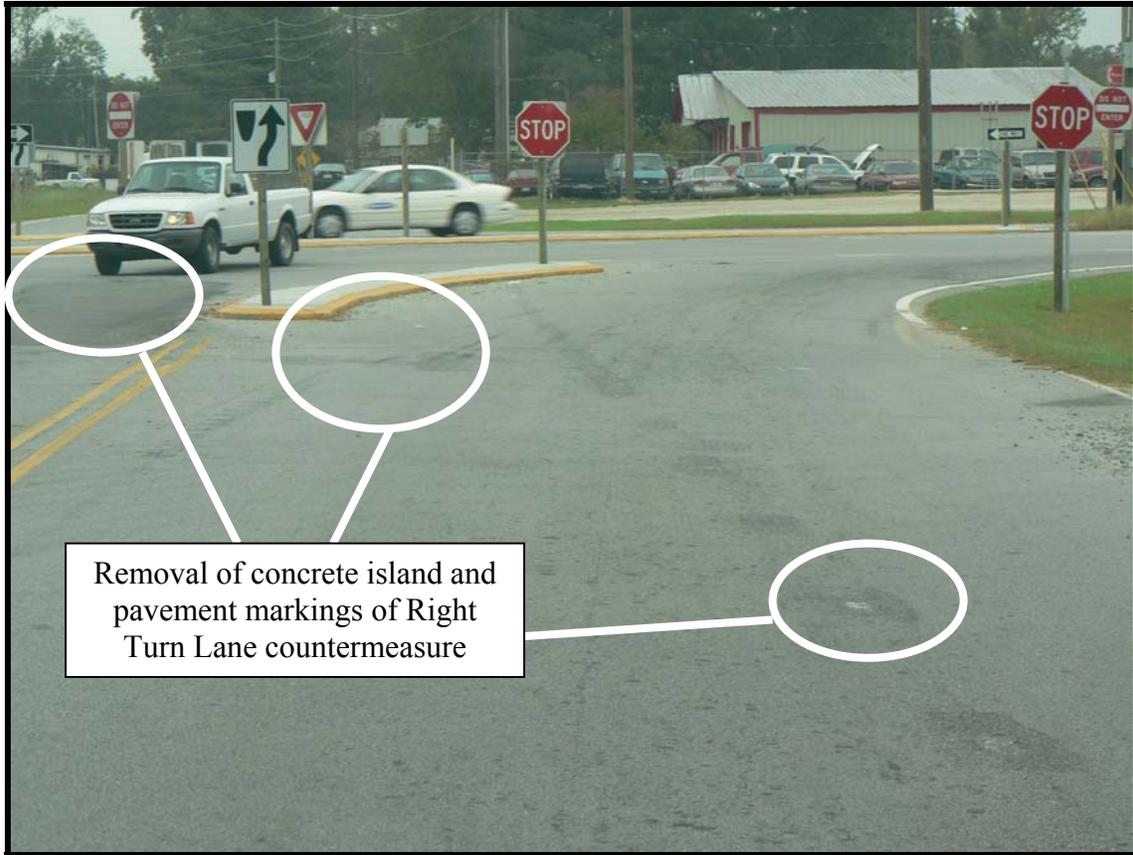
TREATMENT SITE PHOTOS TAKEN 10/3/2007

Traveling South on SR 1409 (Wharton Station Rd)
Notice the removal of Spot Safety Countermeasure under evaluation

Please see the attached *Treatment Site Photos*. Photos are provided for all approaches to the treatment intersection after the crossover was operational as explained in the *Project Background* section. In *Photo 1* notice the evidence of the removed right turn lane countermeasure.

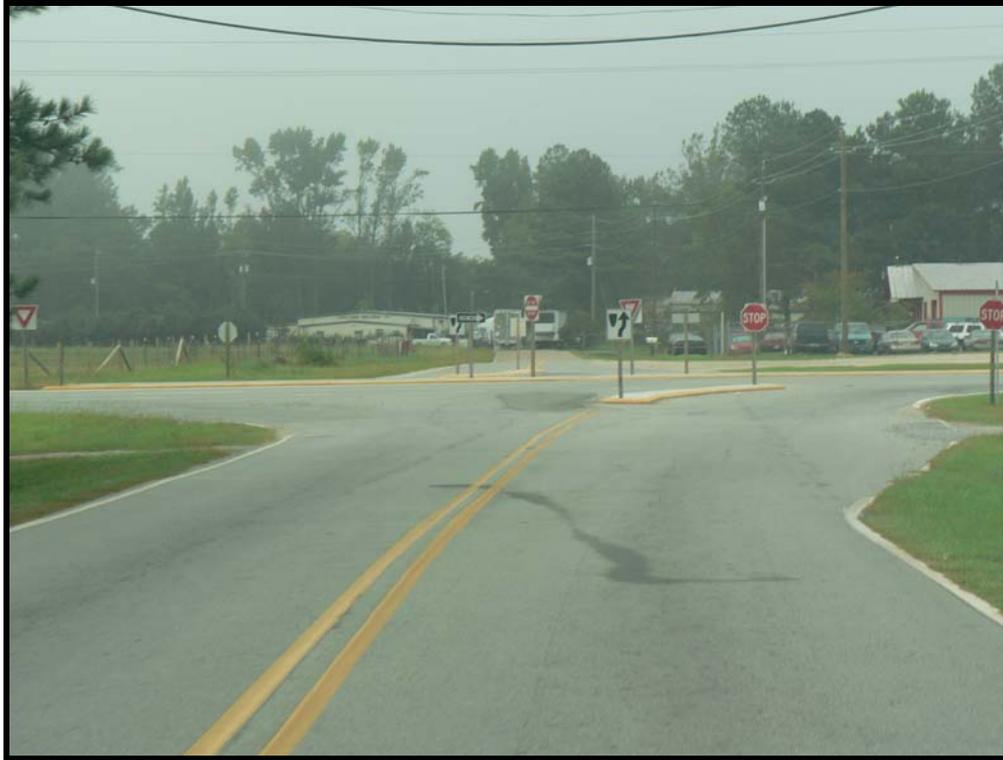
Traveling South on SR 1409 (Wharton Station Rd)
Notice where the Right Turn Lane was installed prior to the crossover

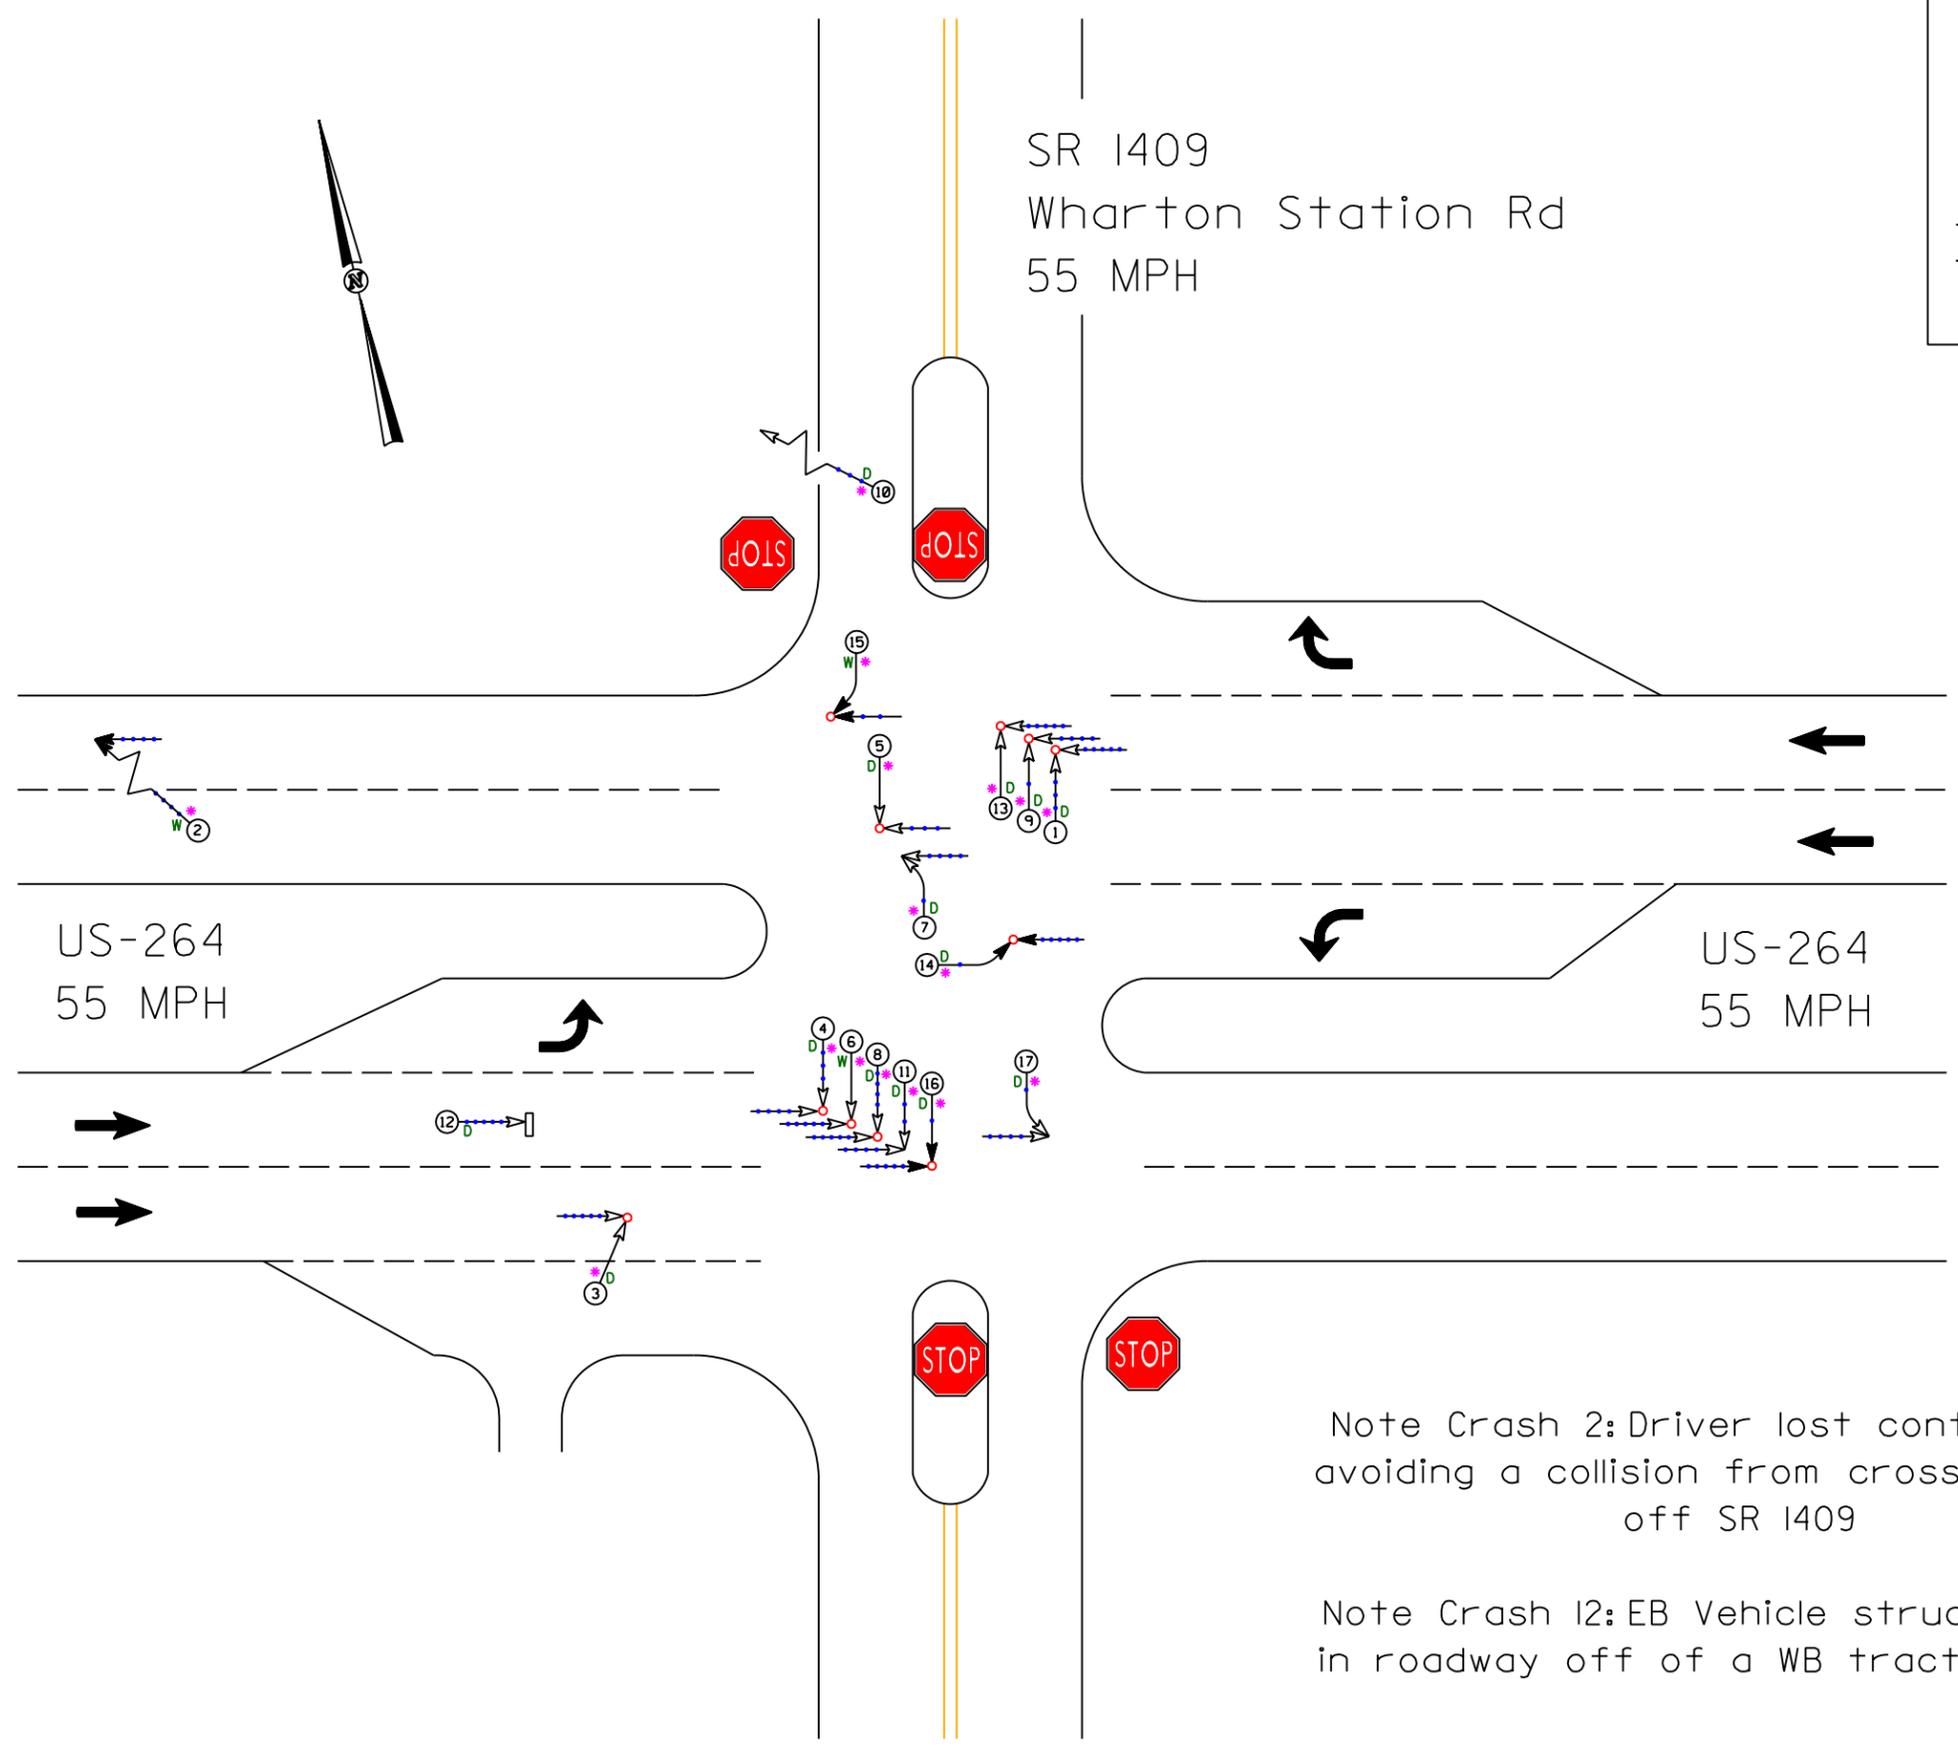
SS# 02-99-208
Beaufort County
Before Period
1/1/97 - 10/31/01
US-264 at SR 1409

Note Crash 2: Driver lost control after avoiding a collision from cross traffic off SR 1409

Note Crash 12: EB Vehicle struck bumper in roadway off of a WB tractor-trailer

Referencing the *Collision Diagrams*, angle collisions increased at the intersection from nine (9) to sixteen (16). Also, rear-end crashes on the southbound leg where the right turn lane was installed increased from zero (0) crashes in the before period to five (5) in the after. This countermeasure seems to have been installed to enhance operational conditions instead of boosting safety. Although the crash data is not available to measure the crossover effectiveness, it should solve the major crash patterns at this location. The angle crash pattern in the after period resulted in one (1) fatality and one (1) class “A” injury collision.

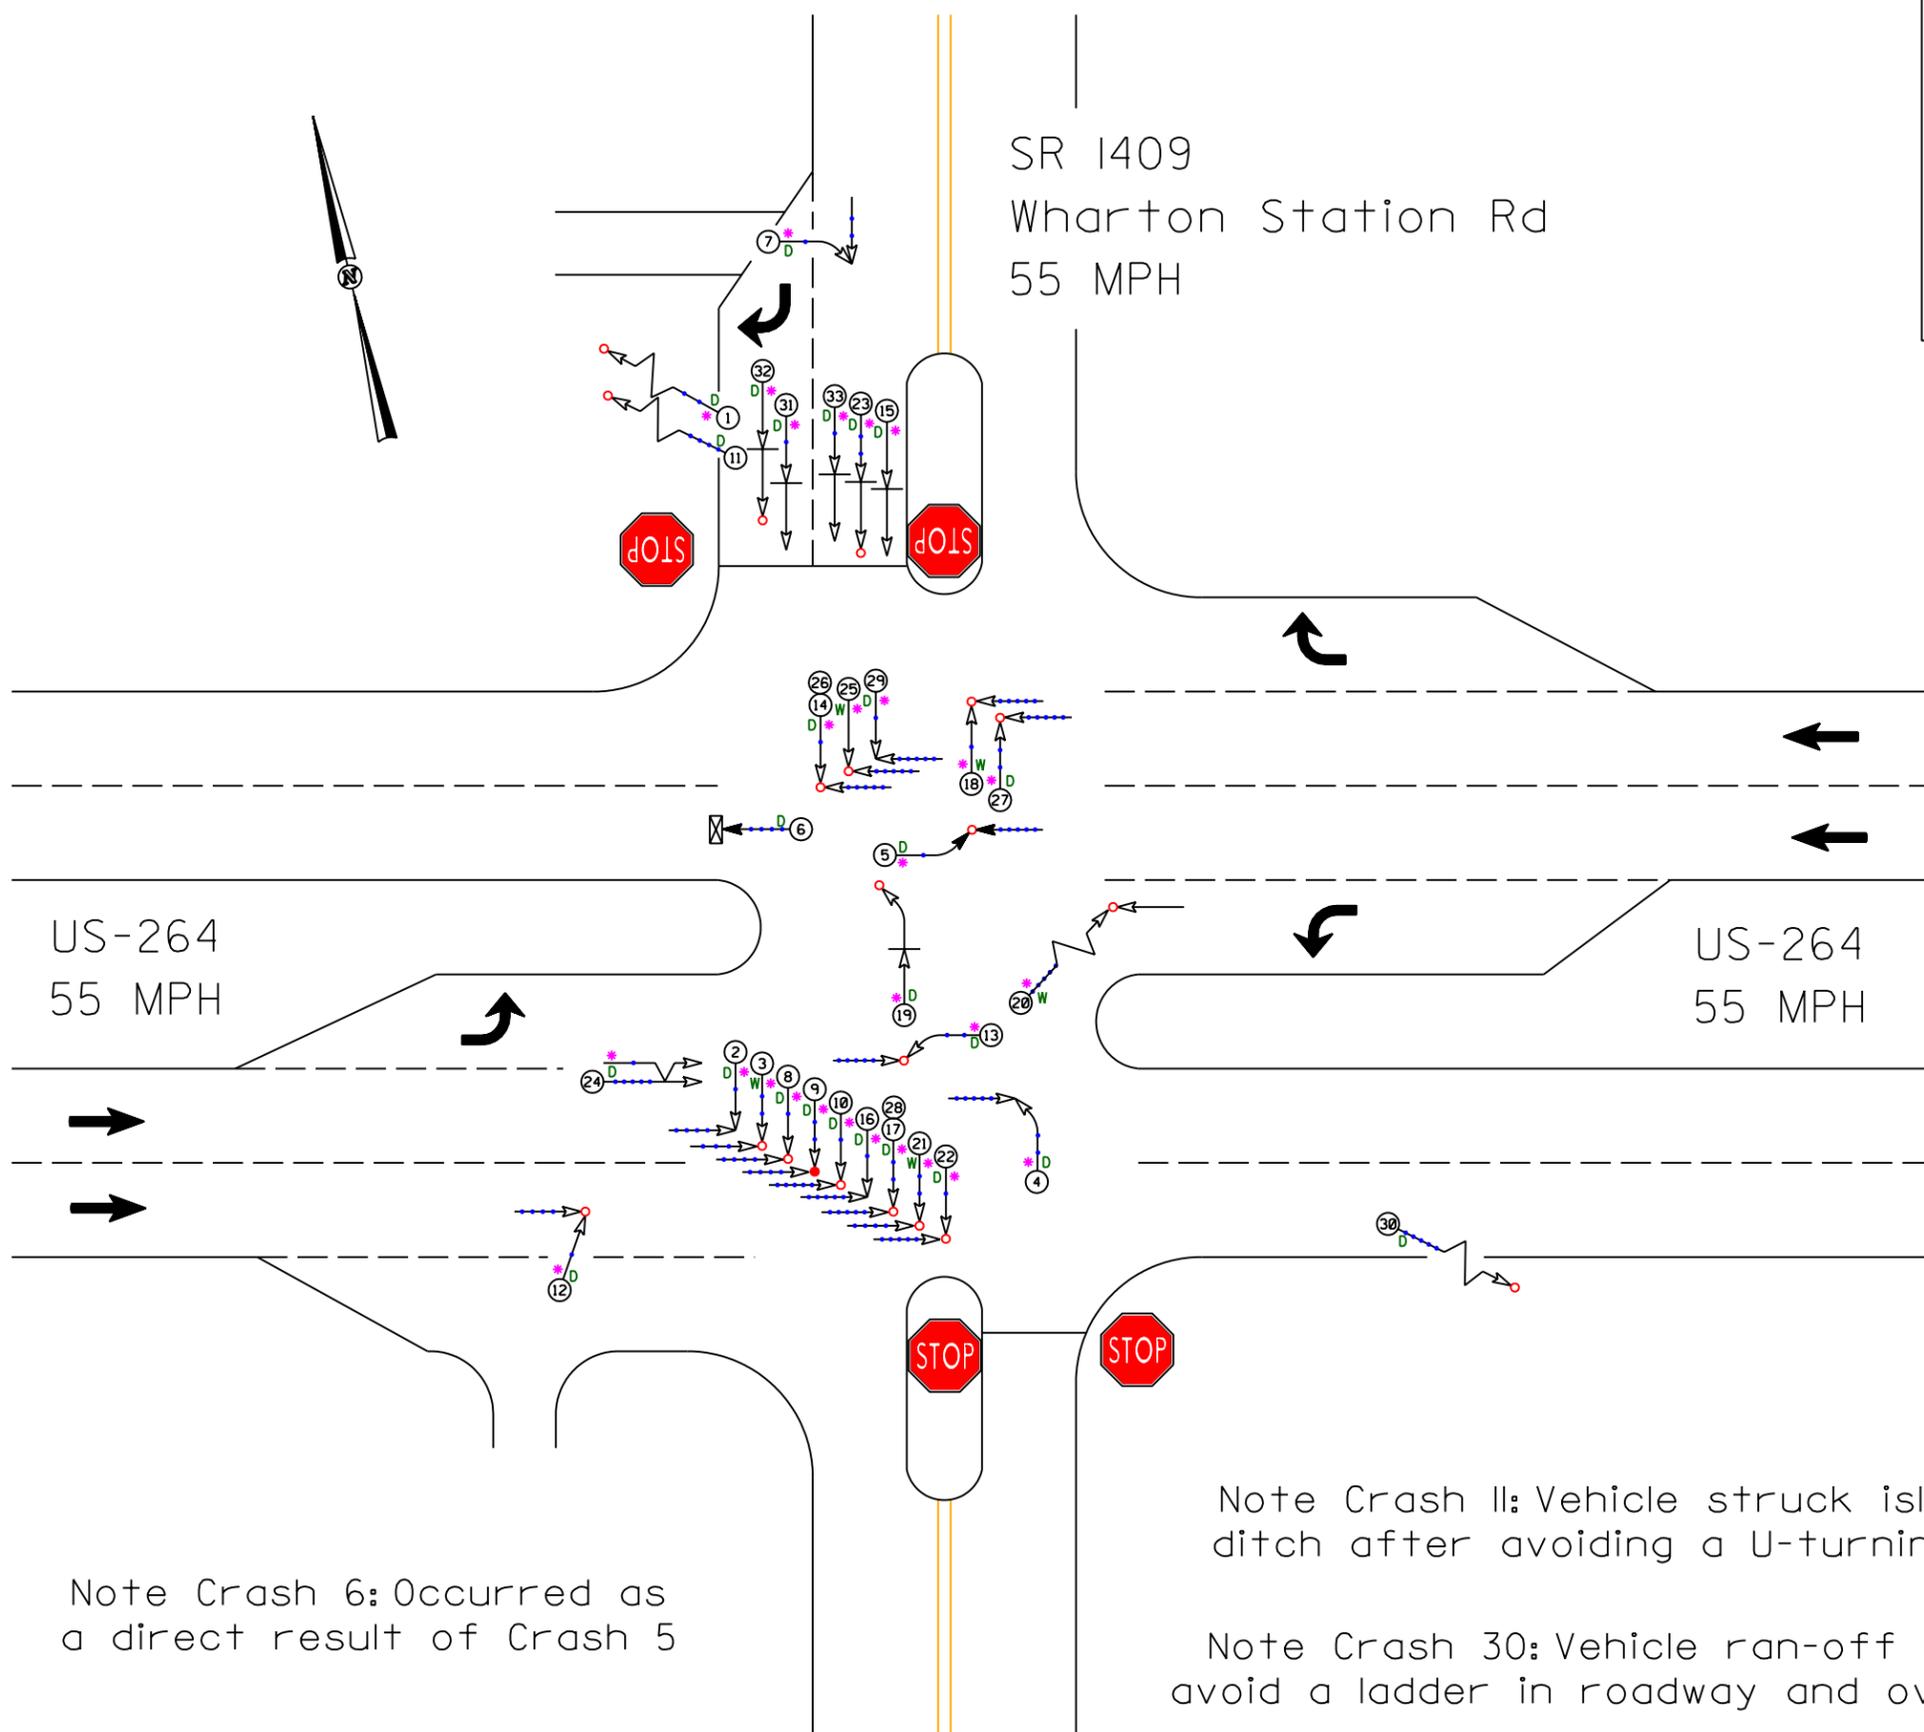
SS# 02-99-208
Beaufort County
After Period
5/1/02 - 2/28/07
US-264 at SR 1409

After Period Changes:
Installed SB Right Turn
Lane on SR 1409

Note Crash 6: Occurred as
a direct result of Crash 5

Note Crash 11: Vehicle struck island and
ditch after avoiding a U-turning truck

Note Crash 30: Vehicle ran-off road to
avoid a ladder in roadway and overturned
