Spot Safety Project Evaluation

Spot Safety Project # 03-02-221

Spot Safety Project Evaluation of the Signal Phase Changes and Intersection Countermeasure Progression NC 24 Bypass (Kenansville Bypass) at NC 11 Duplin County, Town of Kenansville

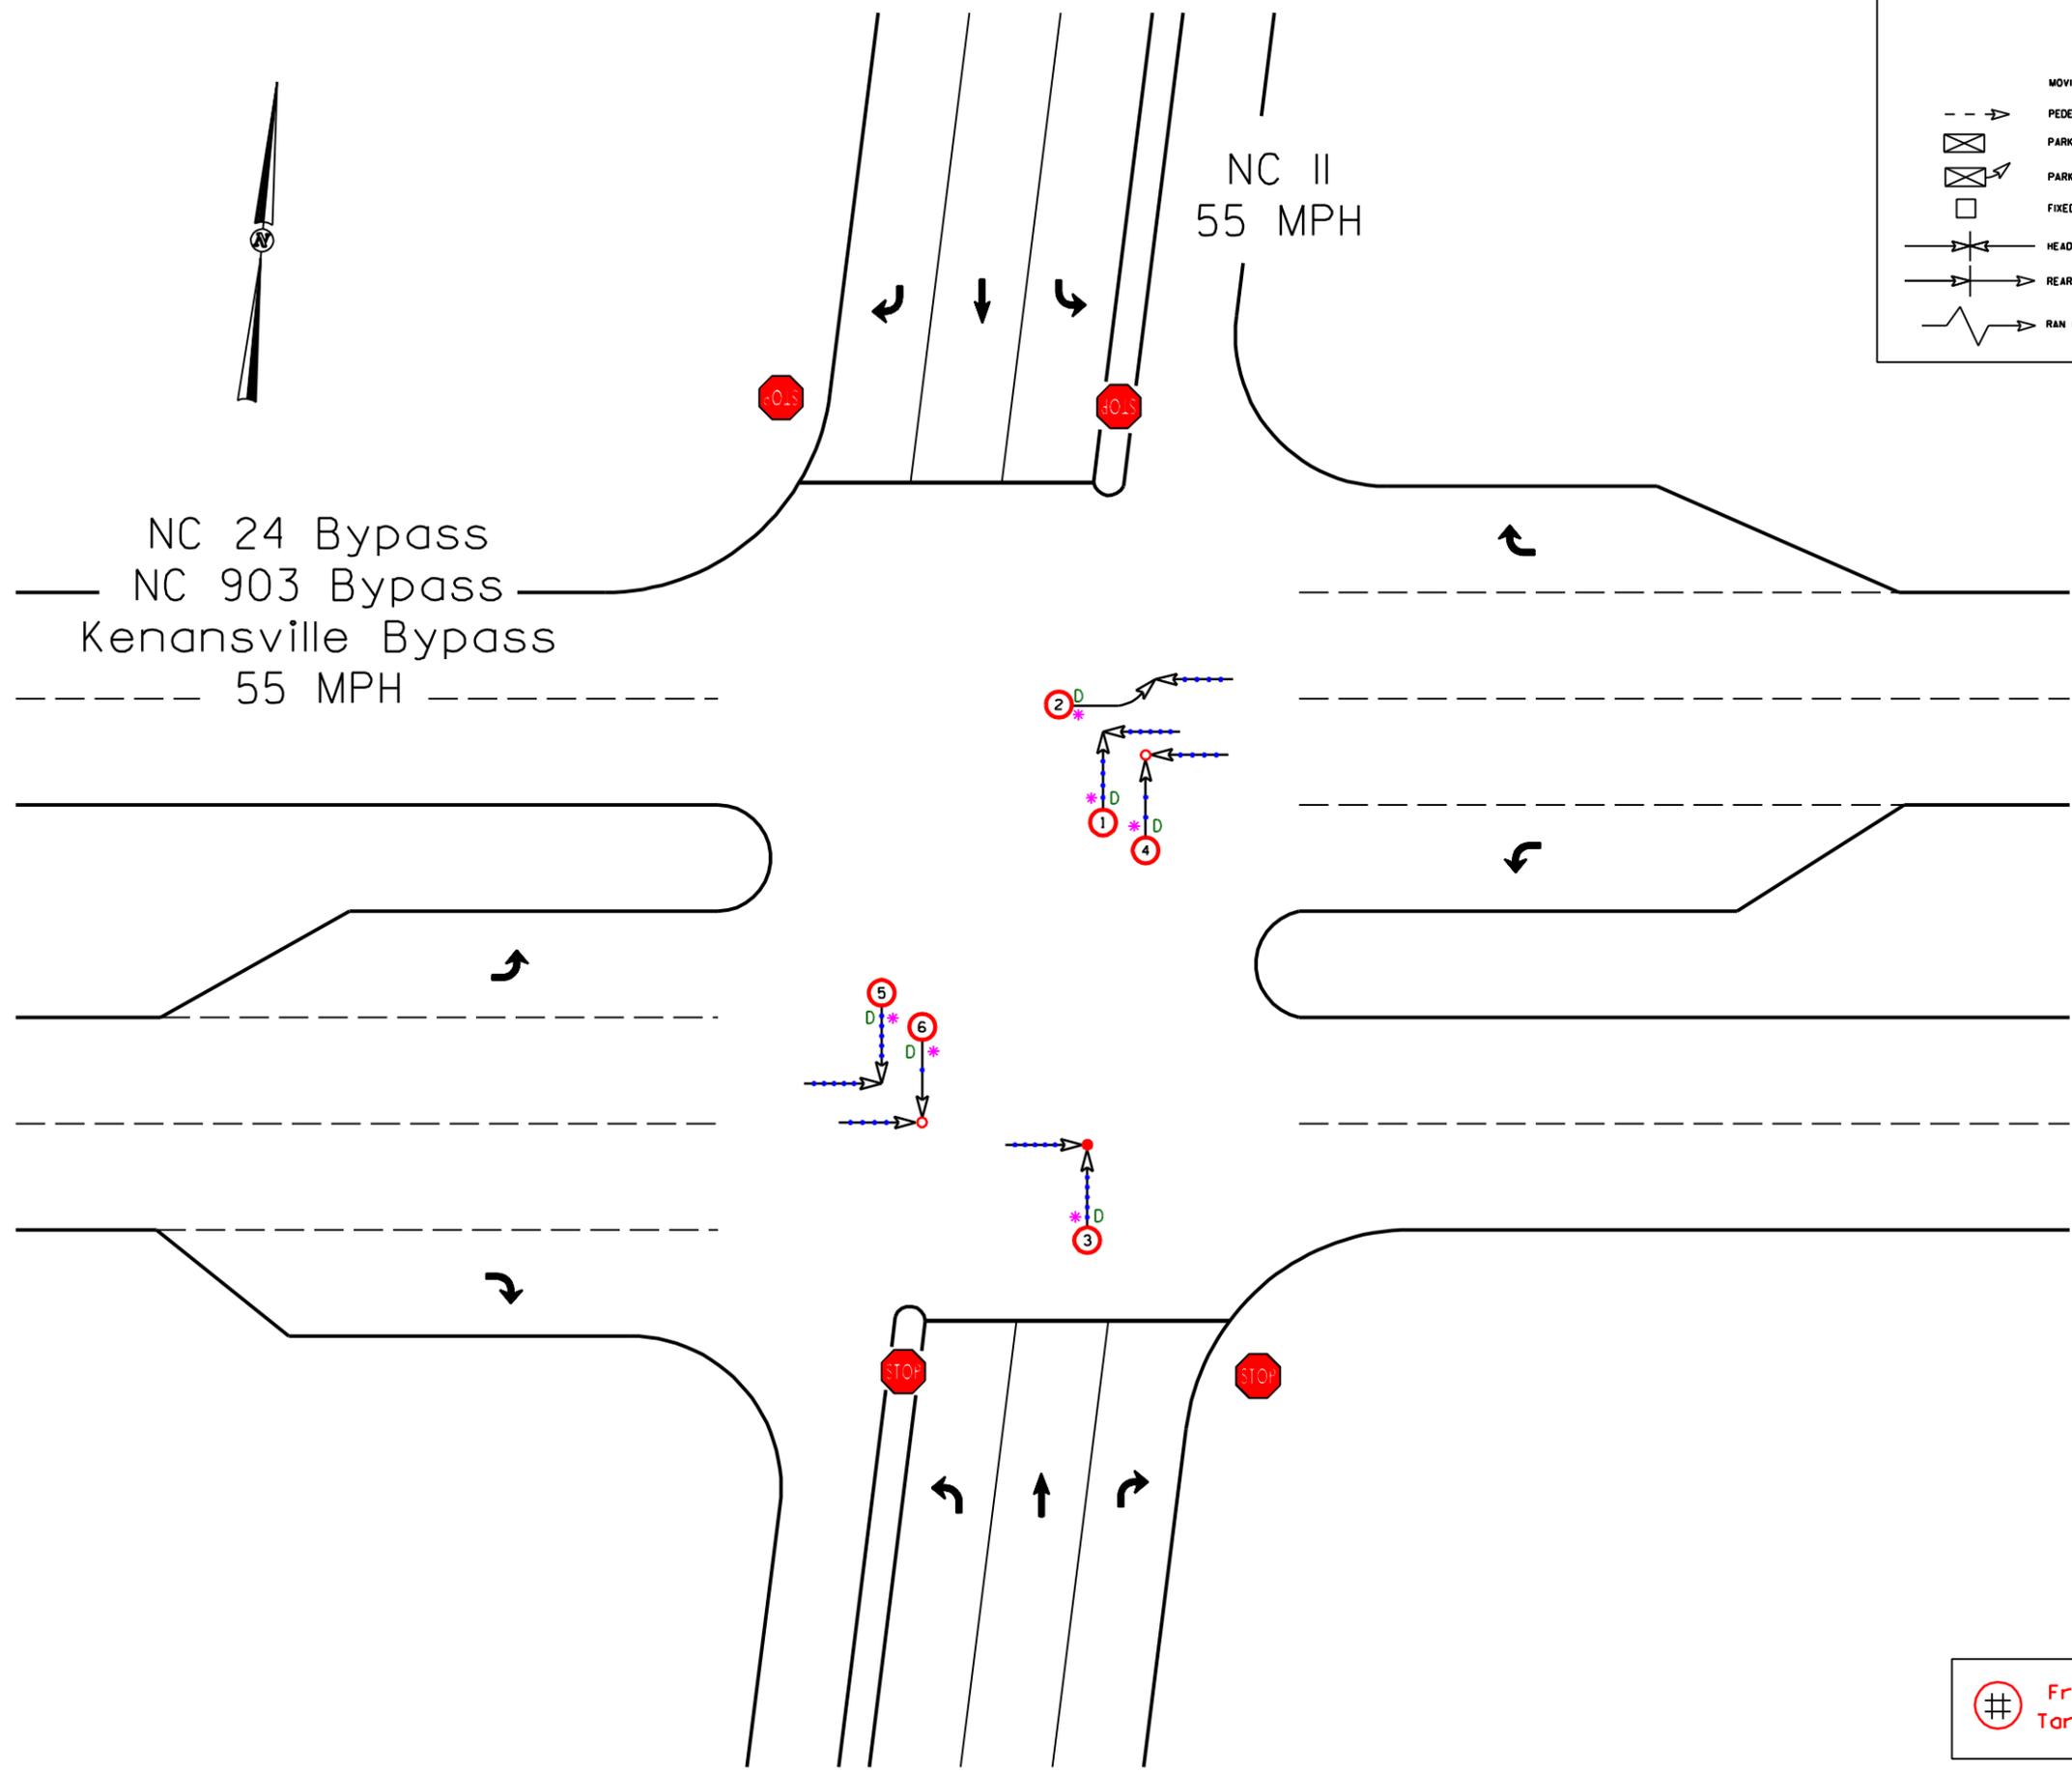
SS# 03-02-221
BEFORE I Period
Stop Control
0.34 Yrs
10/1/98 - 1/31/99

Frontal Impact
Target Crashes

Referencing the *Collision Diagrams*, the two signal controlled before periods indicate severe patterns of NC 24 left turn same roadway crash patterns especially vehicles accessing NC 11 northbound; including 2 fatal collisions. After the NC 24 protected left turn phase installation, the left turn same roadway pattern was significantly reduced to only 4 crashes over 6.25 years. The after period is still experiencing red light run collisions (seven angles, one ran-off road). Permissive NC 11 left turn same roadway crashes are also occurring at a rate of 0.48 crashes per year. Overall, the crash data demonstrates that the intersection countermeasure progression has had a considerable positive impact on the number and severity of collisions at this location.

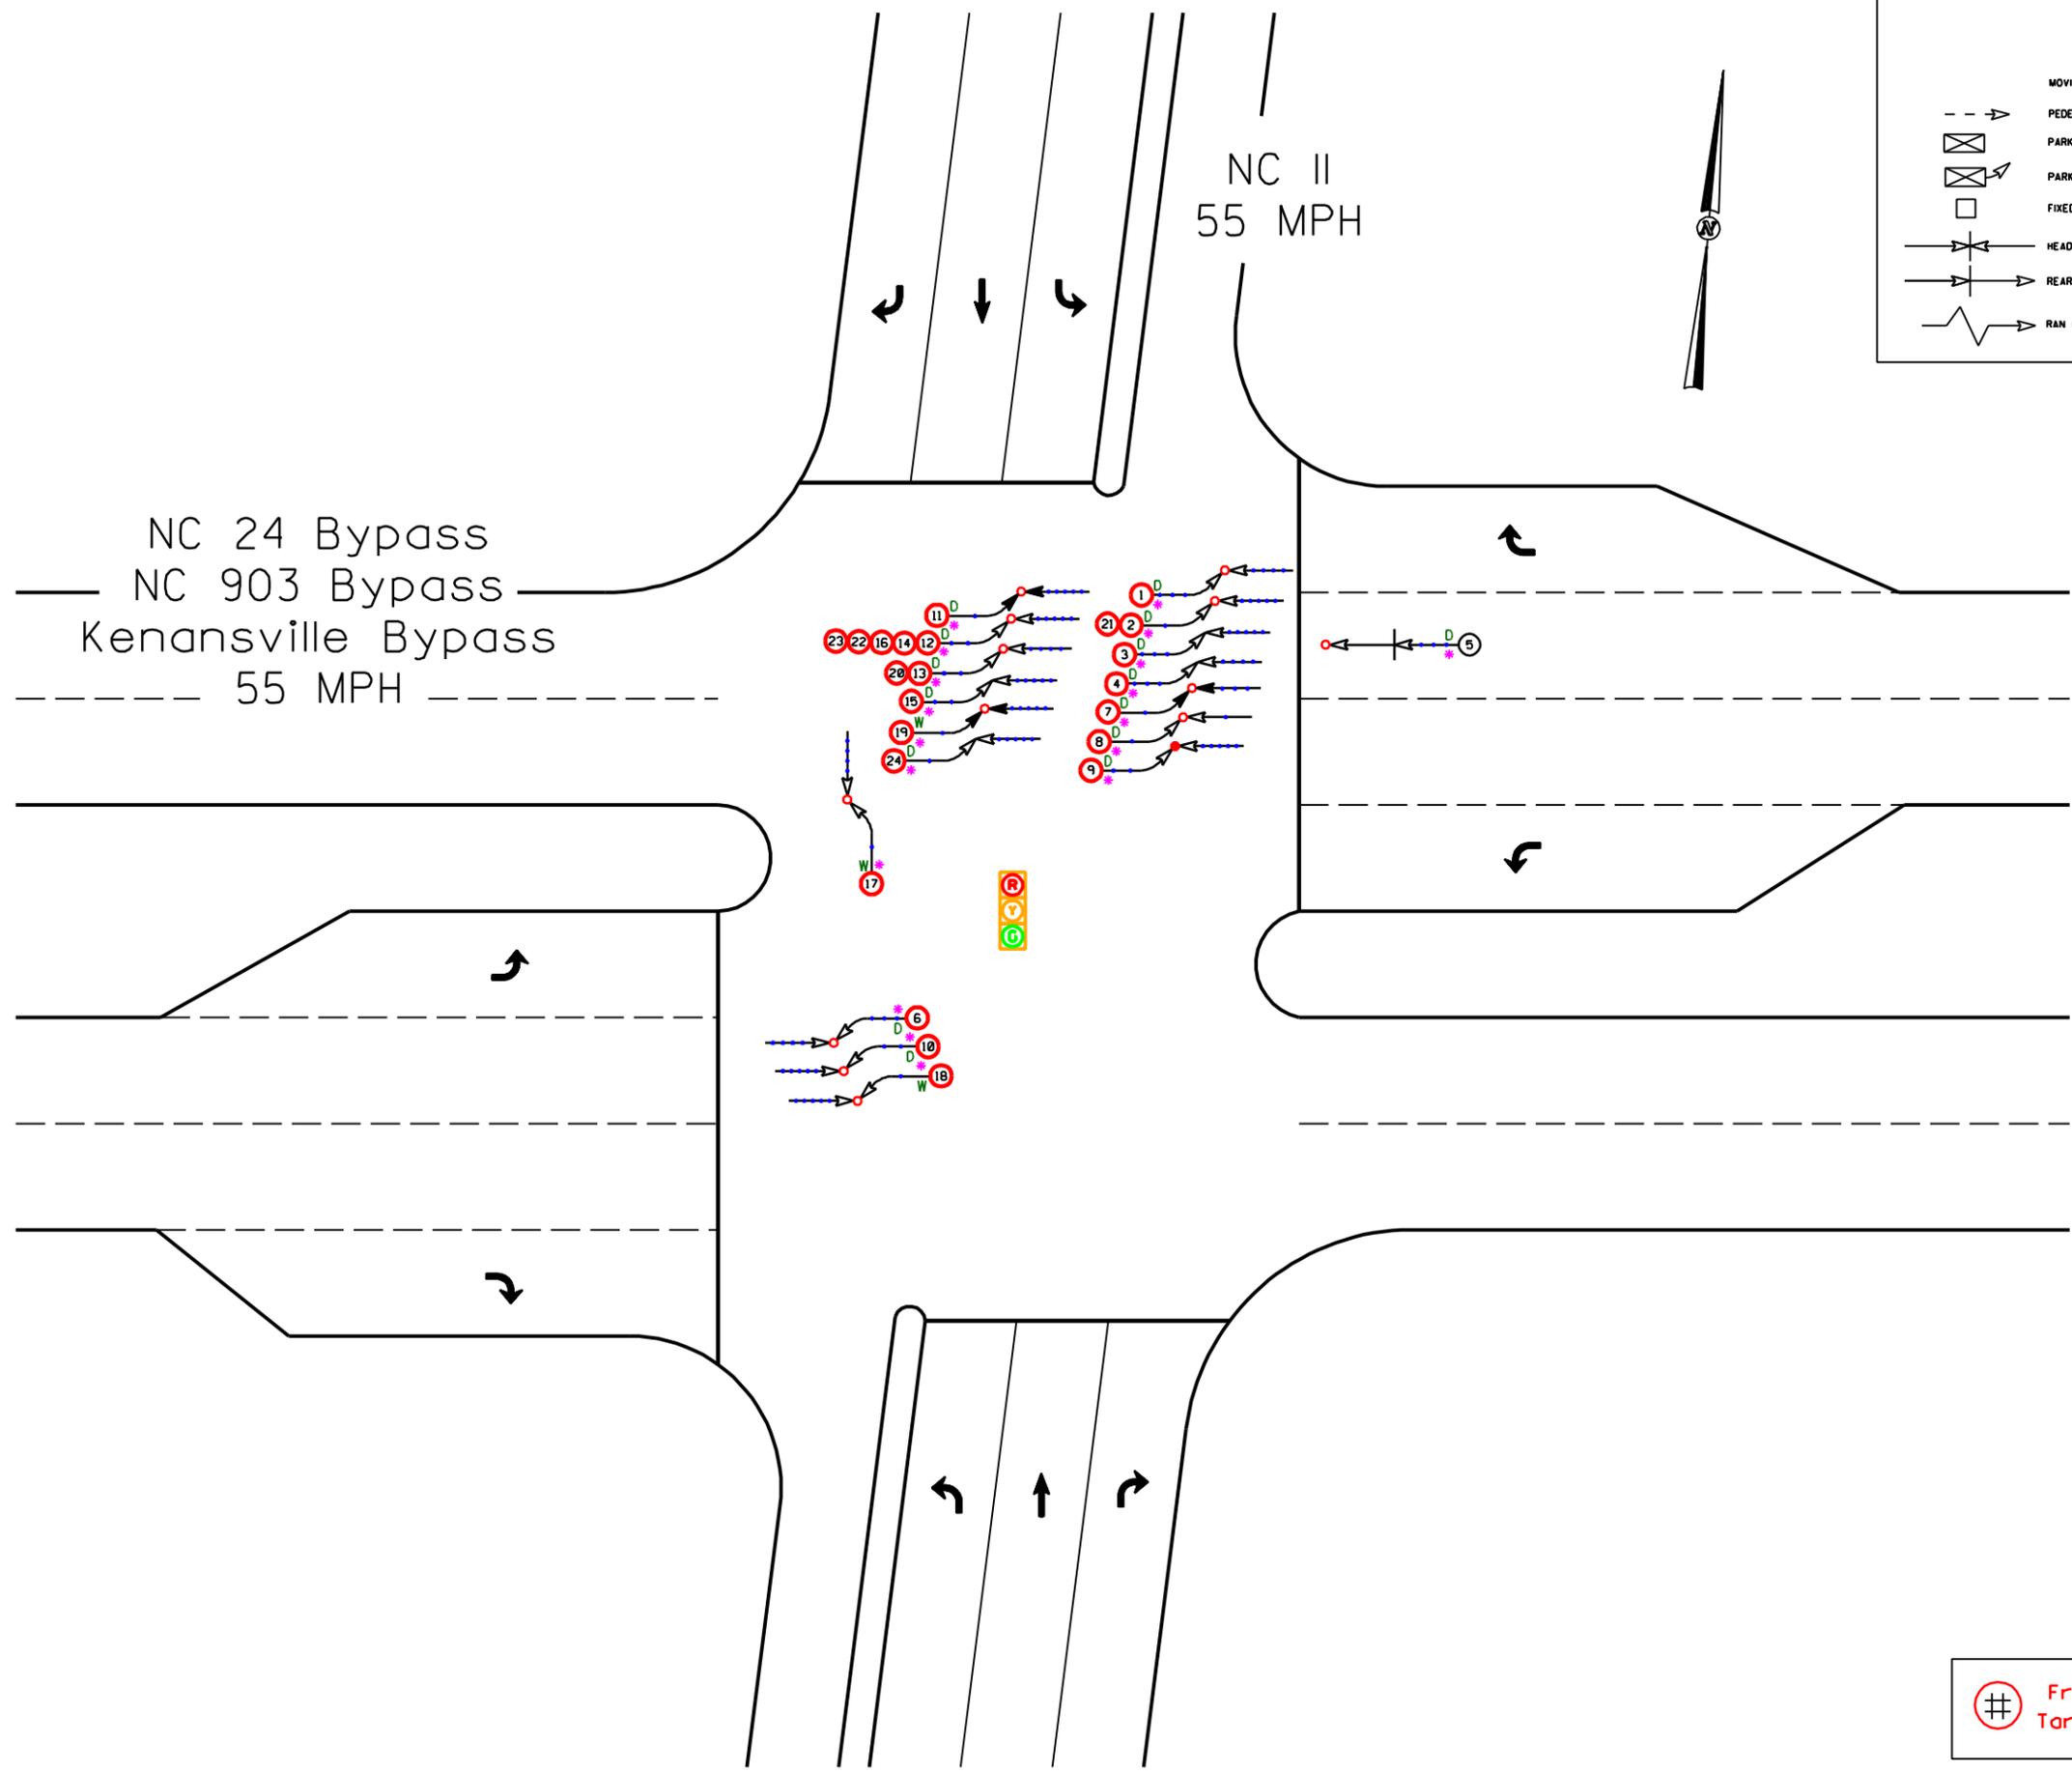
SS# 03-02-221
 BEFORE 2 Period
 Signal Control
 0.67 Yrs
 3/1/99 - 10/31/99

New Signalized
 Intersection
 Sig ID 03-0538

Frontal Impact
 Target Crashes

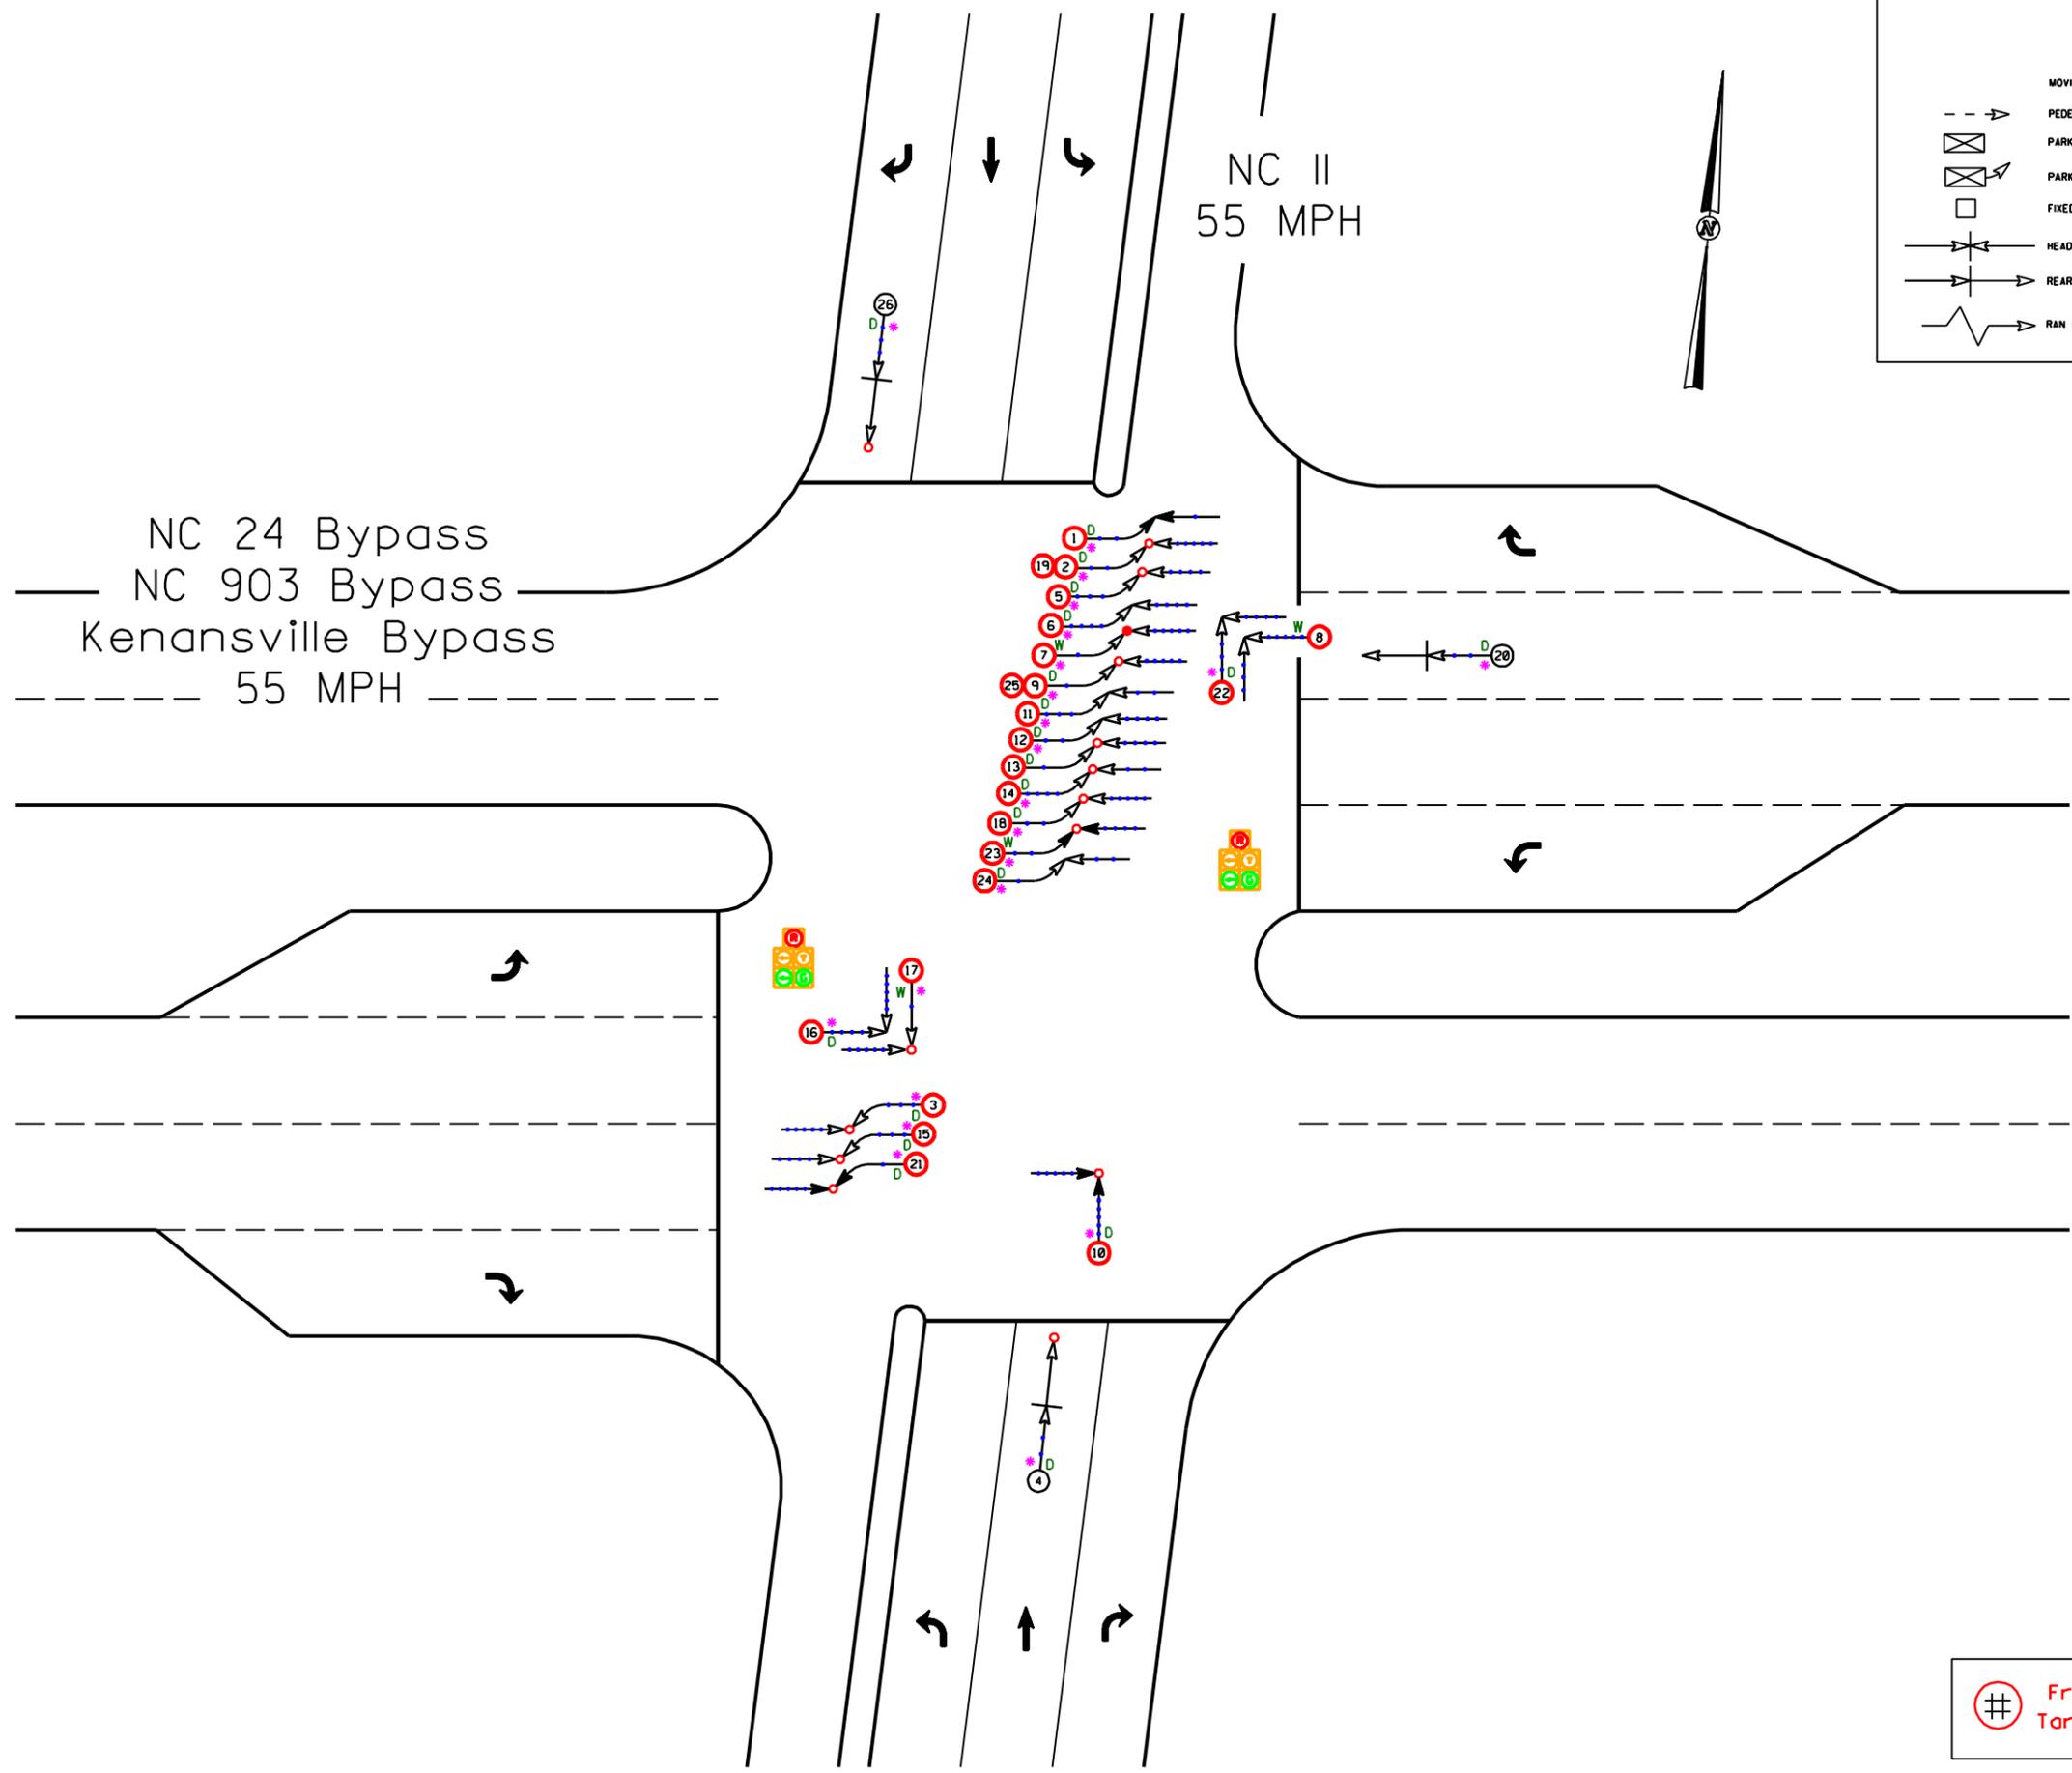
SS# 03-02-221
BEFORE 3 Period
Protected-Permissive
3.08 Yrs
12/1/99 - 12/31/02

Signal Upgrade
NC 24 Protected/
Permissive Phasing

Frontal Impact
Target Crashes

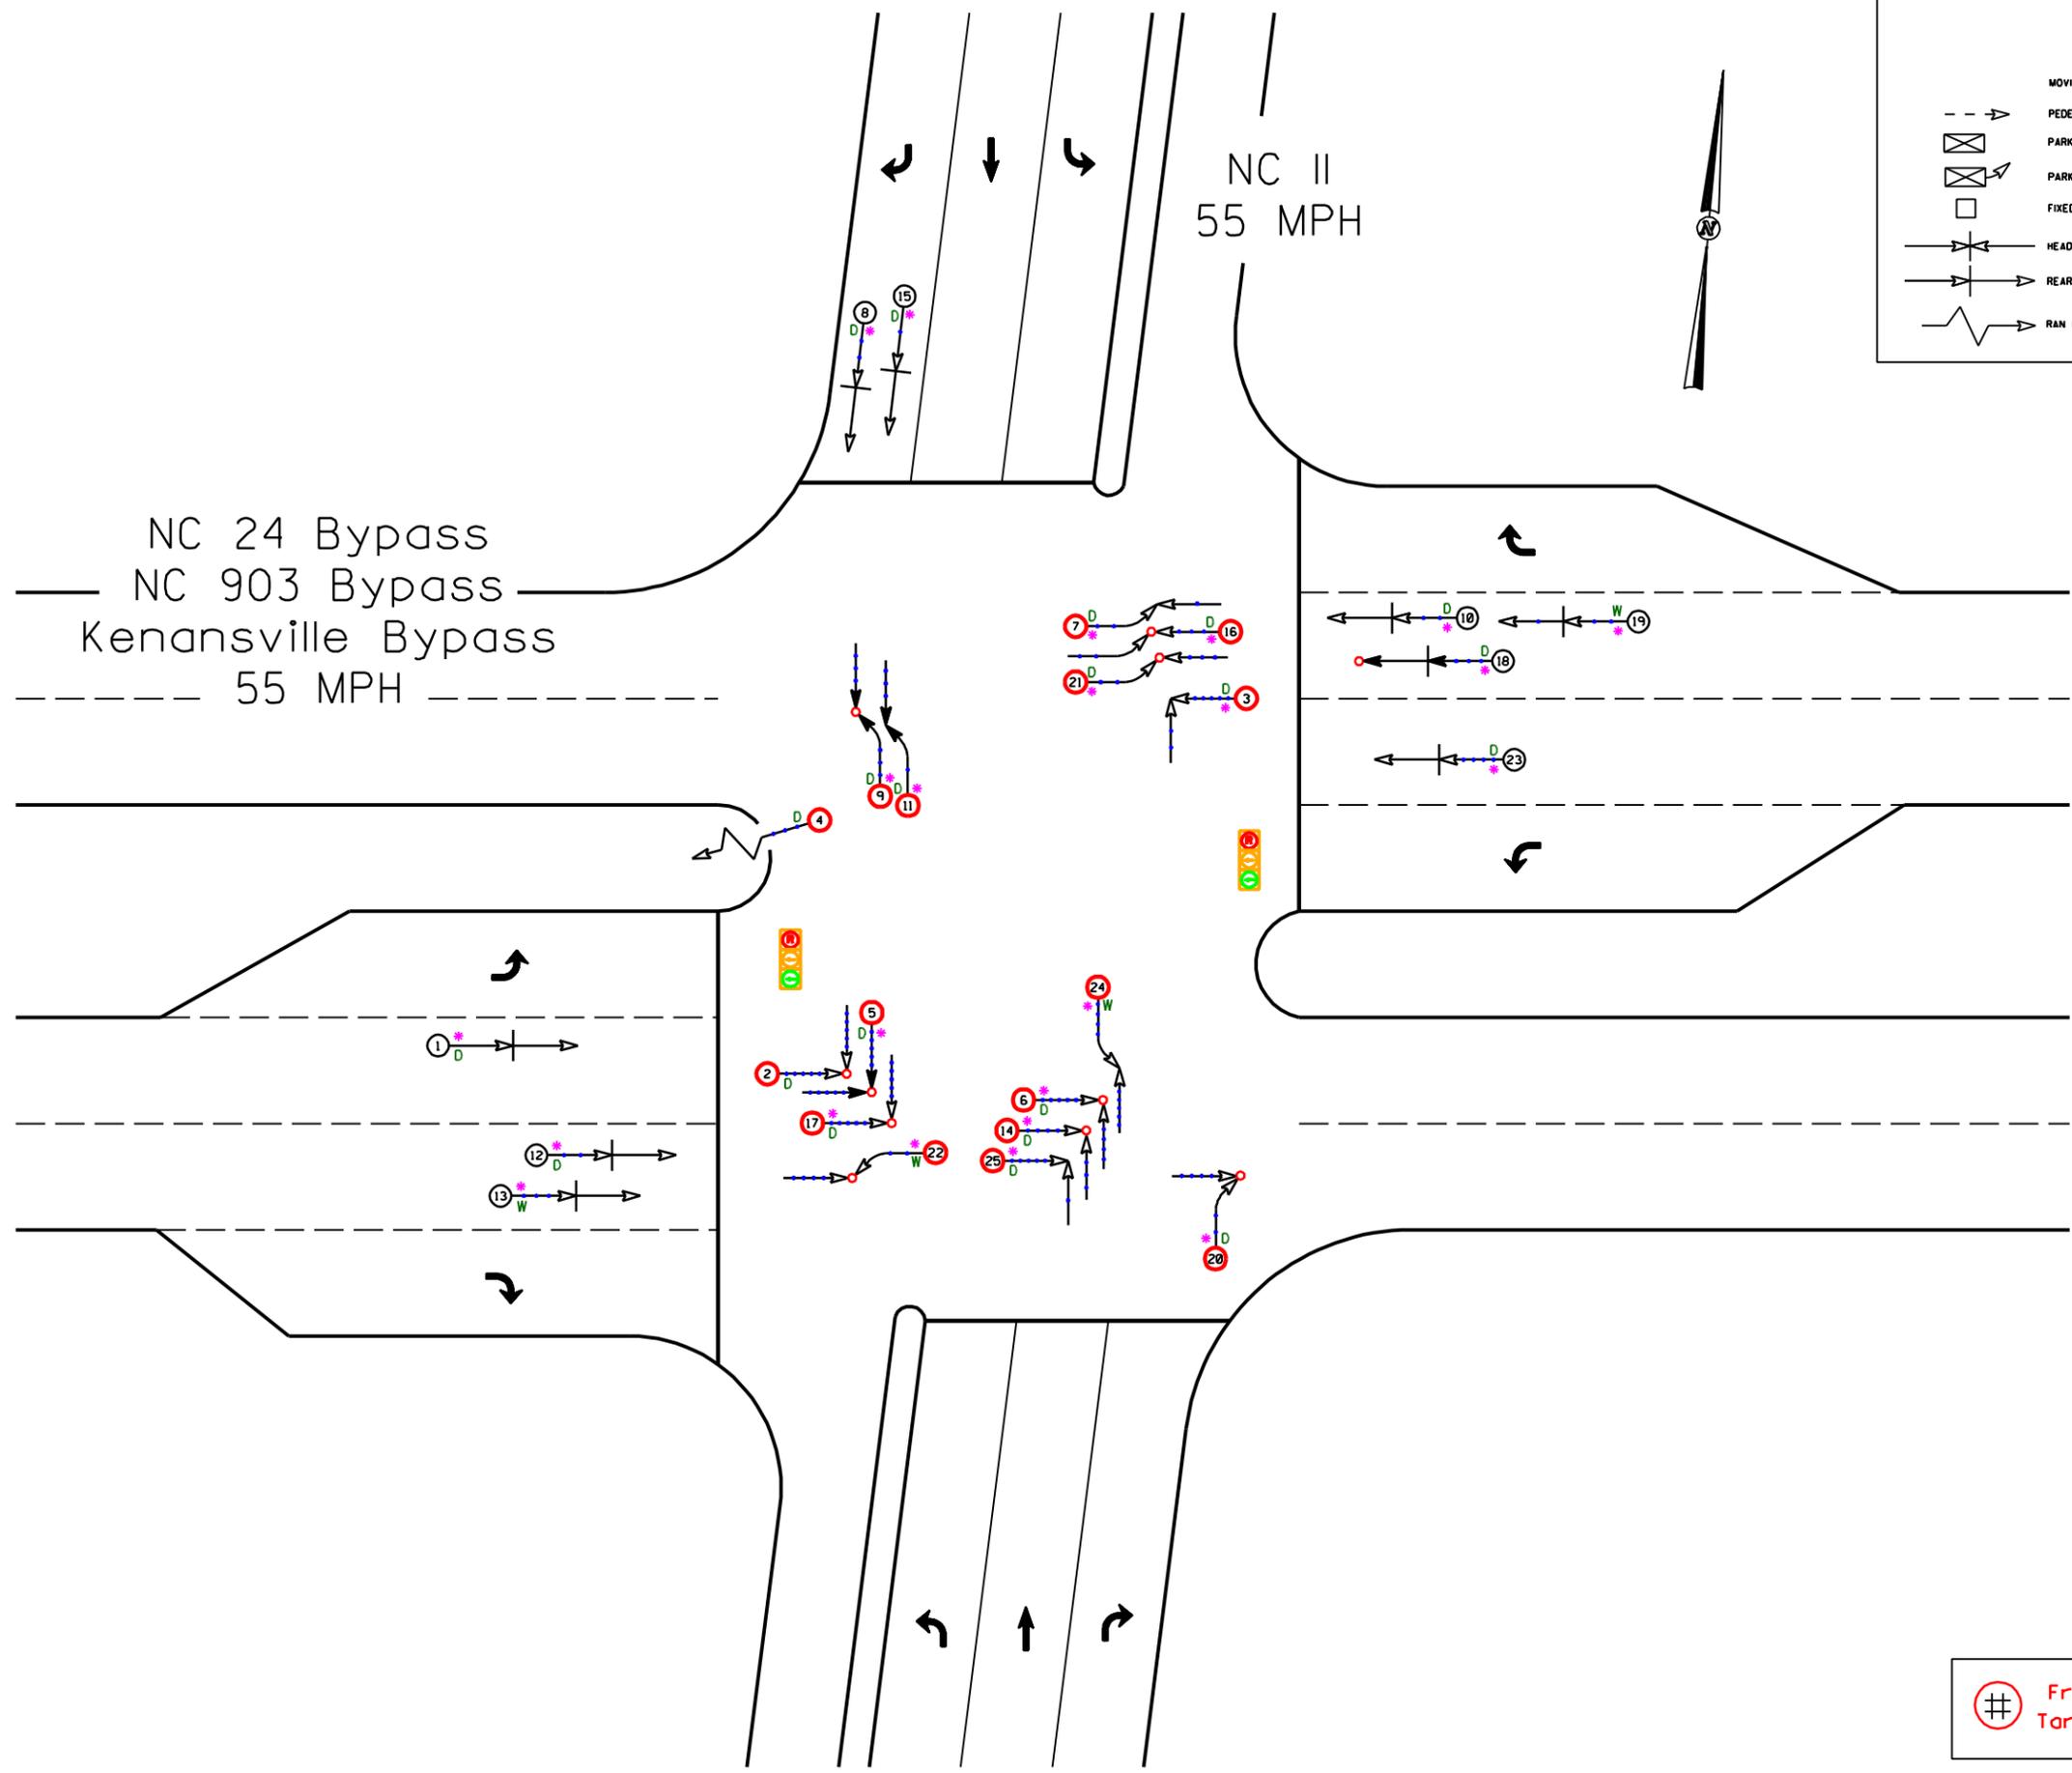
SS# 03-02-221
AFTER Period
Protected Phase Only
6.25 Yrs
2/1/03 - 4/30/09

Signal Upgrade
NC 24 Protected
Phasing Only

Frontal Impact
Target Crashes
