Spot Safety Project Evaluation

Project Log # 200606162

Spot Safety Project # 03-01-213

**Spot Safety Project Evaluation of the Offset Left Turn Lane Installation
At the Intersection of US 421 (Carolina Beach Rd) and SR 1524 (Golden Rd) /
Masonboro Commons Shopping Center, New Hanover County**

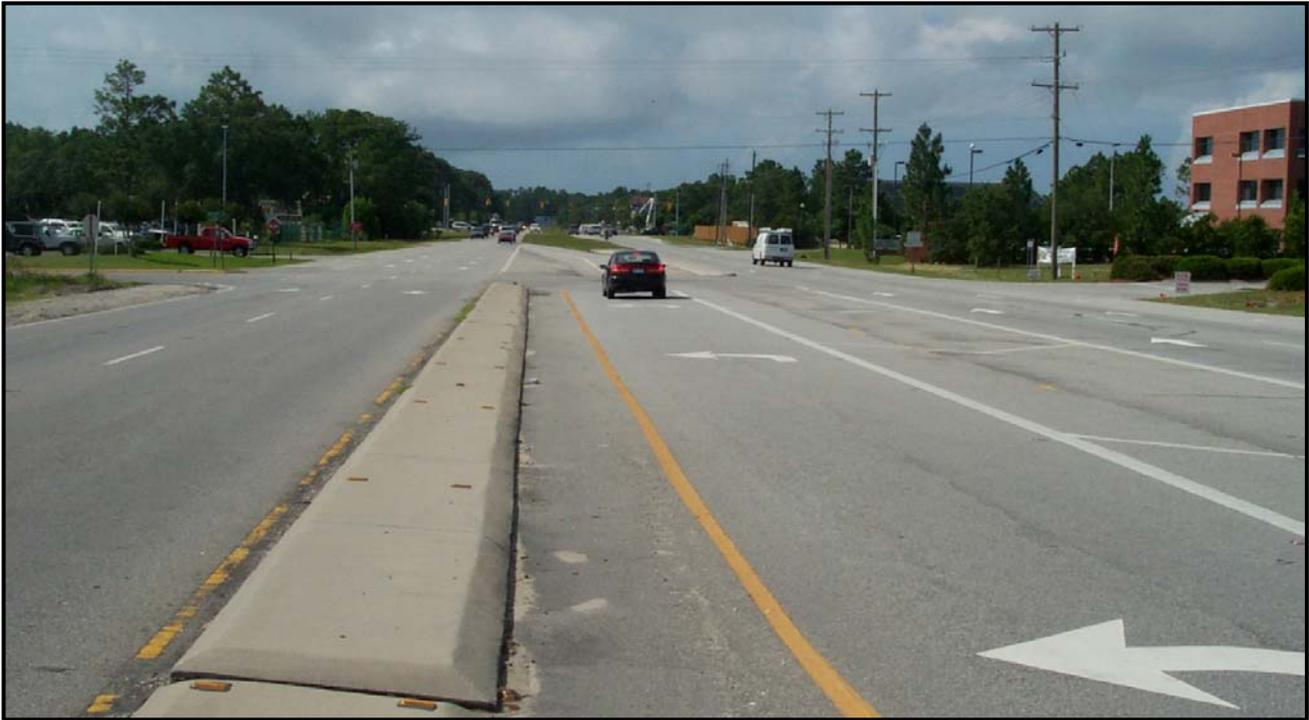
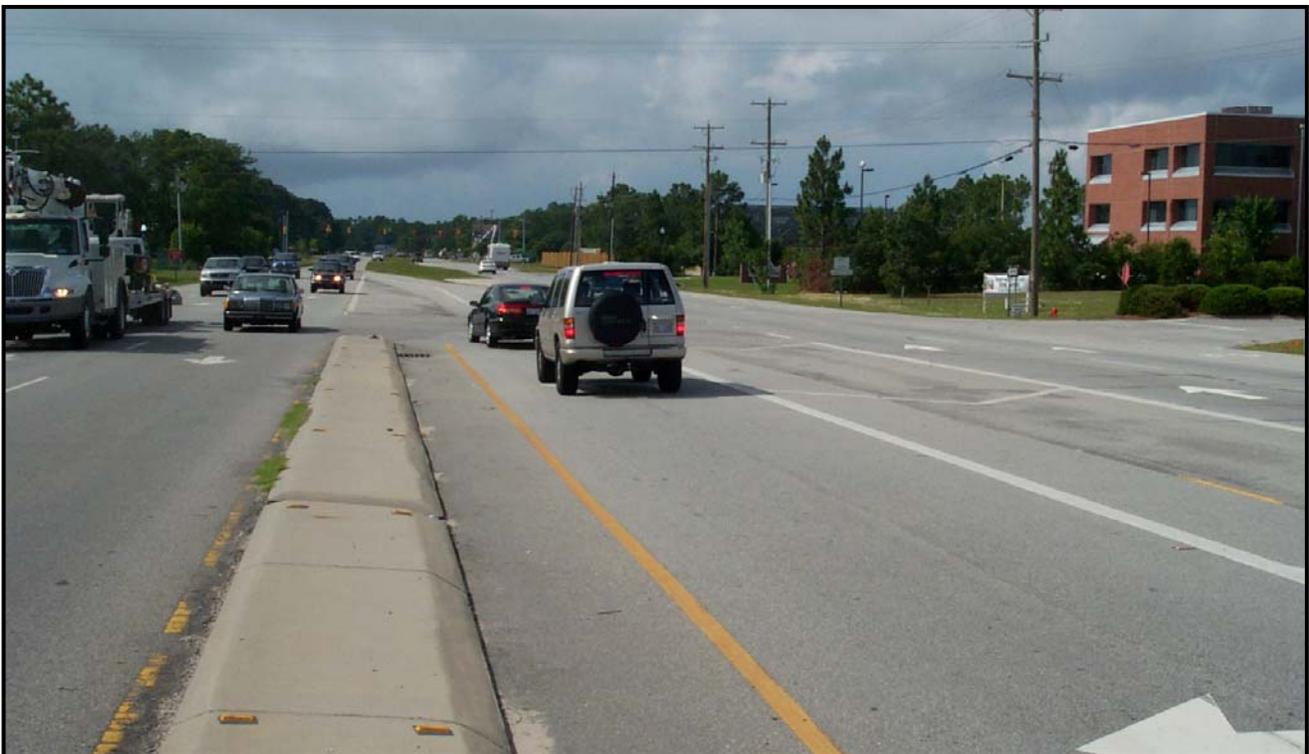
Treatment Location Photos (Taken on June 26, 2006)

Both photos taken at the treatment intersection while looking south on US 421.

Please see the attached Treatment Site Photos. The photos were taken from each leg of the treatment location. Also included are photos looking northbound from the old left turn alignment and looking northbound from the new offset left turn alignment. As you can see from the photos, offsetting the left-turn lanes has created much clearer sight lines and eliminated the sight restrictions created when left turning motorists were queued in the opposing left turn lane.

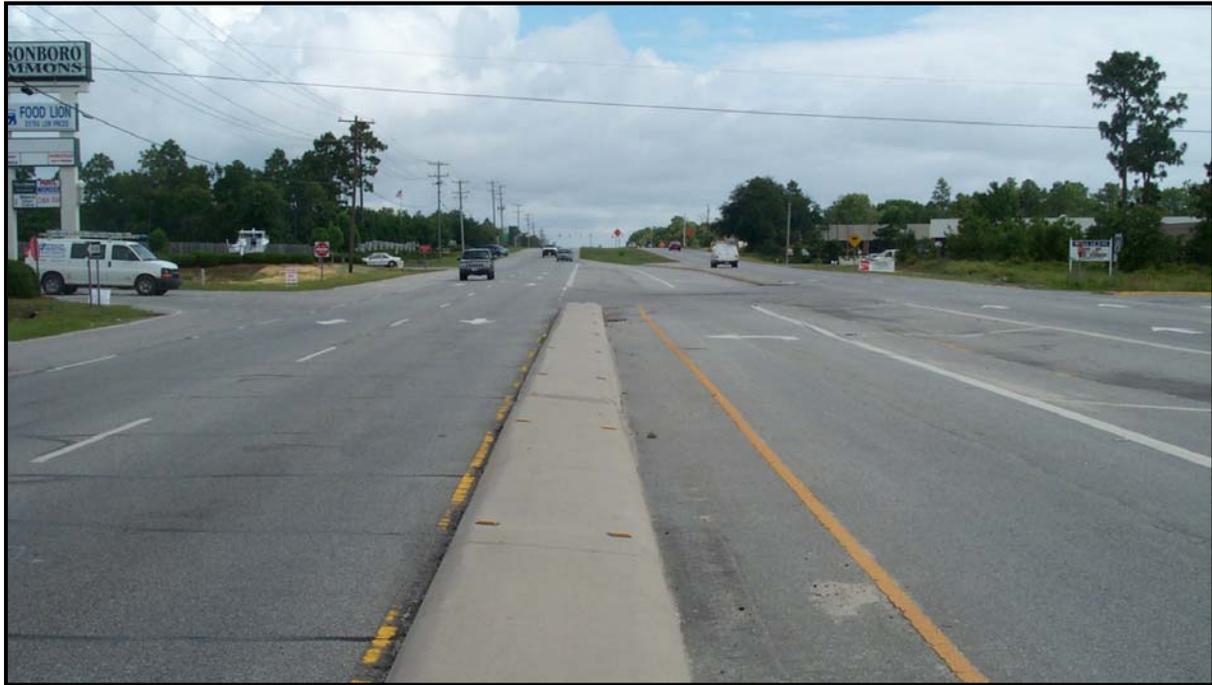
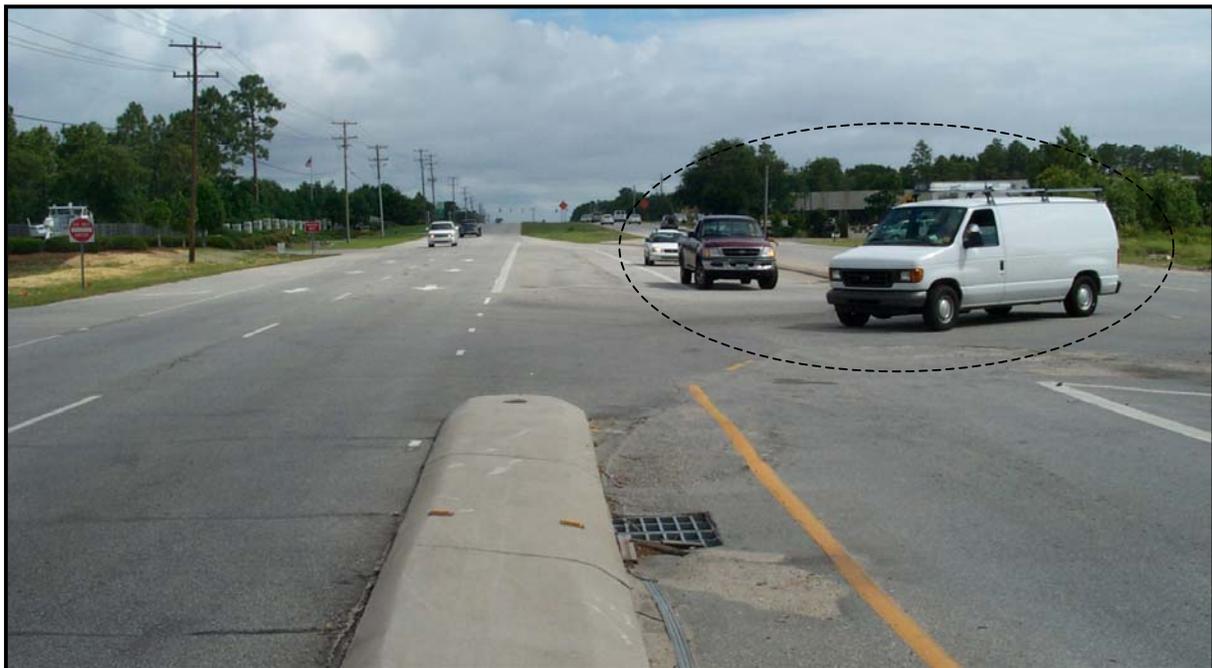
Treatment Location Photos (Taken on June 26, 2006)

Both photos taken at the treatment intersection while looking north on US 421.

In the bottom photo, notice the vehicle that pulled into the median from Golden Rd and blocked the vehicles attempting to turn left from southbound US 421.

Also notice (as shown in a photo) that during the field investigation vehicles from the side streets were pulling into the median on US 421 and waiting to finish their turning movement. While these vehicles were queued in the median the sight lines for any left turn movements from the mainline were blocked.

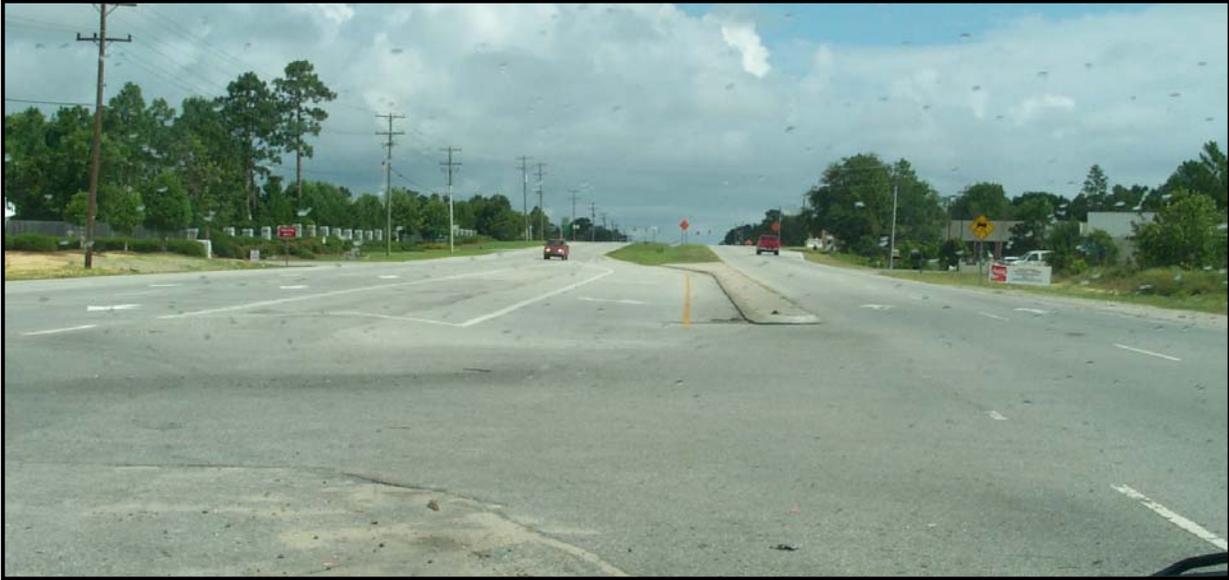
Looking north from the OLD Left Turn Lane on US 421.

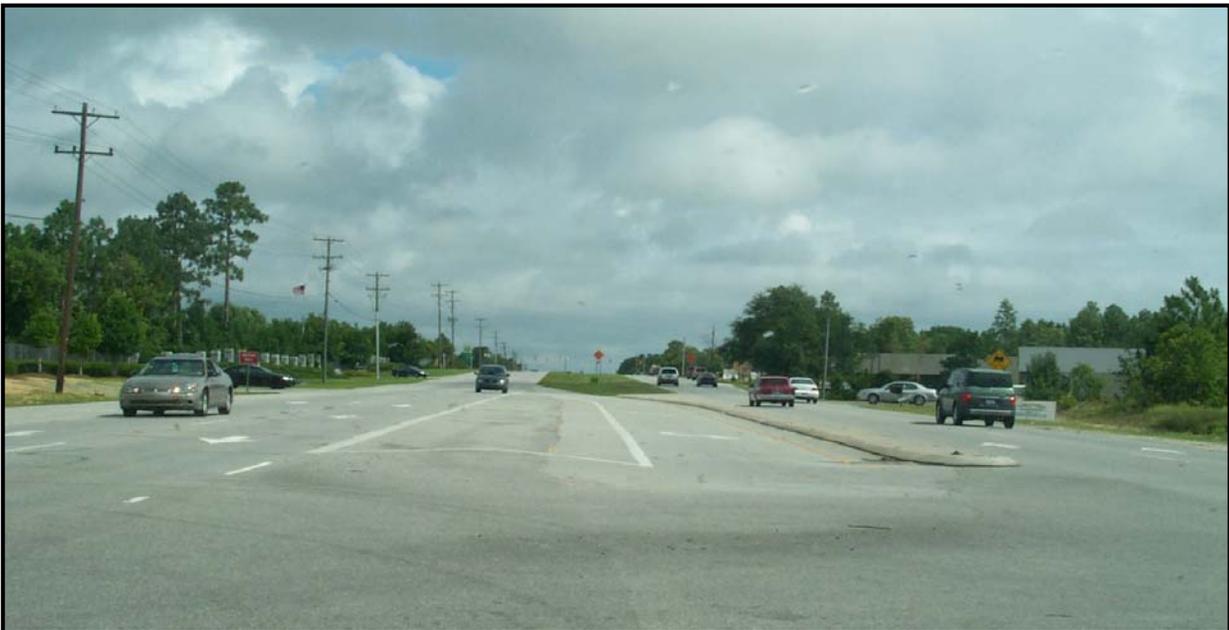
Looking north from the NEW Left Turn Lane on US 421.

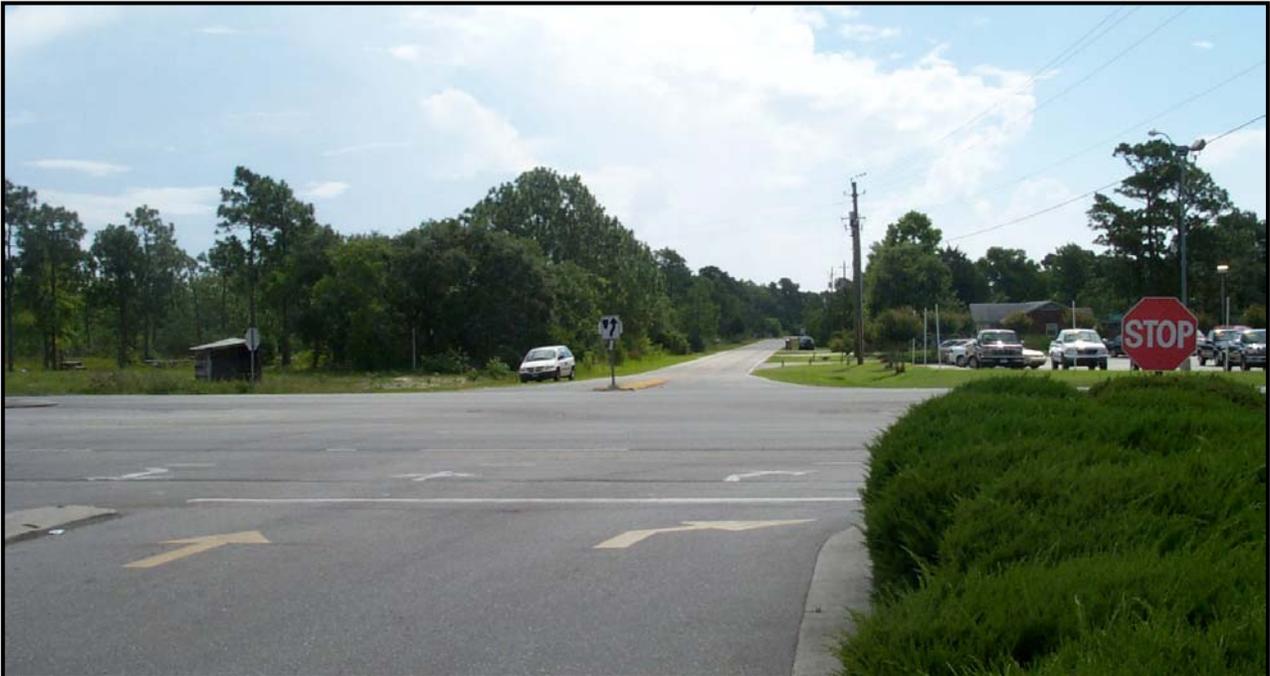
Photo taken while looking east from the entrance to Masonboro Commons Shopping Center.

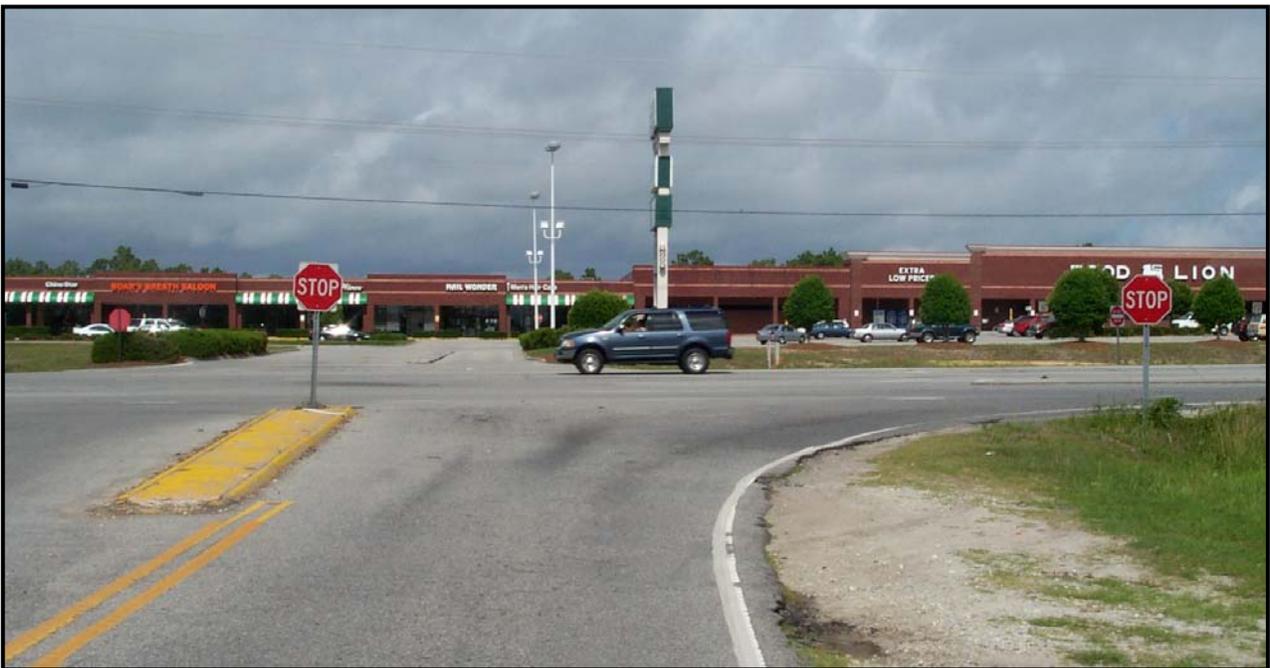
Photo taken while looking west on SR 1524 (Golden Road).

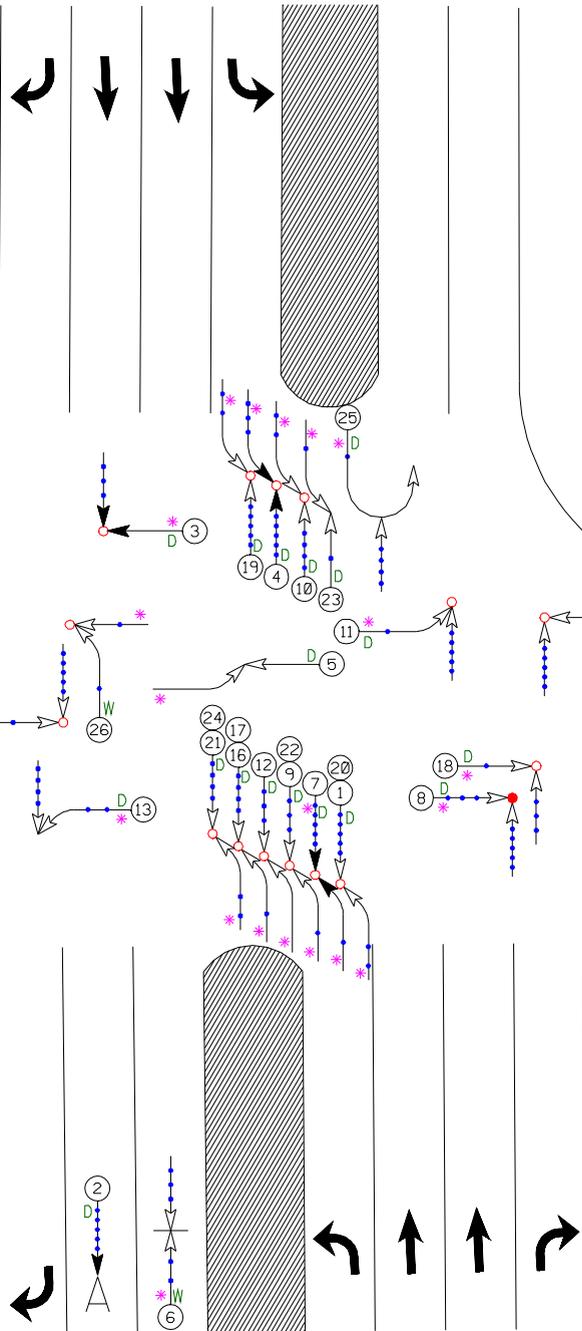
US 421 at SR 1524
Before Period

Treatment Site - Total Crashes
Before Period
11/1/1999 - 11/30/2002
(3 years, 1 month)

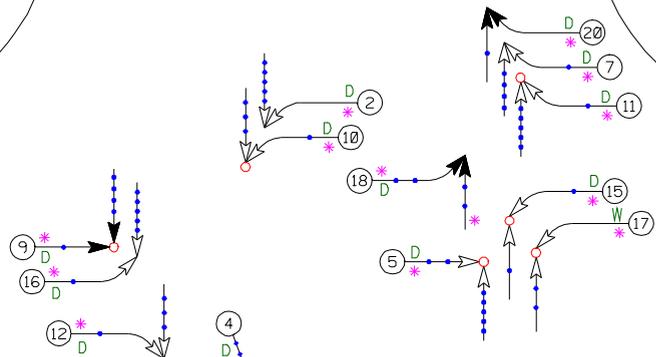
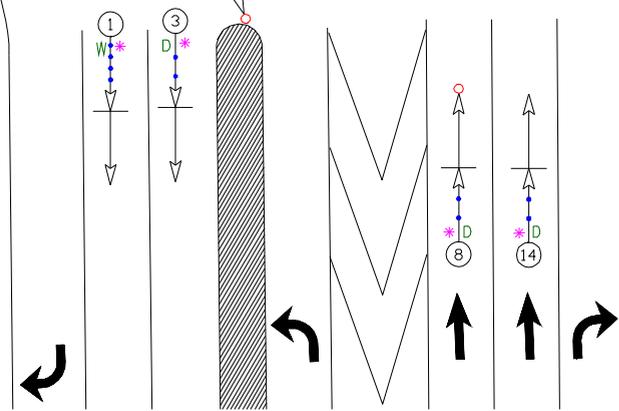
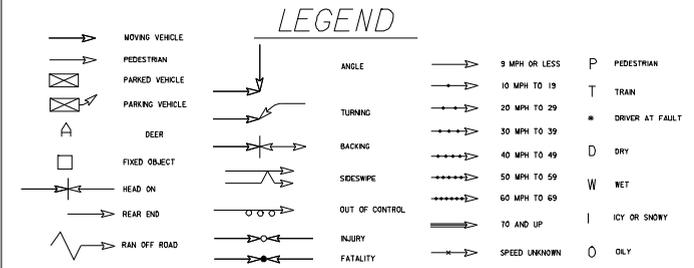
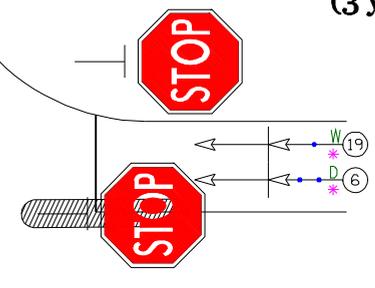
US 421 at SR 1524
After Period

Treatment Site - Total Crashes
After Period
4/1/2003 - 4/30/2006
(3 years, 1 month)
