Spot Safety Project Evaluation

Spot Safety Project # 04-00-256

**Spot Safety Project Evaluation of the Traffic Signal Installation
At the Intersection of NC 111 (Patetown Rd) and SR 1571 (Tommys Rd)
City of Goldsboro, Wayne County**

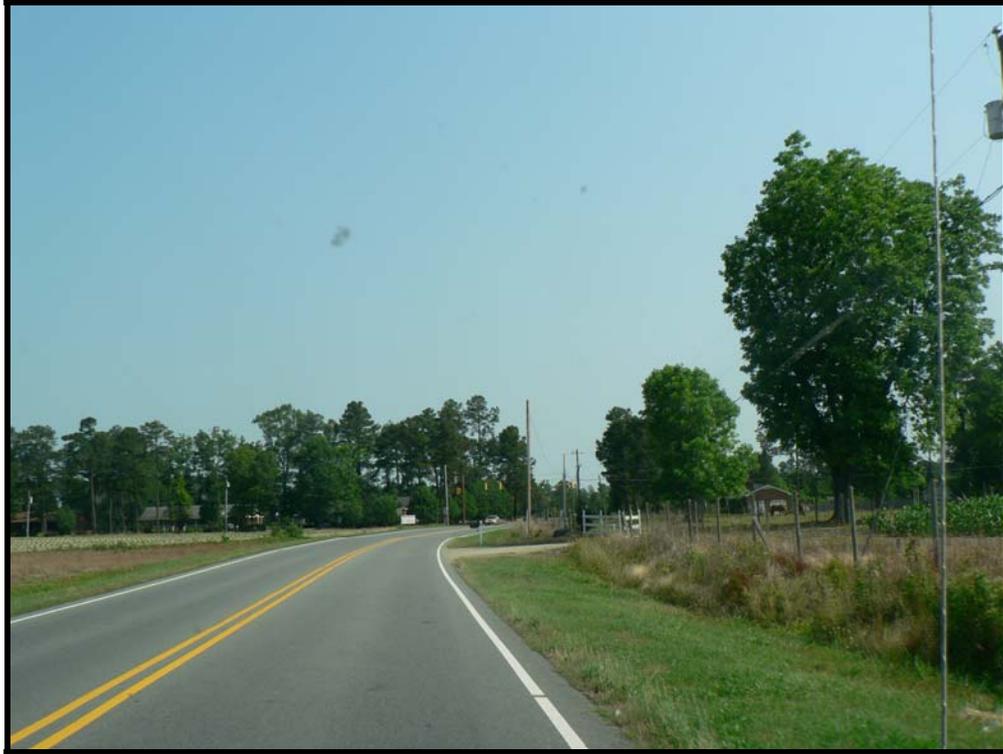
TREATMENT SITE PHOTO TAKEN 5/30/2007

Traveling North on NC 111 (Patetown Rd) – limited sight distance due to curve

Please see the attached *Treatment Site Photos*. Photos are provided for all approaches to the treatment intersection.

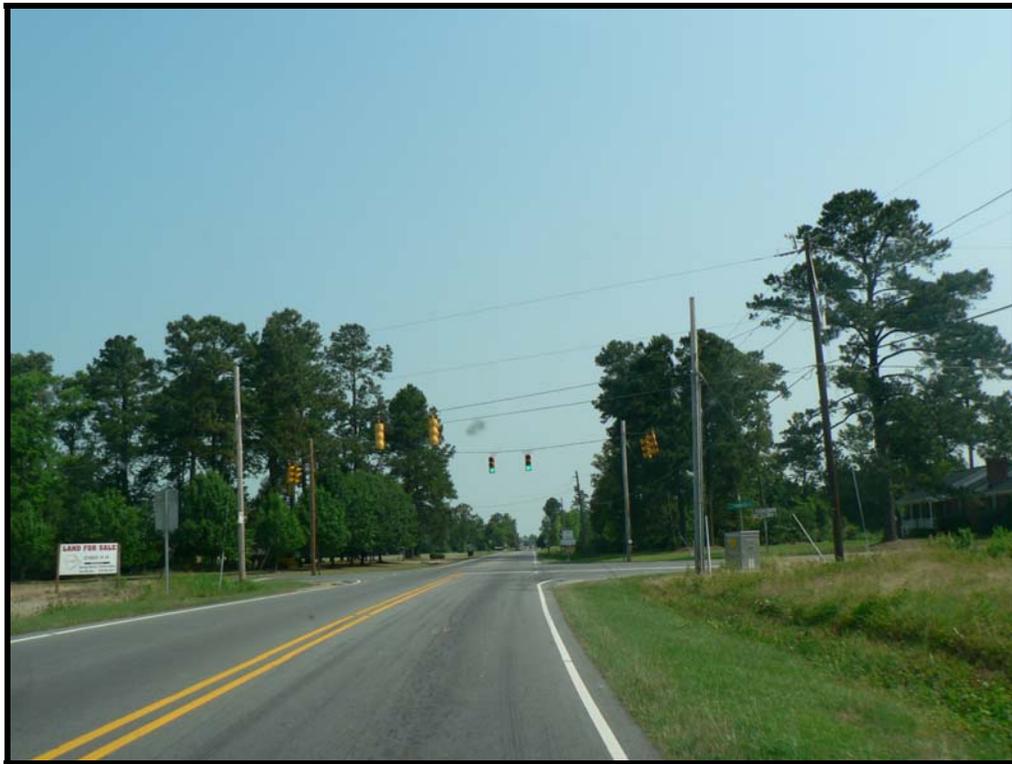
Traveling North on NC 111 (Patetown Rd)

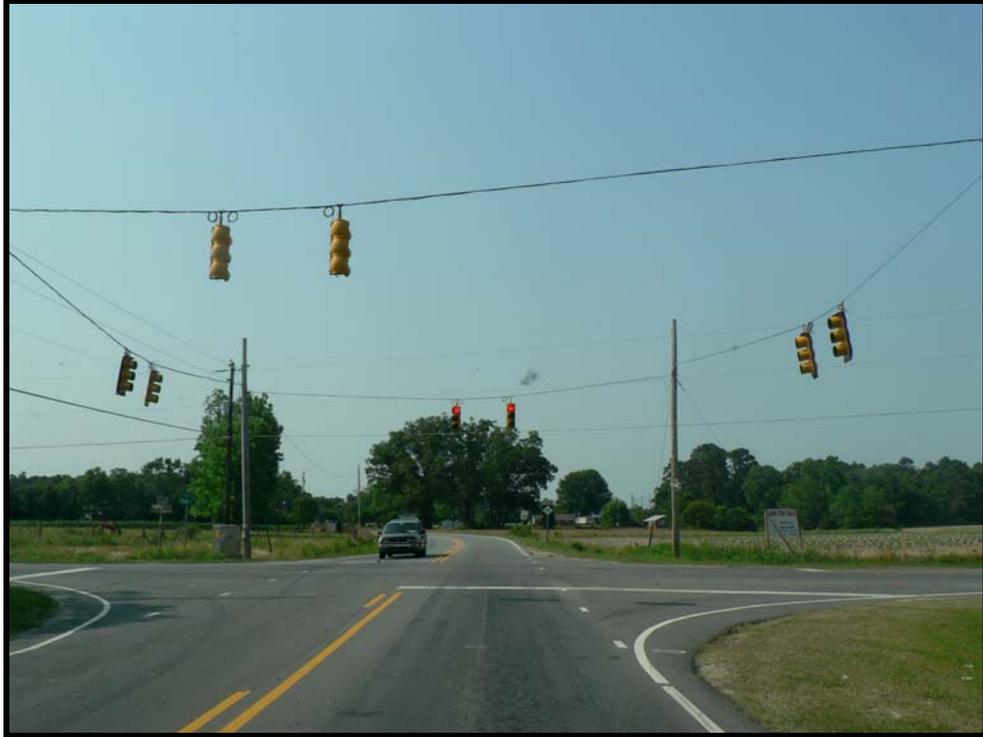
Traveling South on NC 111

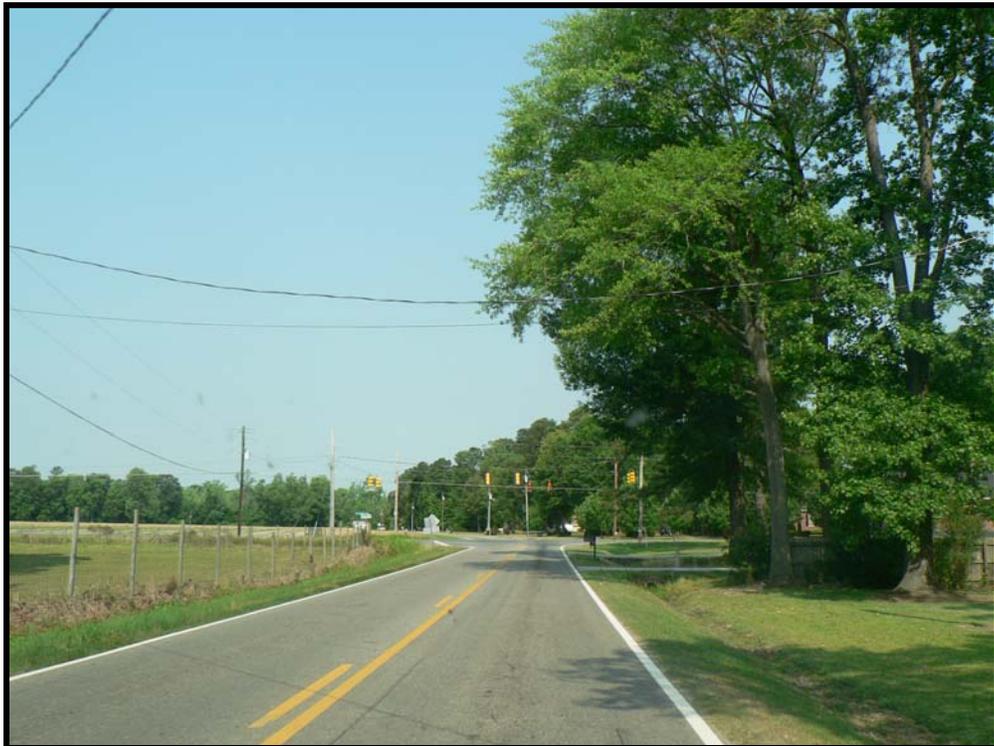
Traveling West on SR 1571 (Tommys Rd)

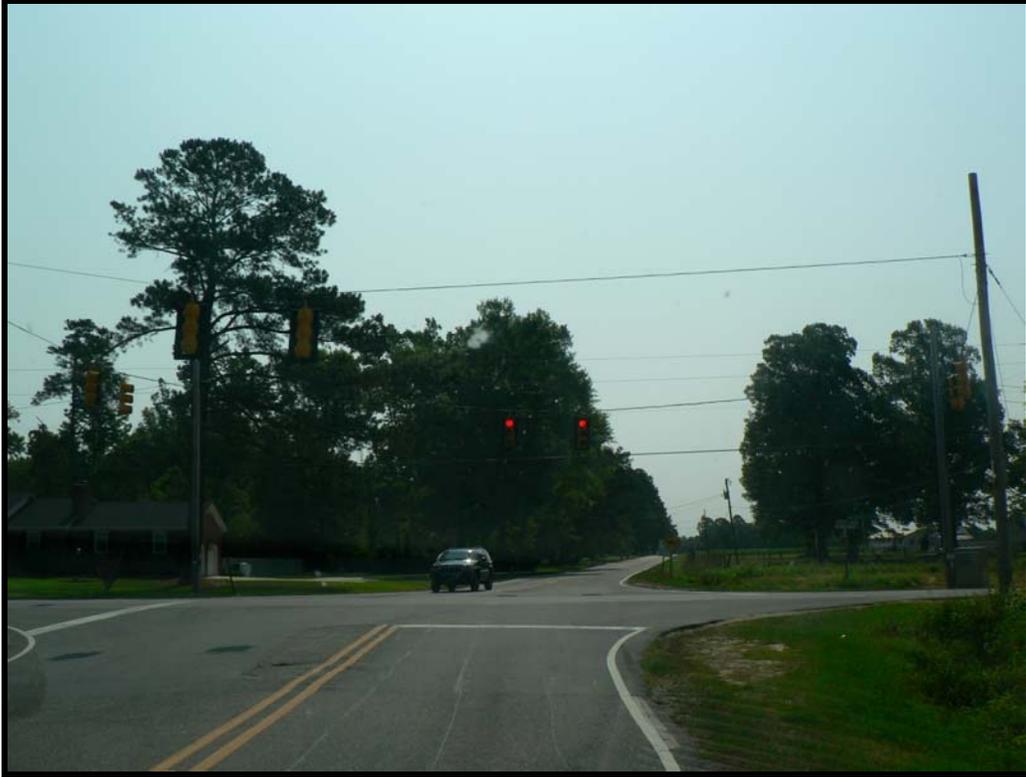
Traveling East on SR 1571 (Tommys Rd)

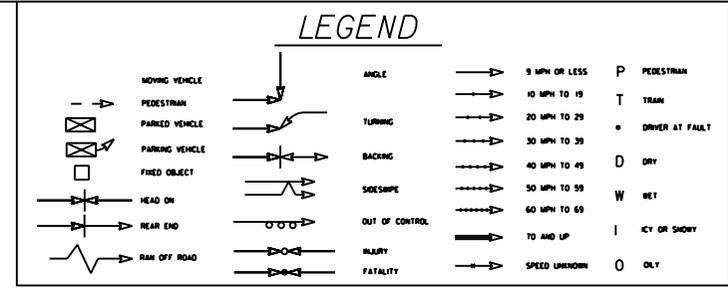
SS# 04-00-256
Wayne County
Before Period
Stop Control Only
11/1/93 - 10/31/97
NC III at SR 1571

Crash 13 and 24: Vehicles crashed while avoiding an angle collision

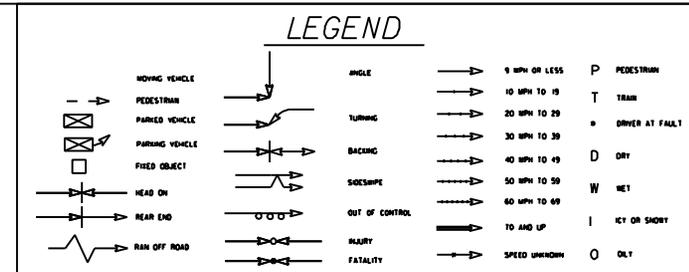
SS# 04-00-256
Wayne County
After Period
Signal Control
8/1/02 - 7/31/06
NC III at SR 1571

Crashes 2, 3, 4, 5, 9, 10, and 14
resulted from vehicles running
red indication light

Crashes 11, 12, and 19
resulted from vehicles making
an illegal passing movement

Crashes 11-19: Occurred after Stop Bars
retraced in Aug 2005 and Advanced
Detection Loops removed in
September 2005 (These crashes
represent 1 year of the 4 year
after period)

Referencing the *Collision Diagrams (before period flasher and after period)*, a large portion of crashes at the intersection in the before period (15 of 22) were the result of a vehicle entering or crossing NC 111 from SR 1571 in an unsafe manner. This pattern is evident involving vehicles traveling both directions on SR 1571. After the signal installation, this pattern is translated to vehicles that are running the red indication signal. Seven (7) collisions occurred in the after period from vehicles running the red light, including one fatal. There were also three (3) collisions caused by illegal passing maneuvers in the intersection during the after period.

The after period fatal collision occurred in June of 2005. The Regional Traffic Engineer requested alterations for safety at this intersection following the fatal investigation report. The Division confirmed retracing the stop bars on both approaches of SR 1571 in August of 2005 and the Advanced Detection Loops were removed from the Tommys Road approaches in September of 2005 after being reviewed by the Signal Supervisor.
