Spot Safety Project Evaluation

Spot Safety Project # 04-05-217

**Spot Safety Project Evaluation of the 1.5-Foot Paved Shoulders Installation
SR 1003 (Buffalo Rd) / SR 1908 (Fire Department Road)
Johnston County**

Safety Evaluation Group
Traffic Safety Systems Management Section
Transportation Mobility and Safety Division
North Carolina Department of Transportation

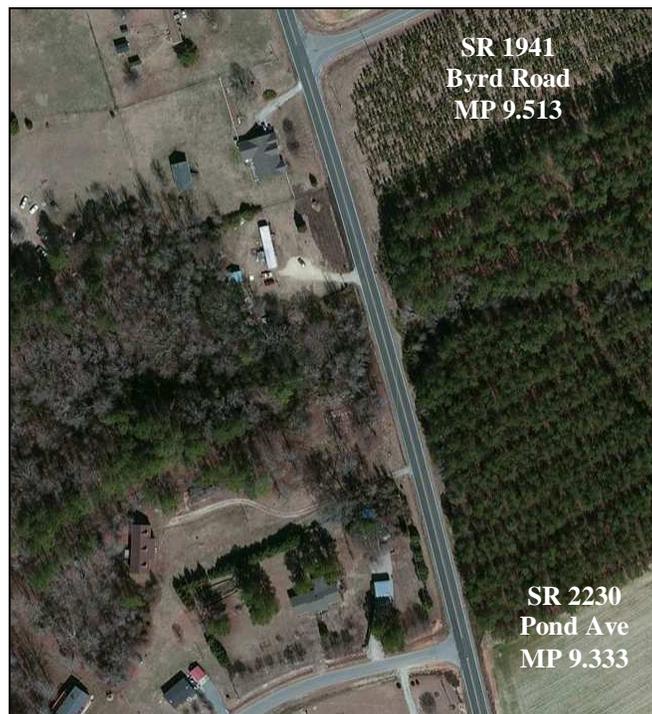
Aerial Map of SR 1003 Segment – BING Maps

The *GIS Collision Diagrams* did indicate one small segment that experienced an increase in after period lane departure crashes. This segment on SR 1003 (Buffalo Road) from SR 2230 (Pond Ave) to SR 1941 (Byrd Road) jumped from two (2) lane departure crashes to five (5) lane departure collisions through the analysis. The following picture shows an aerial of this 0.18 mile segment (MP 9.333 to 9.513). Additionally, the Safety Evaluation Group plotted this 0.18 mile strip into a separate attached collision diagram for your reference.

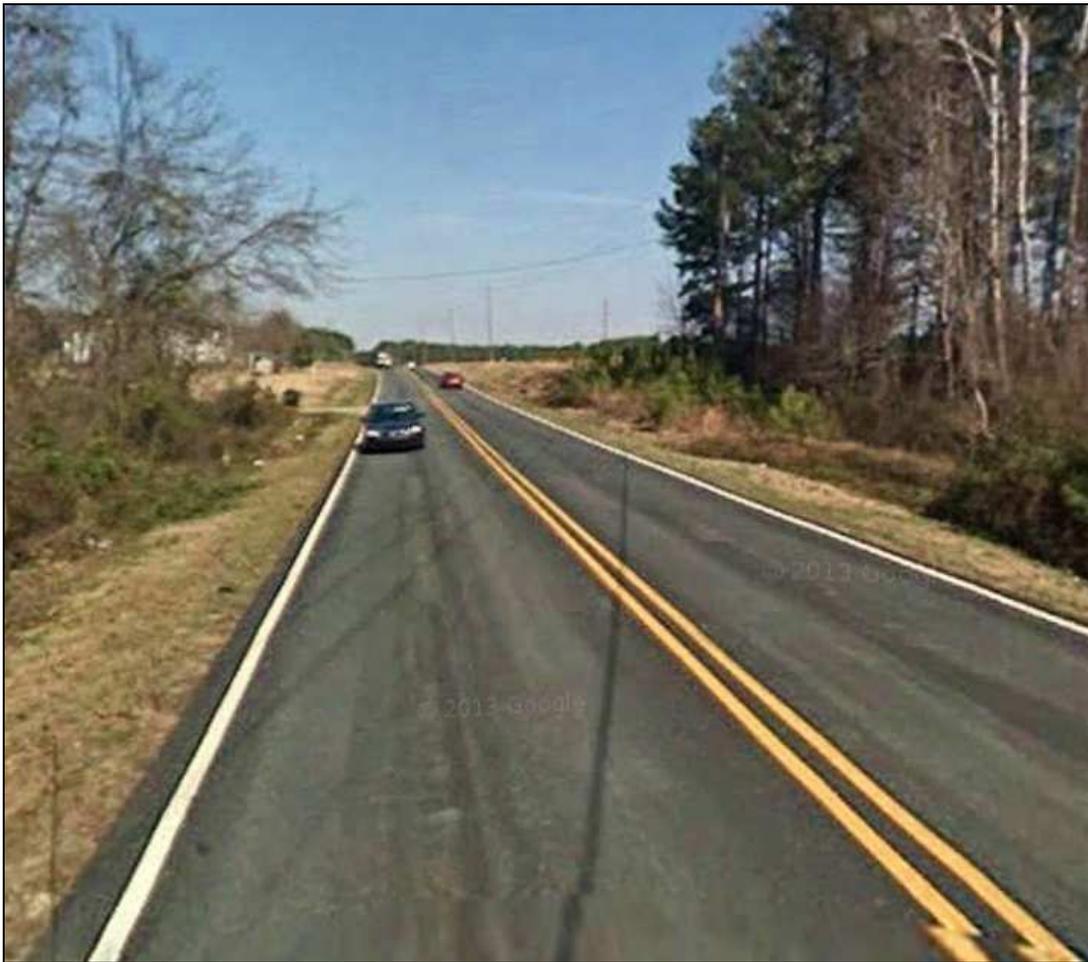
**SR 1003 (Buffalo Rd) – Near MP 9.4 (north of SR 2230) looking North
Google Street View – March 2009 Photo**

Please see the attached *Treatment Site Photos*. Photos are provided from Google Street View for an example of the treated roadway segment of SR 1003. As the Safety Evaluation Group completes additional spot safety reviews for this type of countermeasure, we will be able to provide objective and definite information regarding actual crash reduction factors for this type of countermeasure.

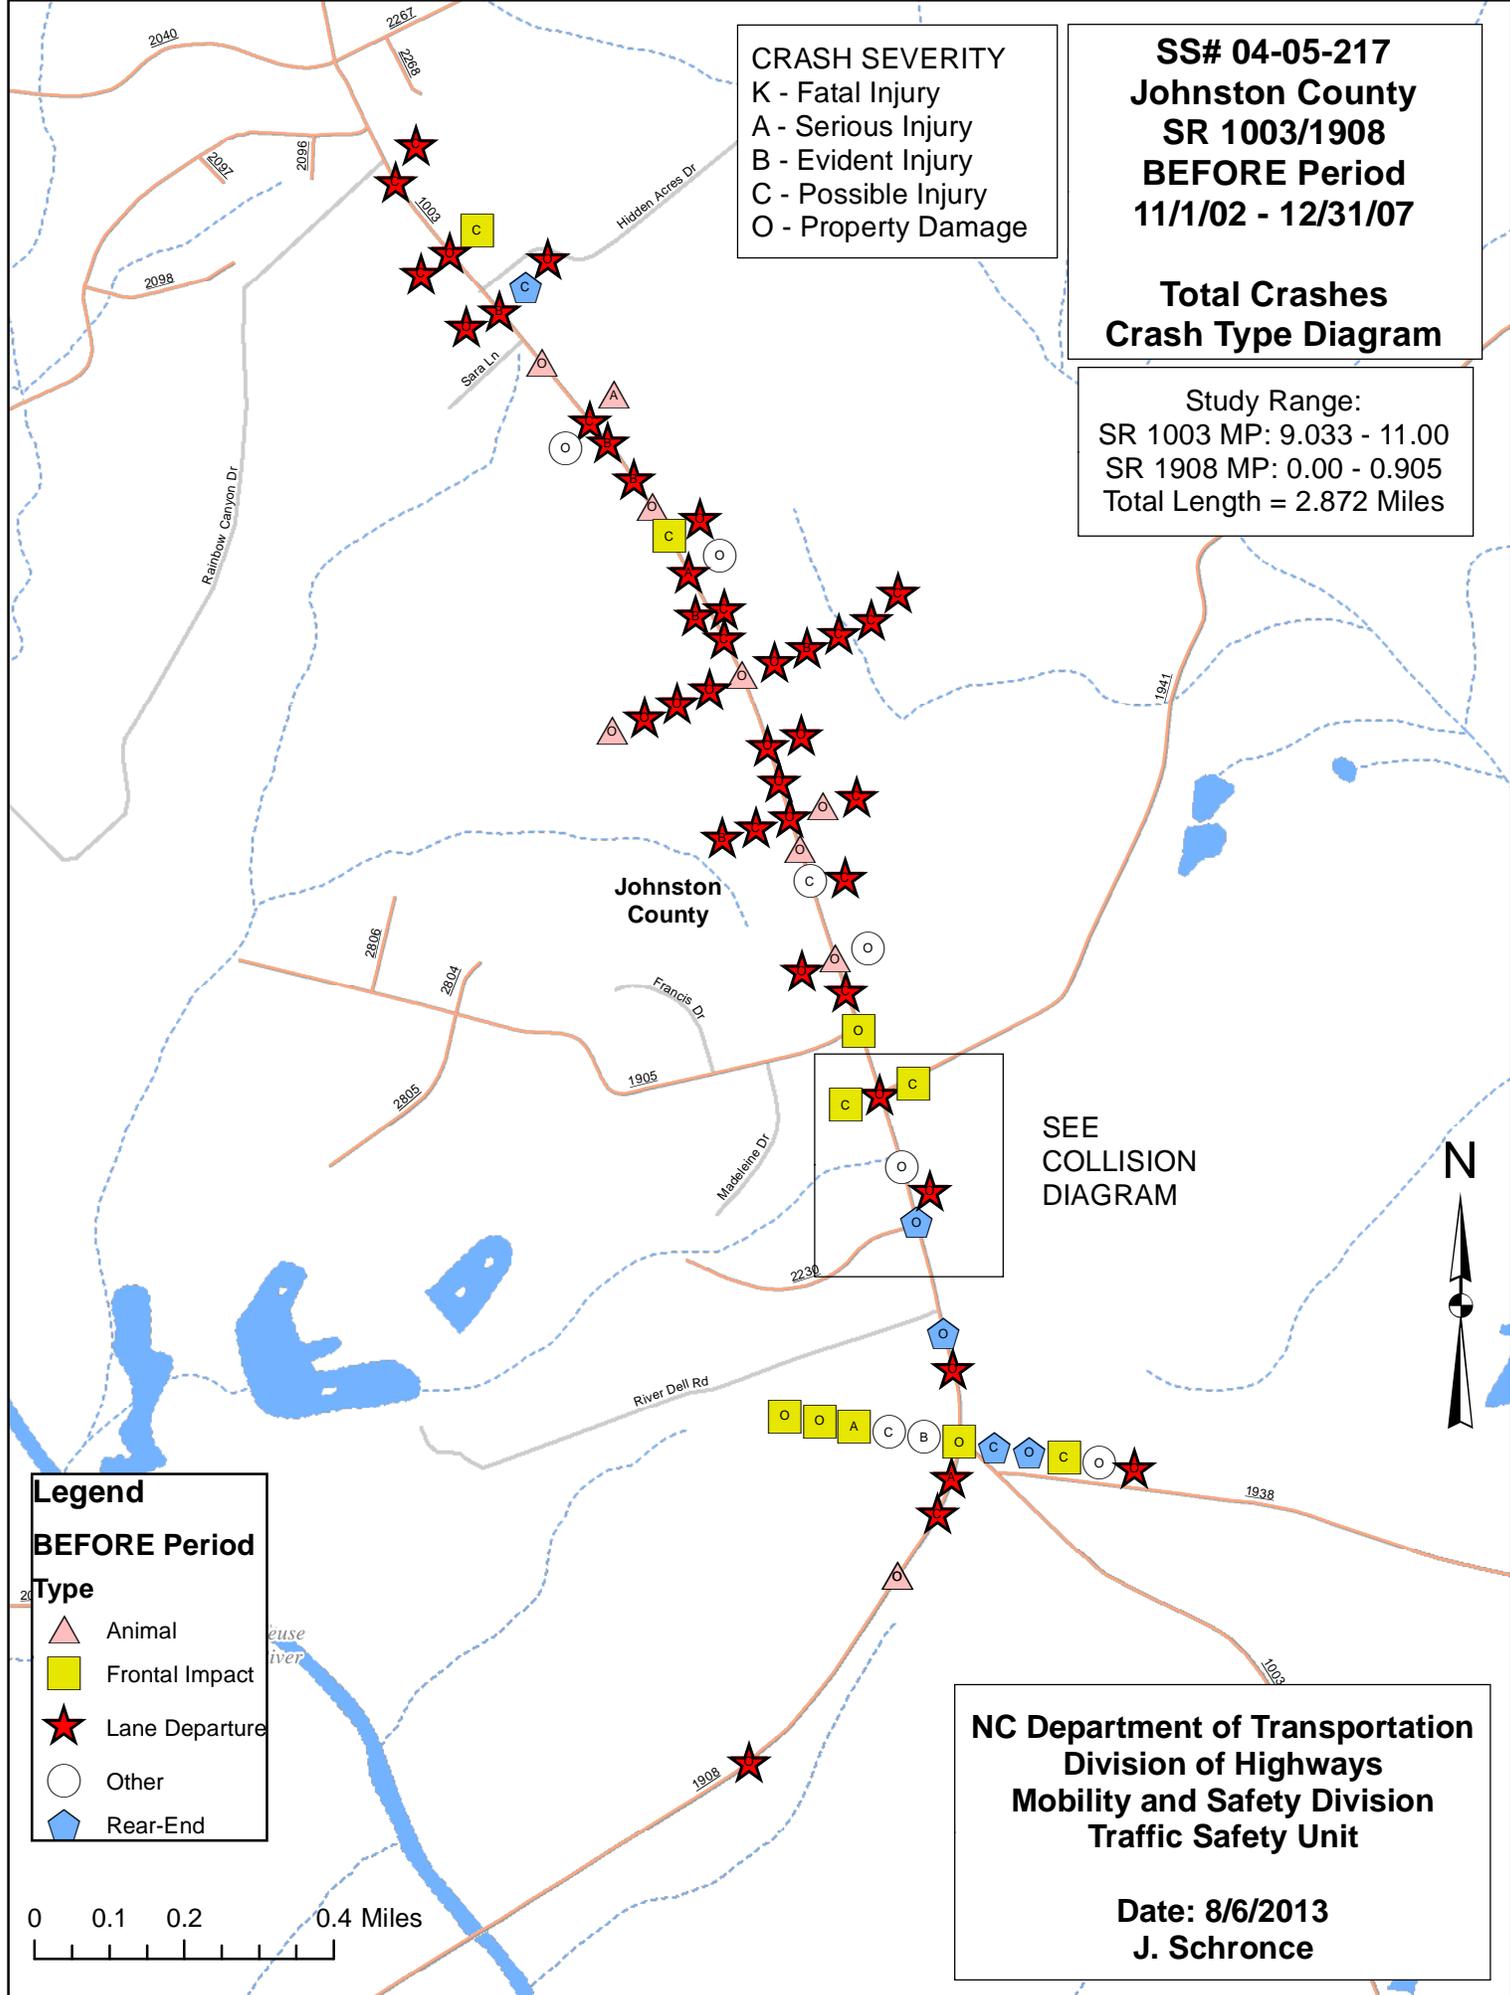
Total Crashes
Crash Type Diagram

SS# 04-05-217
Johnston County
SR 1003/1908
BEFORE Period
11/1/02 - 12/31/07

Study Range:
 SR 1003 MP: 9.033 - 11.00
 SR 1908 MP: 0.00 - 0.905
 Total Length = 2.872 Miles

Referencing the *GIS Collision Diagrams*, the before period presented a strong pattern of twenty-nine (29) lane departure crashes between SR 1905 (Clark Pond Rd) and Hidden Acres Drive on SR 1003 (Buffalo Rd), which is 1.097 mile segment. During the after period, this same segment only experienced six (6) lane departure target crashes.

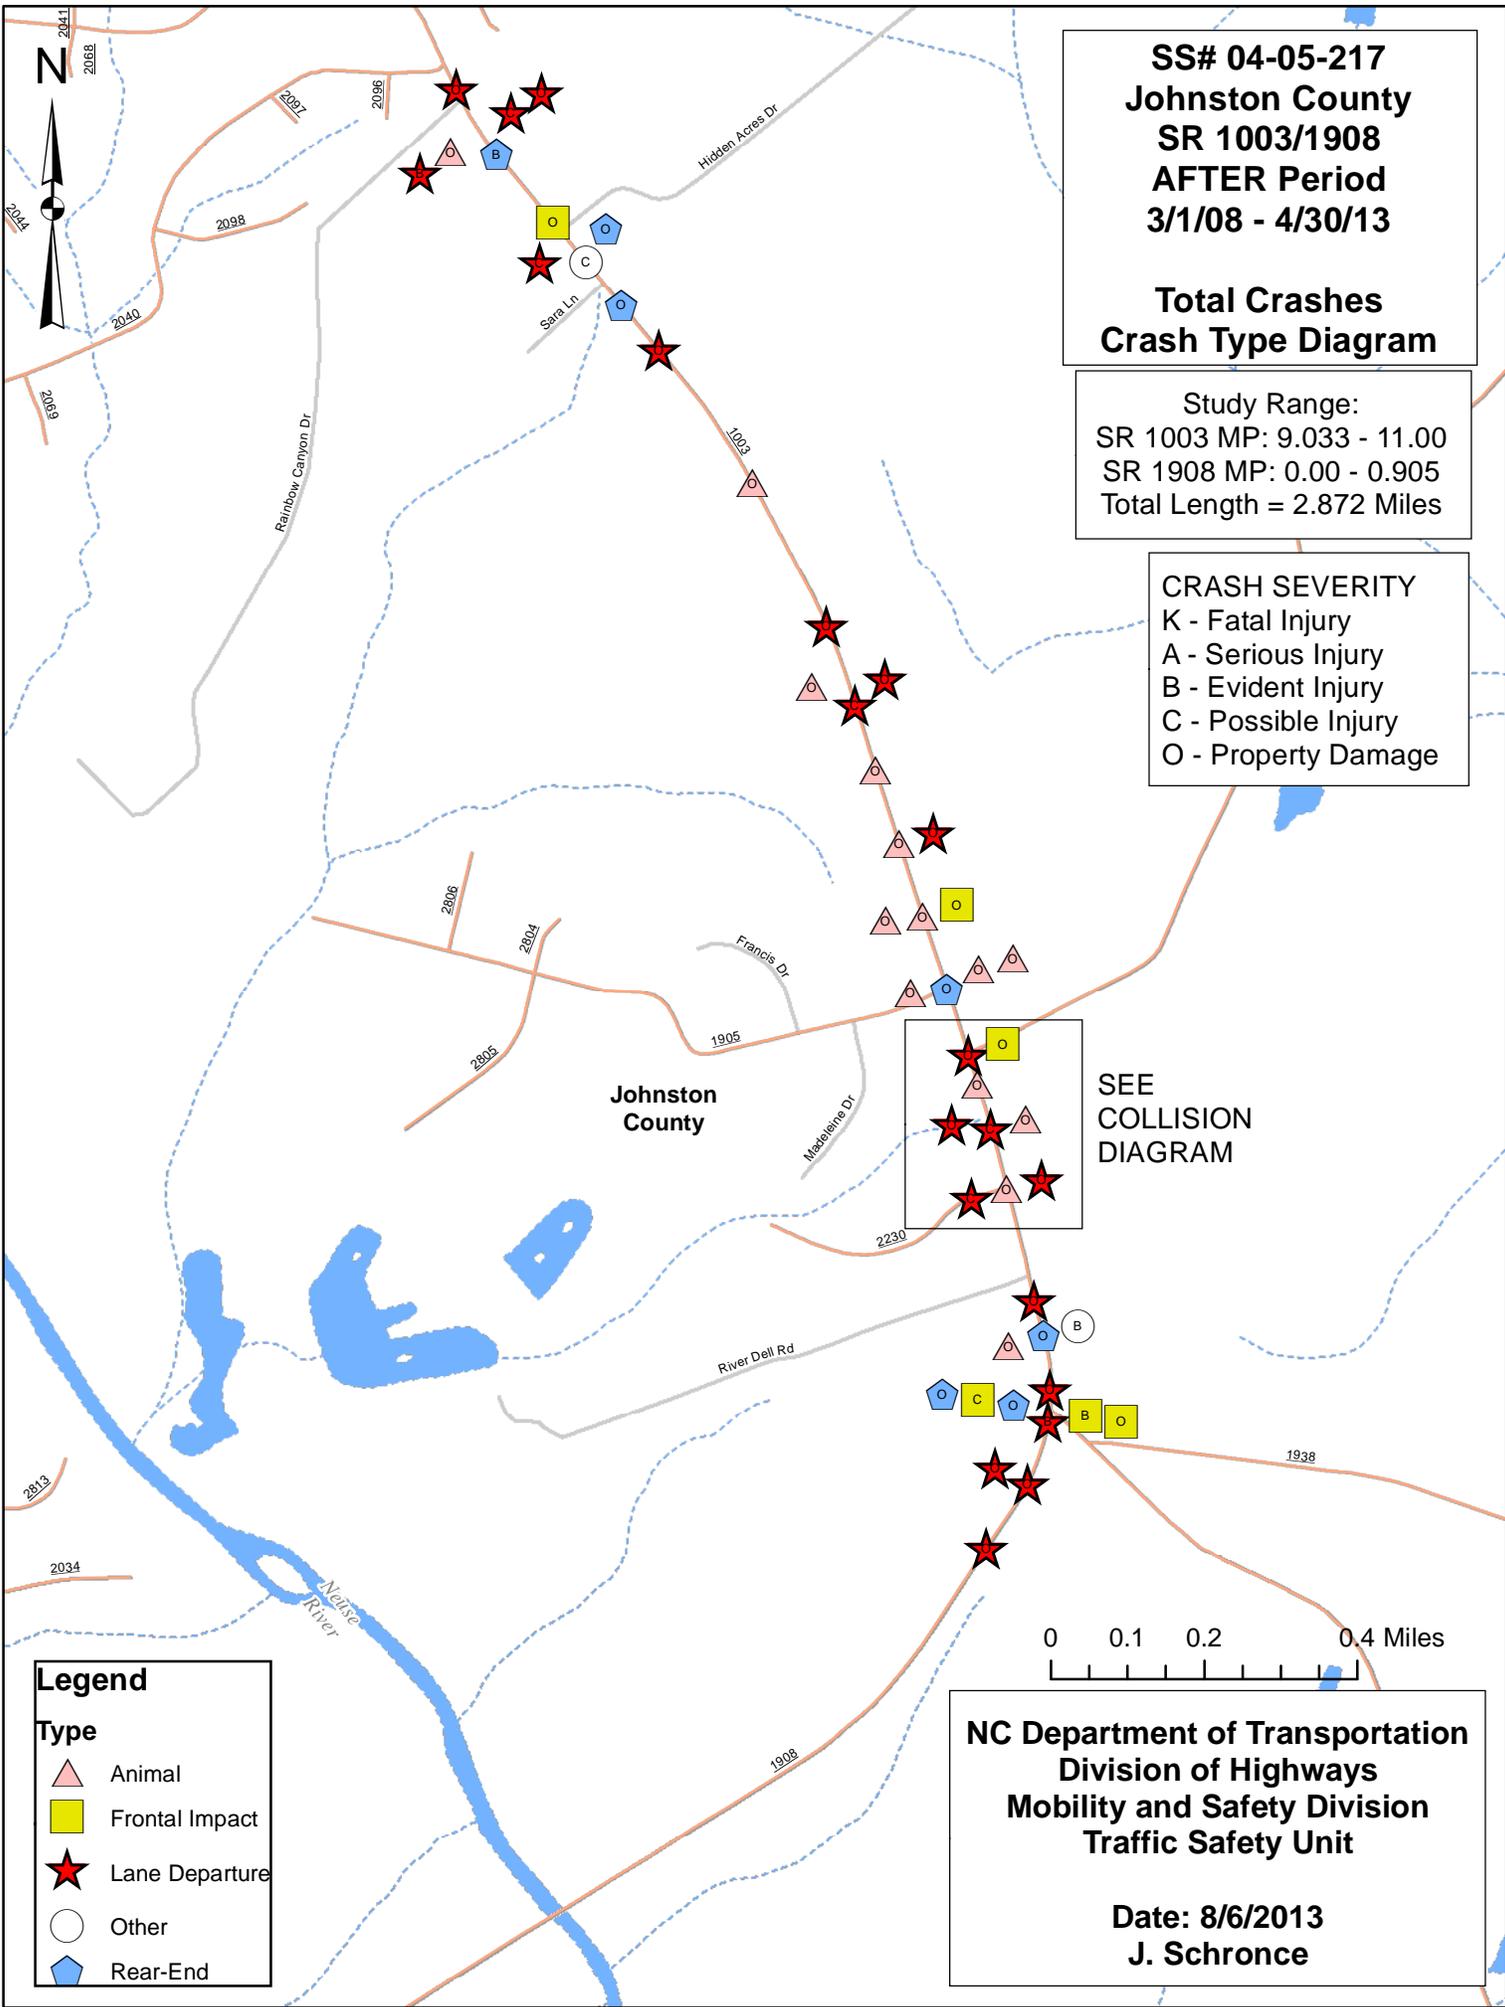
Total Crashes
Crash Type Diagram

SS# 04-05-217
Johnston County
SR 1003/1908
AFTER Period
3/1/08 - 4/30/13

Study Range:
 SR 1003 MP: 9.033 - 11.00
 SR 1908 MP: 0.00 - 0.905
 Total Length = 2.872 Miles

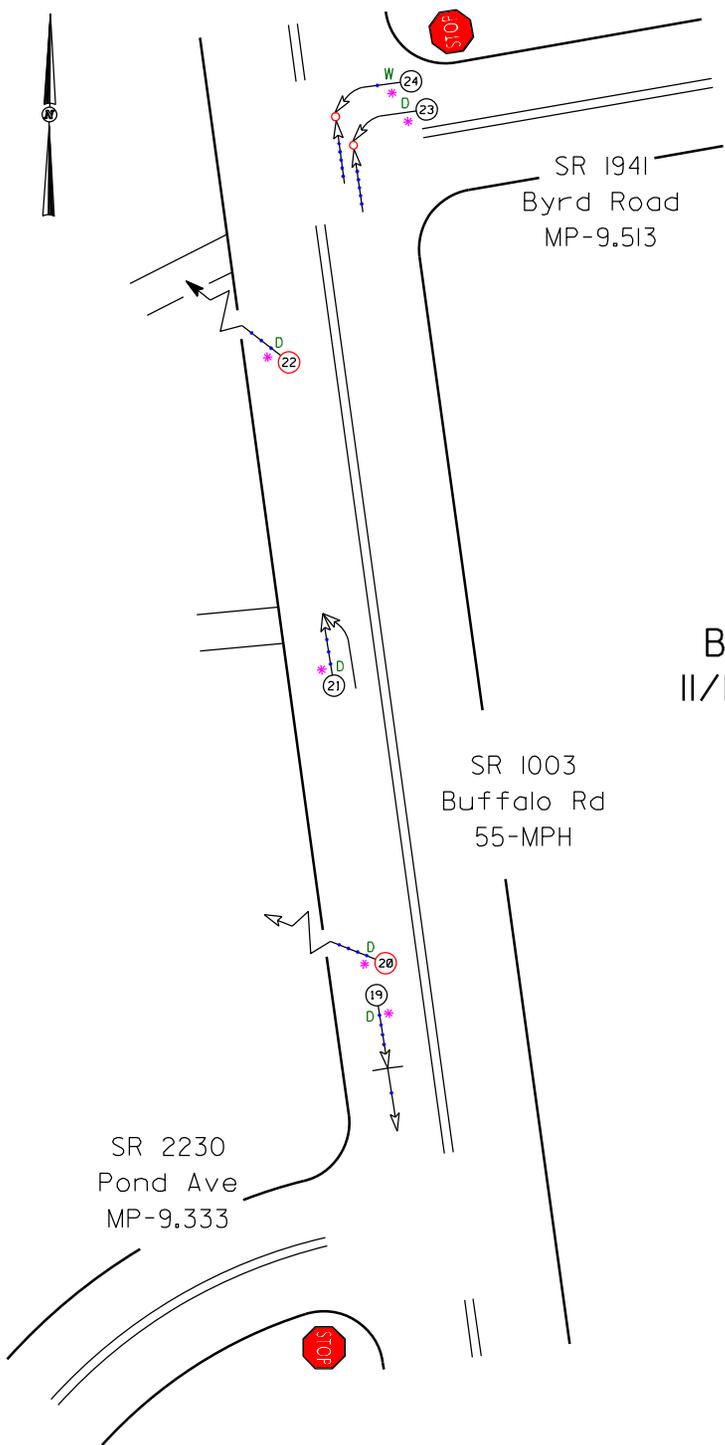
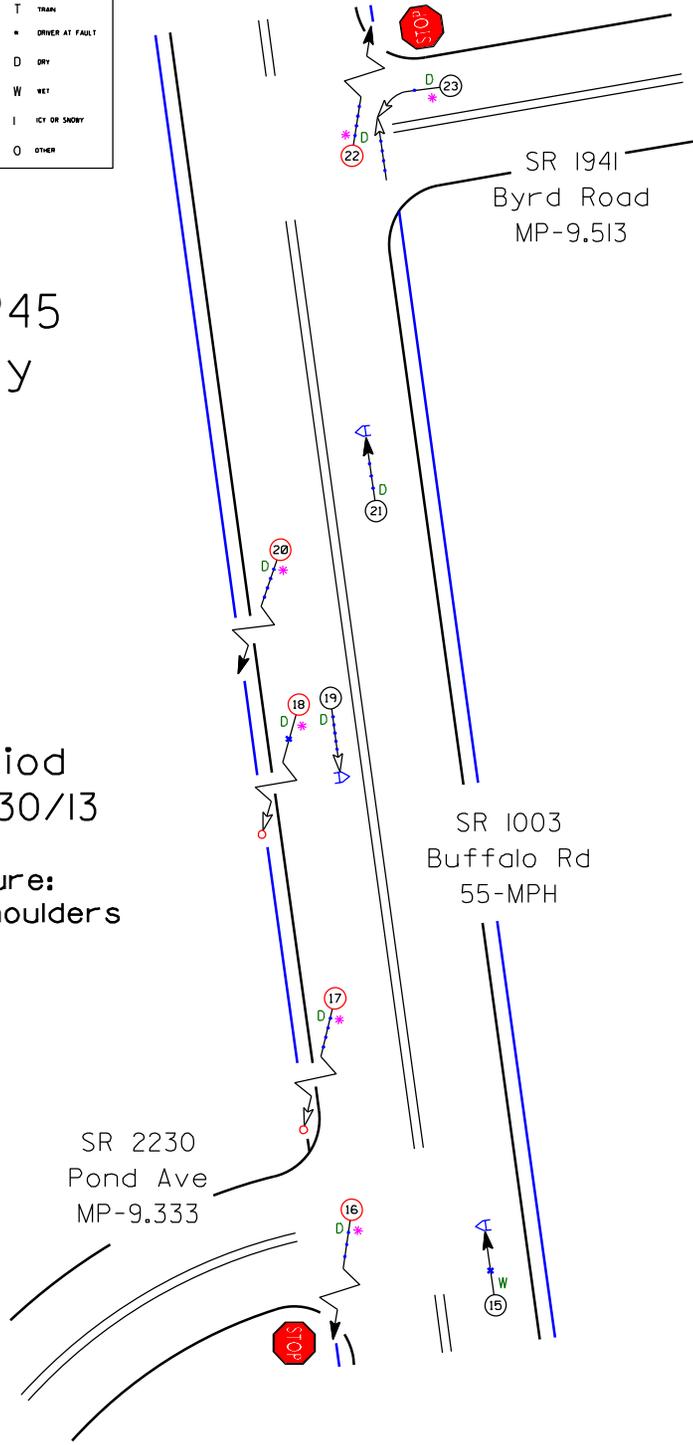
Lane Departure
Target Crashes

SS# 04-05-217
Order# 41000023245
Johnston County

BEFORE Period
11/1/02 - 12/31/07

AFTER Period
3/1/08 - 4/30/13

Countermeasure:
1.5-Foot Paved Shoulders
