# **Spot Safety Project Evaluation**

## **Spot Safety Project Evaluation of the Traffic Signal Installation at US 301 and Peedin Street and Canterbury Road in Johnston County**

Evaluation of Spot Safety Project Number 04-01-228 – Traffic Signal Installation at US 301 at Peedin Street and Canterbury Road in Johnston County.

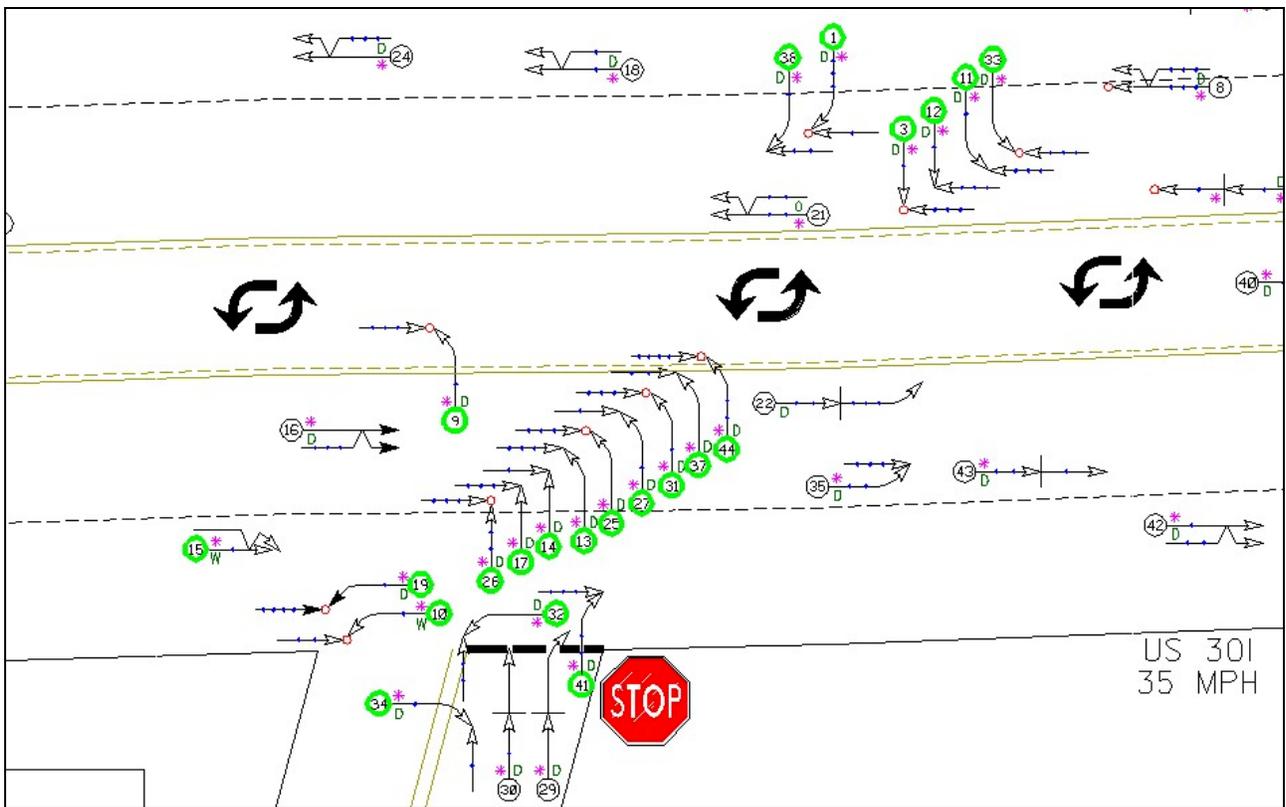
Figure 1. (The green, bolded circles denote “correctable crashes”)

Table 1 and the collision diagrams show a significant decrease in frontal impact crashes. Referencing the before period collision diagram there were 22 frontal impact crashes which may be considered correctable, for the after period there were 9 (see Figures 1 and 2). This information shows that the signal was successful in reducing frontal impact crashes.

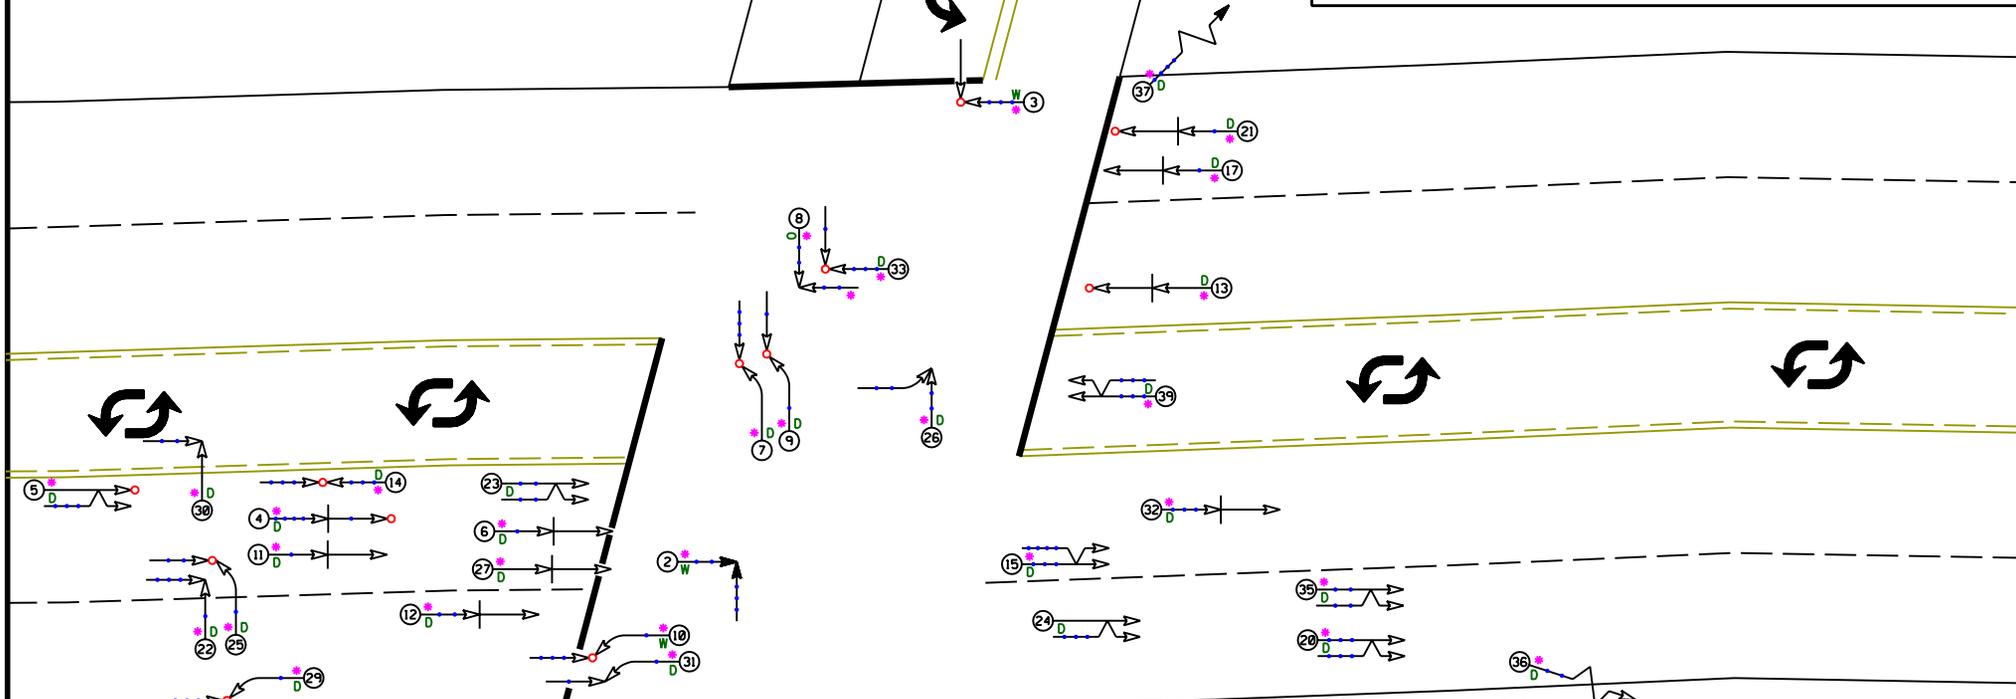
Johnston County  
Treatment Site - Total Crashes  
After Period  
February 1, 2003 - September 30, 2006  
(3 years, 8 months)

Signal over  
Left Turn lane  
on US 301

Signalized  
Intersection
