Spot Safety Project Evaluation

Spot Safety Project # 04-97-267

**Spot Safety Project Evaluation of the Traffic Signal Installation at SR 1538 (Fenner Road)
and SR 1539 (Instrument Drive) in Nash County**

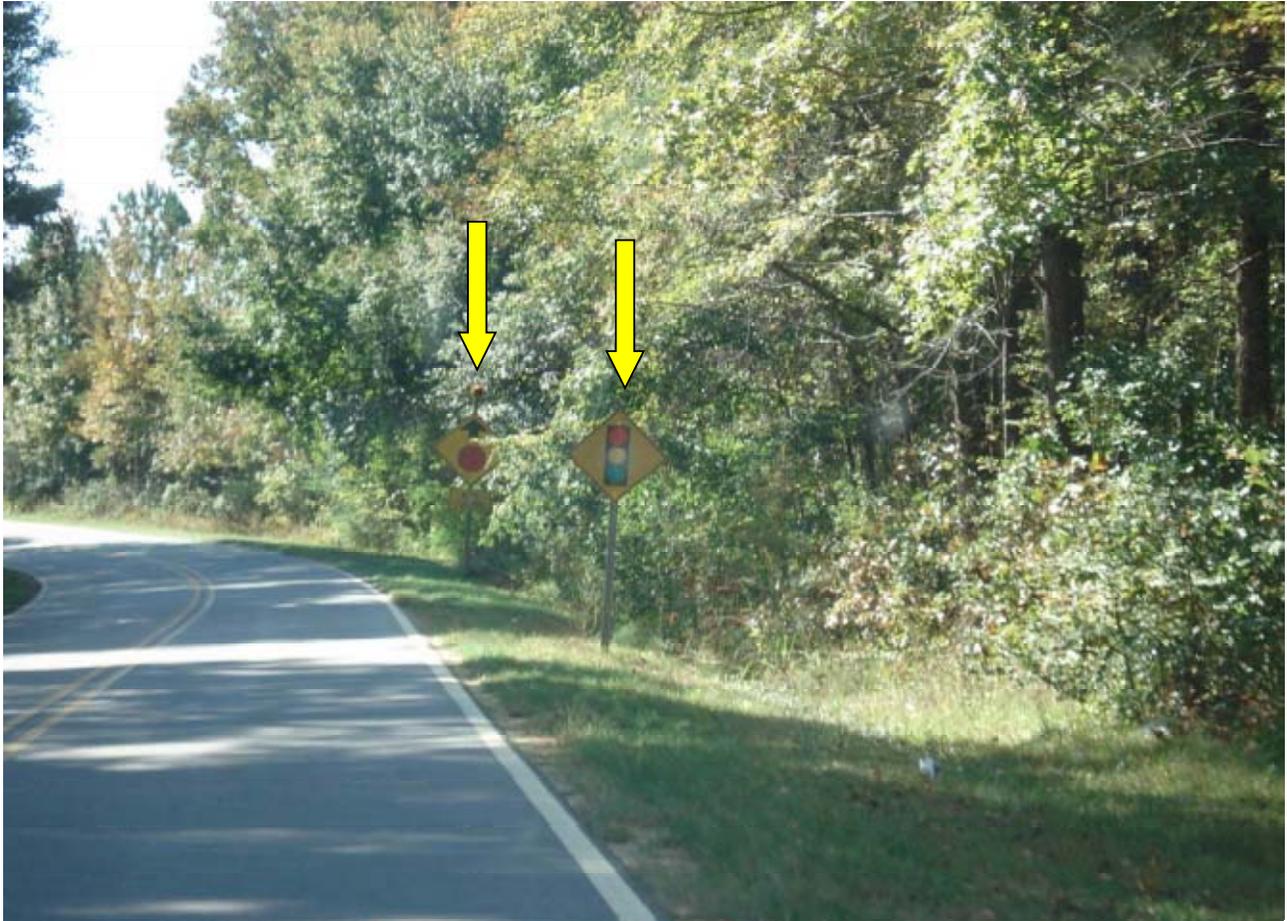
Figure 1.

This photo shows a Signal Ahead and a Stop Ahead sign in succession. This may be confusing as to which traffic control device is being used at the intersection.

Prior to the traffic signal installation, there were other countermeasures implemented. Signing and pavement markings were improved, the speed limit was reduced to 45 mph on a portion of the north leg of SR 1538, and an actuated, shoulder mounted “Vehicle Entering When Flashing” sign was installed on the north approach of SR 1538. Upon installation of the signal all of the previous countermeasures remained unchanged except for the shoulder mounted flasher. The shoulder mounted flasher is now actuated by the yellow interval on SR 1538 alerting vehicles to stop ahead (Figures 1 and 2).

The following is the standard, from the MUTCD 2003 edition Section 2C.29, for this type of situation:

When a BE PREPARED TO STOP (W3-4) sign is used in advance of a traffic control signal, it shall be used in addition to a Signal Ahead sign.

The BE PREPARED TO STOP sign may be supplemented with a warning beacon (see Section 4K.03).

When the warning beacon is interconnected with a traffic control signal or queue detection system, the BE PREPARED TO STOP sign should be supplemented with a WHEN FLASHING plaque.

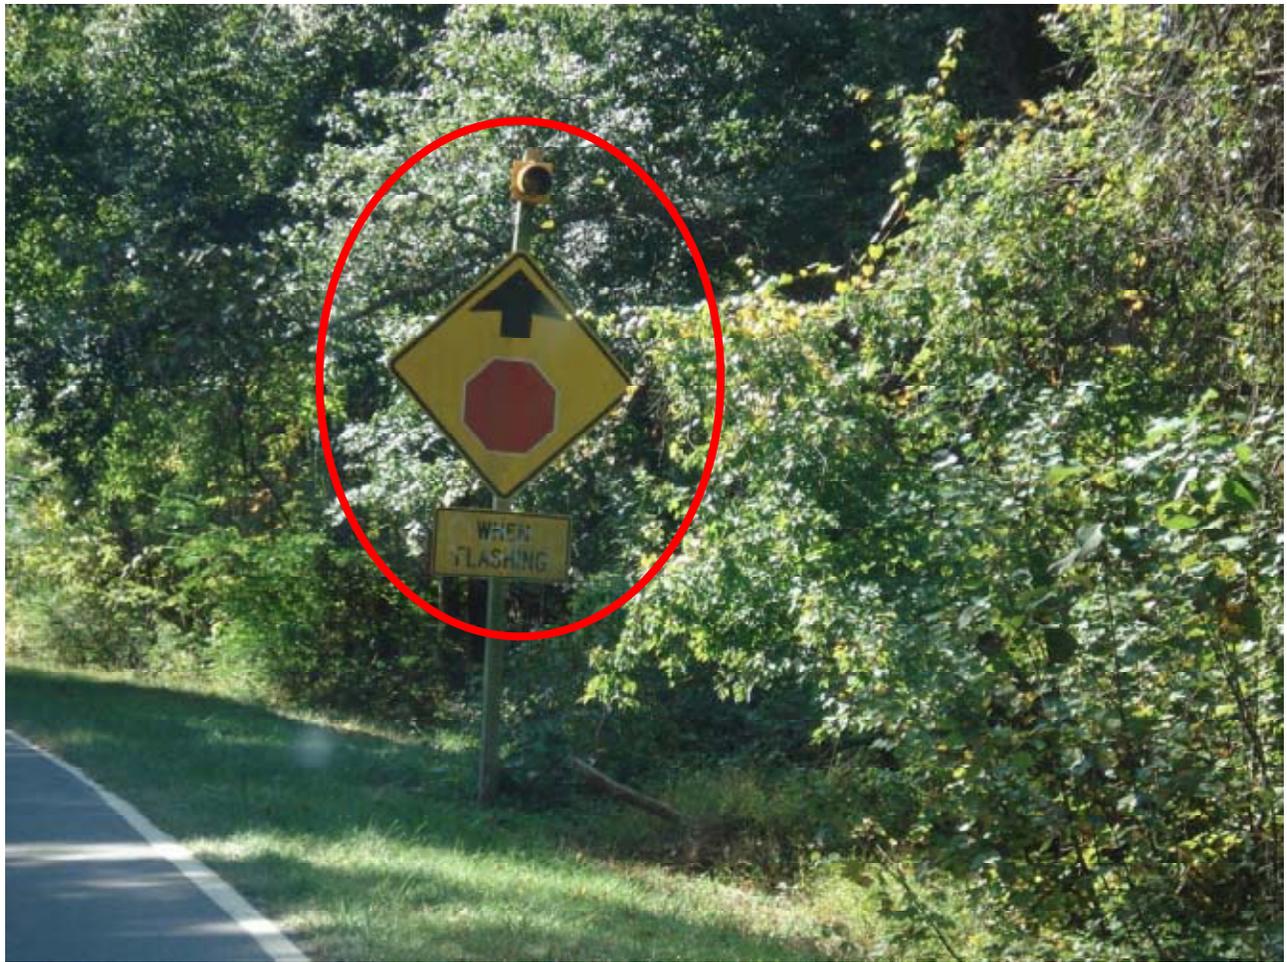
Figure 2.

A Stop Ahead (W3-1) sign shall be used where a STOP sign is not visible for a sufficient distance to permit the road user to bring the vehicle to a stop at the STOP sign. (MUTCD 2003, Section 5C.04)

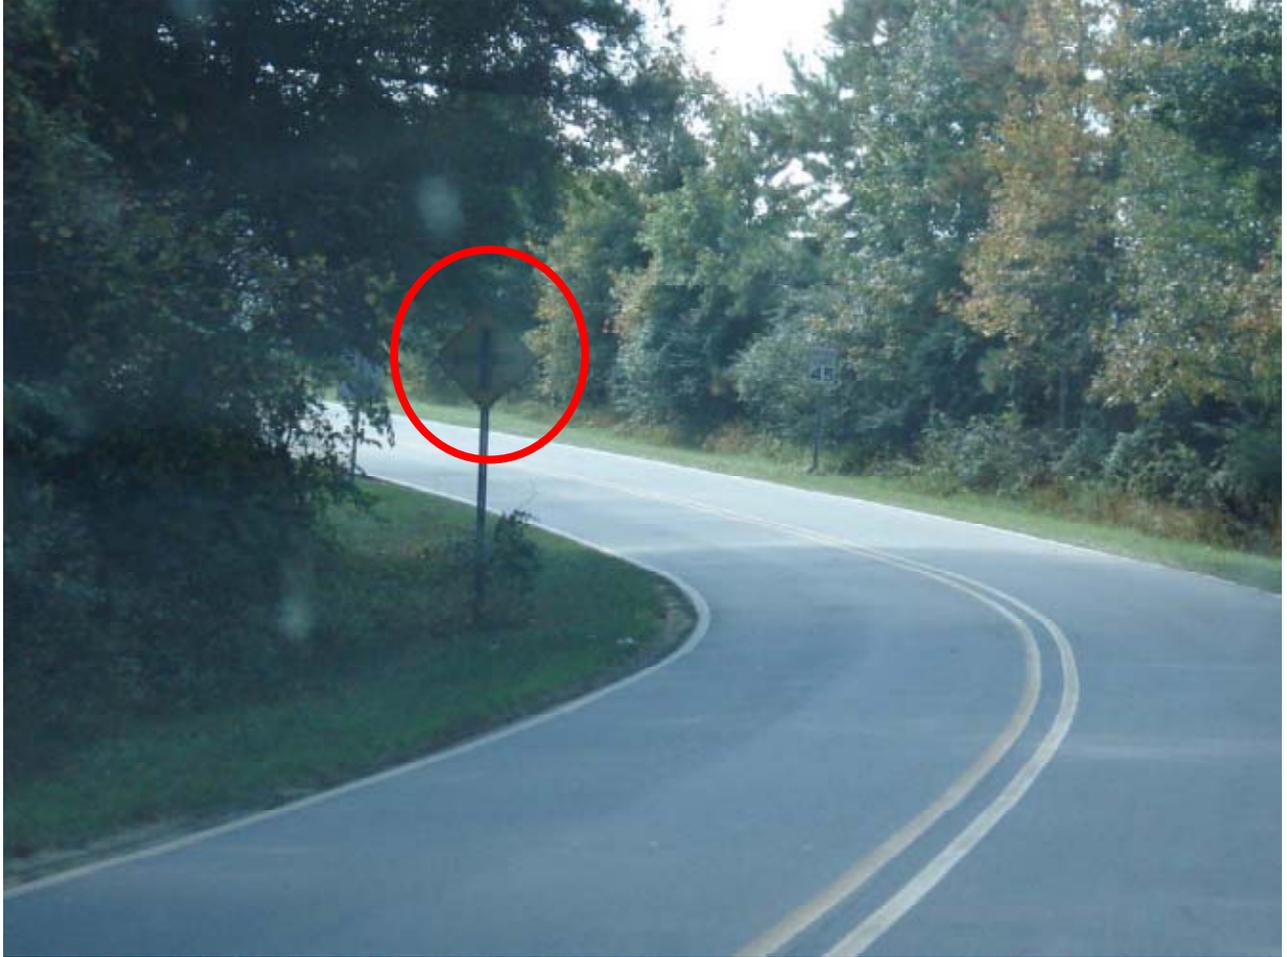
Figure 3.

Intersection warning signs, other than the Circular Intersection symbol (W2-6) sign and the T-intersection symbol (W2-4) sign, should not be used on approaches controlled by STOP signs, YIELD signs or signals. (MUTCD 2003, Section 2C.37) Also this sign was placed on the left side of the roadway which gives it the potential to be blocked by trucks from the local industrial area.

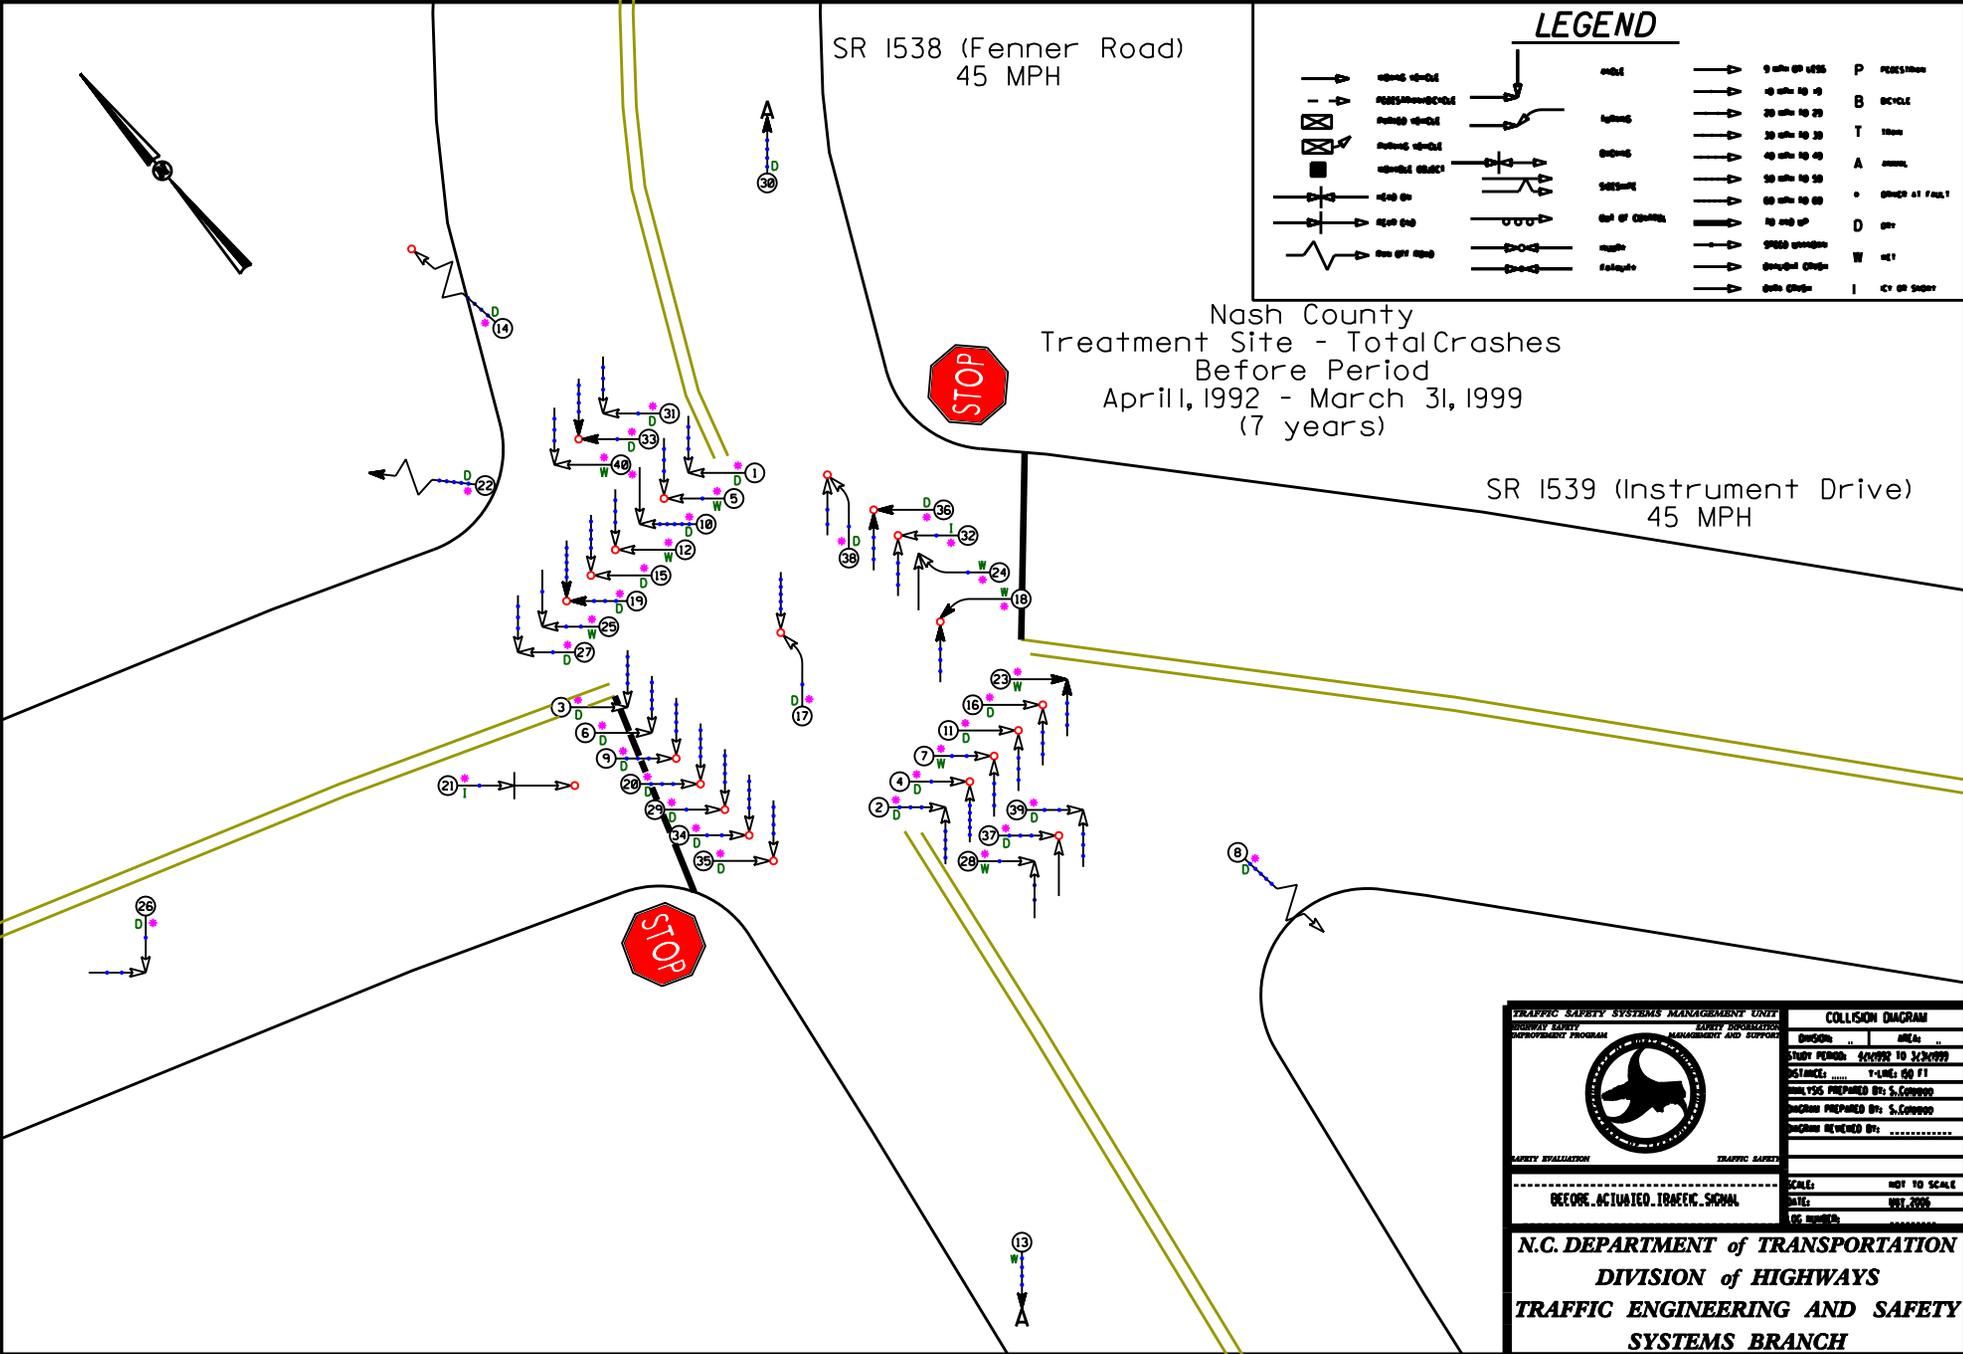
Nash County
Treatment Site - Total Crashes
Before Period
April 1, 1992 - March 31, 1999
(7 years)

The treatment location shows a significant decrease in the number of Frontal Impact Crashes and severity from the before to the after period. There were 33 Frontal Impact crashes in the before period directly at the intersection. Eighteen crashes involved vehicles from the north approach and 15 from the south approach. The after period shows a total of three Frontal Impact crashes, all involving vehicles from the north approach. Poor sight distance may still exist at the intersection, but adequate signing and traffic control seems to have assisted in reducing crashes.

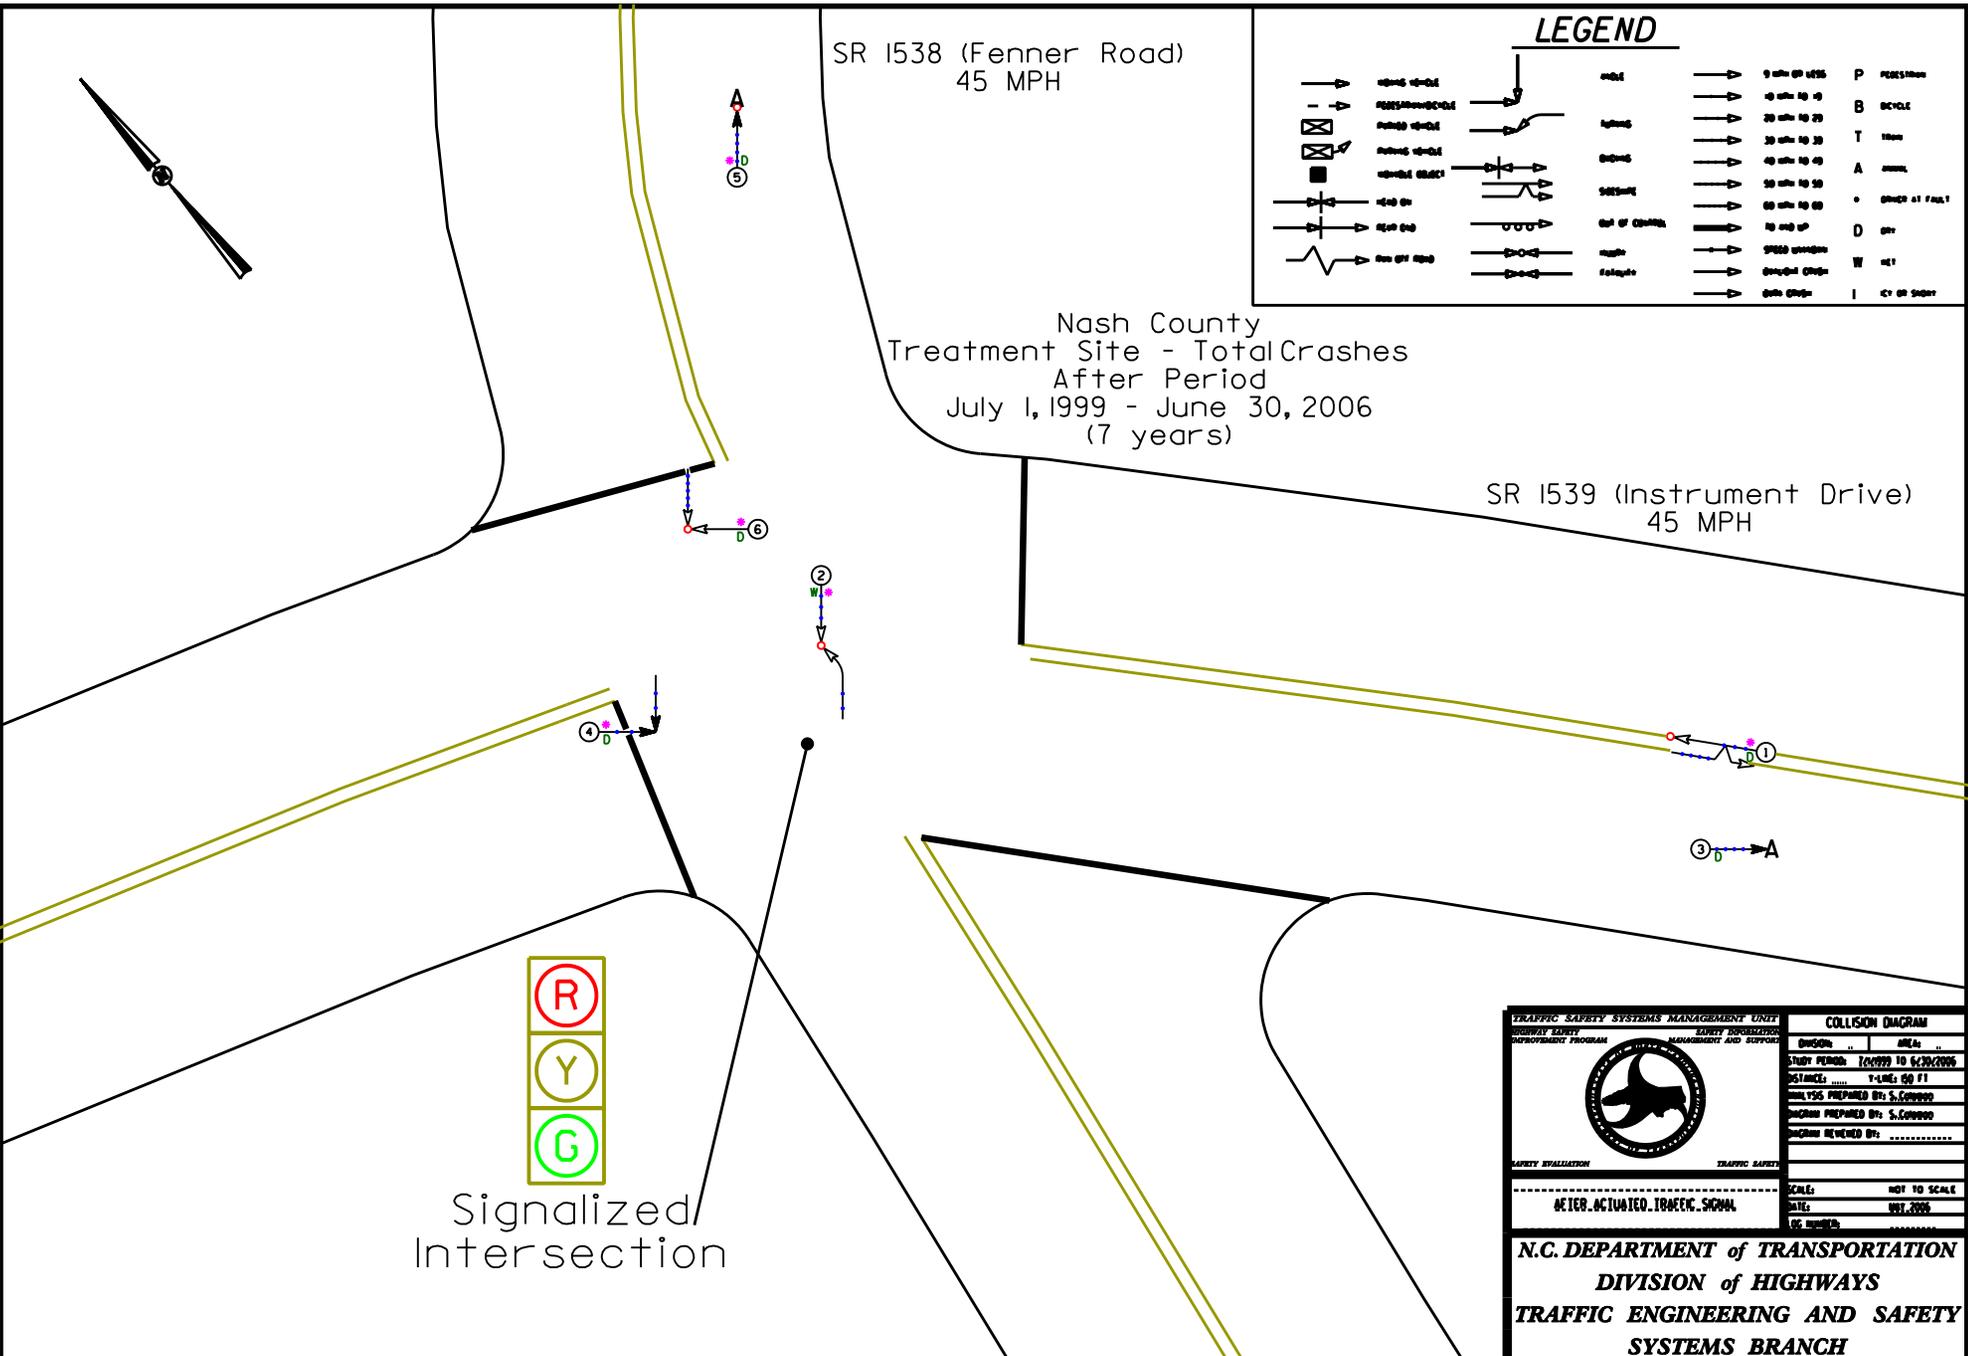
The naïve before and after analysis involving the comparison of treatment actual before data versus treatment actual after data resulted in an 85 percent decrease in Total Crashes and a 91 percent decrease in Frontal Impact Crashes. The summary results above demonstrate that the treatment location appears to have had a decrease in the number of Total Crashes and a decrease in the number of Frontal Impact Crashes from the before to the after period.
